**ALIWAL QUARRY**  
**A PORTION OF ERF 2928,**  
**ALIWAL NORTH, EASTERN CAPE PROVINCE**

**ENVIRONMENTAL PERFORMANCE ASSESSMENT /**  
**ENVIRONMENTAL AUDIT REPORT**

<b>DMR REFERENCE NUMBER:</b>	<b>EC 30/5/1/2/2/215 MR</b>
<b>AUDIT PERIOD:</b>	<b>August 2023 – May 2024</b>

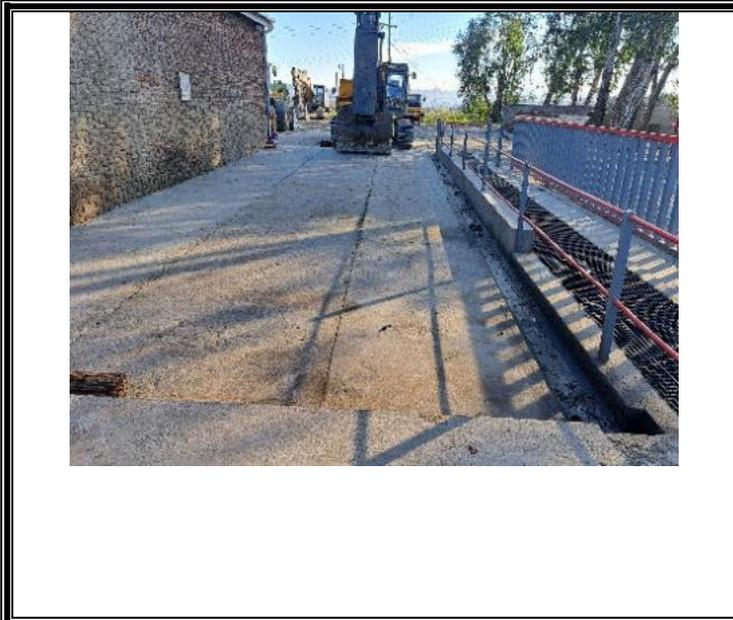
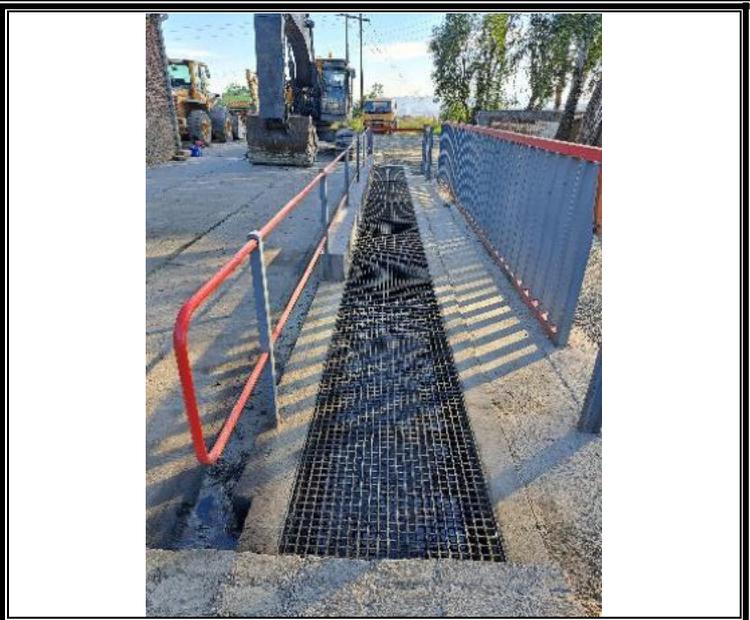
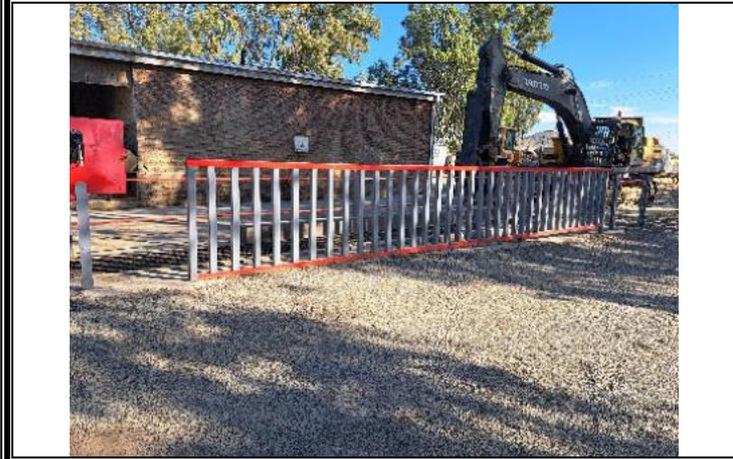
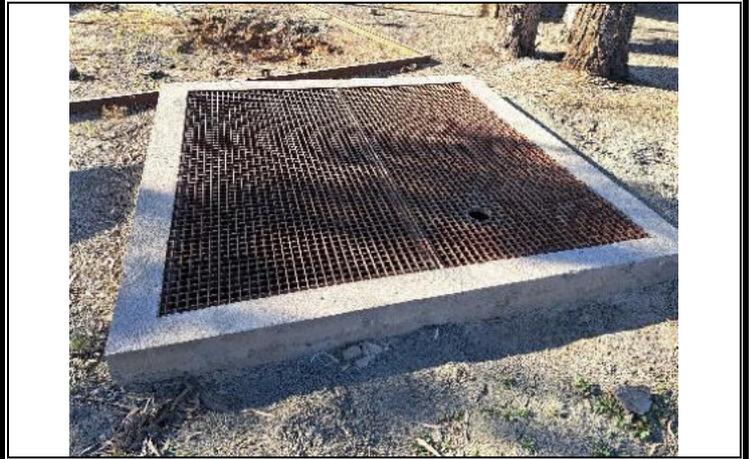
**Wash bay and oil sump improvements**

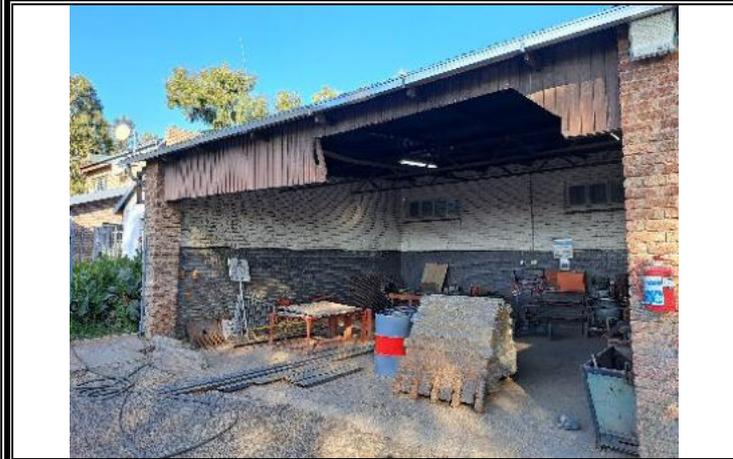
**Neatly managed workshop**

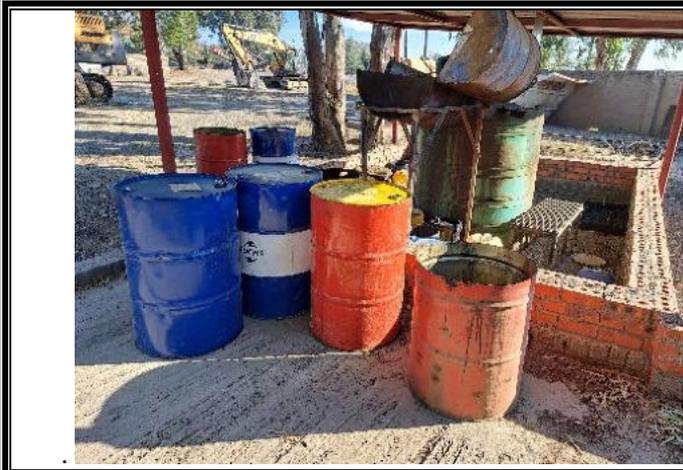
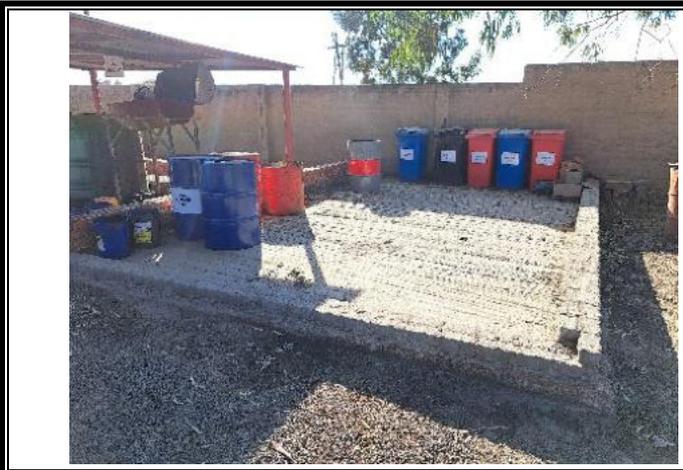
The bund of the hazardous waste/used oil storage area must be sealed, and management must ensure that all drums and drip trays containing used oil or other chemicals are stored inside the bunded areas.

**Waste storage area where the bund must be sealed and all drums placed inside the bund**

20. Obtain proof of registrations certificates from the waste service providers;
21. Seal the bund of the hazardous waste storage area;
22. Increase the capacity of the diesel tank bund and seal the walls;

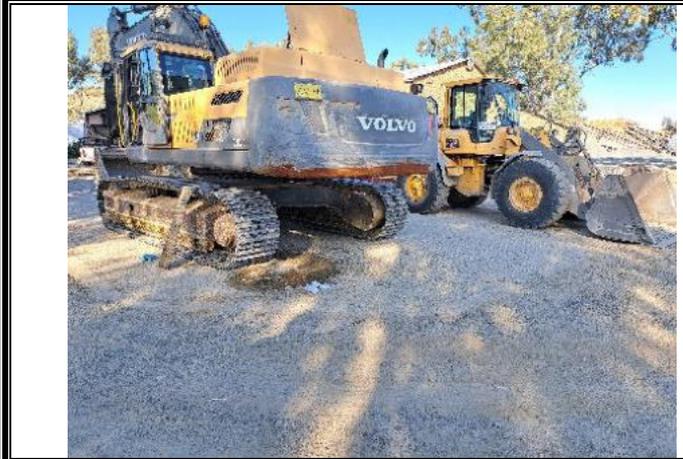
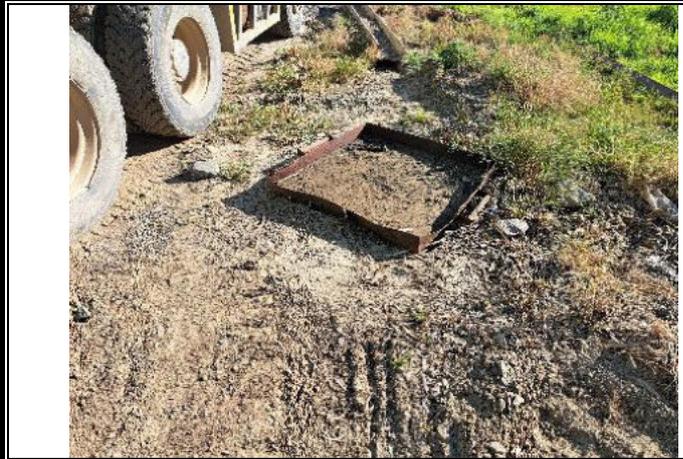
**Drip trays in use and servicing taking place on paved area**

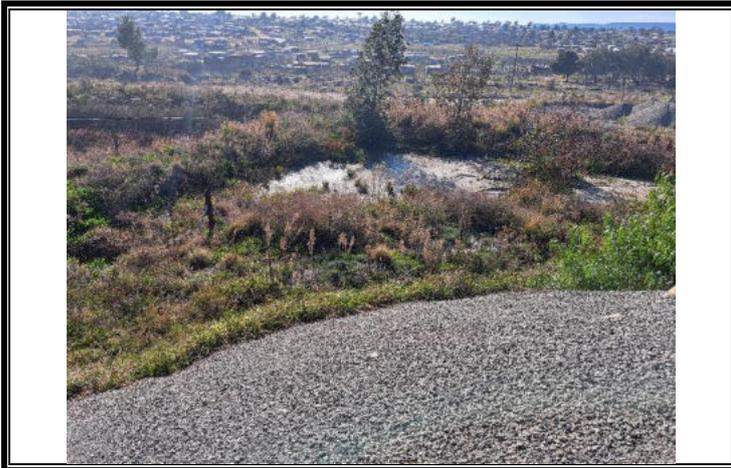
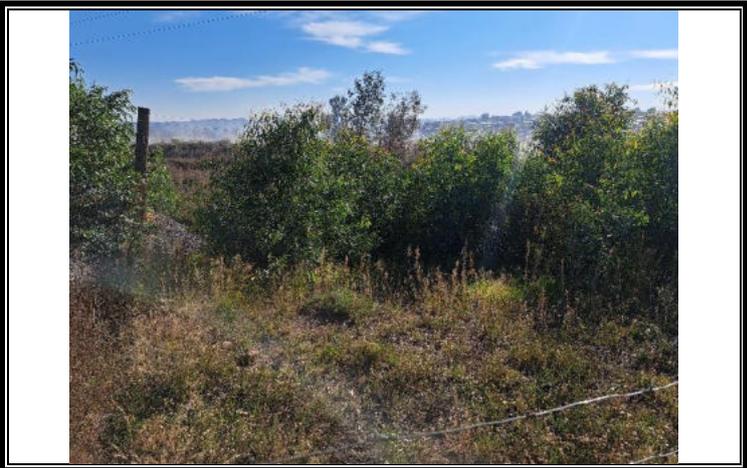
**Settling ponds to be cleaned**

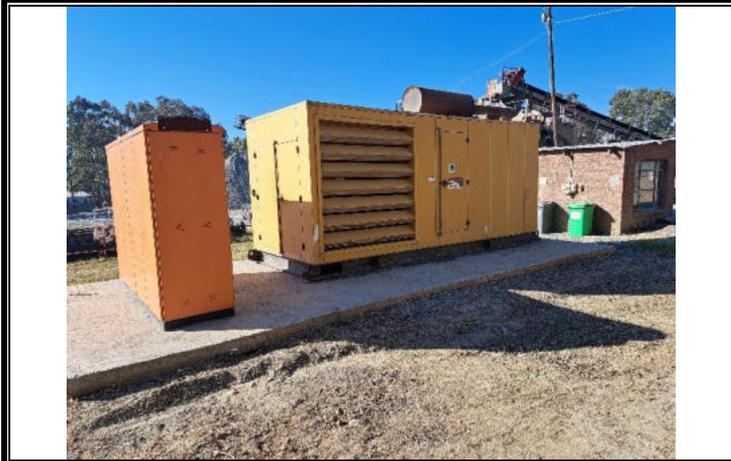
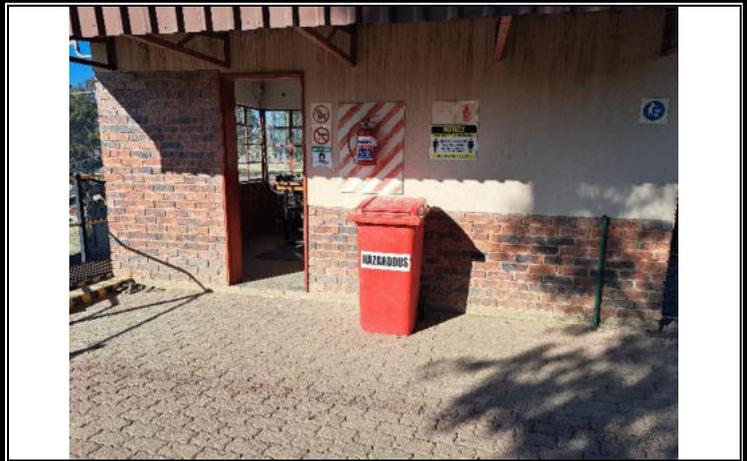
**Bund wall to be added to the generator**

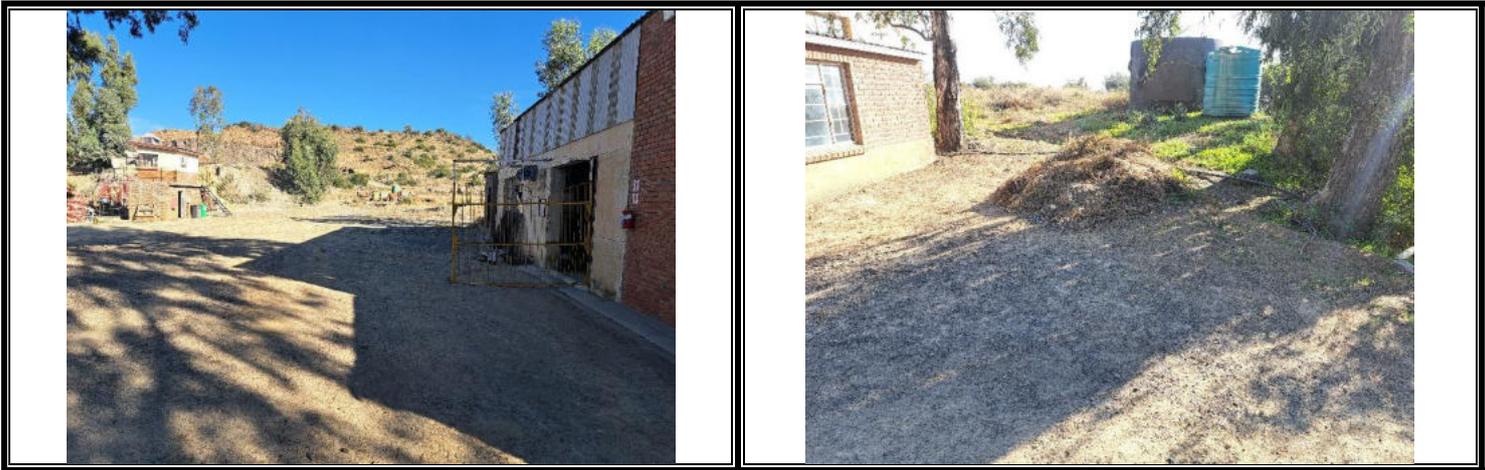
**Clearing of problem plants in progress**

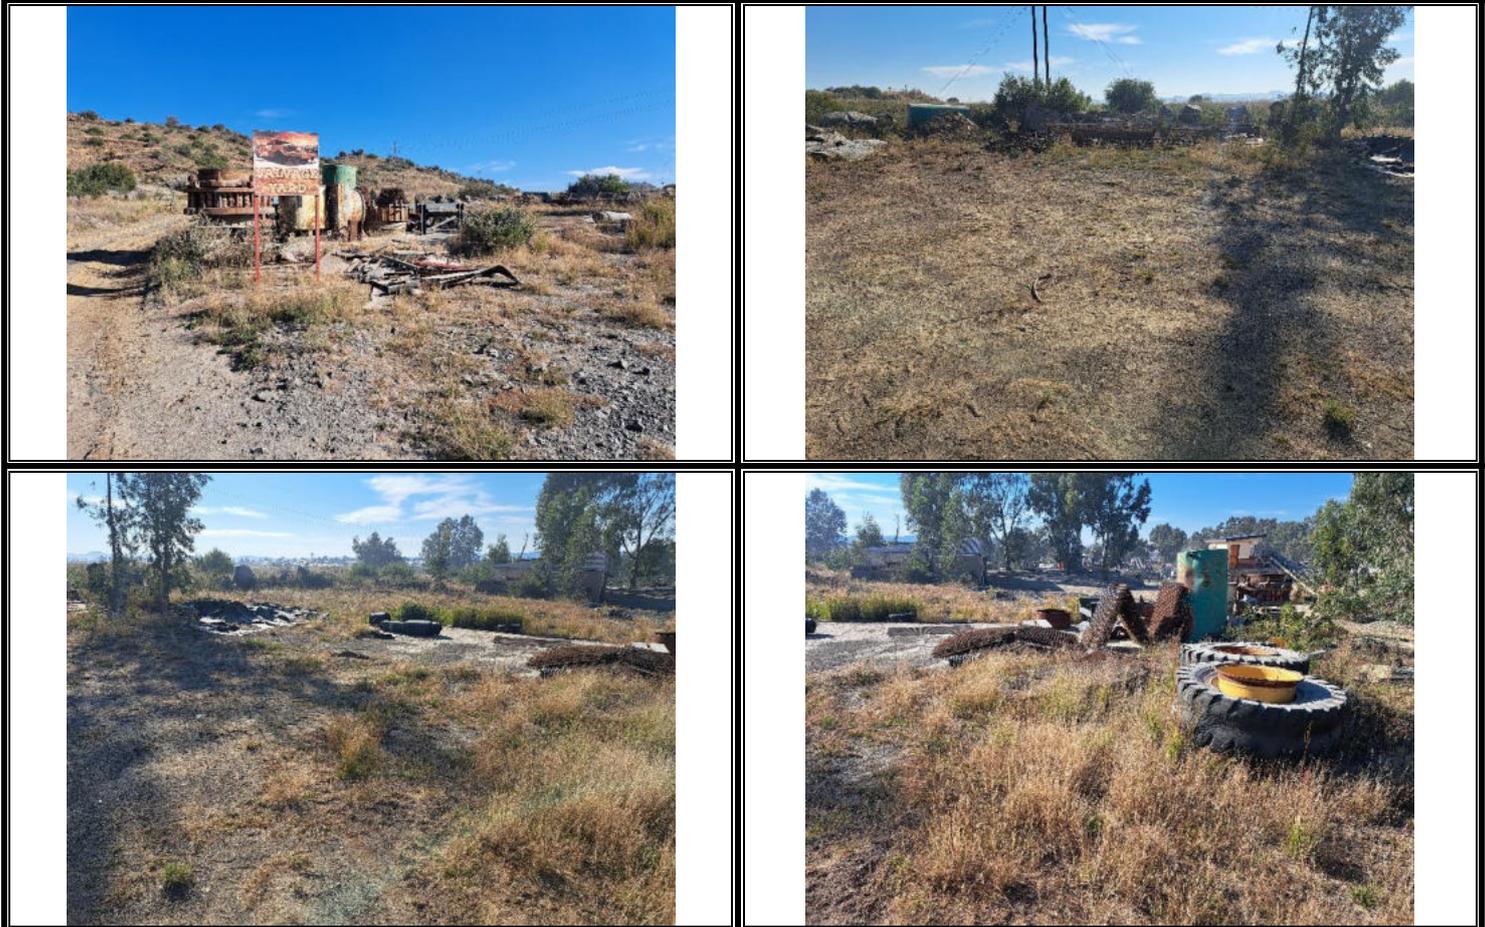
**Salvage yard cleaned up**

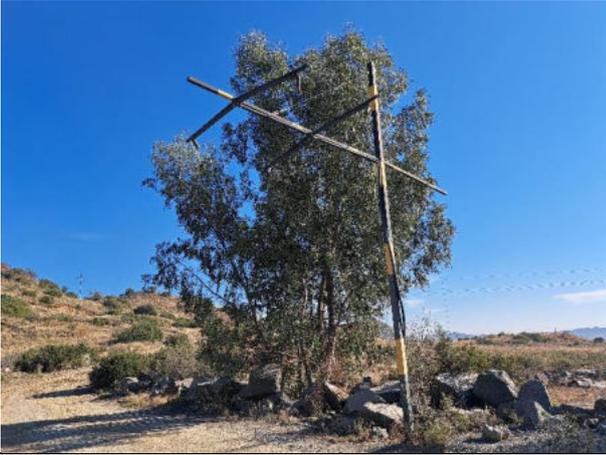
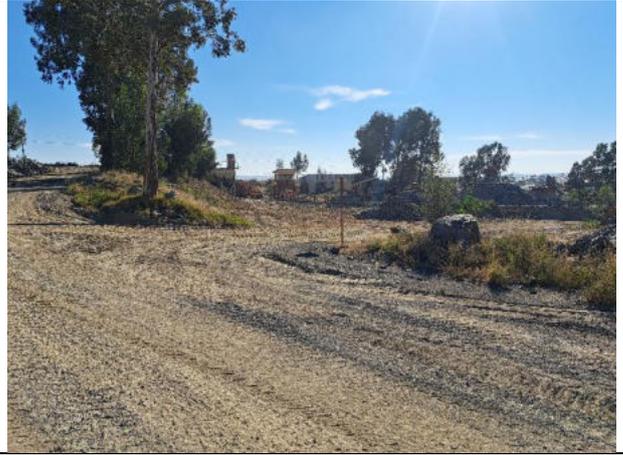
Sprayers added to alleviate dust

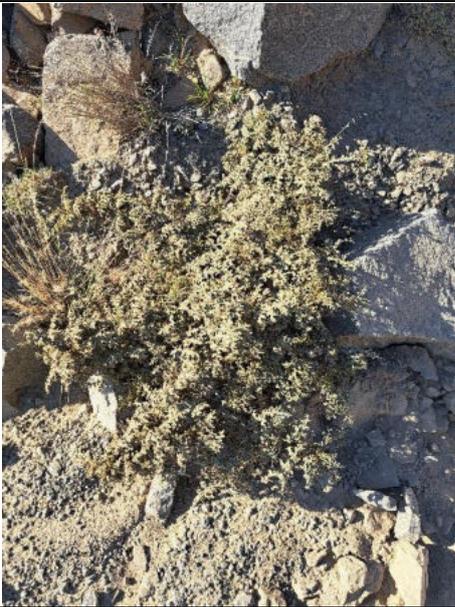
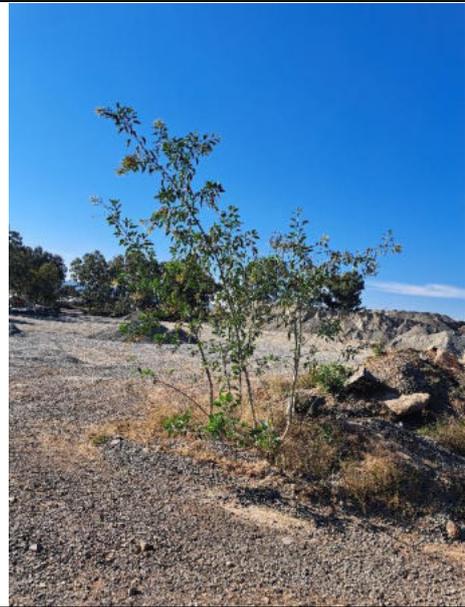
Problem plants to be cleared from site

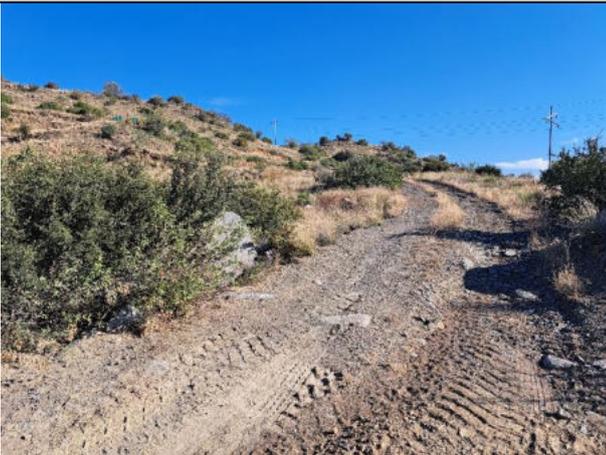
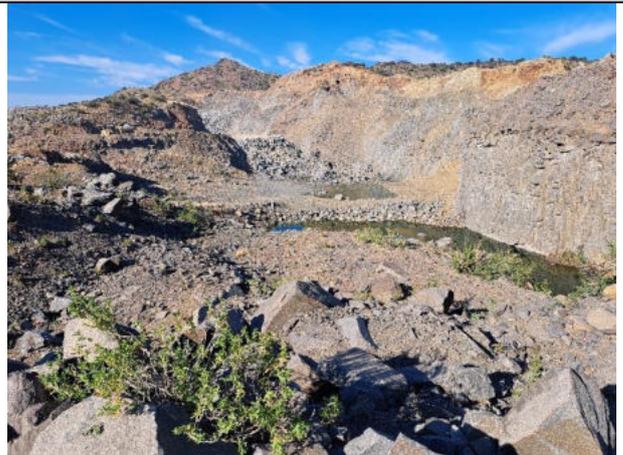
Quarry pit where the bridge (under construction) can be seen

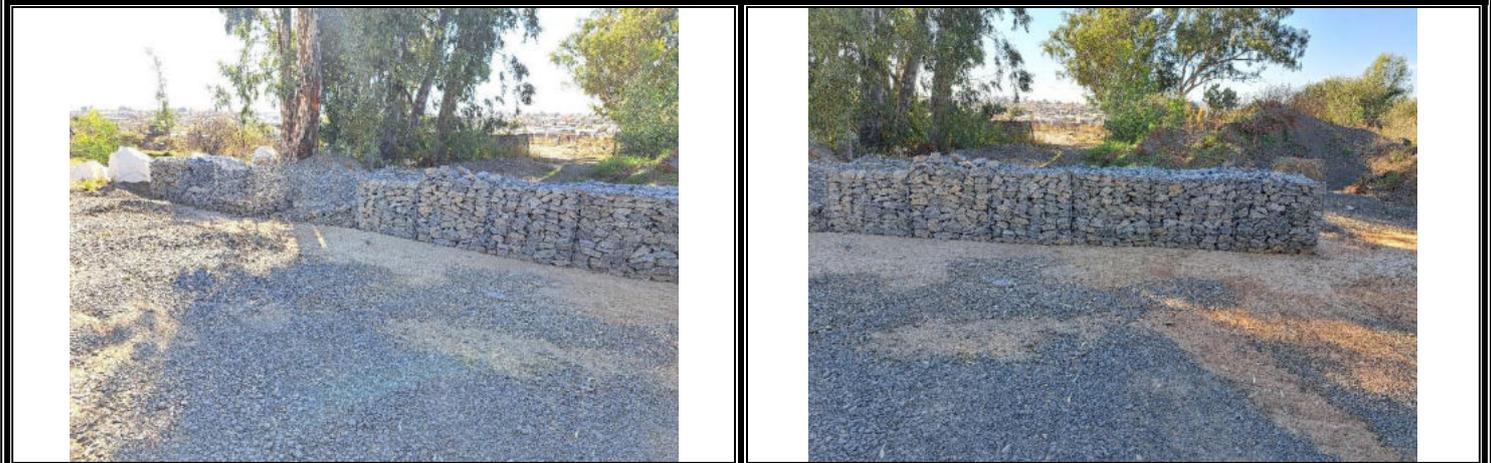
**Gabions being installed on site**

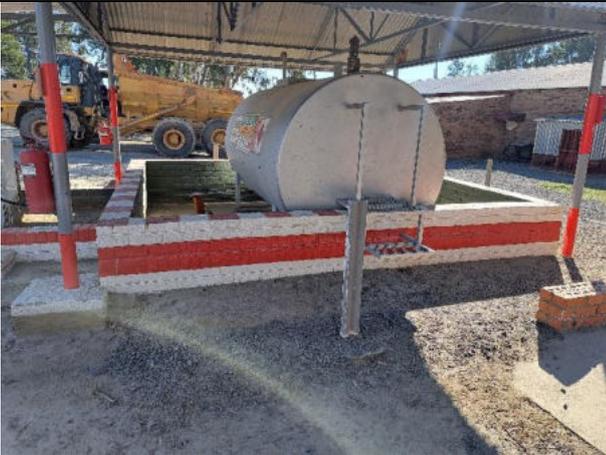
**Bund of diesel tank to be increased**
