AGGREGATE / GRAVEL MINE ON PORTION 7 OF THE FARM ROODEKRANS 457

ENVIRONMENTAL PERFORMANCE ASSESSMENT REPORT

REFERENCE NUMBER:	MP 30/5/1/3/2/10893 MP
AUDIT PERIOD:	NOVEMBER 2025

Permit Number:	MP 30/5/1/3/2/10893 MP	Date of Commencement:	June 2024
Site Name:	Roodekrans Quarry	Inspection Date:	11 November 2025
Contractor:	B&E International (Pty) Ltd	Report Number:	03
Environmental Control Officer:	Zoë Norval	Other Authorisations:	None

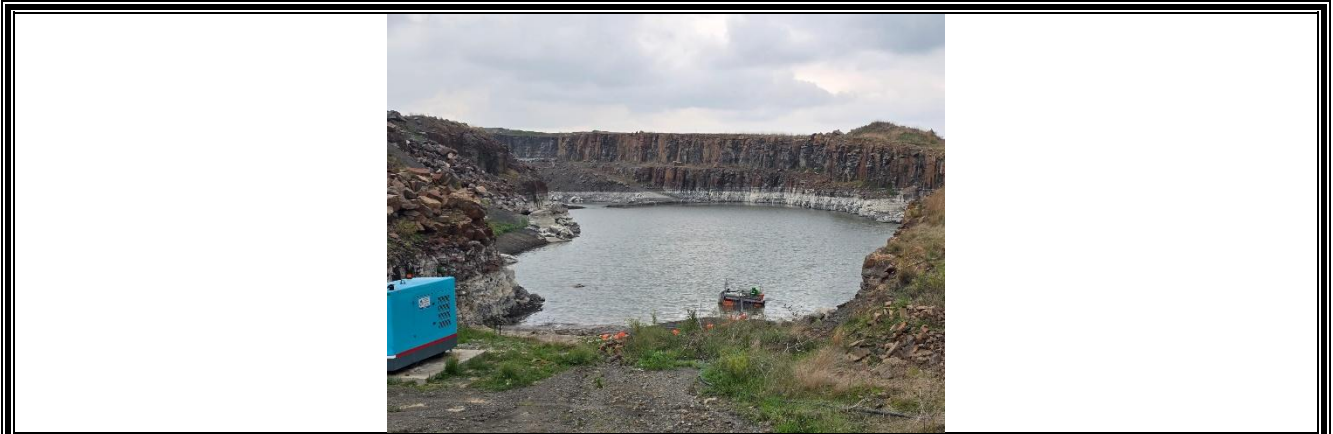
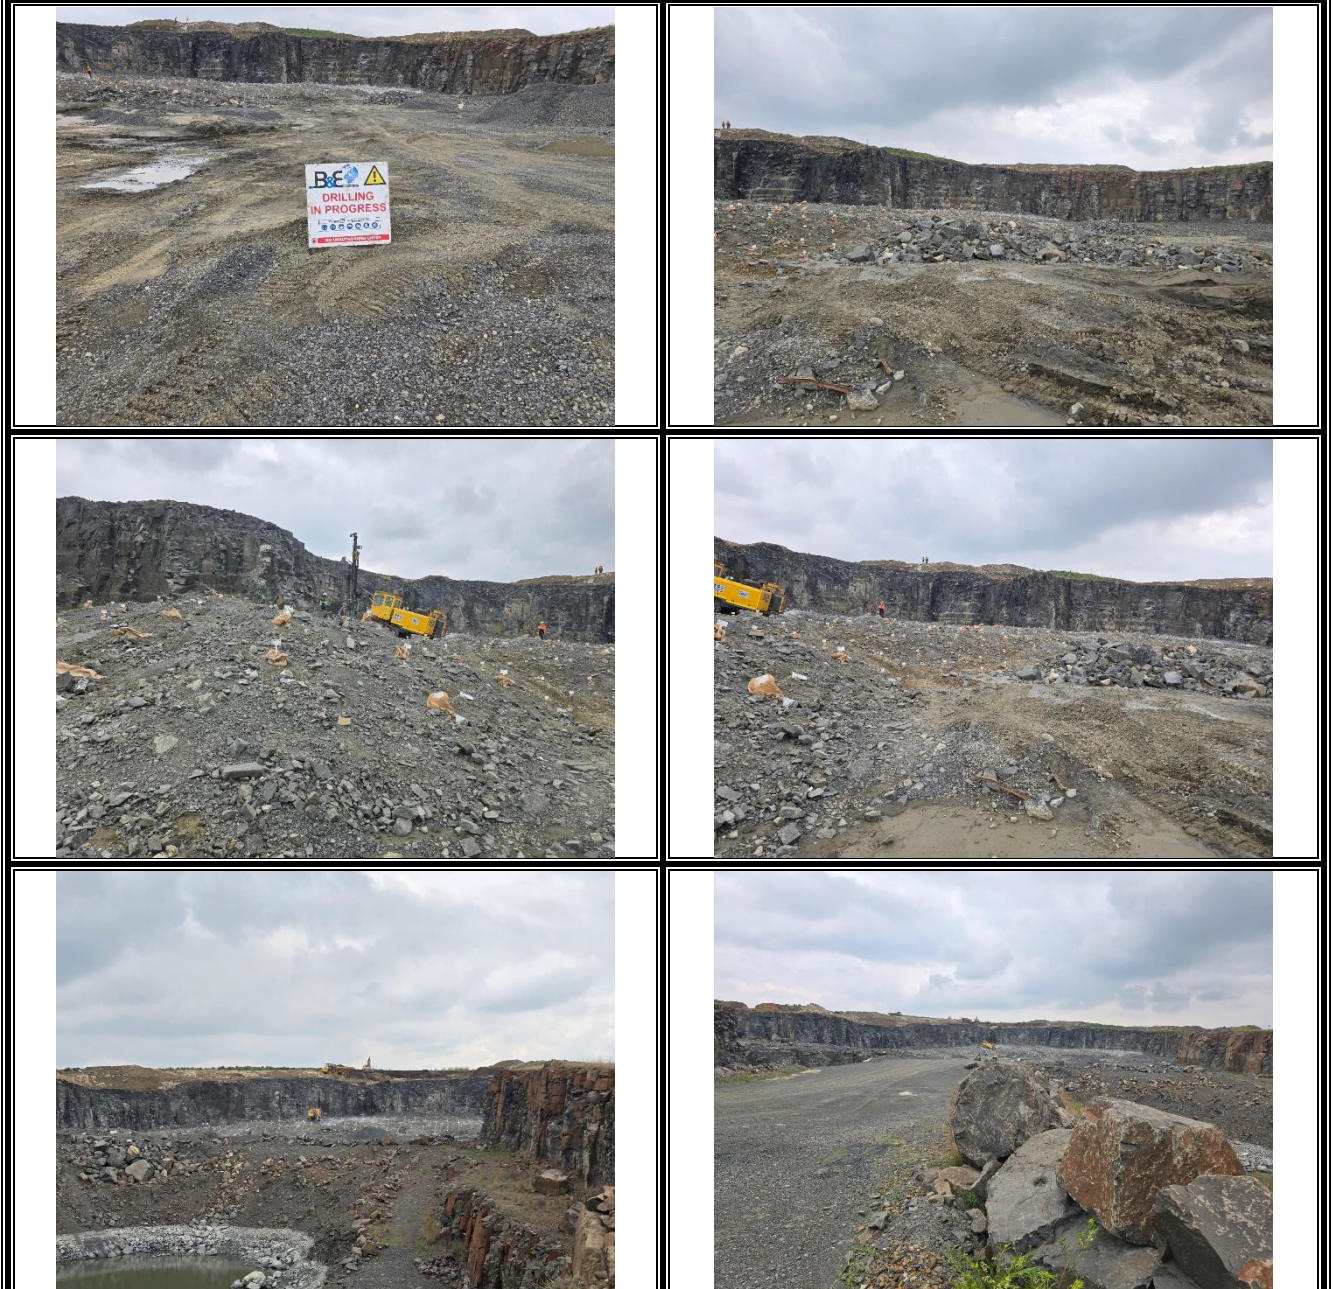
EXCAVATION AND PROCESSING AREA

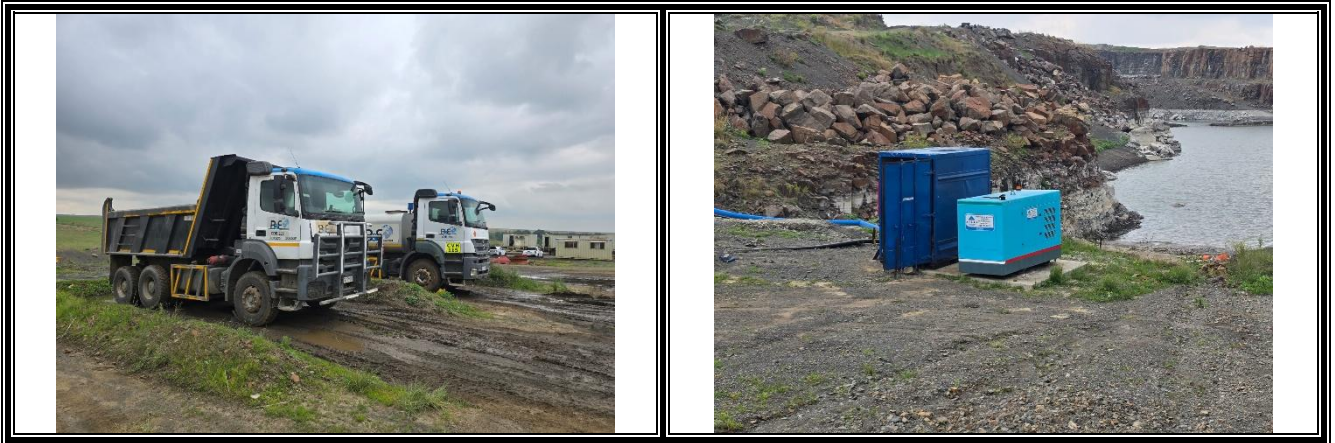
GENERATOR WITH OIL LEAK (TO BE REMOVED)

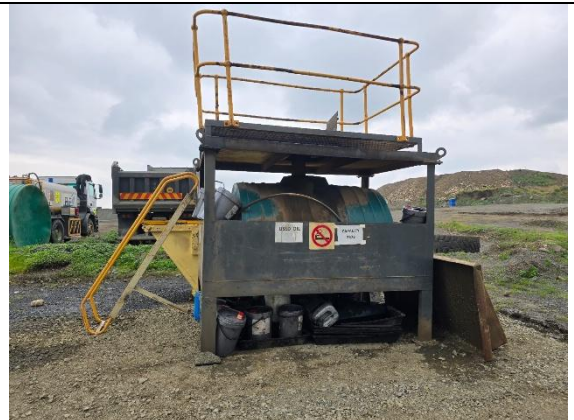
Management of fuel and oil spills	1	3	Non-compliant	The mobile diesel tank has visible oil leaks at the fuel pump area, indicating poor refuelling practices that must be urgently improved to prevent further contamination.
Drip trays present when refuelling is done outside the service bay	1	3	Non-compliant	Although drip trays are in place, oil leakage is still evident around them, indicating that the trays are not being used effectively or are not adequately maintained.
Drip trays placed underneath stationary vehicles/ mining equipment.	3	3	Partially compliant	
WASTE MANAGEMENT				
No processing area or waste pile may be established within 100m of the edge of any river channel or other water bodies.	5	-	Compliant	-

OIL TANK WITH OIL LEAKS

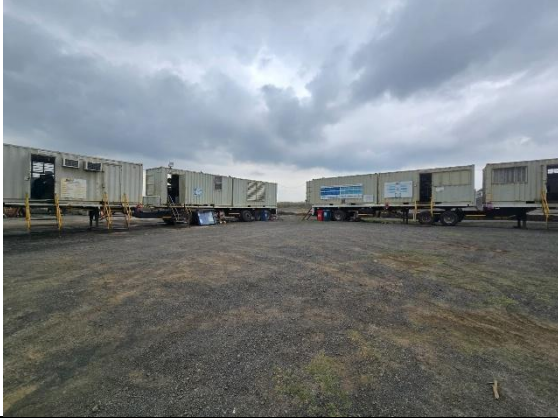
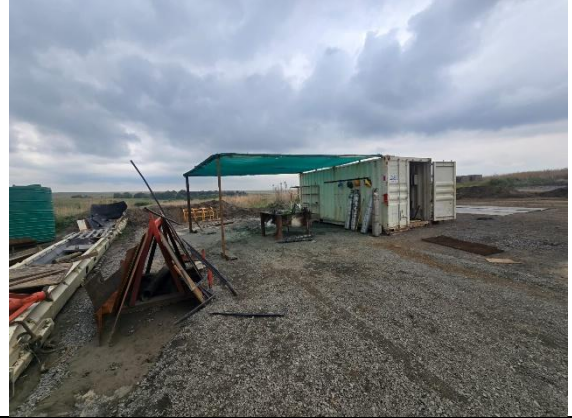
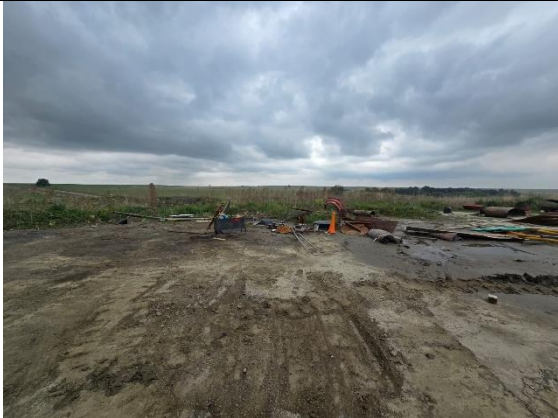
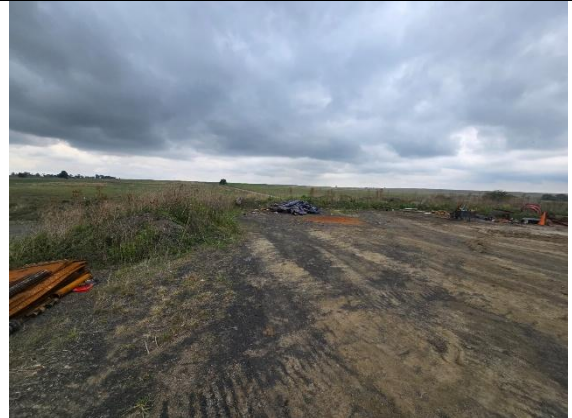
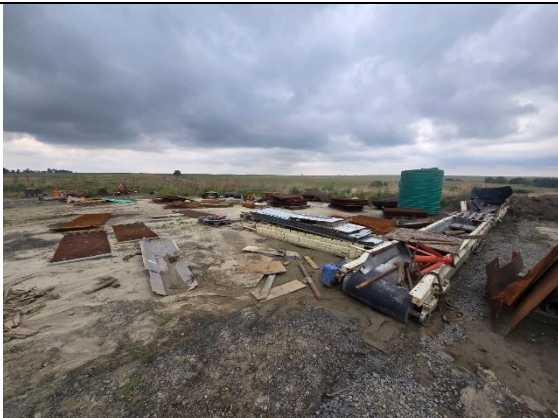
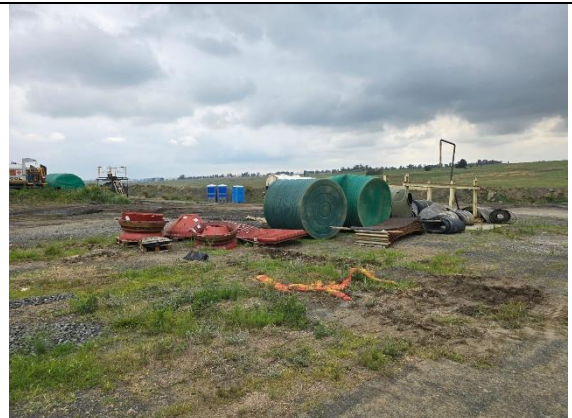
LITTER TO BE REMOVED

- Site housekeeping must be improved to address scattered litter, poor visual condition and general disorganisation.
- Machinery and workshop practices must be improved, including repairing oil leaks and maintaining proper pollution control.

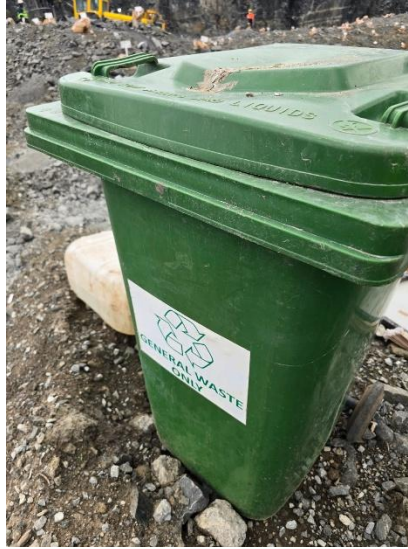
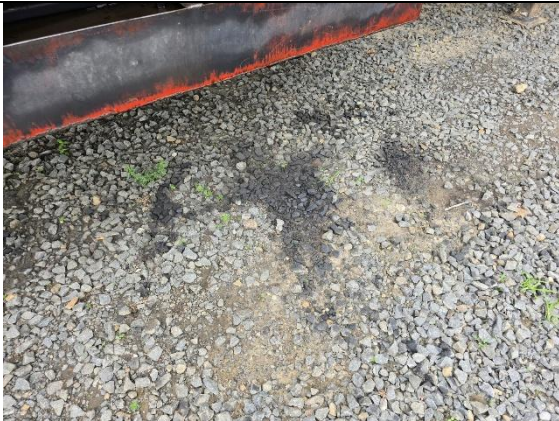
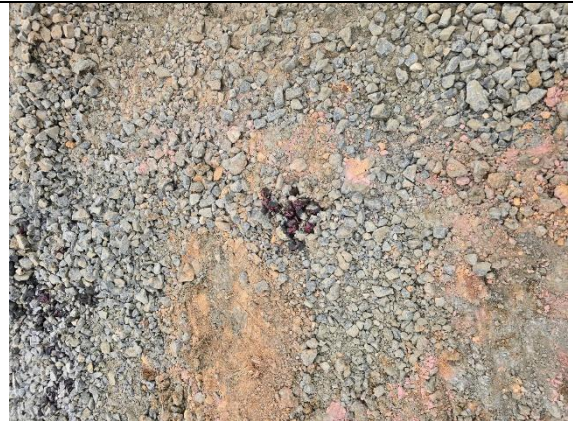
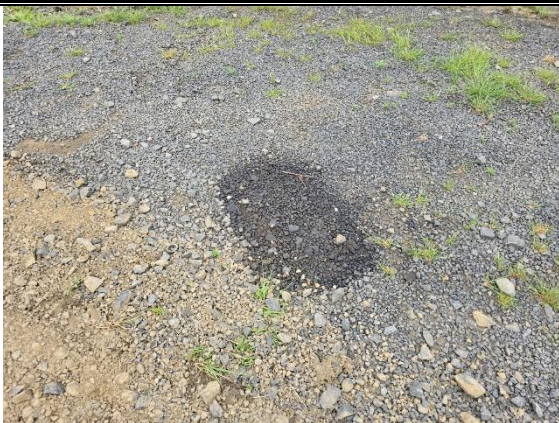
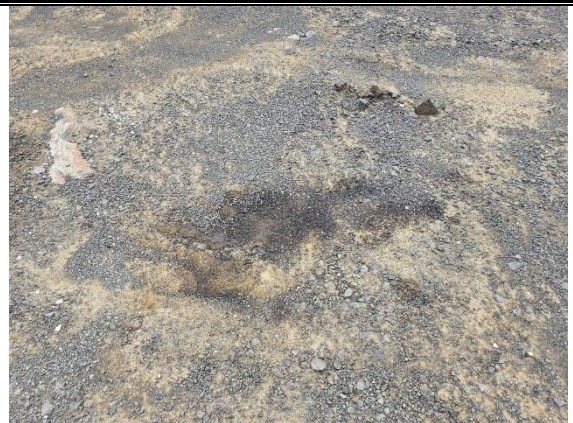
Significant issues were observed regarding hydrocarbon and hazardous substances management. Oil spills and hydrocarbon-contaminated soil were evident in multiple locations, and several drip trays were either overflowing or inadequately maintained. The mobile diesel tank displayed signs of leakage at the refuelling point, indicating poor refuelling practices, while hazardous materials were stored outside a suitably bunded area. These findings highlight a systemic failure in managing hydrocarbon risks effectively and demonstrate the need for improved spill response readiness and training.

OIL SPILLS

- Hydrocarbon spills, leaks and contaminated soil must be cleaned and prevented through proper storage, bunding and effective drip tray use.
- Waste management practices must be improved, including waste separation, housekeeping, and correct disposal of contaminated materials.
- Topsoil stockpiles must be demarcated, rehabilitated and kept free of weeds and invasive species.
- The invasive and weed species management plan must be implemented immediately across the site.
