BALMORAL QUARRY

**BALMORAL QUARRY (STONE GRAVEL / AGGREGATE) ON A PORTION  
OF PORTION 30 OF THE FARM DOORNRUG 302 JS, BALMORAL  
DISTRICT, MPUMALANGA PROVINCE**

**ENVIRONMENTAL PERFORMANCE ASSESSMENT**

<b>DMR REFERENCE NUMBER:</b>	MP 30/5/1/2/10104 MR
<b>DMR REFERENCE NUMBER:</b>	MP 30/5/1/3/3/2/1/ 00073 EM
<b>NEAS NO:</b>	MP/EIA/0000957/2015
<b>AUDIT PERIOD:</b>	<b>September 2025</b>

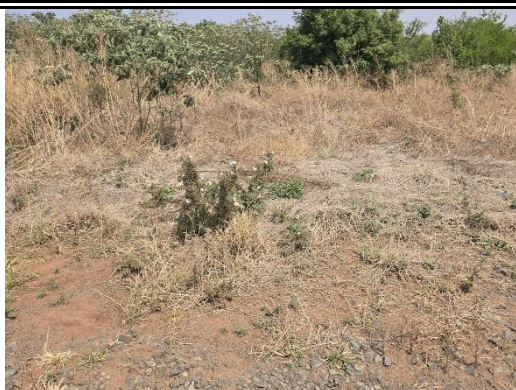
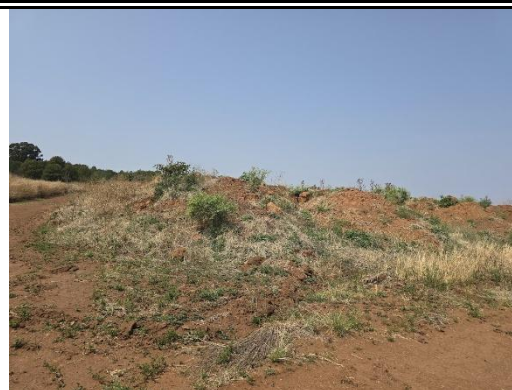
Listed invasive plant species were observed along stockpiles and haul road edges. This remains an ongoing management issue. Site management has measures in place to limit the spread of these weeds, and active removal is being carried out on a regular basis. To strengthen control, it is recommended that:

**WEEDS VISIABLE ON SITE**

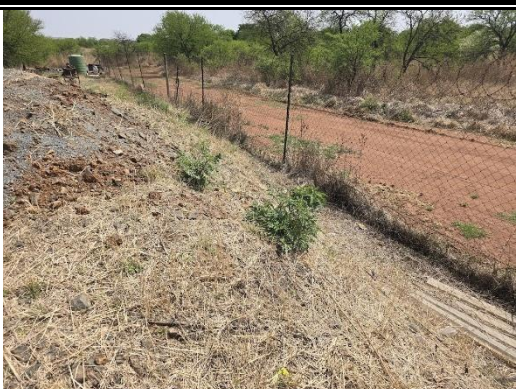
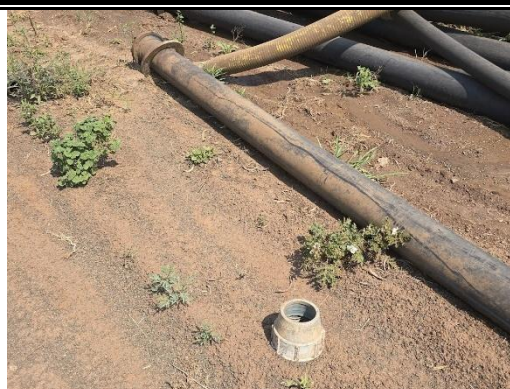
**WEEDS VISIBLE ON SITE**

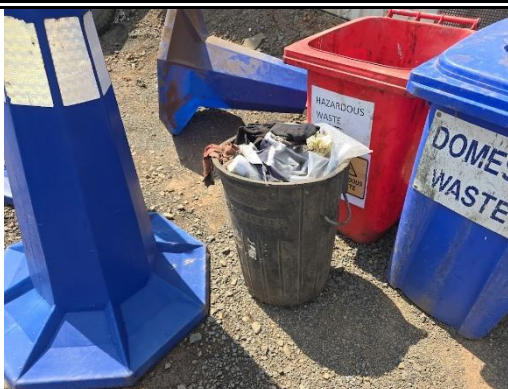
**WASTE INCORRECTLY DISPOSED**

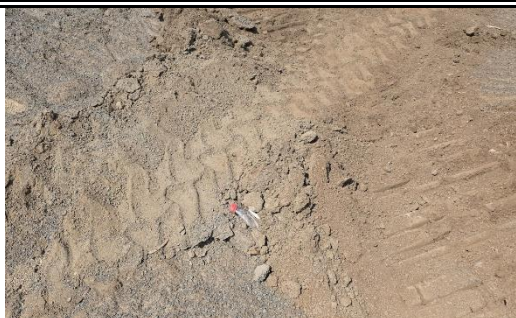
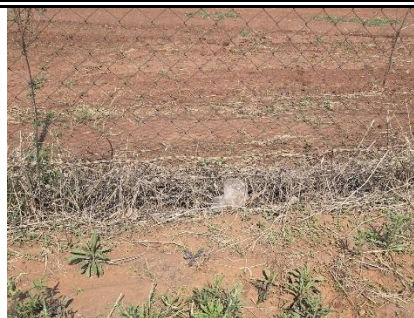
WASTE MANAGEMENT				
Site free of day-to-day litter	4	1	Non - Compliant	Litter was observed across several areas of the site during the inspection, indicating that routine housekeeping and clean-up activities are not being implemented effectively. This issue was also raised during the previous audit, and no significant improvement has been noted. Poor litter control detracts from the visual standard of the operation and may result in environmental risks if waste is dispersed beyond the operational footprint. Enhanced site-wide litter management through regular inspections, prompt removal of waste, and improved staff awareness is required to achieve and maintain compliance with housekeeping standards.
Mixing of waste prevented	5		Compliant	
General waste must be kept in containers which are wind and scavenger proof. This be disposed of at the permitted landfill site. No temporary dumping and littering of waste are allowed on site.	5		Compliant

**LITTER FOUND ON SITE**

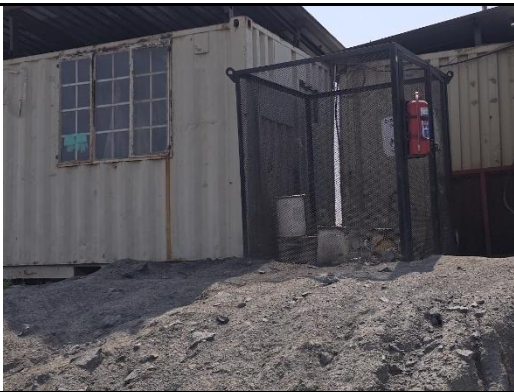
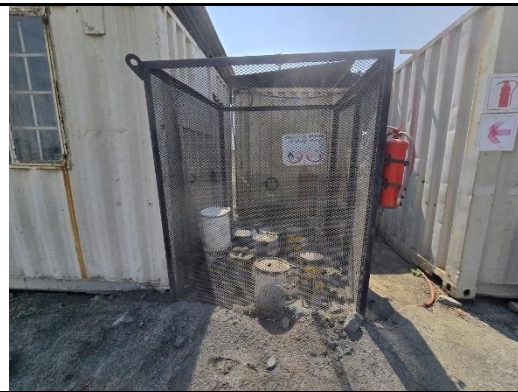
HYDROCARBONS STORED IN A CAGE – NOT BUNDED

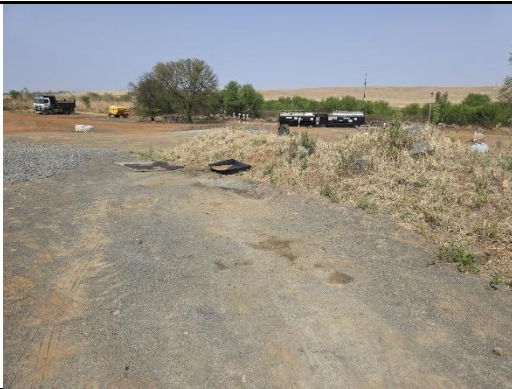
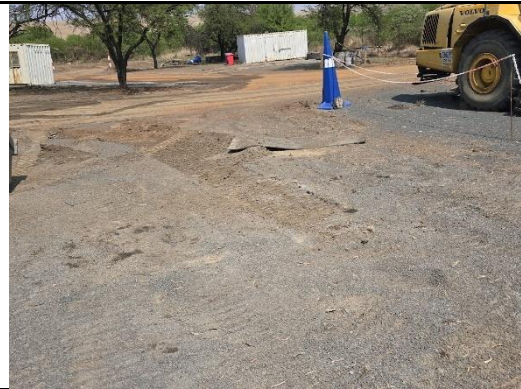
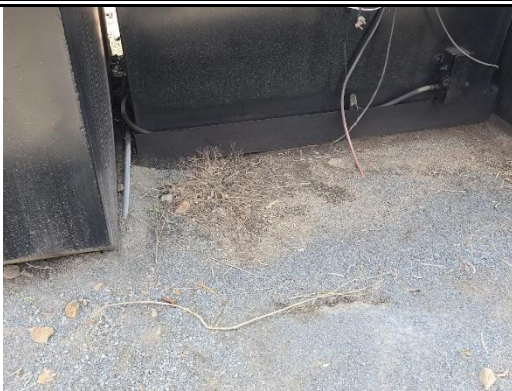
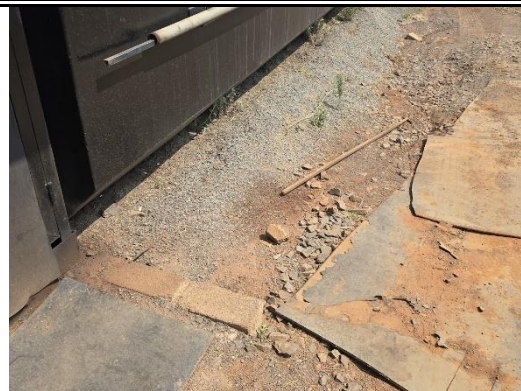
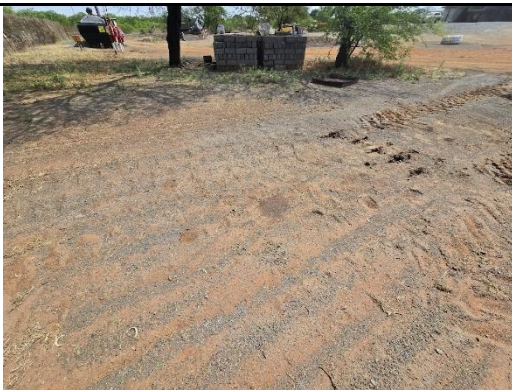
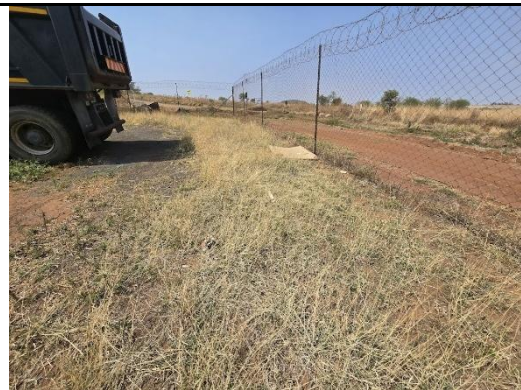
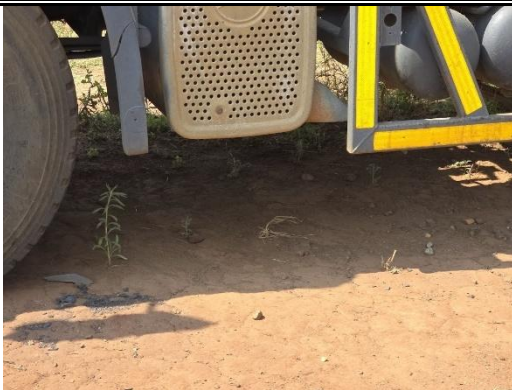
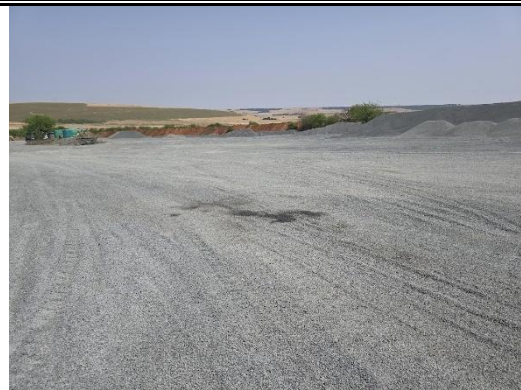
Management of fuel and oil spills	1	3	Non - Compliant	The management of fuel and oil on site was found to be inadequate. Multiple hydrocarbon spills were evident during the inspection, with drip trays observed to be overflowing due to accumulated rainwater. Furthermore, the diesel tank at the main workshop area appears to be leaking, contributing to contamination risks. Current controls are insufficient, and the lack of proactive spill prevention and containment measures indicates that fuel and oil management requires significant improvement to ensure compliance and to minimise environmental impact.
Drip trays present when refuelling is done outside the service bay	3	3	Non - Compliant	No refuelling activities were observed during the site inspection; however, numerous hydrocarbon spills were noted across the operational areas. This suggests that the contamination may be primarily linked to leaking vehicles and equipment rather than active refuelling incidents. While drip trays are available on site, their use appears inconsistent, and existing containment measures are insufficient to prevent hydrocarbon leakage to ground. Improved inspection, maintenance, and containment practices are required to minimise ongoing spill risks.

HYDROCARBON SPILLS THAT MUST BE REMOVED

Widespread hydrocarbon spills observed across operational areas require immediate clean-up.

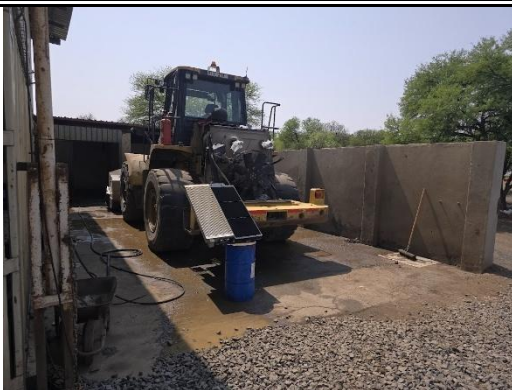
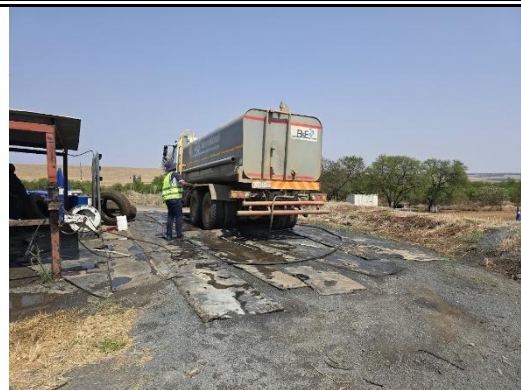
VEHICLE NOT BEING WASHED IN WASHBAY

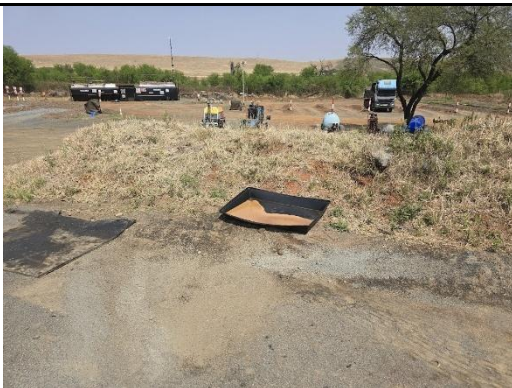
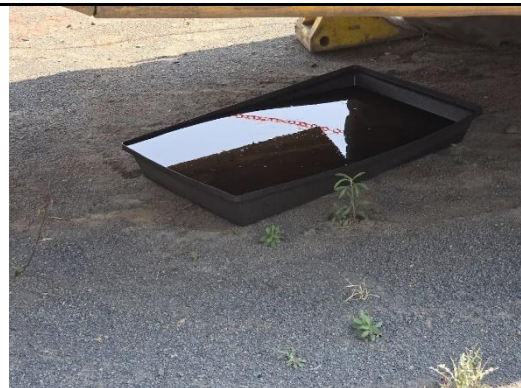
MISMANAGEMENT OF DRIP TRAYS

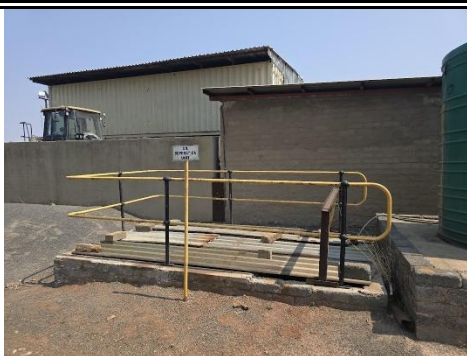
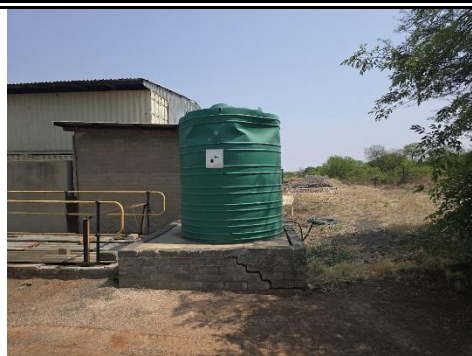
**OIL SPILL SUMP WITH WATER TANK**

Sump and oil separator operational	4	1	Non - Compliant	The sump at the workshop area has been covered since the previous inspection; however, evidence of leakage was observed during the current audit. This indicates that, although some improvement in containment has been made, the sump and oil separator system are not functioning effectively. The apparent leakage suggests that maintenance or repair is required to ensure proper operation and to prevent further hydrocarbon contamination of surrounding areas.

Investigate and repair the leak detected in the sump and oil separator system.

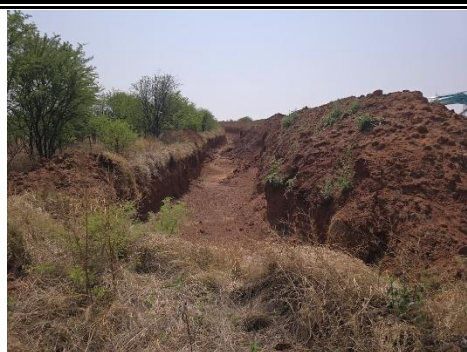
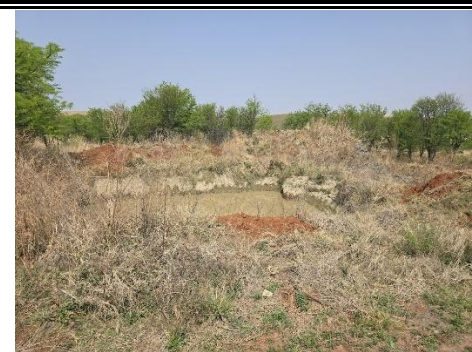
**UNAUTHORISED TRENCH AND DAM AT PLANT AREA**
