PROPOSED MINING OF AGGREGATE ON PORTION 18 (PORTION 2) OF THE FARM LOUTERBRONNEN 250, THEUNISSEN DISTRICT, FREE STATE PROVINCE

ENVIRONMENTAL AUDIT REPORT

DMR REFERENCE NUMBER:	FS 30/5/1/2/2/10040 MR
AUDIT PERIOD:	March 2021

March 2021

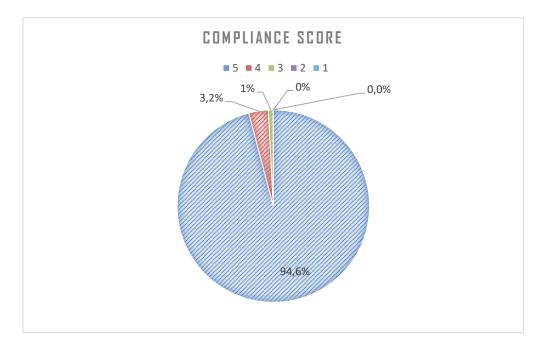
Figure 1: Compliance scores for all activities as listed within the approved Environmental Management Programme for the Louterbronnen Aggregate Quarry.
