BUTTERWORTH QUARRY

ENVIRONMENTAL PERFORMANCE ASSESSMENT / ENVIRONMENTAL AUDIT REPORT

DMRE REFERENCE NUMBER:	EC 30/5/1/2/2/0183 MR
AUDIT PERIOD:	May 2024 – May 2025

Right Number:	EC 30/5/1/2/2/0183 MR	Date of Commencement:	January 2010
Site Name:	Butterworth Quarry	Inspection Date:	22 May 2025
Right Holder:	Transkei Quarries (Pty) Ltd	Other Authorisations:	General Authorisation: 27/2/2/T420/2/1
Report Number:	03

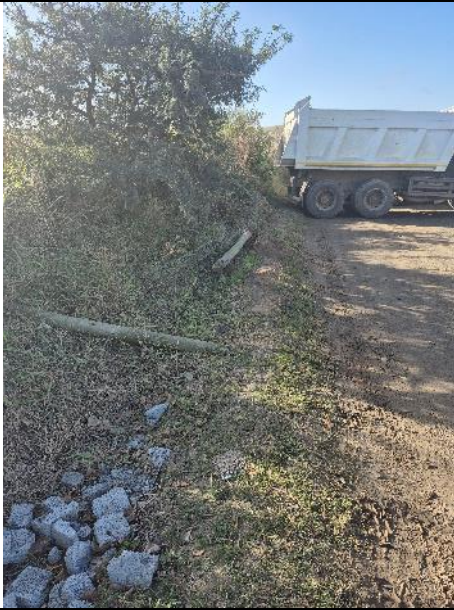
Truck parking area clear of litter

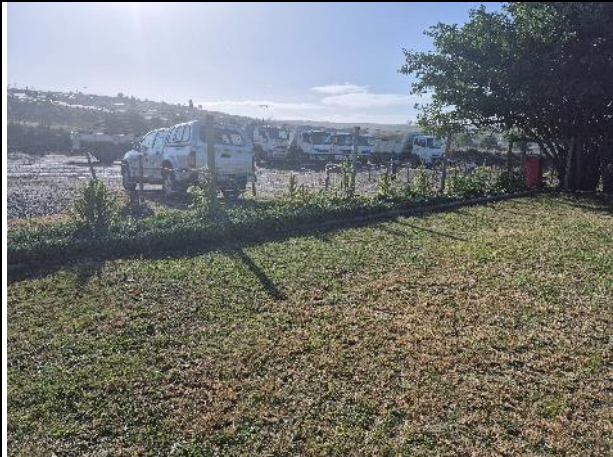
Spekboom growing along the office fence

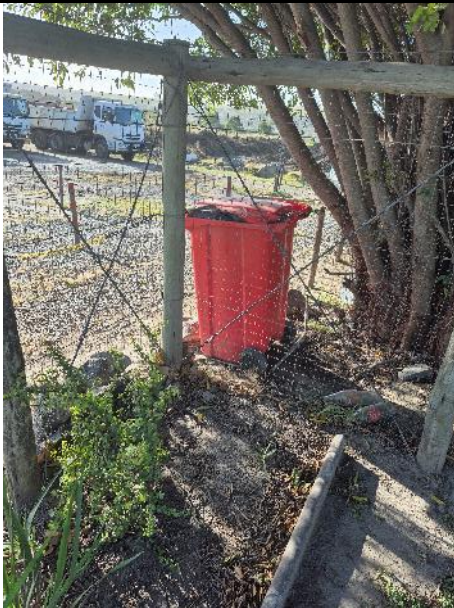
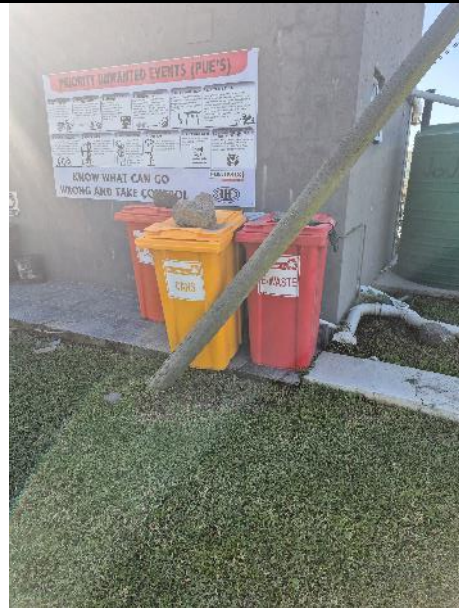
Refuse bins available on site

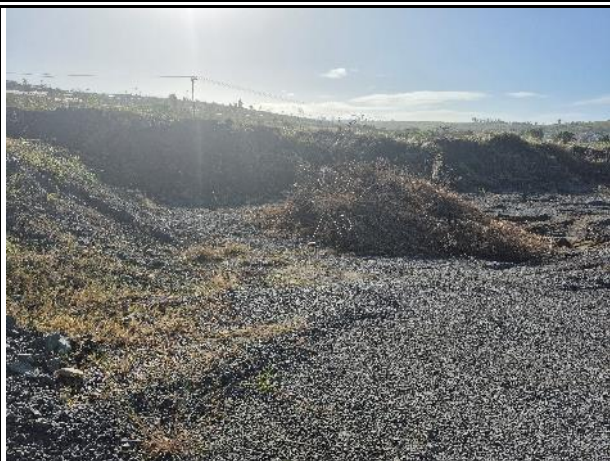
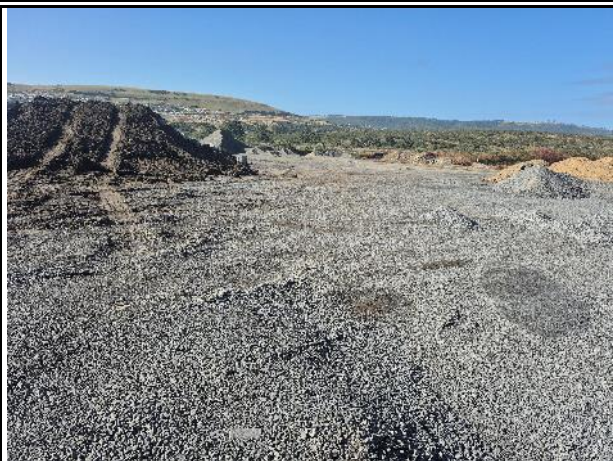
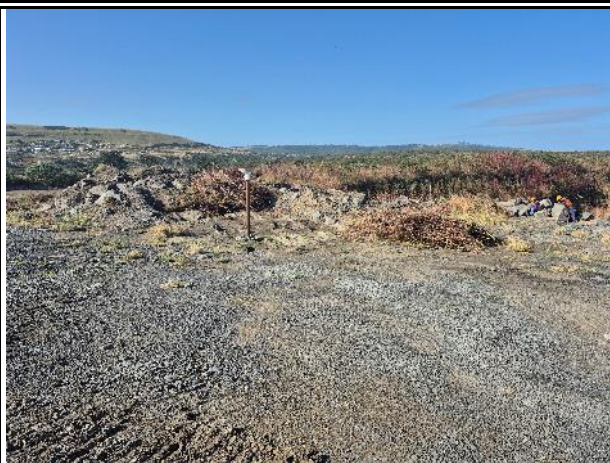
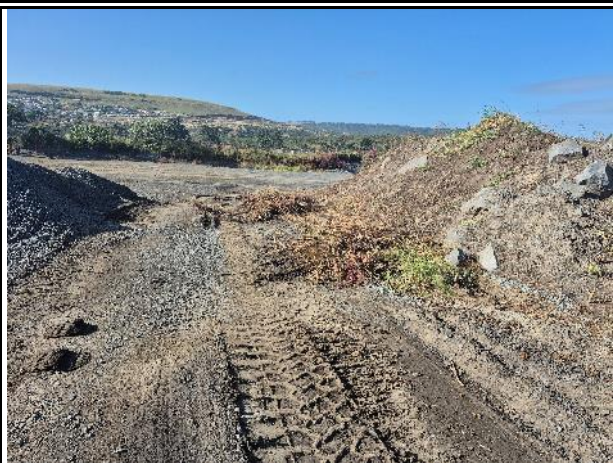
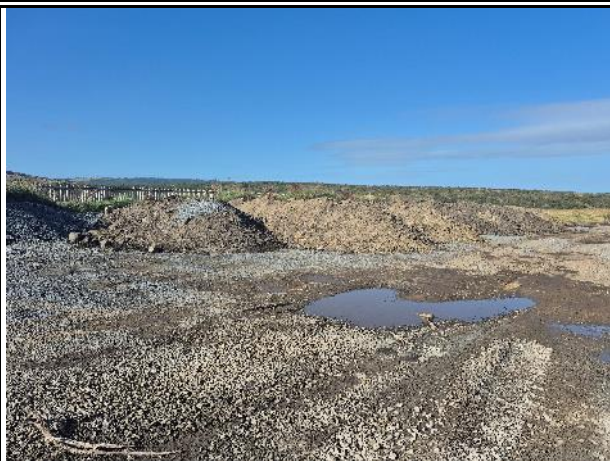
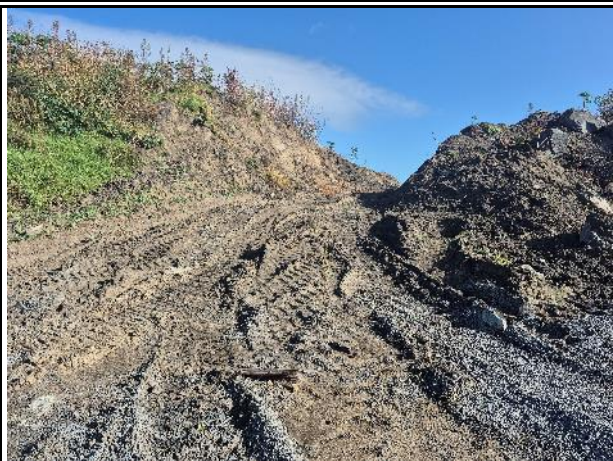
Clearing of problem plants

It is further recommended that the subcontractor responsible for removing invasive vegetation prioritise the eradication of plant species listed under Categories 1a, 1b, and 2 of the Alien and Invasive Species Regulations, 2020, published in terms of the National Environmental Management: Biodiversity Act, 2004 (Act No. 10 of 2004). While certain plants may be regarded as common weeds, priority should be given to the removal of listed invasive species in accordance with the legal requirements.

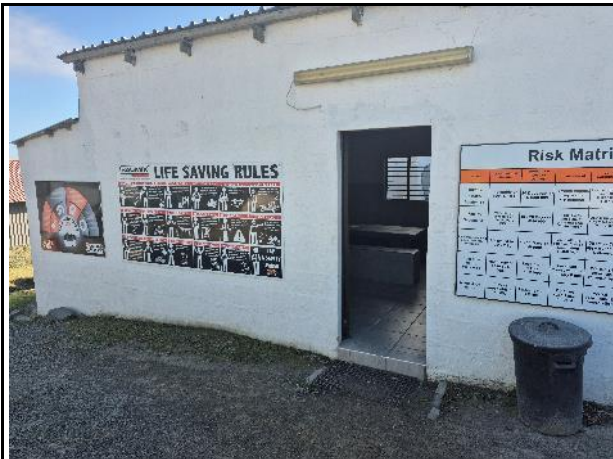
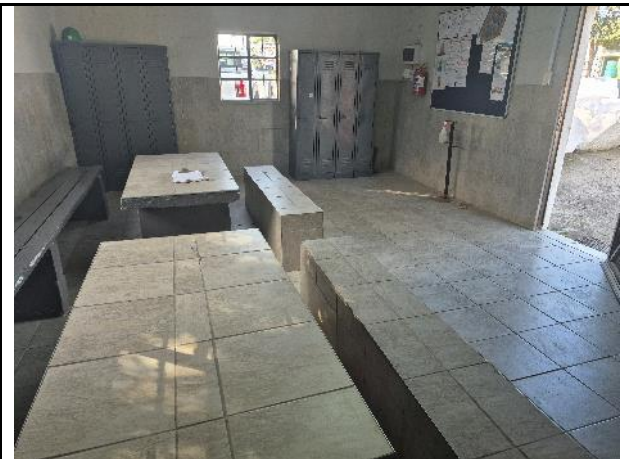
Renovated ablutions

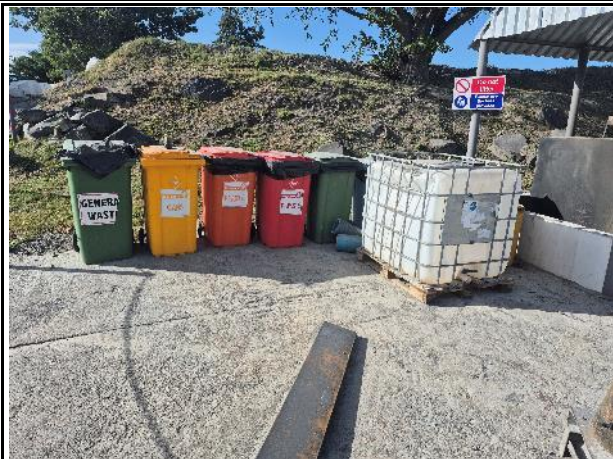
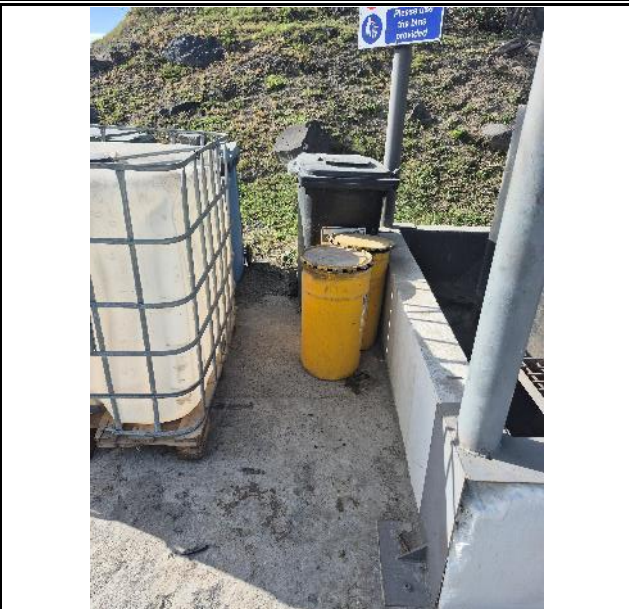
Hazardous waste bins were added to the waste storage area but must still be signposted as "Hazardous Waste" containers.

Waste storage area

Hazardous waste bins to be signposted

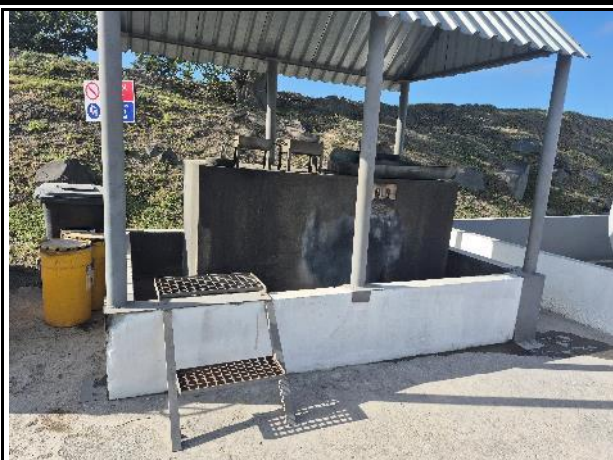
Bund to be sealed

As mentioned earlier, the bunds of the diesel tank, used oil tank and generator must be sealed, and management must ensure that the bunds are large enough to contain 110% of the liquid stored within. The proof of the leak tests must be filed for auditing purposes.

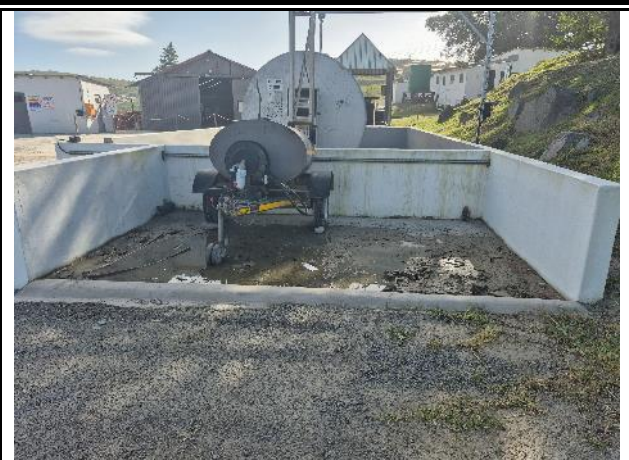
The cables that previously ran through the bund wall of the diesel tank have been removed, and the resulting opening was repaired. Additionally, a berm was constructed in the diesel bowser parking area to prevent any potentially contaminated water from entering the surrounding environment.

Berm added to bowser parking area

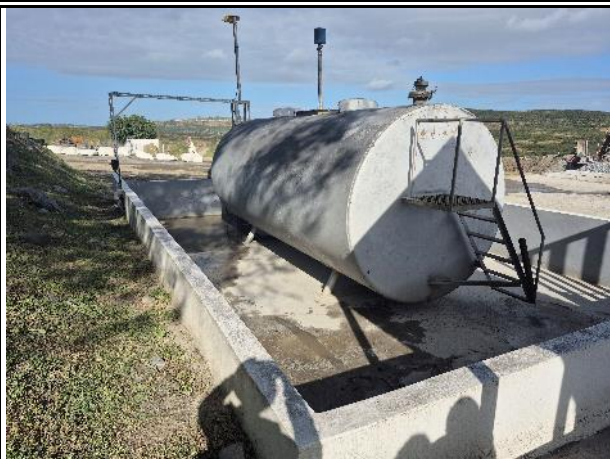
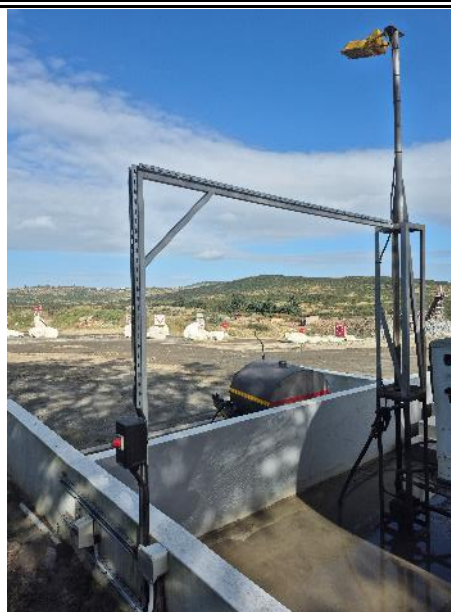
Berm to be sealed. Note cables removed from the bund that now runs overhead

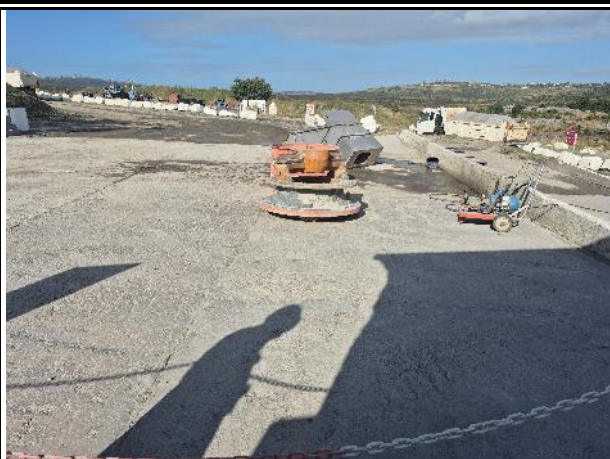
Wash bay

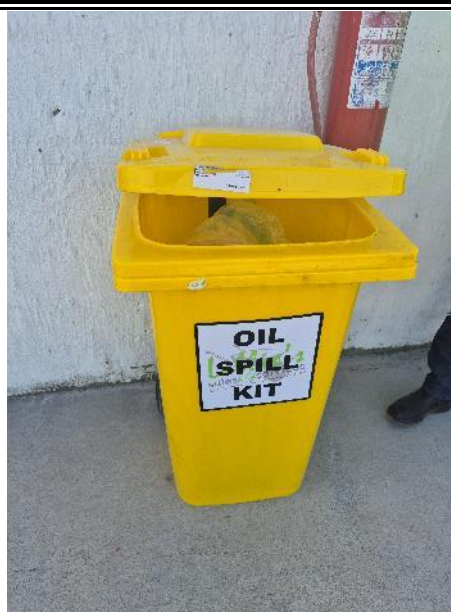
Oil spill kit on site

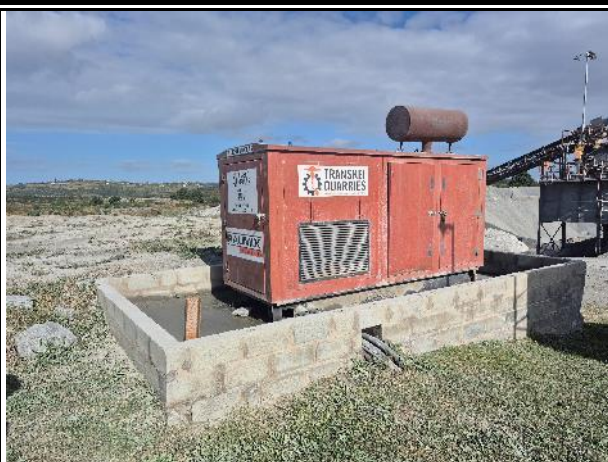
Bund to be sealed

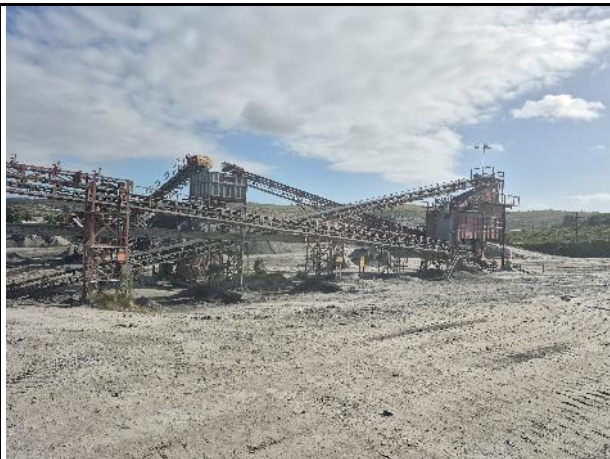
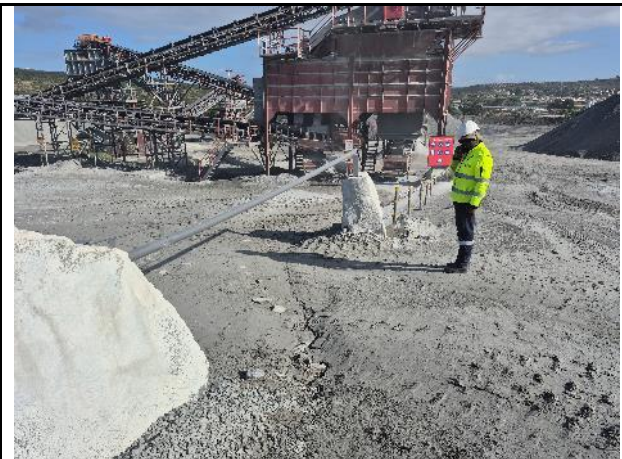
Processing area where a stormwater berm is proposed to direct runoff water from the plant

The stormwater drainage system at and around the processing area was reviewed. It is recommended that a berm be constructed along the northern entrance to the plant to prevent runoff water from entering the processing area and instead divert it towards the north-western corner of the mine.

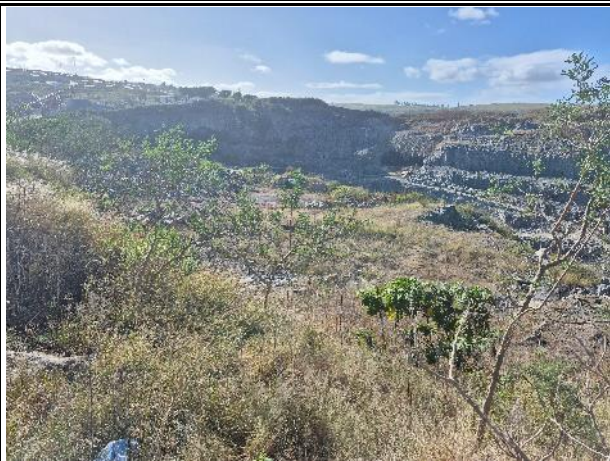
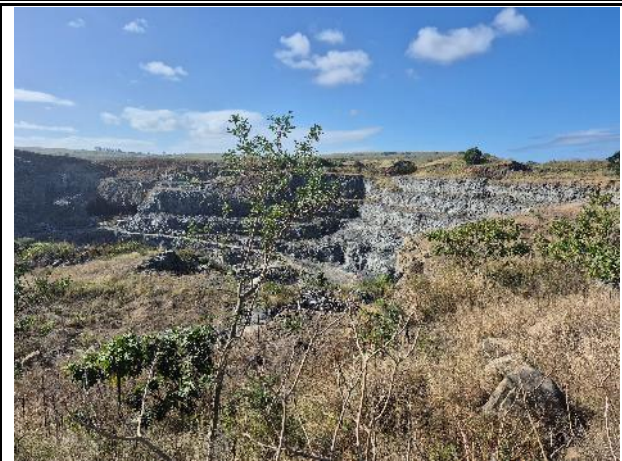
Quarry pit with remaining problem plants to be removed

A significant effort has been made to remove invasive plant species from the mining area. Unfortunately the mine and surrounding areas are highly infested that requires constant management. It is proposed that the cleared areas are sown with an indigenous grass mix to minimise the denuded areas and lessen the re-occurrence of problem species.

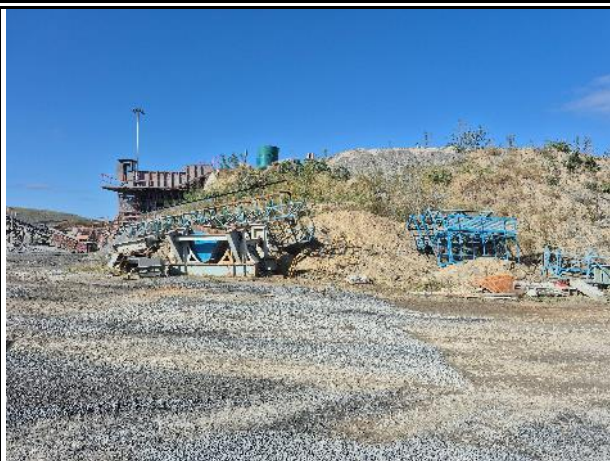
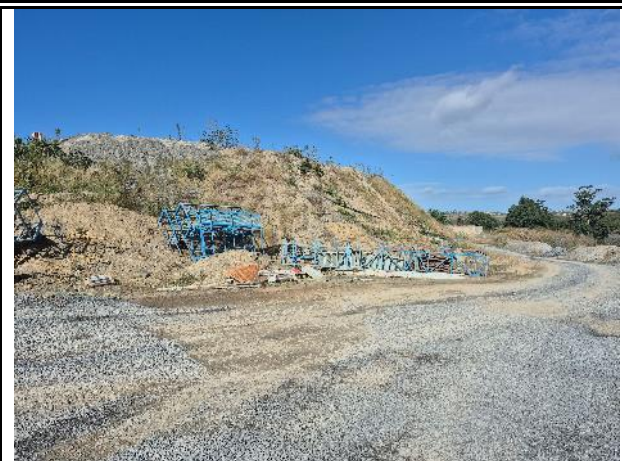
Berms being cleared of problem plants

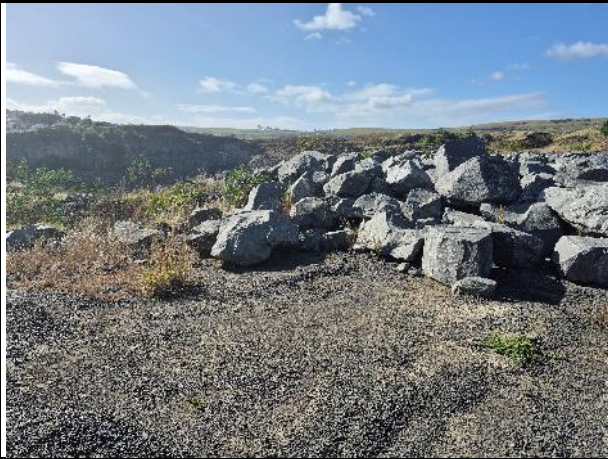
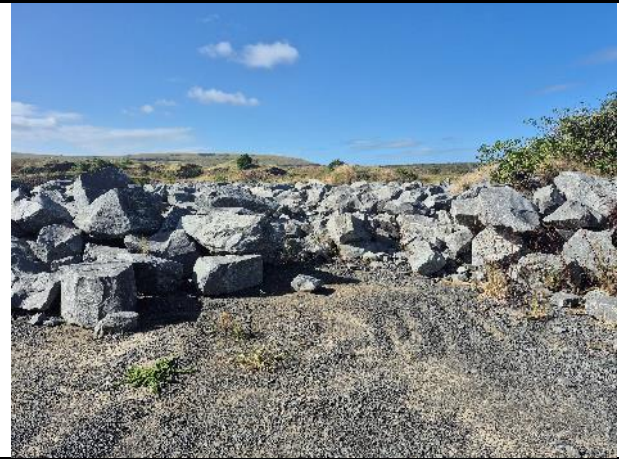
Oversize rock stored on site

As discussed, management must ensure that oversize and unwanted rocks from the quarry are not stockpiled in areas earmarked for future mining. This is particularly important given the potential southern expansion of the excavation area, pending approval of the Section 102 application.

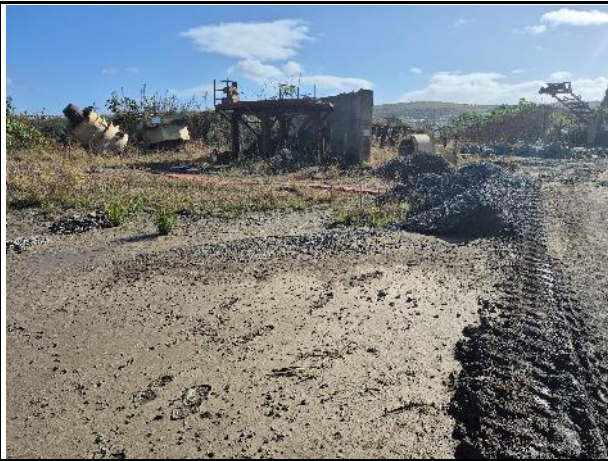
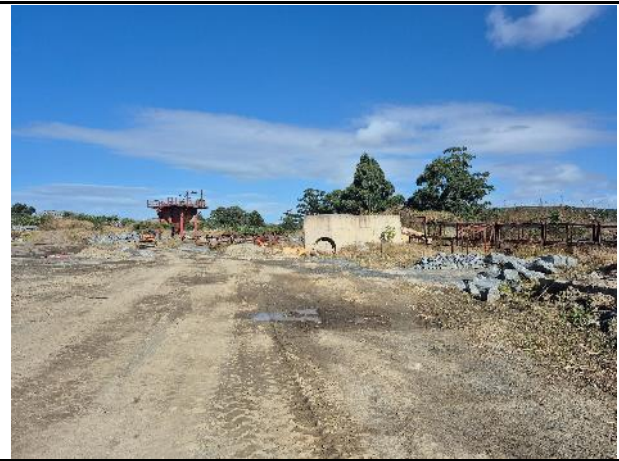
Old plant and structures being removed

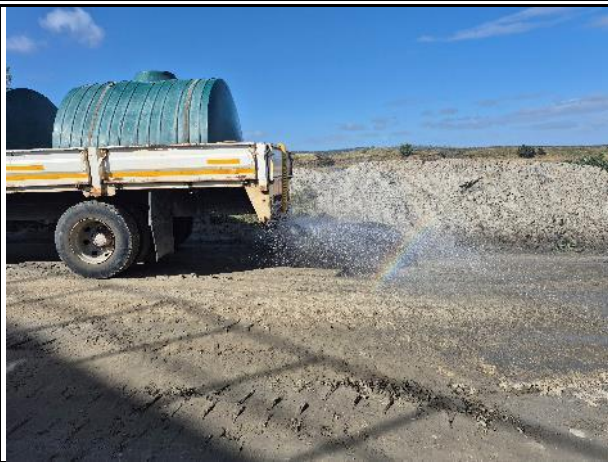
Dust suppression in progress

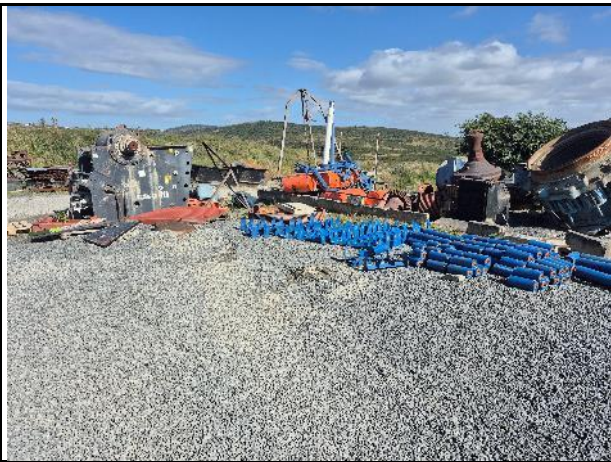
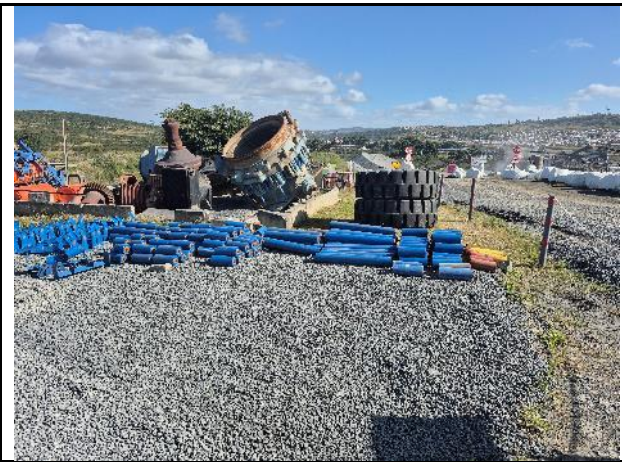
Neatly managed salvage yard
