MINING OF SAND AND GRAVEL FROM A PORTION OF THE FARM DOORNKRAAL 832, MALMESBURY, WESTERN CAPE PROVINCE

ENVIRONMENTAL AUDIT REPORT

DMR REFERENCE NUMBER:	WC 30/5/1/2/2/10096 MR	
AUDIT PERIOD:	26 February 2021

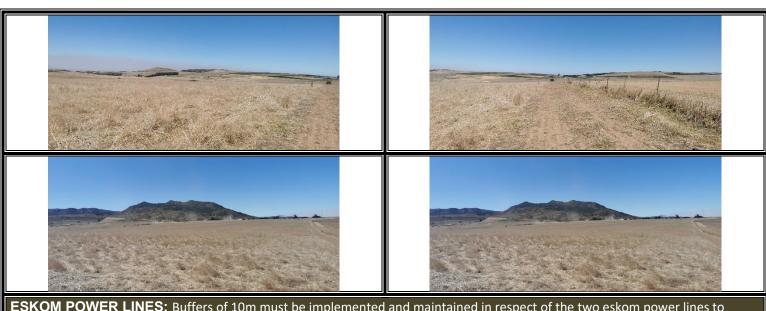
ESKOM POWER LINES: Buffers of 10m must be implemented and maintained in respect of the two eskom power lines to ensure that no construction work is executed close to any eskom structure or structures supporting mechanisms. No work or machinery is near to the conductors of the respective power lines and there is an obstruction free zone around all pylons.
