# Leandra Photo Report

Mining Area and surrounds

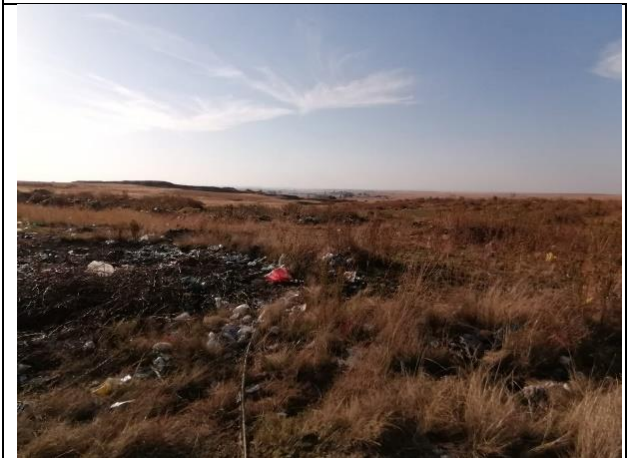
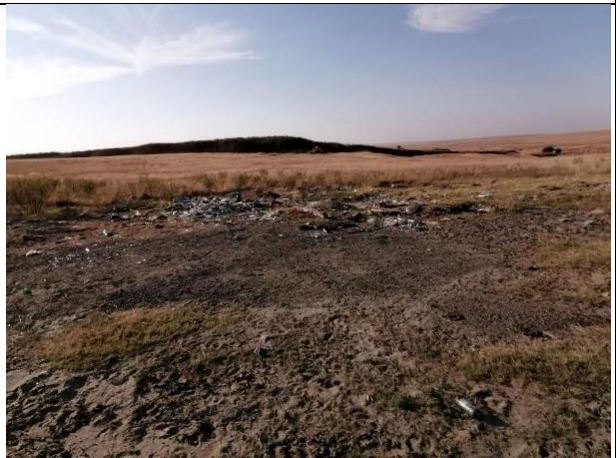
Polluted area

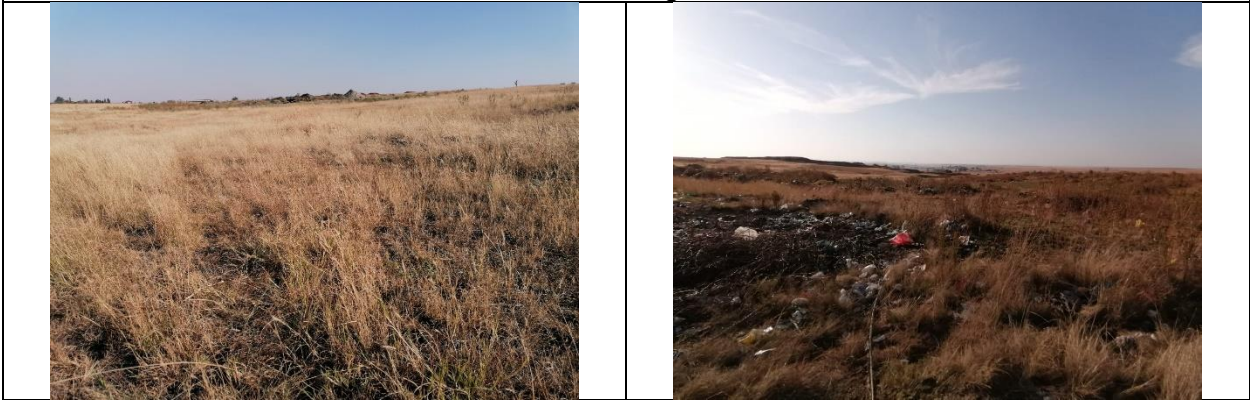
Ground cover and vegetation on site

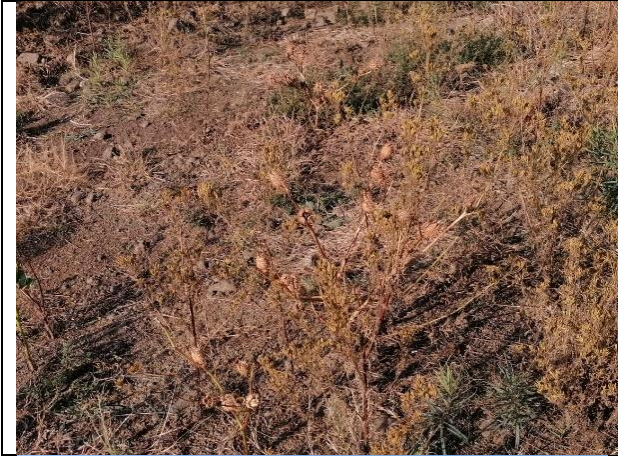
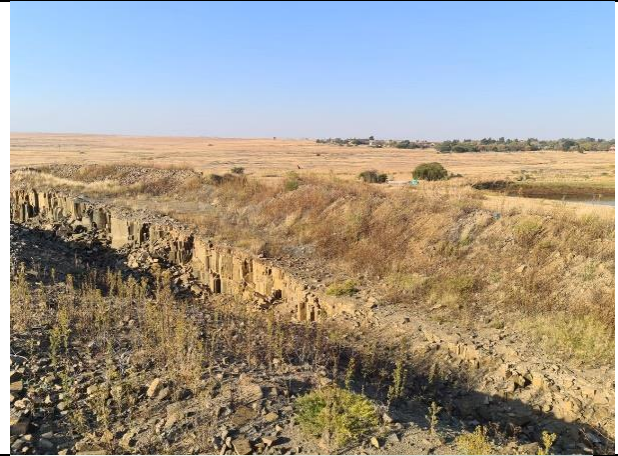
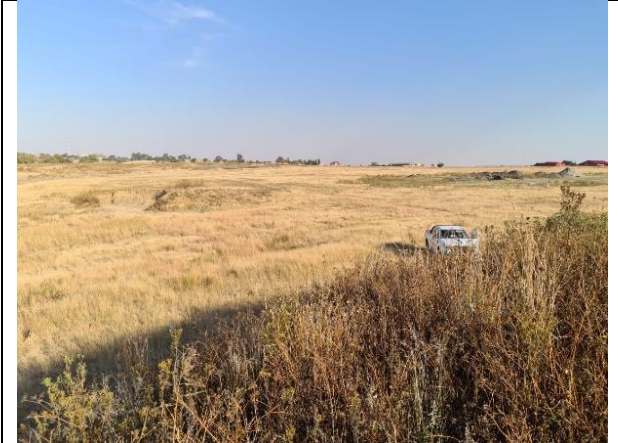
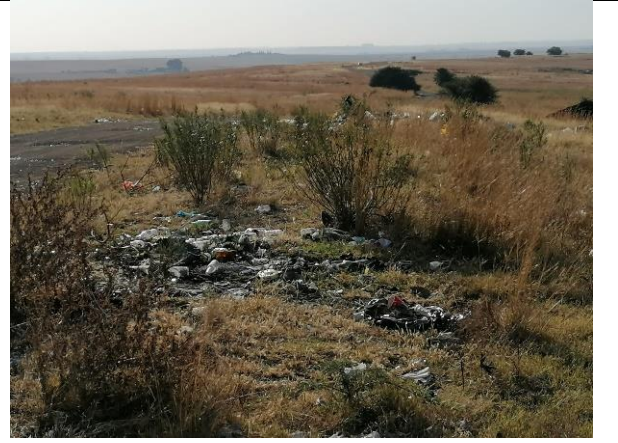
Weeds found on site

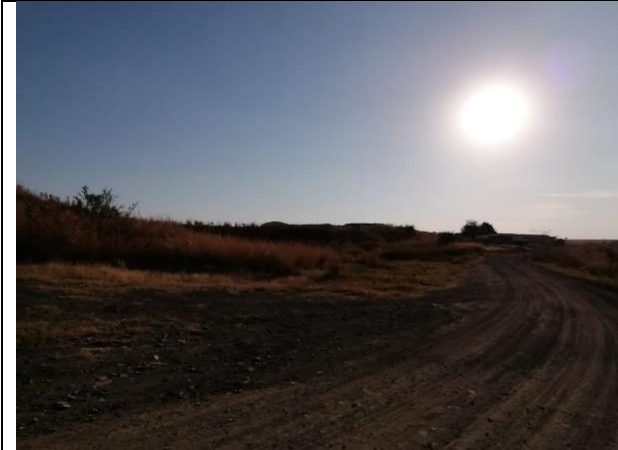
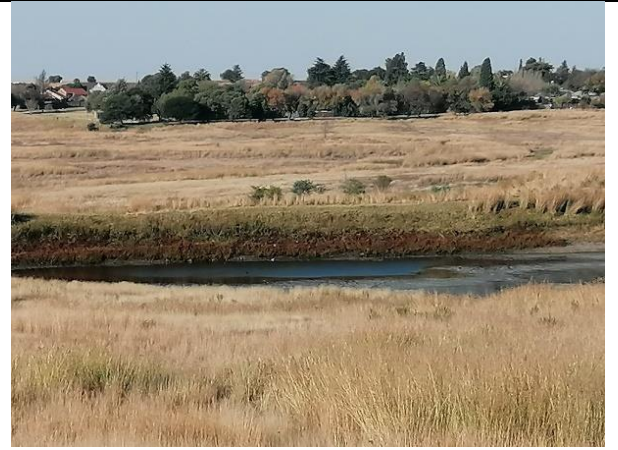
Artificial Wetland

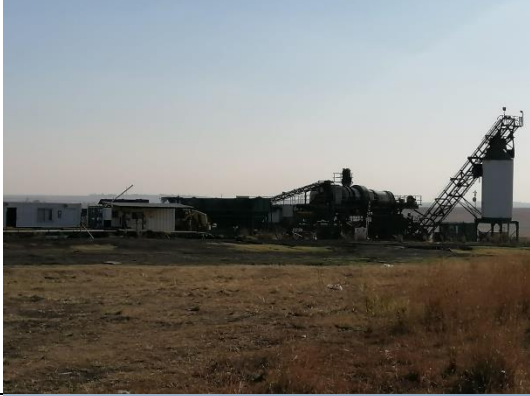
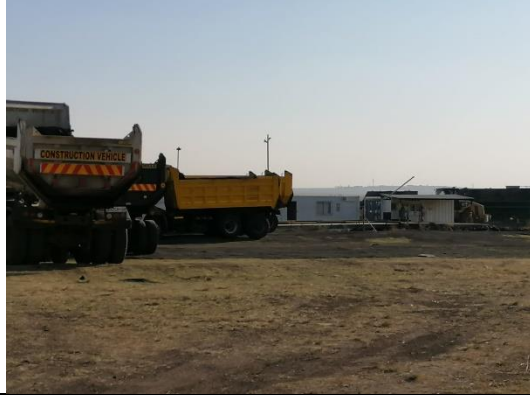
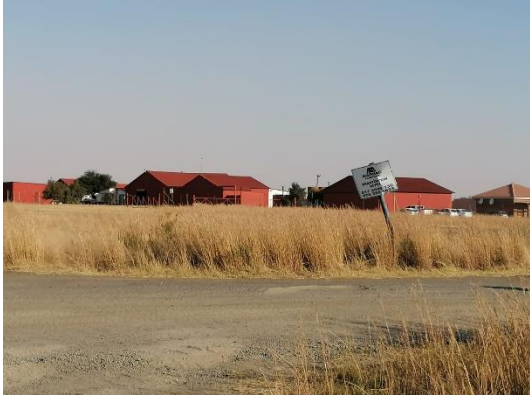
Neighbouring Asphalt plant and existing infrastructure

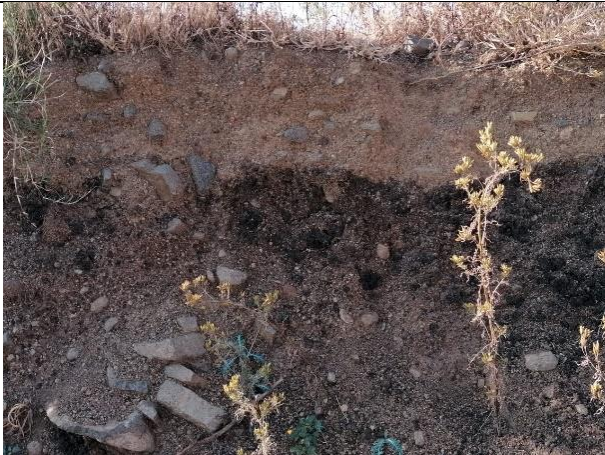
Topsoil profile
