PROPOSED MINING OF AGGREGATE ON PORTION 18 (PORTION 2) OF THE FARM LOUTERBRONNEN 250, THEUNISSEN DISTRICT FREE STATE PROVINCE

ENVIRONMENTAL PERFORMANCE ASSESSMENT / ENVIRONMENTAL AUDIT REPORT

DMR REFERENCE NUMBER:	FS 30/5/1/2/2/10040 MR
AUDIT PERIOD:	June 2021 – May 2022

Permit / Right Number:	FS 30/5/1/2/2/10040 MR	Date of Commencement:	15 May 2019
Site Name:	Louterbronnen Aggregate Quarry	Inspection Date:	03 June 2022
Permit / Right Holder:	Vengablox (Pty) Ltd	Other Authorisations:	General Authorisation:
Report Number:	24 (EPA 03)	Onici Authorisations.	27/2/1/C741/13

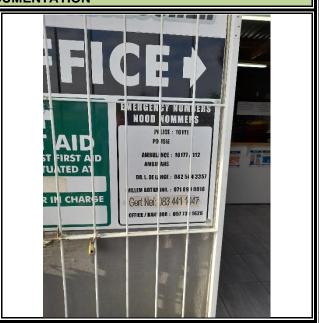
Notice boards informing employees of important matters

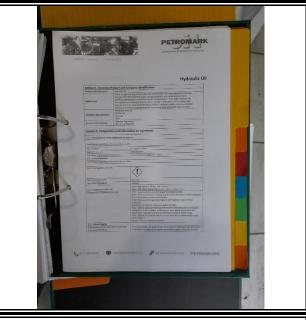
16-point MSDS's
