MALMESBURY SANDS (PTY) LTD KERSFONTEIN SAND MINE MALMESBURY, WESTERN CAPE PROVINCE

ENVIRONMENTAL PERFORMANCE ASSESSMENT

DMPR REFERENCE NUMBER:	WC 30/5/1/2/2/360 MR
AUDIT PERIOD:	SEPTEMBER 2025
SITE SCORE	97,61%

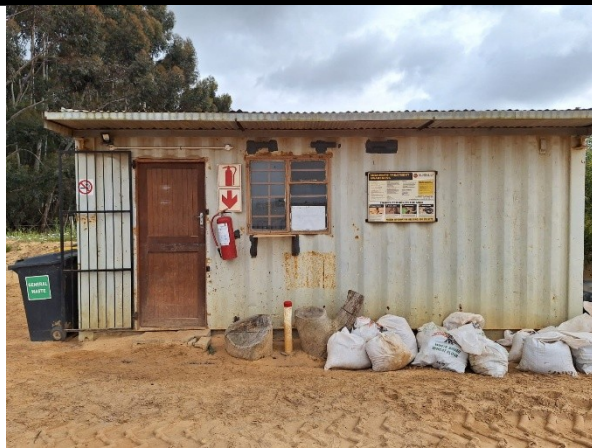
SITE OFFICE WITH FIRE EXTINGUISHER

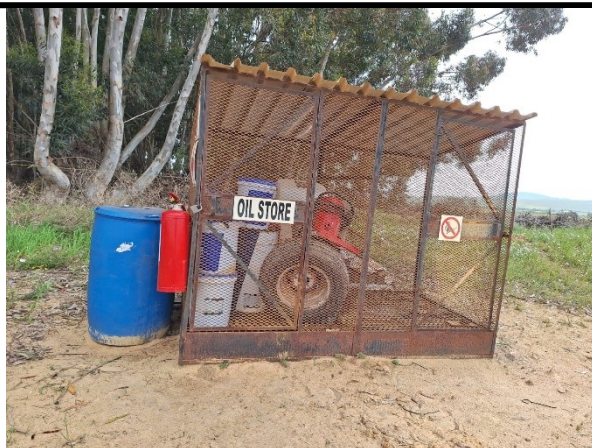
STORAGE CAGE WITH BUND

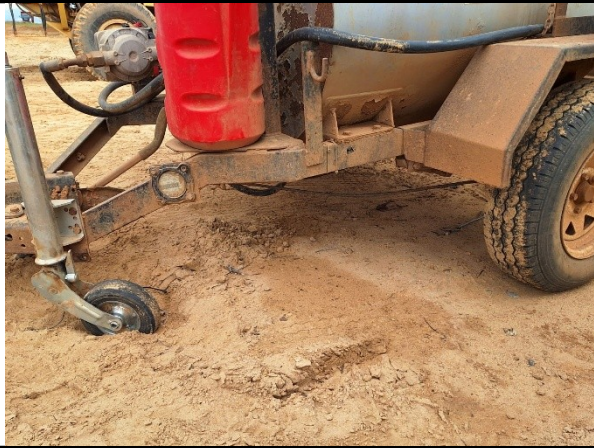
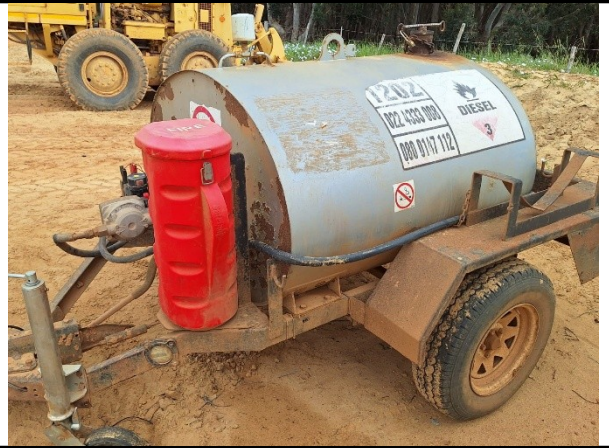
DIESEL TANK – DRIP TRAY BE PLACED UNDERNEATH

- Drip trays to be placed underneath stationary vehicles.
- Port Jackson to be removed (ongoing process)

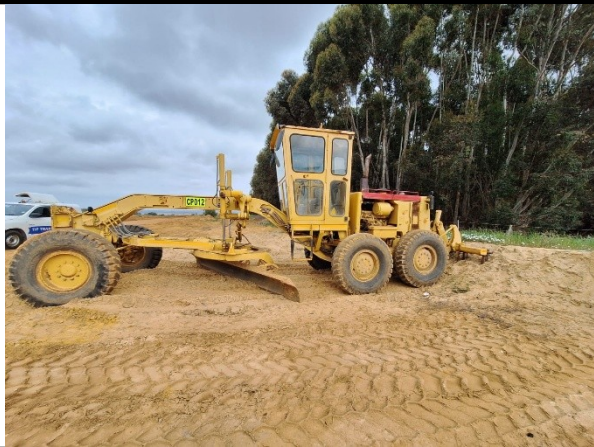
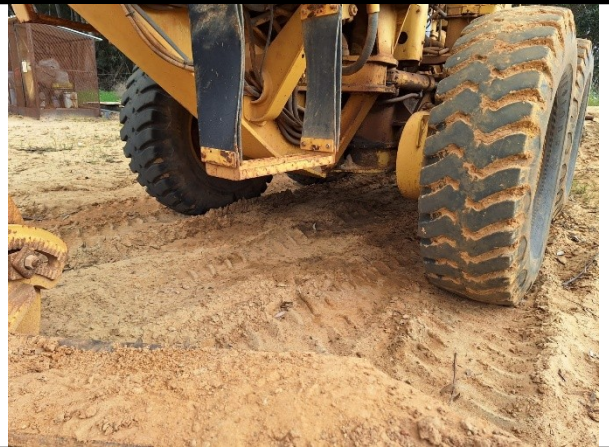
STATIONARY MACHINERY WITHOUT DRIP TRAY

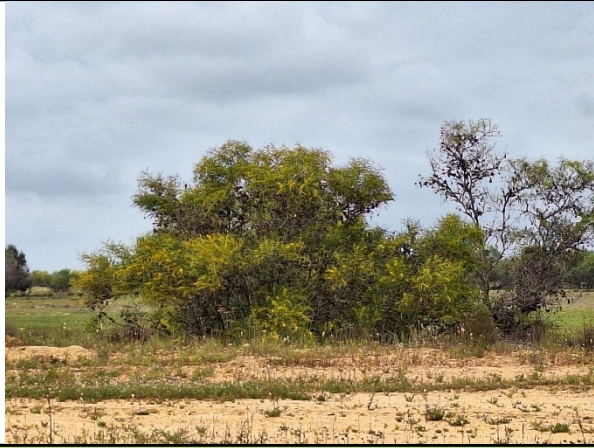
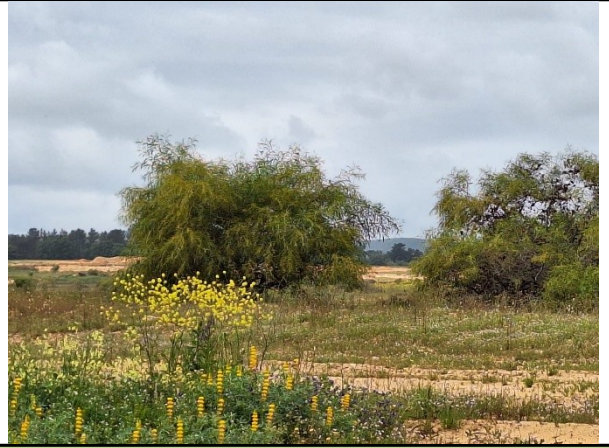
The Port Jackson (*Acacia saligna*) trees germinating on the rehabilitated areas is and should be continuously removed. These plants are listed as Category 1b invasive species in terms of the National Environmental Management: Biodiversity Act, 2004 and Alien and Invader Species Regulations, amended 2016 and must be controlled. In terms of this legislation plants classified as category 1b (or 1a) species are invasive species which must be controlled and whenever possible removed and destroyed. Any form of trade or planting is strictly prohibited. Weeds must be regularly removed from stockpiles.

PORT JACKSONS TO BE REMOVED

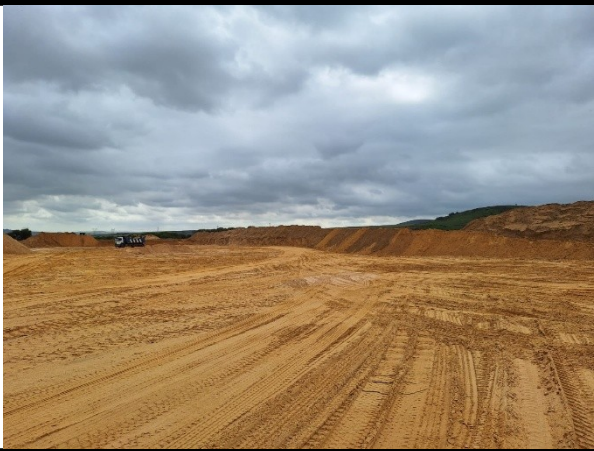
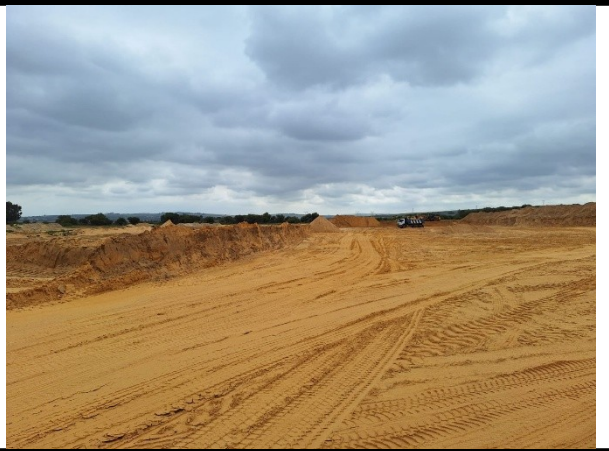
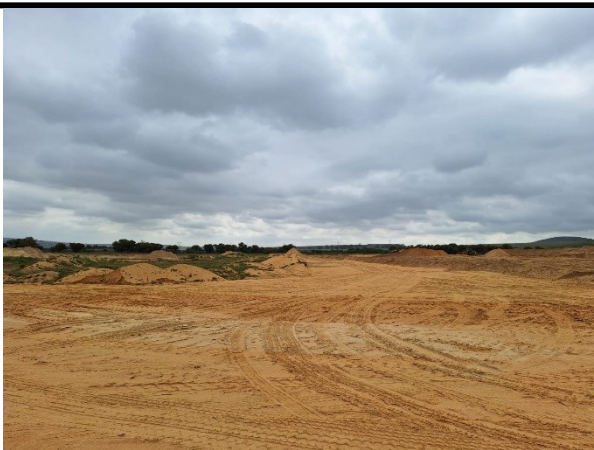
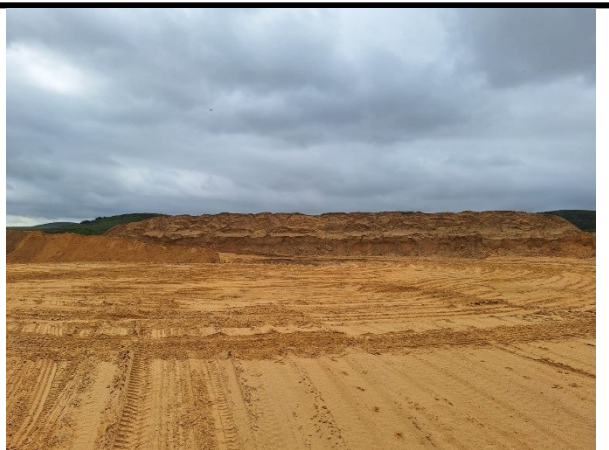
KERSFONTEIN 1 (SECTION A) - MINING AREA

As mentioned earlier, the mine confirmed that mining is not currently being undertaken in 2-hectare sections nor to the prescribed depth of 1.2 m (extending up to 2 m) as stipulated in the approved EMPr, as this method has proven economically unfeasible. However, progressive rehabilitation is still carried out once an area has been mined out. Pioneer species successfully established, through succession, on the rehabilitated areas to provide the re-instated footprints with a sufficient cover.

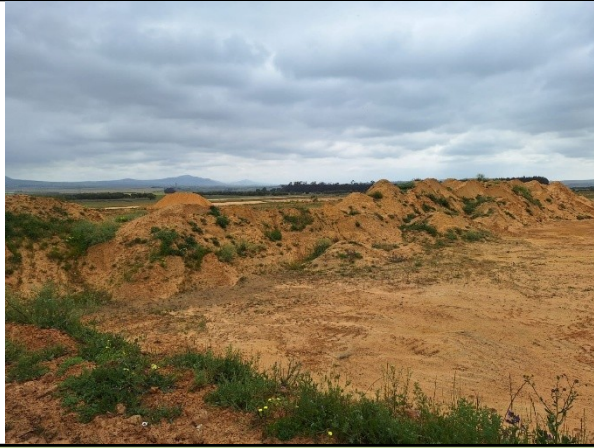
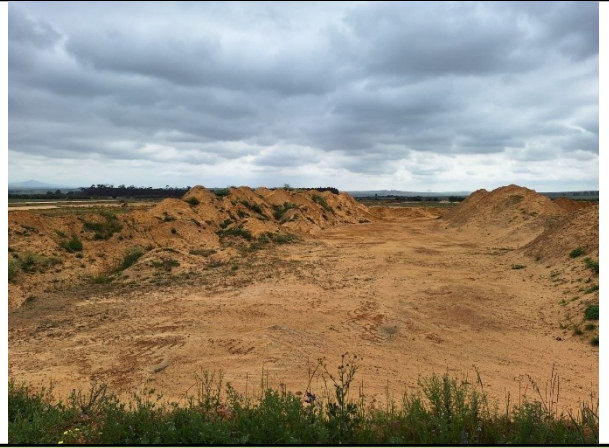
WEEDS TO BE REMOVED FROM STOCKPILES

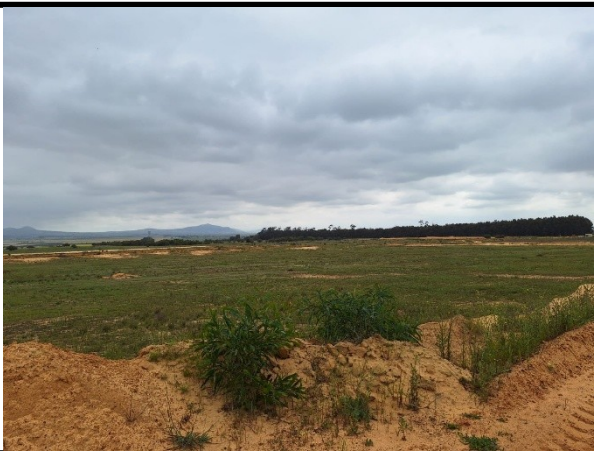
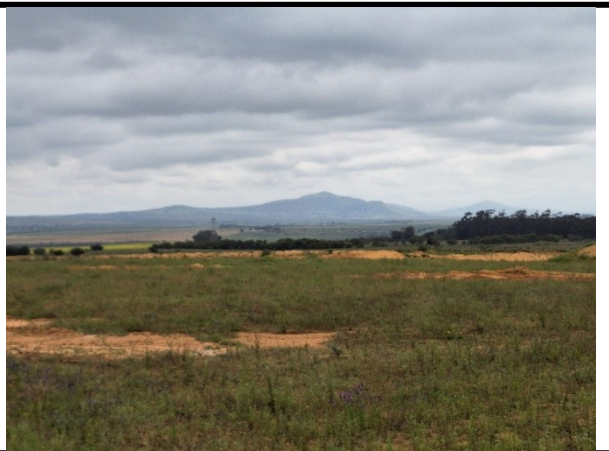
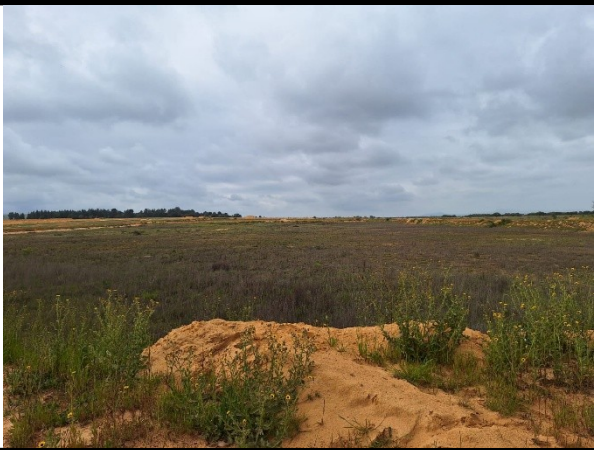
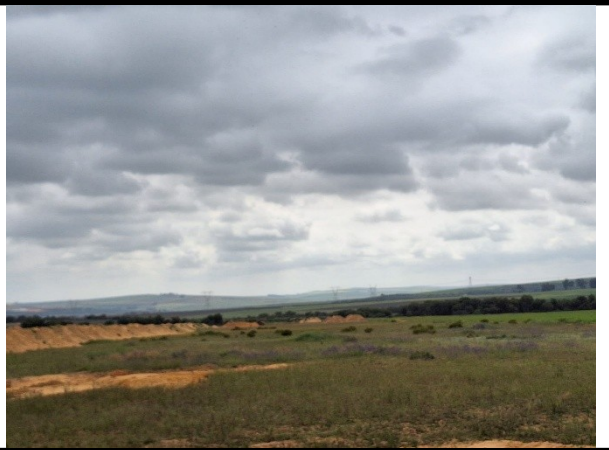
REHABILITATED AREAS WITH ADEQUATE VEGETATION COVER

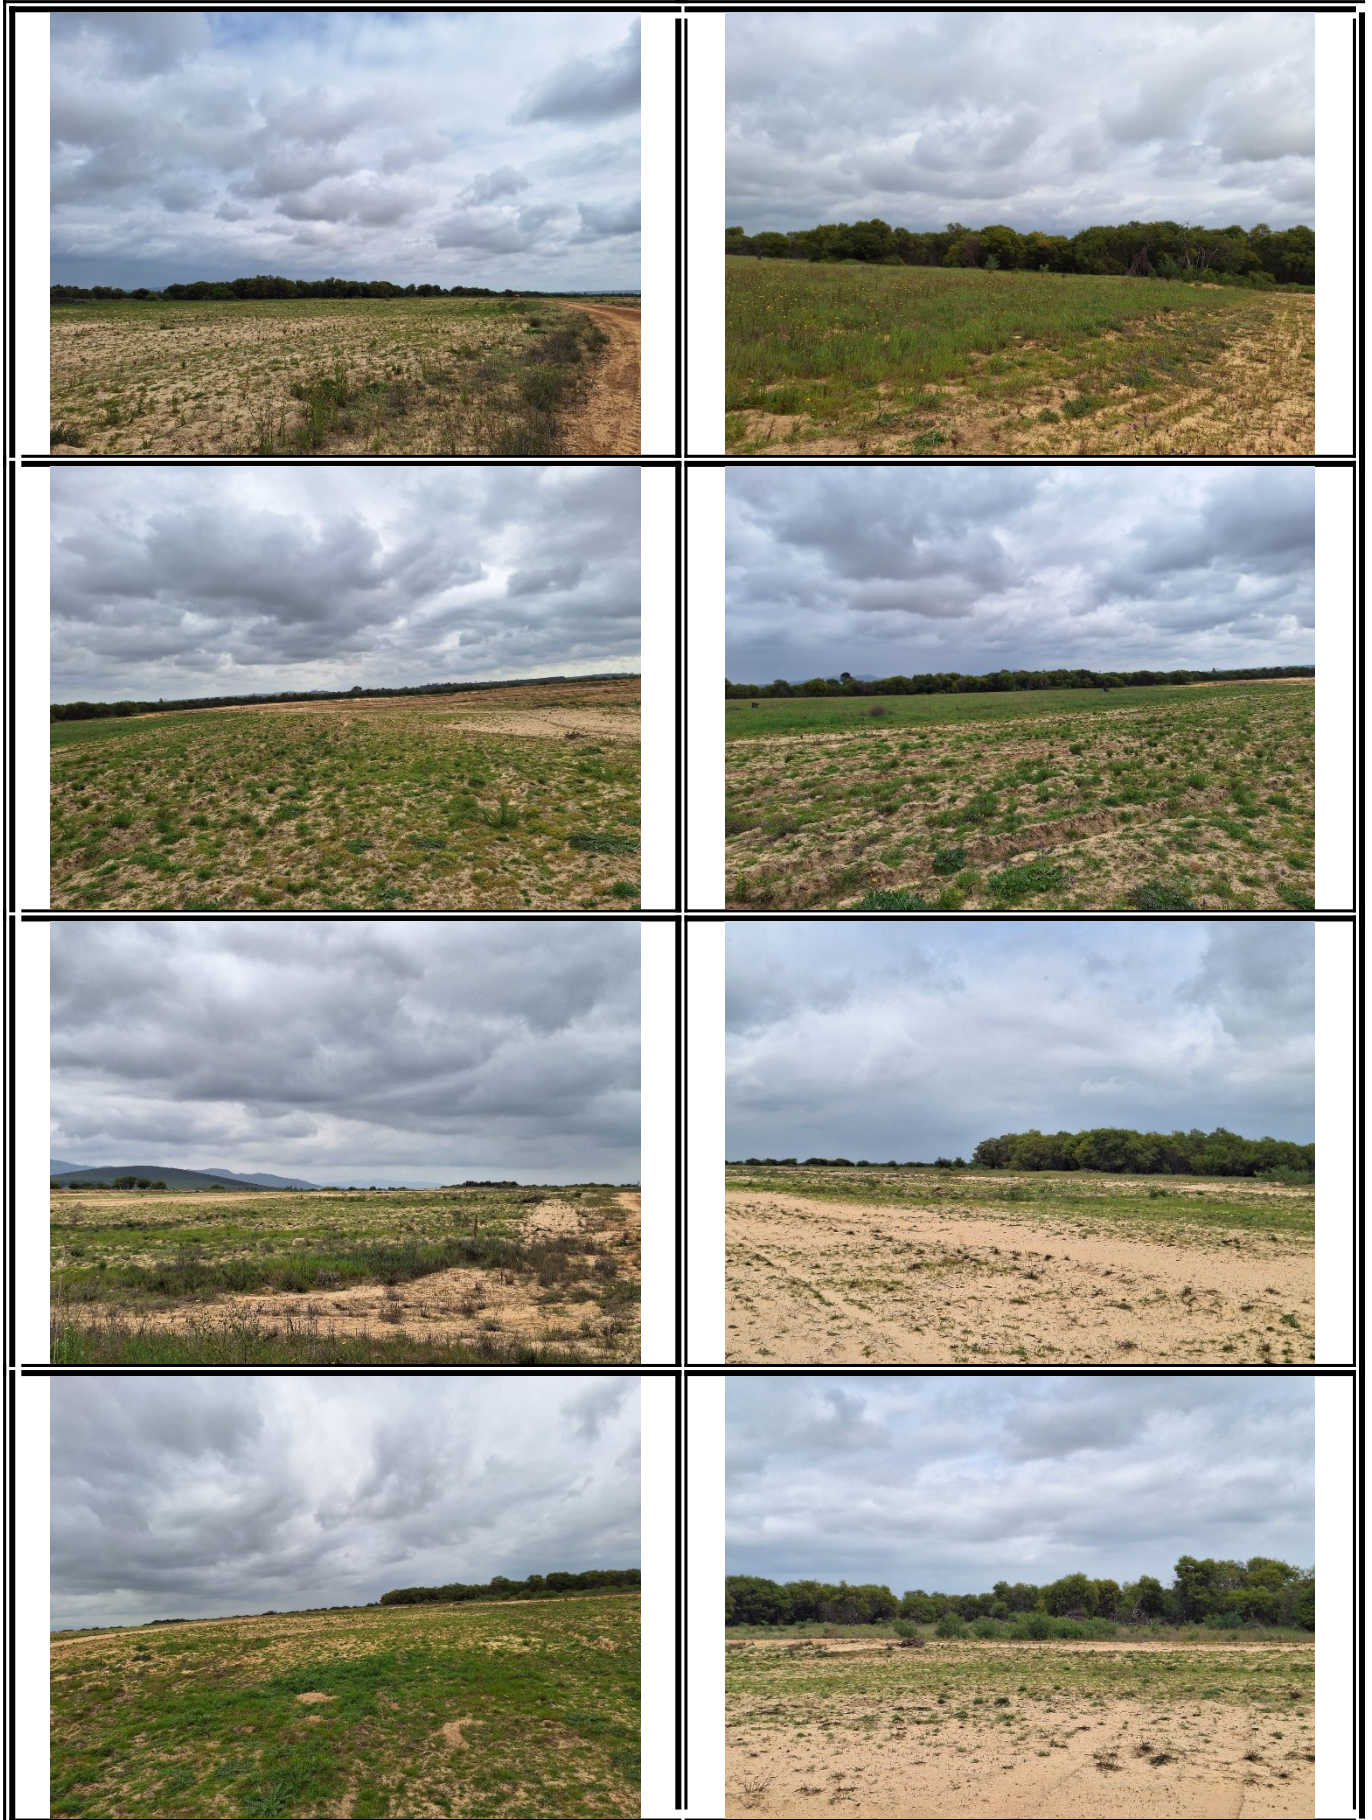
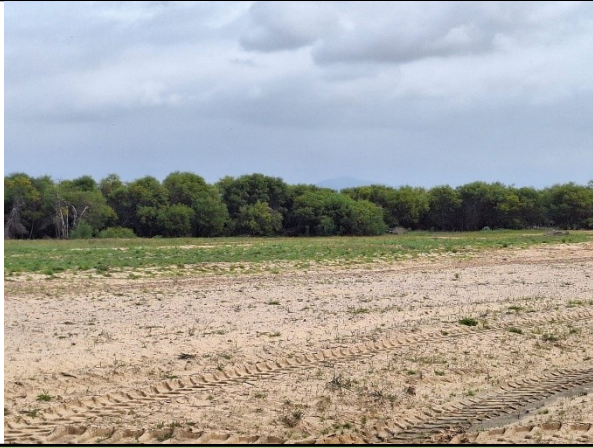
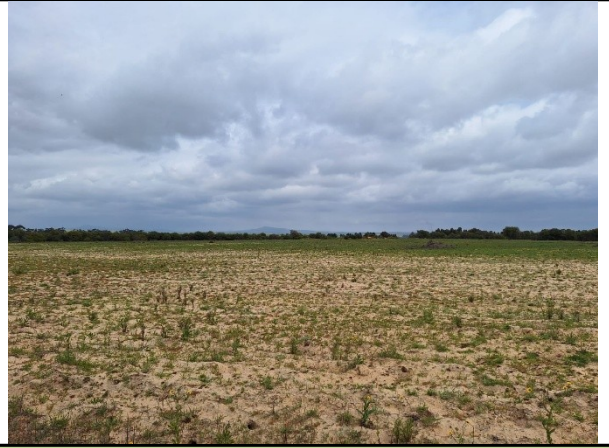
KERSFONTEIN 2 (SECTION B) - REHABILITATED AREAS

At Section B, Kersfontein 2, the area has remained undisturbed since rehabilitation was undertaken by the previous contractor in 2023. Although Google Earth imagery suggests that the area was not rehabilitated, ground-truth verification confirmed that rehabilitation had in fact been completed (refer to the attached photo

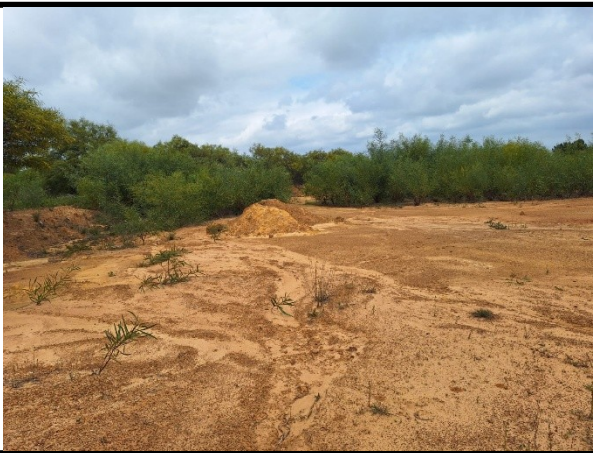
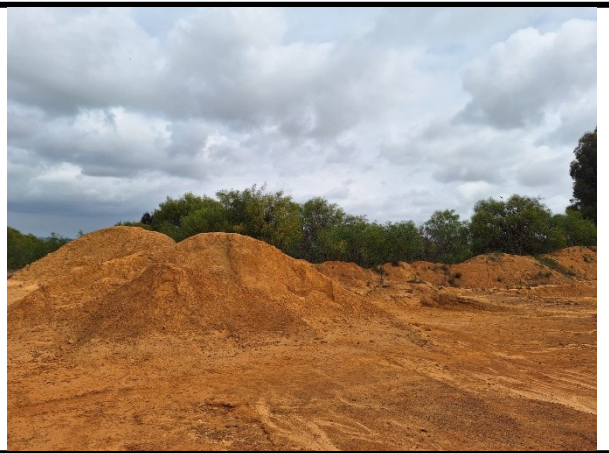
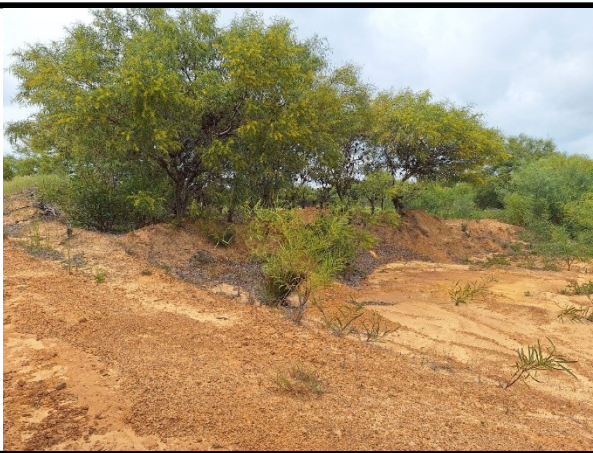
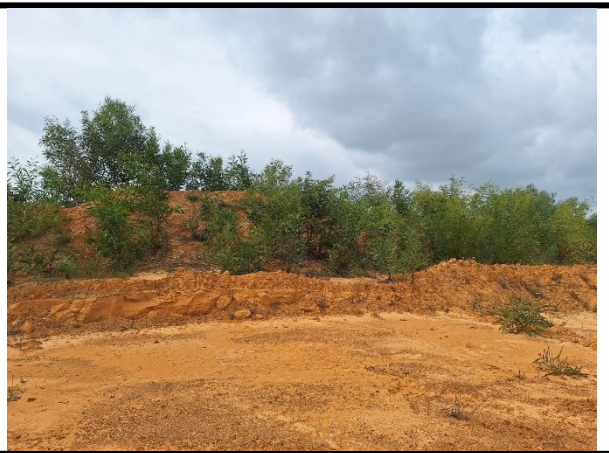
report). However, a portion in the southern section of Kersfontein 2 disturbed by SPH has not been rehabilitated, as the new mining right holder intends to mine that specific area in the future.

SOUTHERN SECTION IN KERSFONTEIN 2 – NOT REHABILITATED
