GRAHAMSTOWN BRICK (PTY) LTD T/A MAKANA BRICK

PORTION 3 OF THE FARM ORCHARDS 233

ENVIRONMENTAL PERFORMANCE ASSESSMENT

Permit Number:	16/2018 (EC 30/5/1/3/2/10397 MP)	Date of commencement:	August 2018
Site name:	Makana Brick – Collingham Quarry	Inspection date:	11 August 2022
Permit Holder:	Grahamstown Brick (Pty) Ltd t/a Makana Brick	Other authorisations:	N/A
Report number:	03

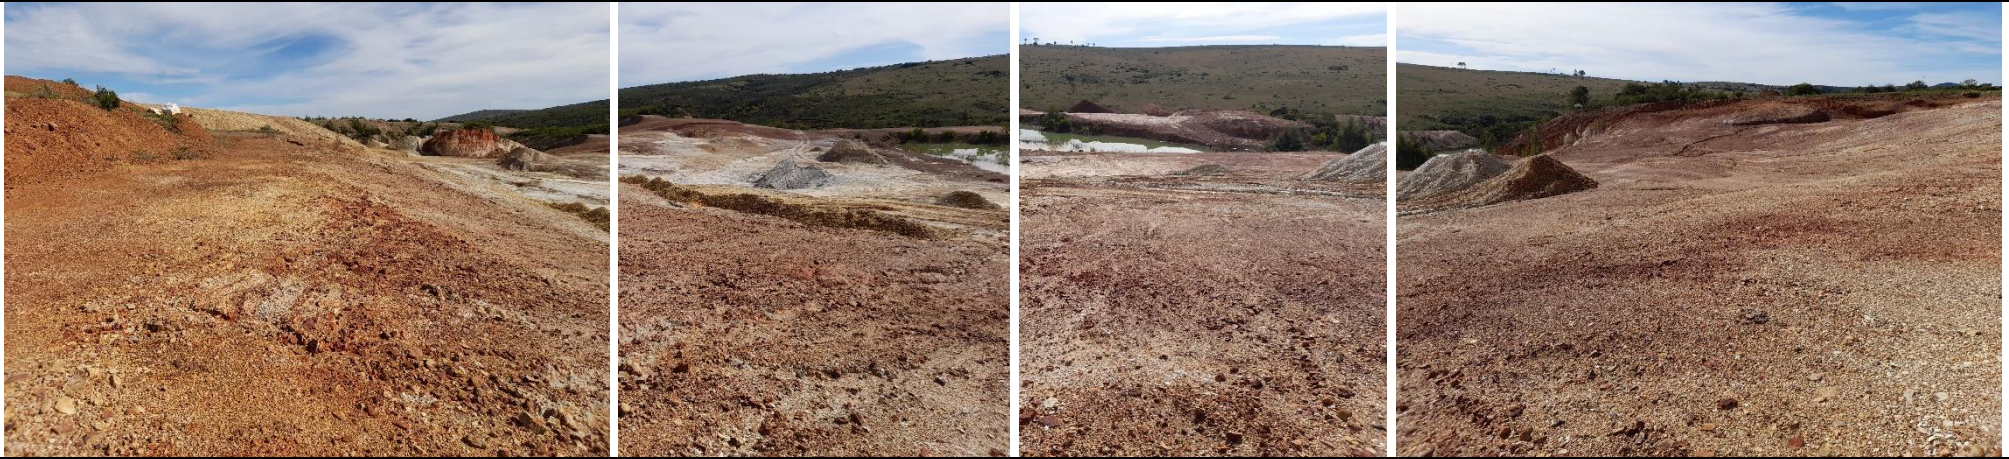
View of the Phase 1 mining area where the existing quarry (outside the mining footprint) can be seen at the back.

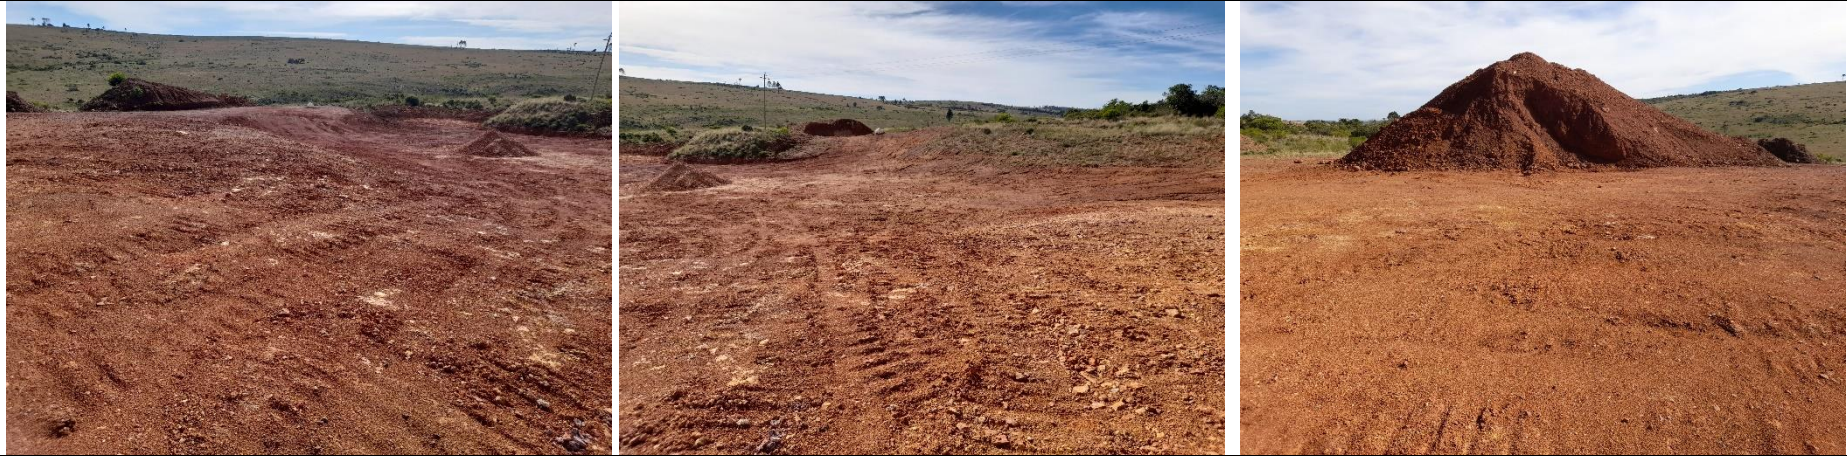
View of the Phase 2 mining area.

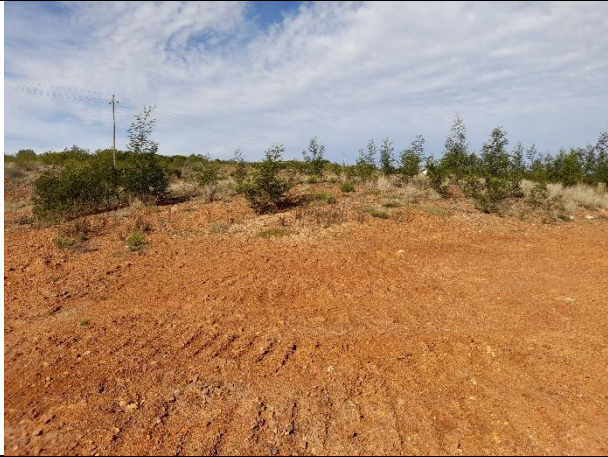
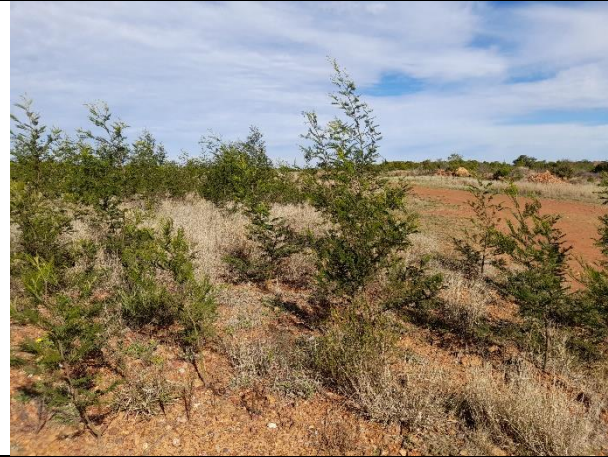
Wattles to be removed from site

As discussed on site, the Wattle trees germinating in and around the mining area must be controlled and removed as soon as possible.

1. Ensure that the employees have access to a chemical toilet that is within walking distance when the site is operational;
2. Ensure a dust alleviating measure is implemented to prevent clay blowing from transport trucks;
3. Control the wattles germinating on site.

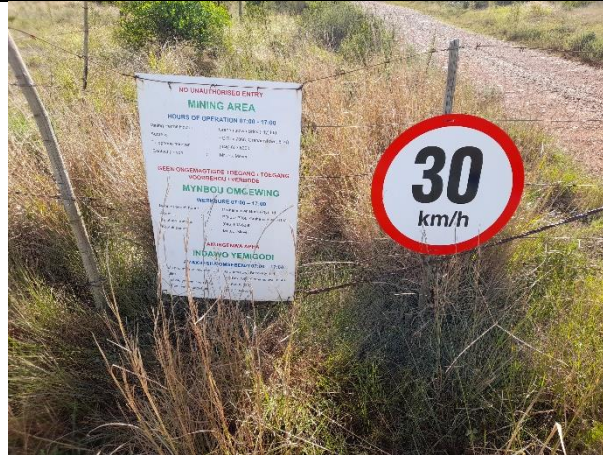
Vehicle speed restricted to 30 km/h.	5	-	Compliant	Signage reducing the speed of site vehicles to 30 km/h was add to the entrance road.

Signage present at entrance to the site
