# PROSPECTING RIGHT OVER PORTION 2 (A PORTION OF PORTION 1), REMAINDER PORTION, REMAINDER PORTION OF PORTION 1 AND PORTION 3 OF THE FARM MAKGANYENE NO 667 KURUMAN RD MAGISTERIAL DISTRICT, NORTHERN CAPE PROVINCE

## ENVIRONMENTAL PERFORMANCE ASSESSMENT

<b>DMRE REFERENCE NUMBER:</b>	<b>NC 30/5/1/1/2/12774 PR &amp; NC 00122 PR/11</b>
<b>AUDIT PERIOD:</b>	<b>July 2022</b>

<b>Right Number:</b>	NC 30/5/1/1/2/12774 PR & NC 00122PR/11	<b>Date of Commencement:</b>	2019
<b>Site Name:</b>	Makganyane Prospecting Right	<b>Inspection Date:</b>	25 July 2022
<b>Right Holder:</b>	Assmang (Pty) Ltd	<b>Other Authorisations:</b>	Not Applicable
<b>Report Number:</b>	03

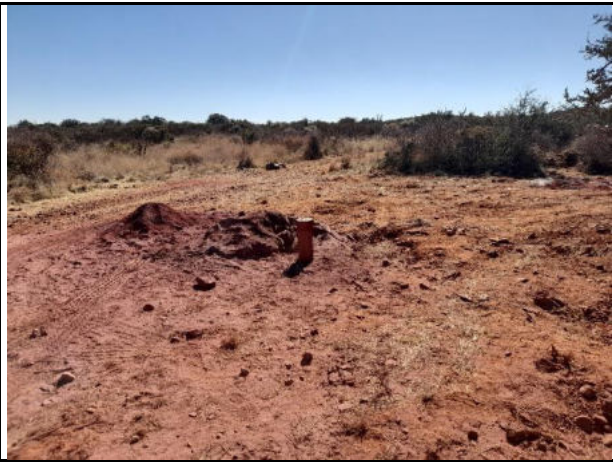
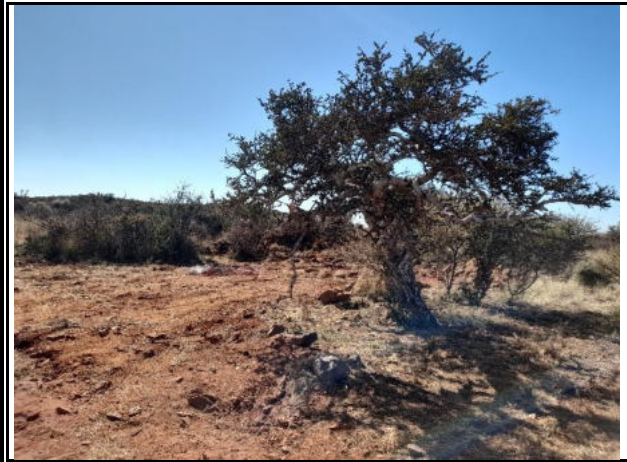
Drill site that was established adjacent to a Sheperd's Tree without affecting it

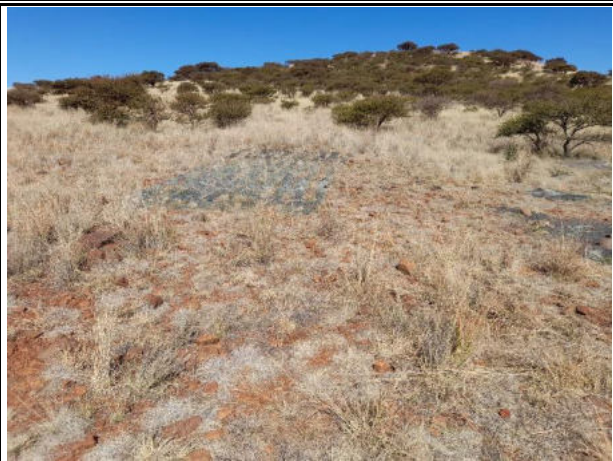
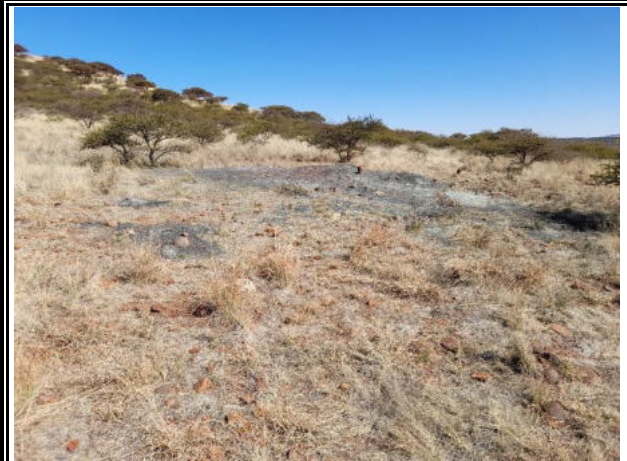
Capped drill site where rehabilitation still needs to be finalised

Site management confirmed that the reinstated areas (trenches and drill sites) will be seeded during the next growth season. However, it was pleasing to see that at the time of the inspection, some pioneer plants already started germinating in the reinstated areas.

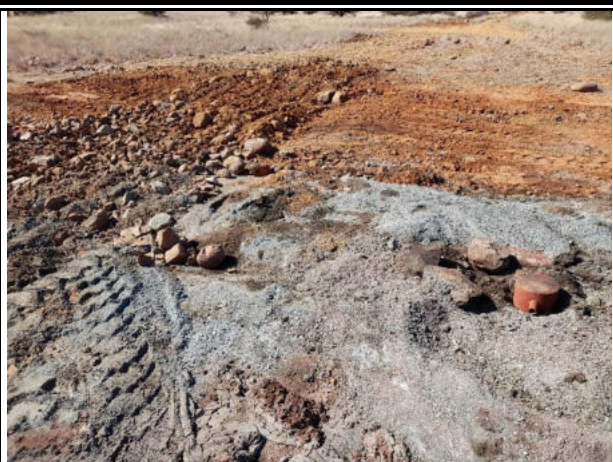
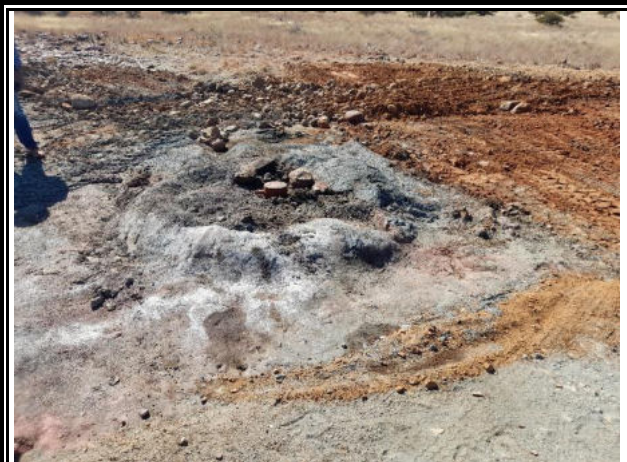
Capped drill site where hydrocarbon spills must be cleaned and rehabilitation still needs to be finalised

As discussed on site, any hydrocarbon spills need to be cleaned immediately after occurrence and the soil must be treated as hazardous waste. The operational drilling sites (that were visited), were neatly managed and work was taking place in between the Shepperd's Trees (*Boscia albitrunca*) where applicable. General- and hazardous waste bins were noted on site, as well as an oil spill kit. The contractor also placed speed reducing signage along the internal roads.

1. Clean all hydrocarbon spills at the drill sites;
2. Seed the reinstated areas during the growth season;
3. Replace the temporary bund of the diesel tank with a more permanent one of adequate size;
4. Ensure all waste removal can be backed up by safe disposal certificates/registers;
5. Proof compliance with the NWA and start a tally sheet to monitor water usage.

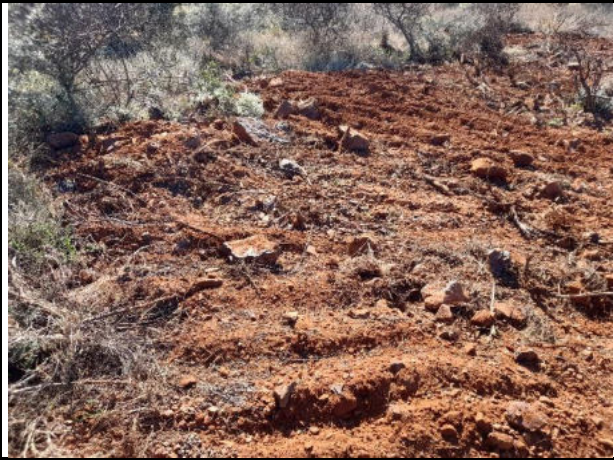
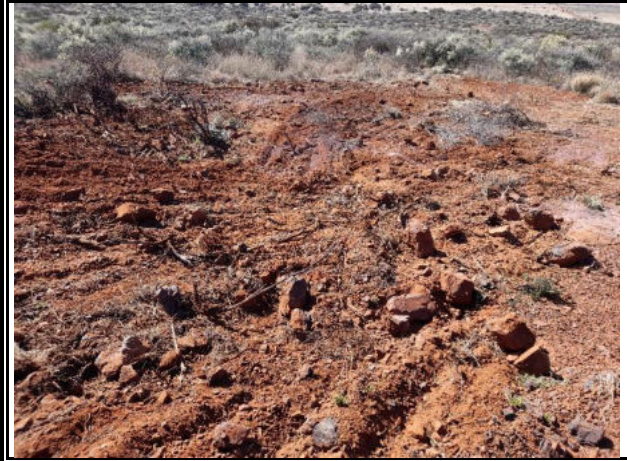
Neatly reinstated drill site (MK0160) to be seeded in the growth season

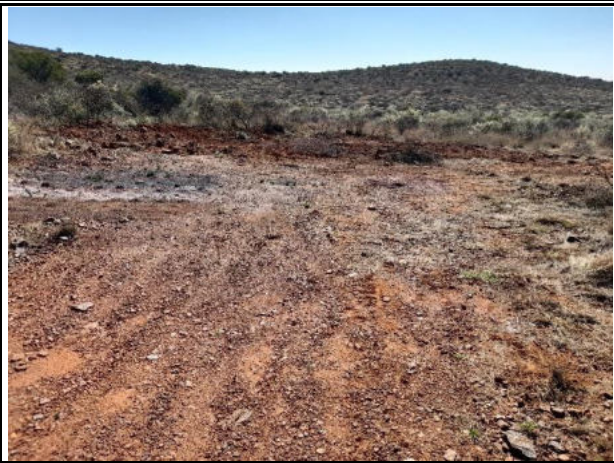
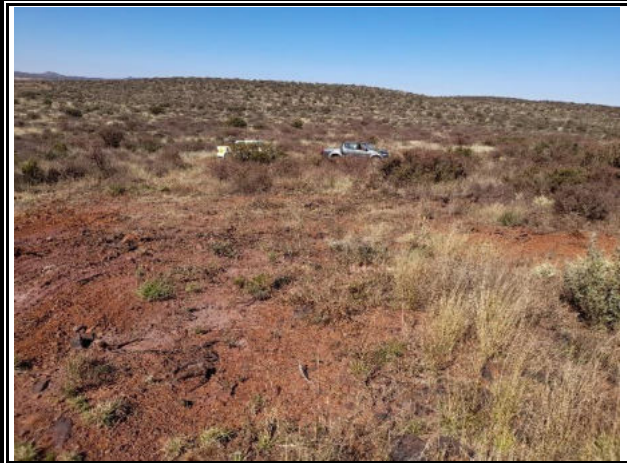
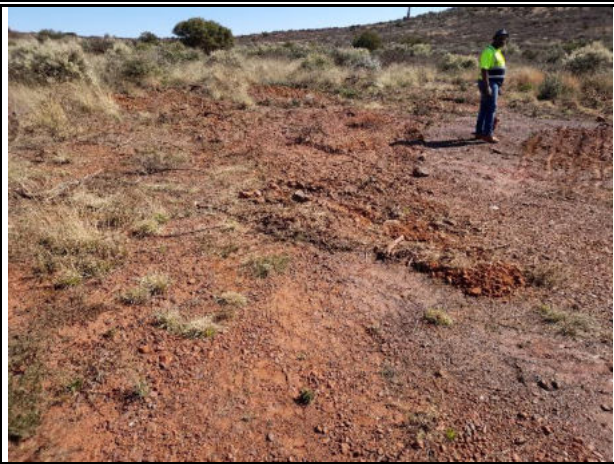
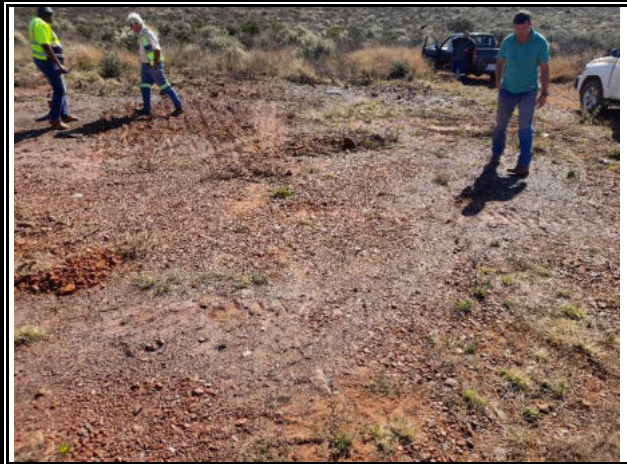
Neatly reinstated drill sites (MK0050 & 0118) to be seeded in the growth season

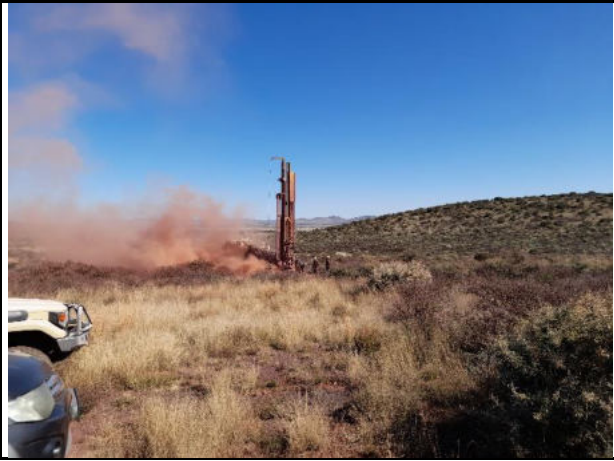
Drilling in progress

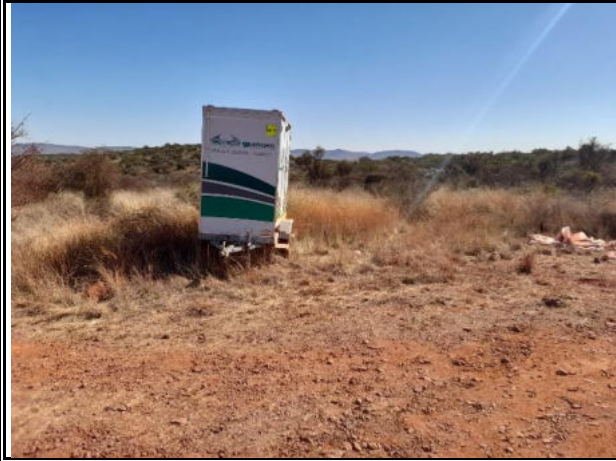
Chemical toilets used on site

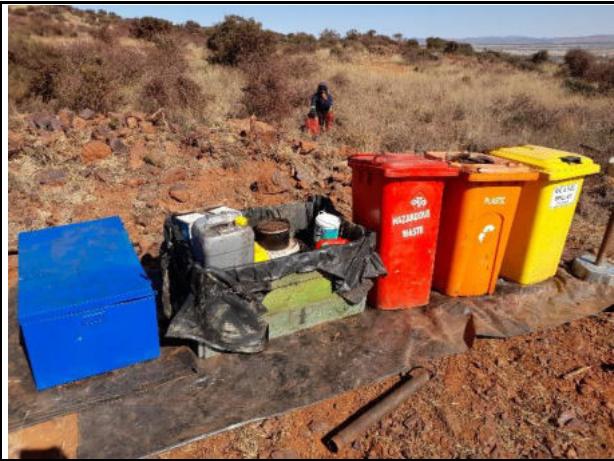
Waste bins used on site, and chemicals contained in a drip tray

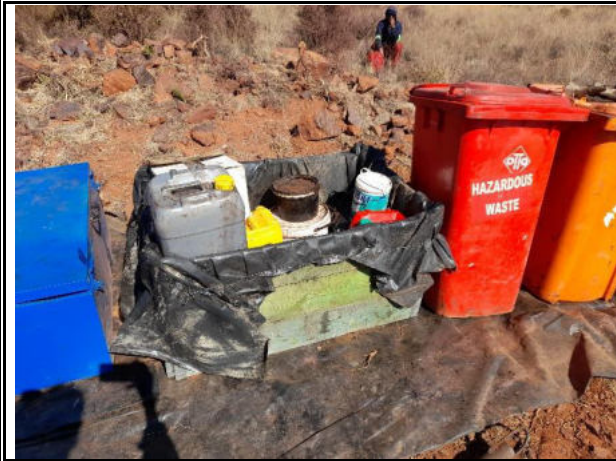
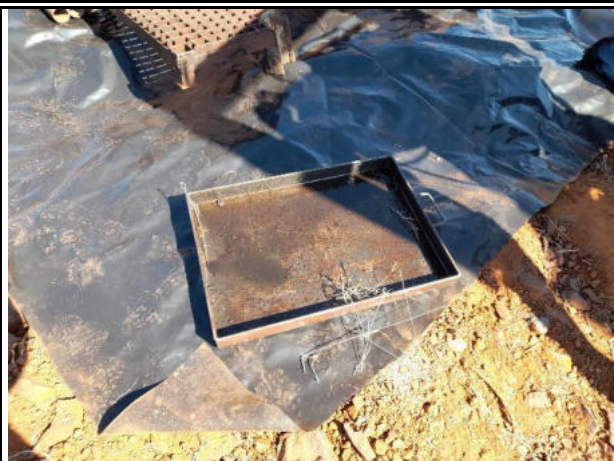
Drip tray used on site

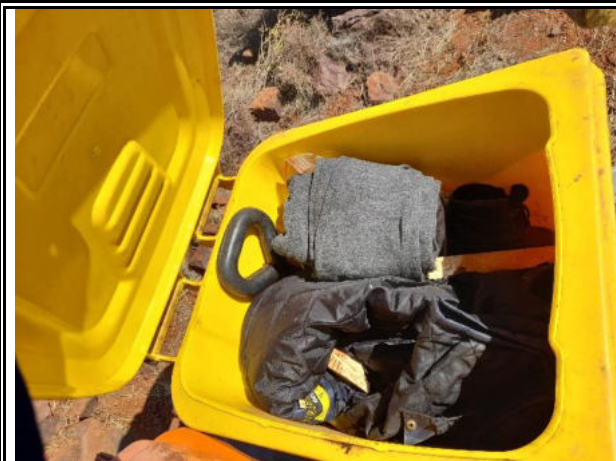
Oil spill kit

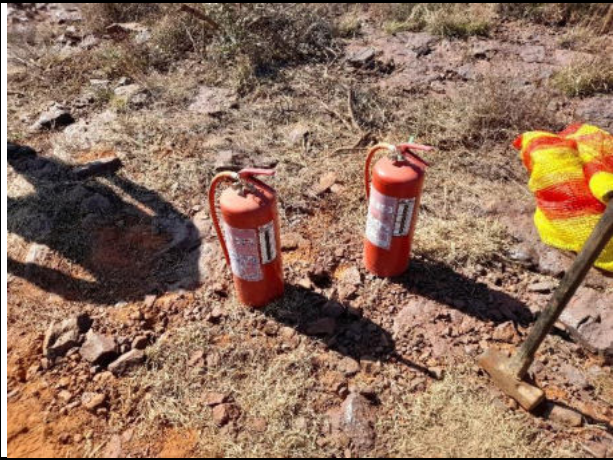
Fire extinguishers available on site

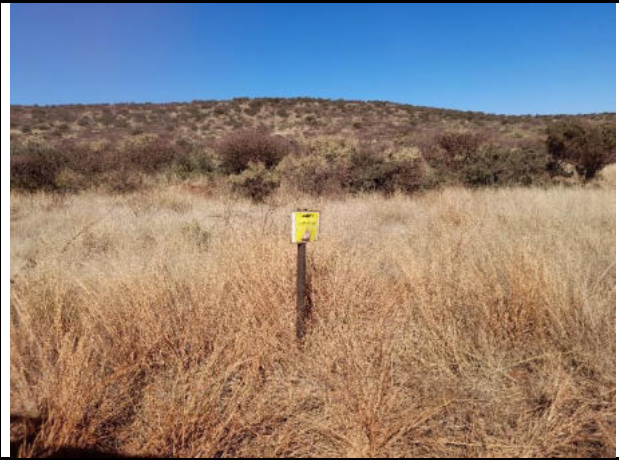
Speed reducing signage

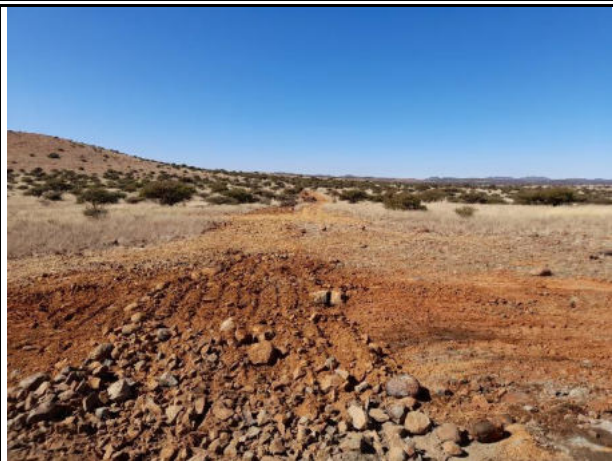
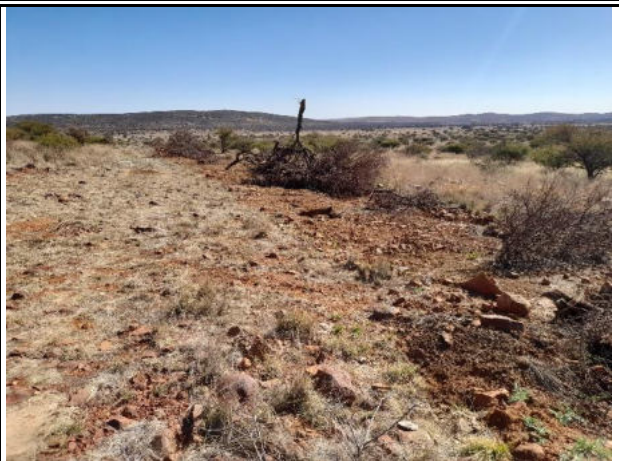
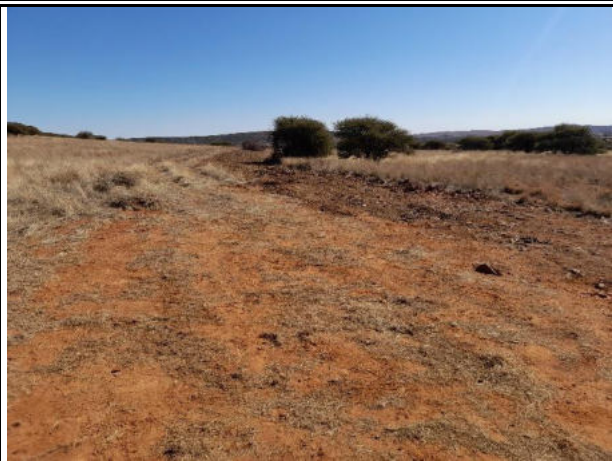
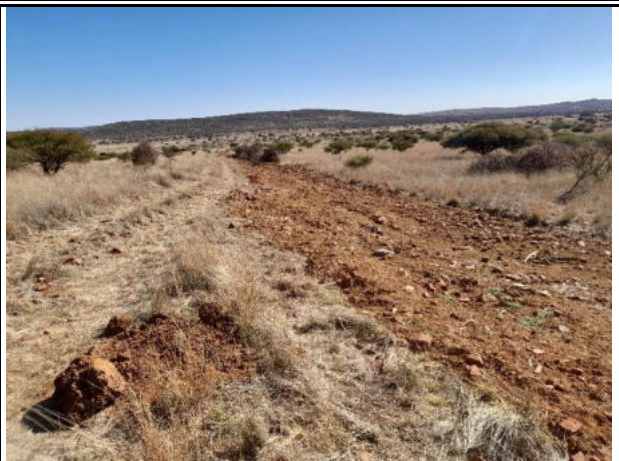
The prospecting trenches were all neatly reinstated and levelled. As discussed on site, brush and old branches can be placed over the reinstated areas for added protection, however care should be taken that the brush/wood does not create an added fire risk. It is proposed that sufficient fire breaks must be left in the row of brush/wood to prevent a veld fire running the entire length of the trench should it occur.

Neatly reinstated trenches to be seeded during the growth season

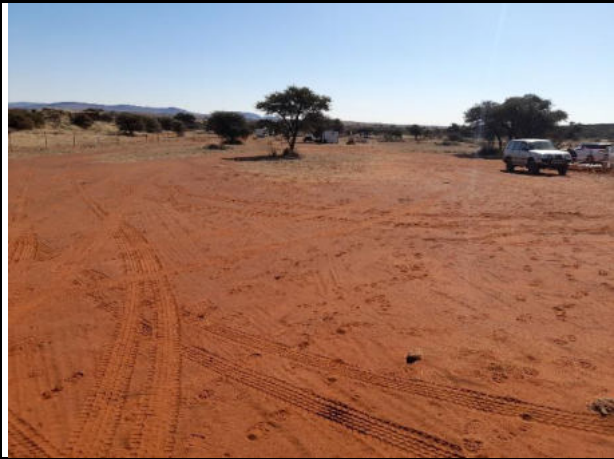
Neatly managed site camp

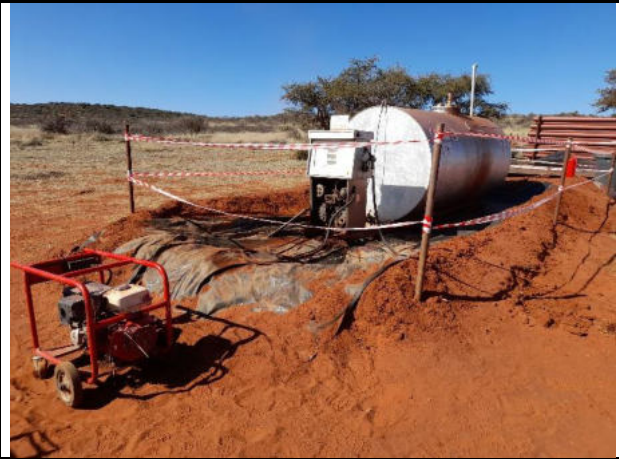
The drilling equipment is neatly stored and demarcated, and the diesel tank was placed inside a temporary bund that will shortly (according to site management) be replaced with a steel bund of adequate size. As discussed on site, all generators must be placed in drip trays to prevent minor spills during refuelling.

Diesel tank with bund. Generator to be placed in a drip tray

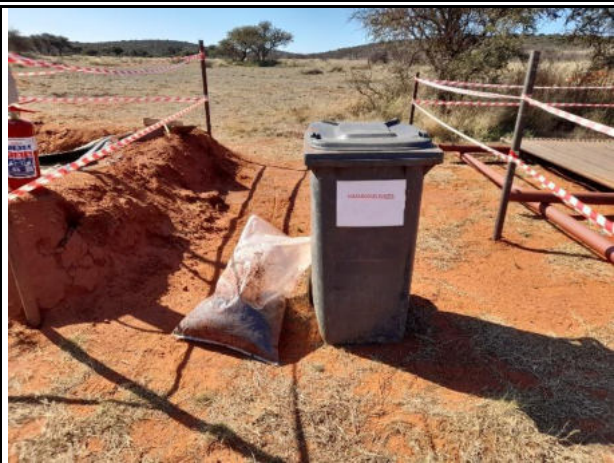
Hazardous waste bin on site

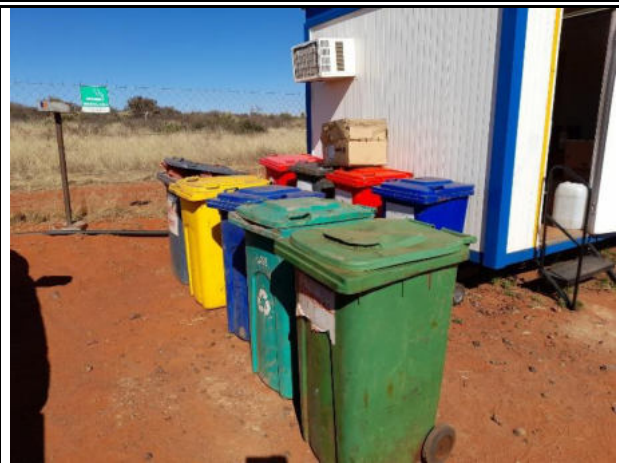
General waste bins
