PROSPECTING RIGHT OVER PORTION 2 (A PORTION OF PORTION 1), REMAINDER PORTION, REMAINDER PORTION OF PORTION 1 AND PORTION 3 OF THE FARM MAKGANYENE NO 667 KURUMAN RD MAGISTERIAL DISTRICT, NORTHERN CAPE PROVINCE

ENVIRONMENTAL PERFORMANCE ASSESSMENT

DMRE REFERENCE NUMBER:	NC 30/5/1/1/2/12774 PR & NC 00122 PR/11
AUDIT PERIOD:	July 2022 – July 2023

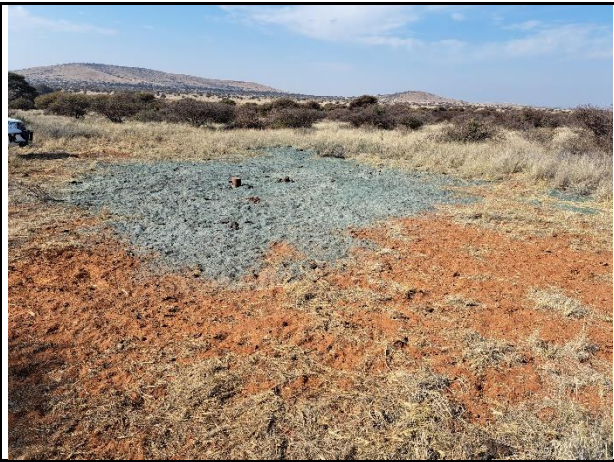
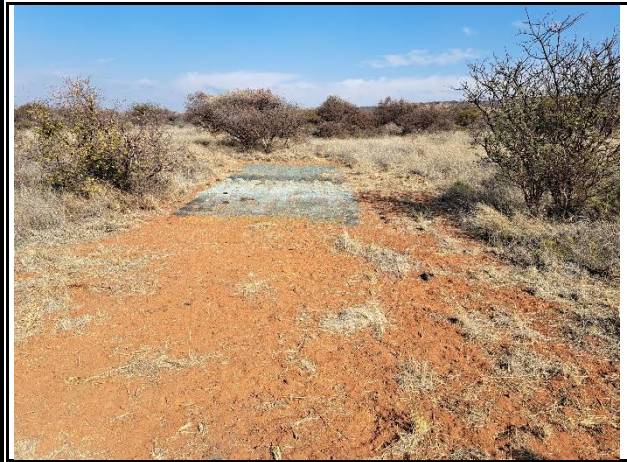
Drill site that was capped with final rehab pending (MK 0325)

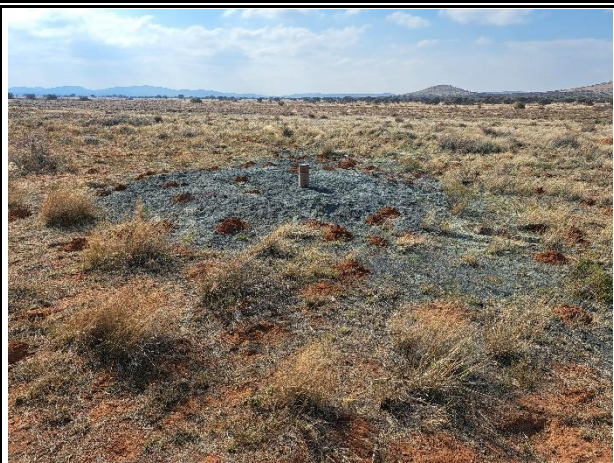
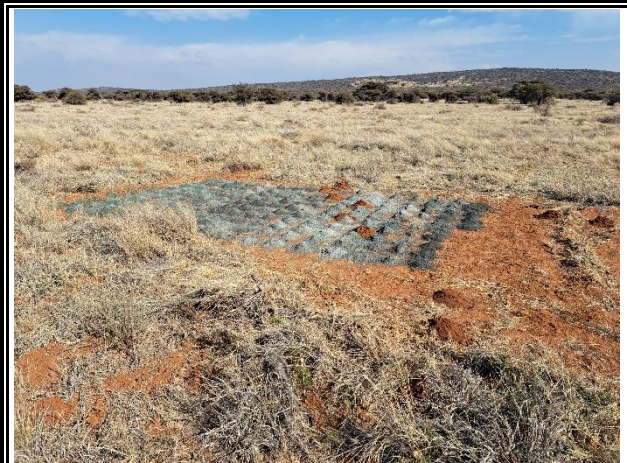
Capped drill site where rehabilitation still needs to be finalised – note vegetation returning through succession (MK 0324)

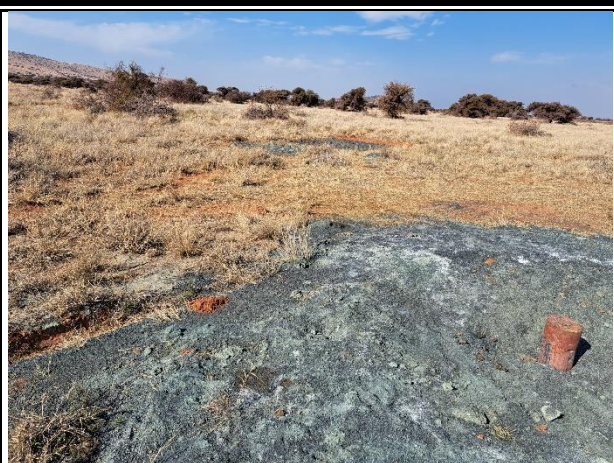
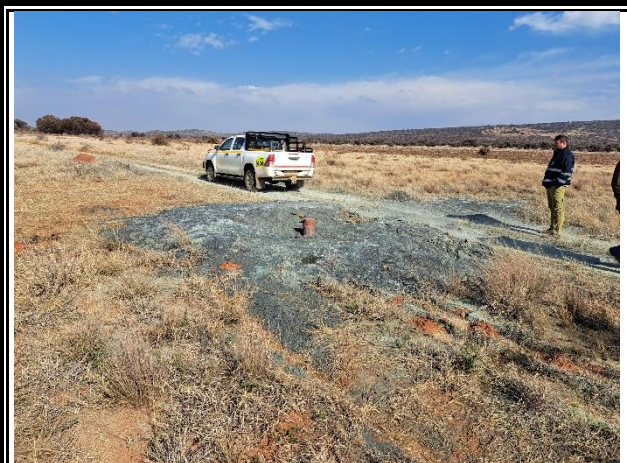
Capped drill site where final rehab must still be done (MK0323)

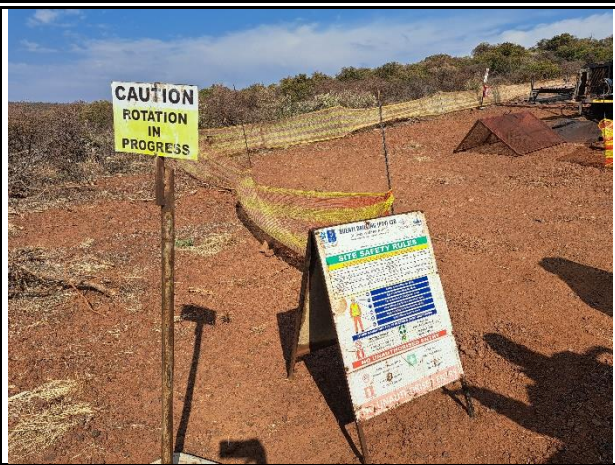
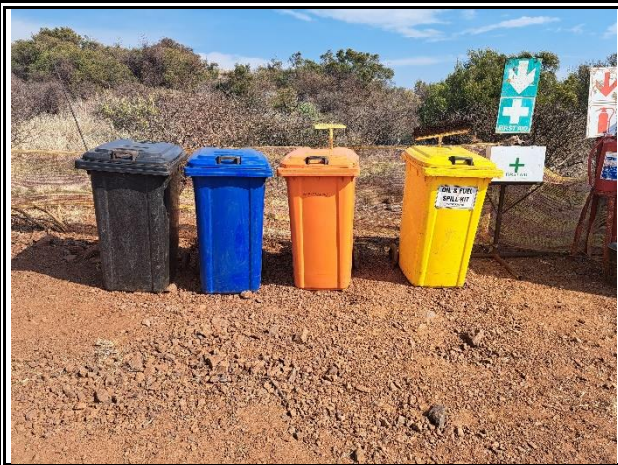
Waste bins and oil spill kit available on site

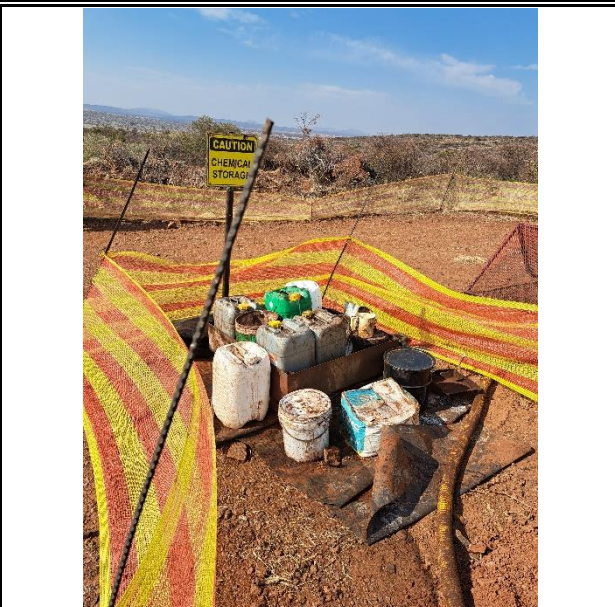
Chemicals stored on plastic sheeting in designated area

As discussed on site, all chemicals must be kept in drip trays or in the site vehicles. The operational drilling sites (that were visited), were all neatly managed. General- and hazardous waste bins were noted on site, as well as oil spill kits.

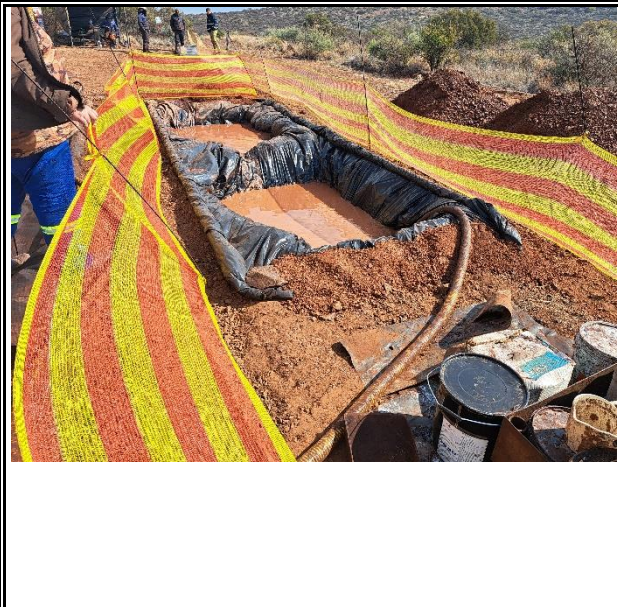
Sumps neatly barricaded

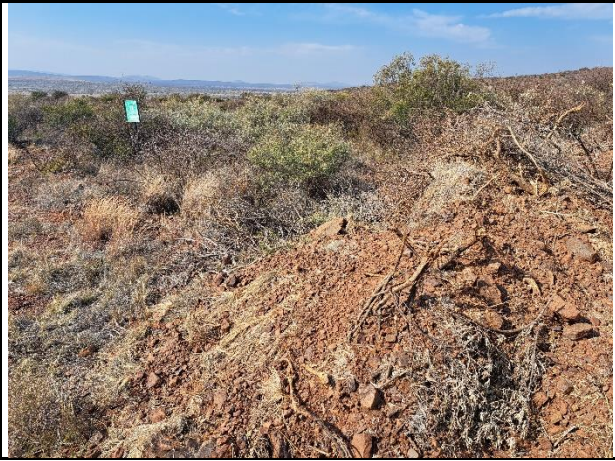
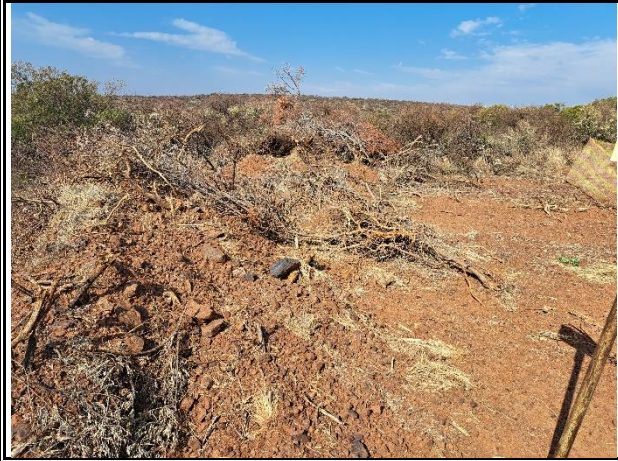
Brush and topsoil removed from operational site

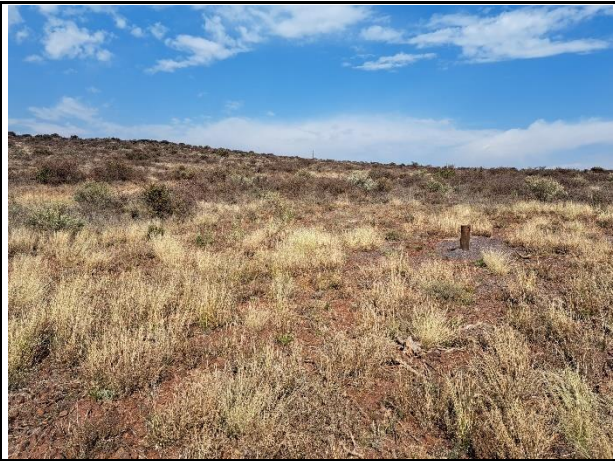
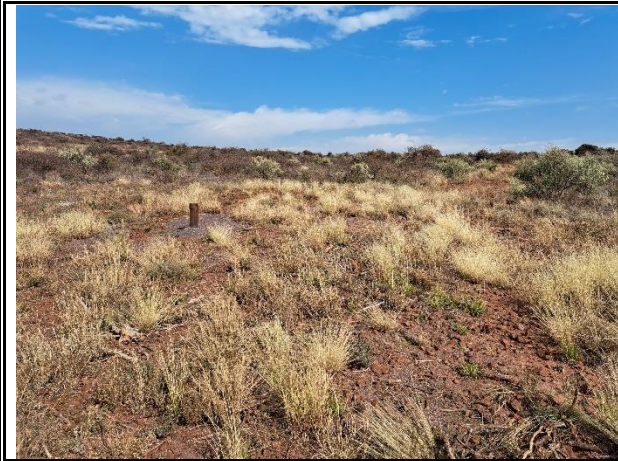
Rehabilitated drillsite that recovered well (MK0257)

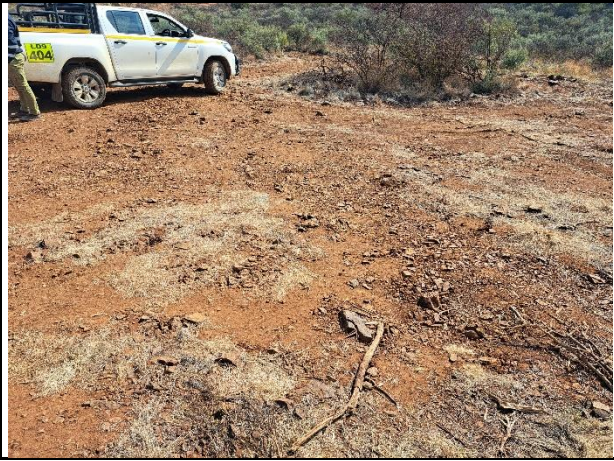
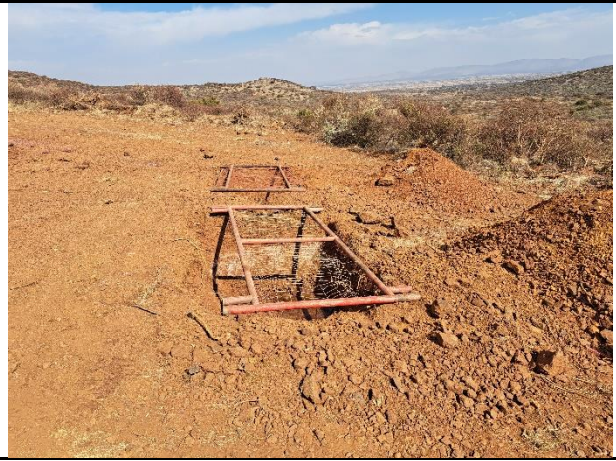
Drilling completed with rehabilitation pending (MK0169)

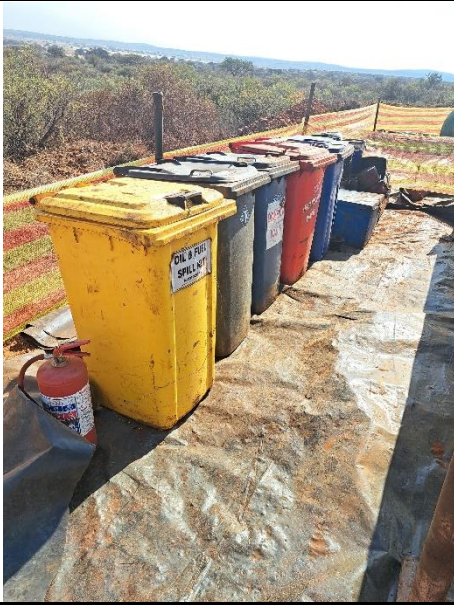
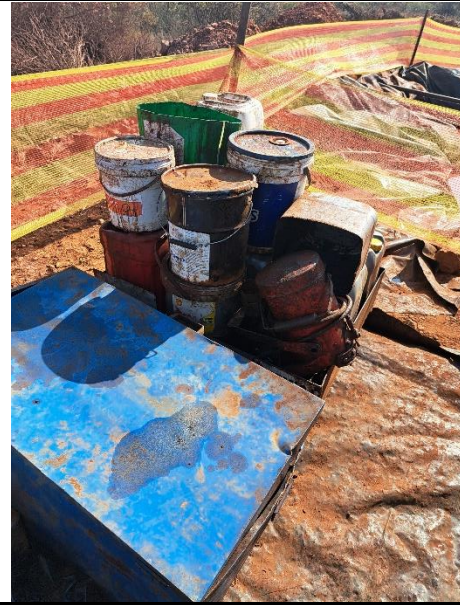
Operational site neatly managed

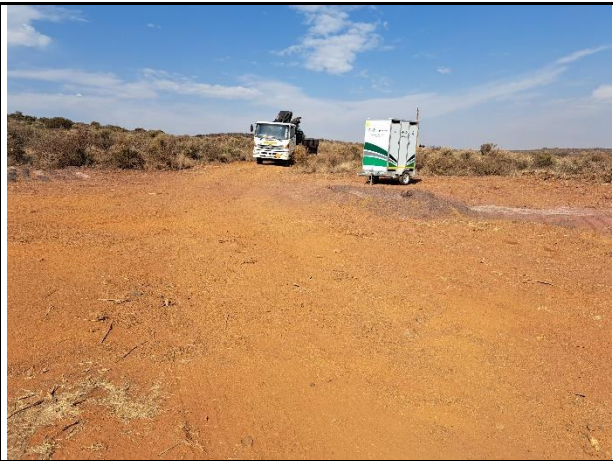
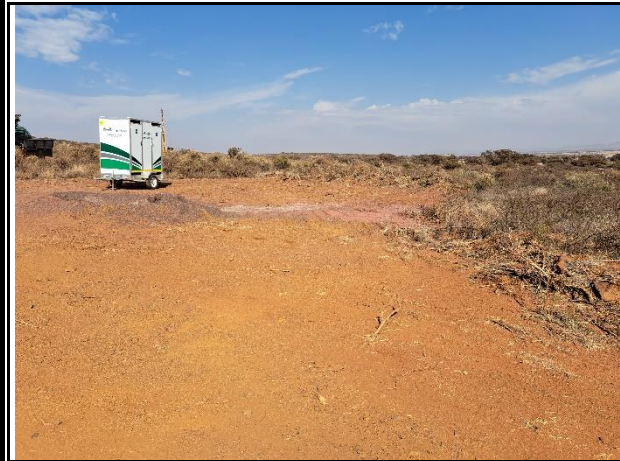
Drilling completed and sumps closed. Final rehab to be done.

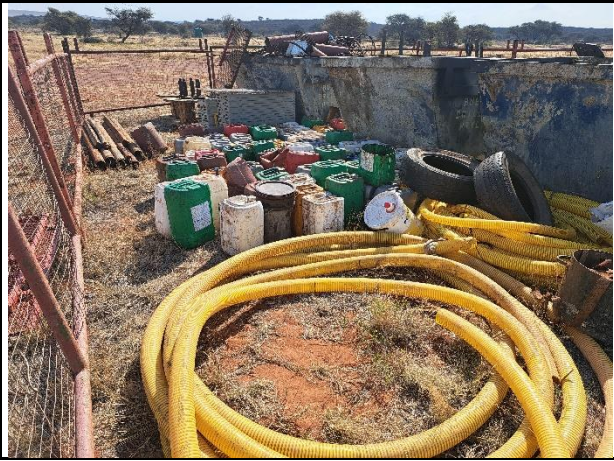
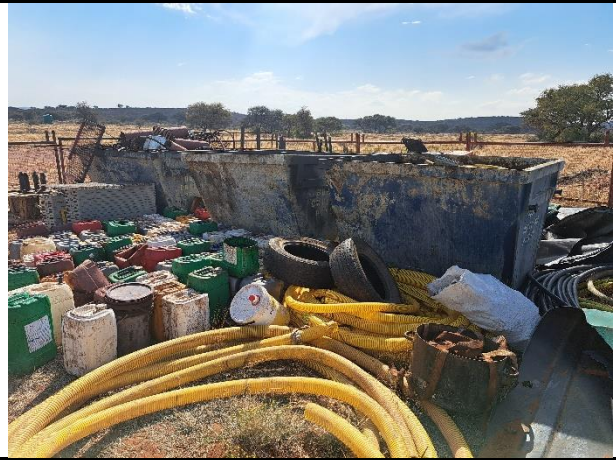
All chemicals must be kept in a bunded area with impermeable surface

It is proposed that a bund with impermeable surface be added to the storage area, where all chemicals, containers, grease pumps etc. can be kept. No chemicals (new/used containers) may be placed on the bare soil

1. Place all chemicals in a bunded area or drip trays of sufficient size;
2. File proof of general waste disposal and hazardous waste disposal (when available);
3. Proof compliance with the NWA and start a tally sheet to monitor water usage.

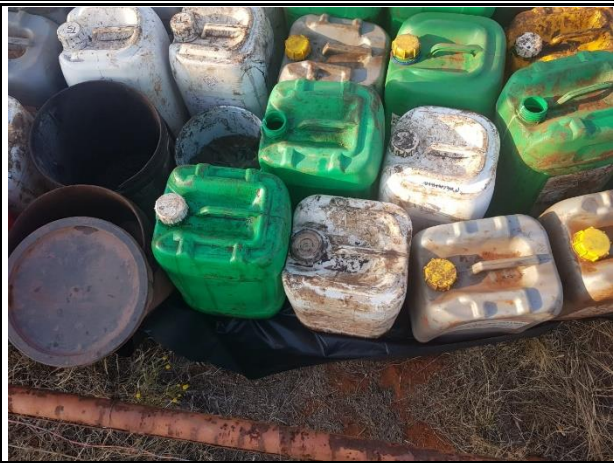
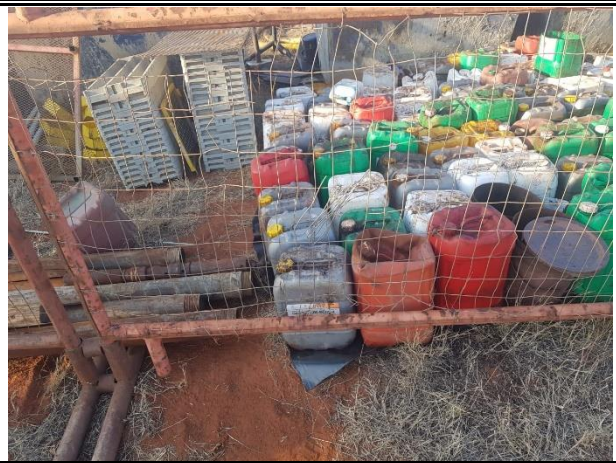
Cans placed on plastic lining as a temporary solution

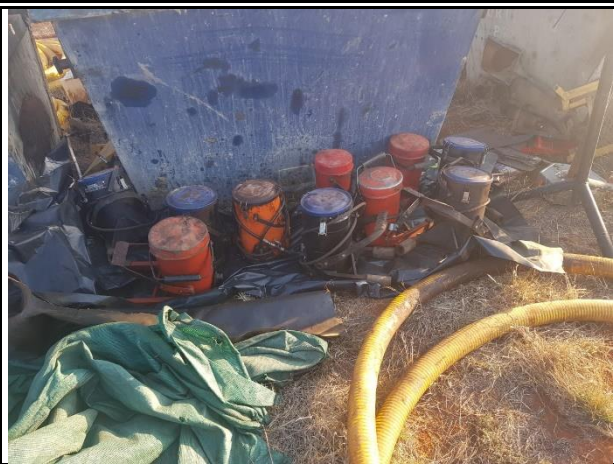
Grease cans also placed on plastic

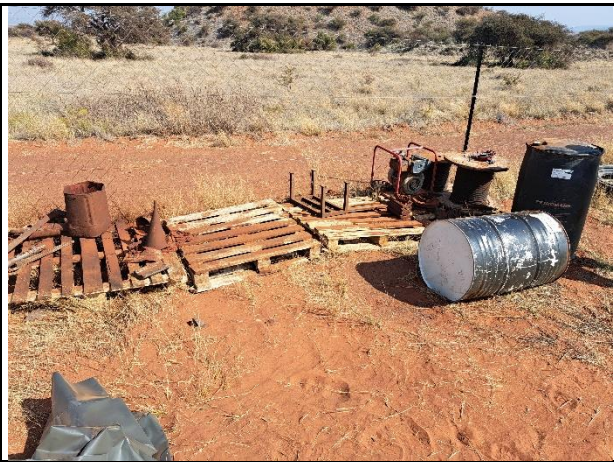
Drums that had to be removed to a bunded area

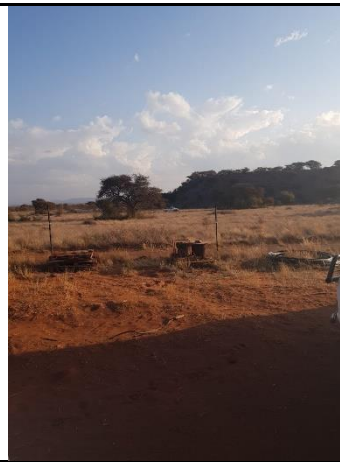
Drums removed to a storage container

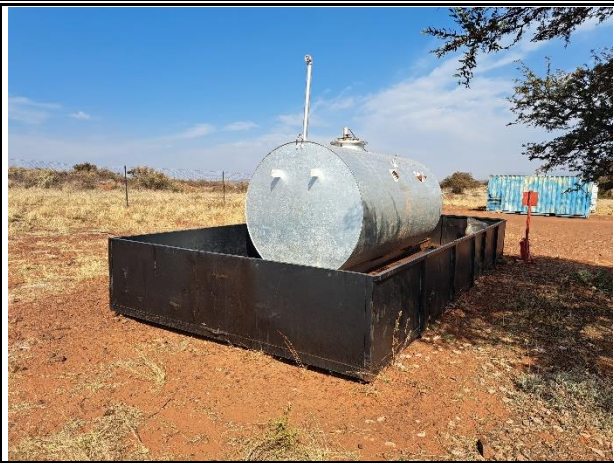
A steel drip tray of adequate size was added around the diesel tank. As discussed on site, drip trays must be used when vehicles/equipment are refilled to prevent diesel spillage.

Well build drip tray installed around the diesel tank

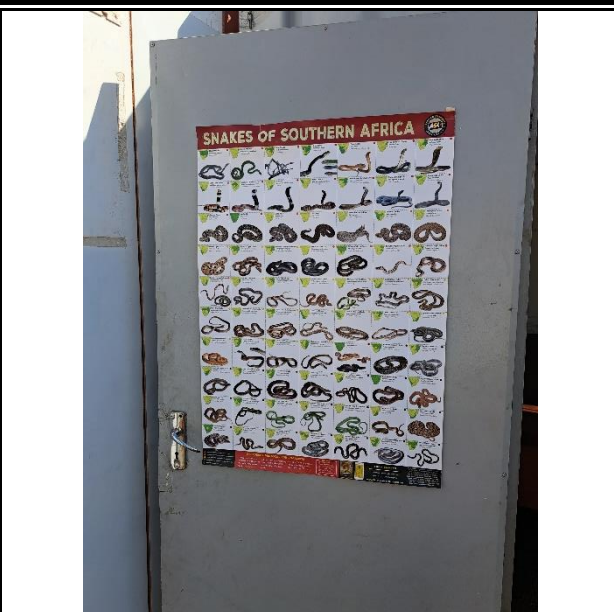
Snake awareness poster on site

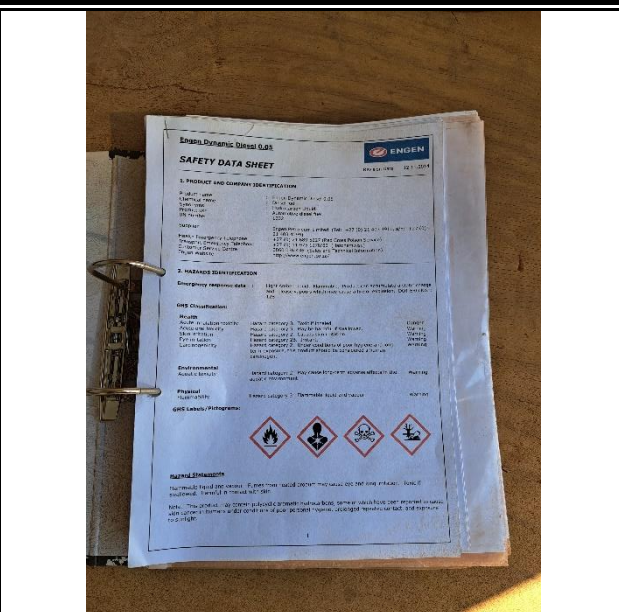
MSDS's available on site
