**MAKHANDA MINING (PTY) LTD**  
**REMAINING EXTENT OF THE FARM BRAKKEFONTEIN 243**  
**MAKHANDA, EASTERN CAPE PROVINCE**

**ENVIRONMENTAL PERFORMANCE ASSESSMENT**

<b>DMRE REFERENCE NUMBER:</b>	<b>EC 30/5/1/2/2/0056 MR</b>
<b>AUDIT PERIOD:</b>	<b>JULY 2021 – AUGUST 2022</b>

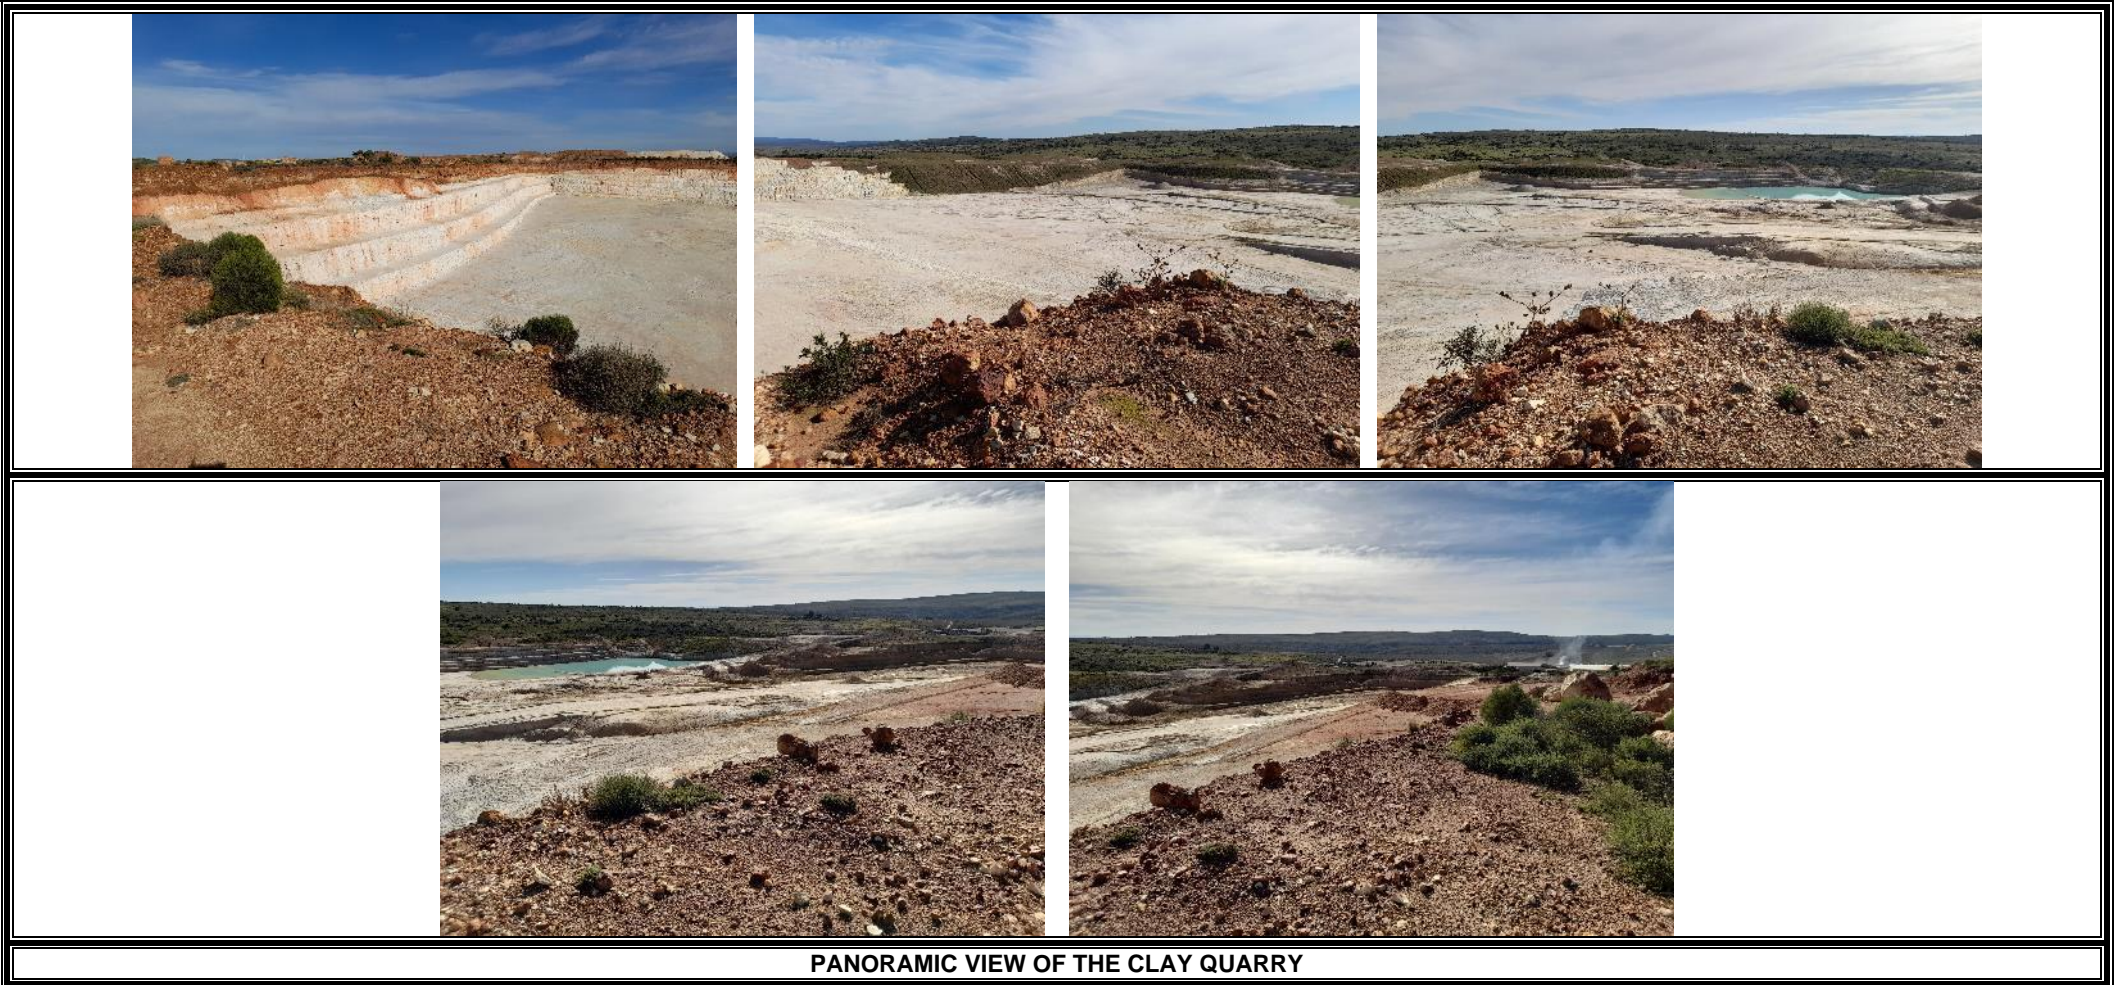
**PANORAMIC VIEW OF THE CLAY QUARRY**

Mining continues along the eastern- and southern banks of the clay quarry. No new areas were opened during the audit period as the depth of the quarry was merely increased, and because of this no progressive rehabilitation could be done. Since the last audit the (surface) water in the north-eastern section of the quarry increased substantially. At the time of the inspection the clay quarry was neat and well managed.

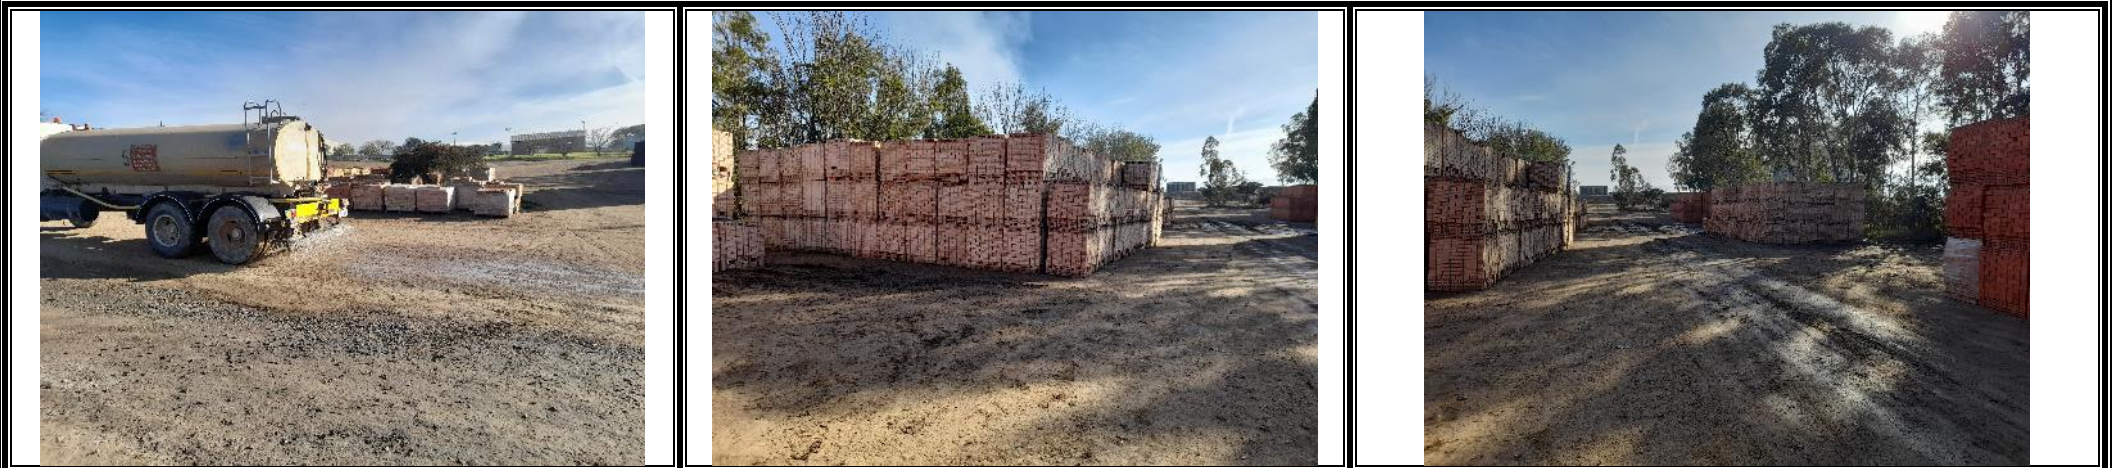
Dust suppression in progress

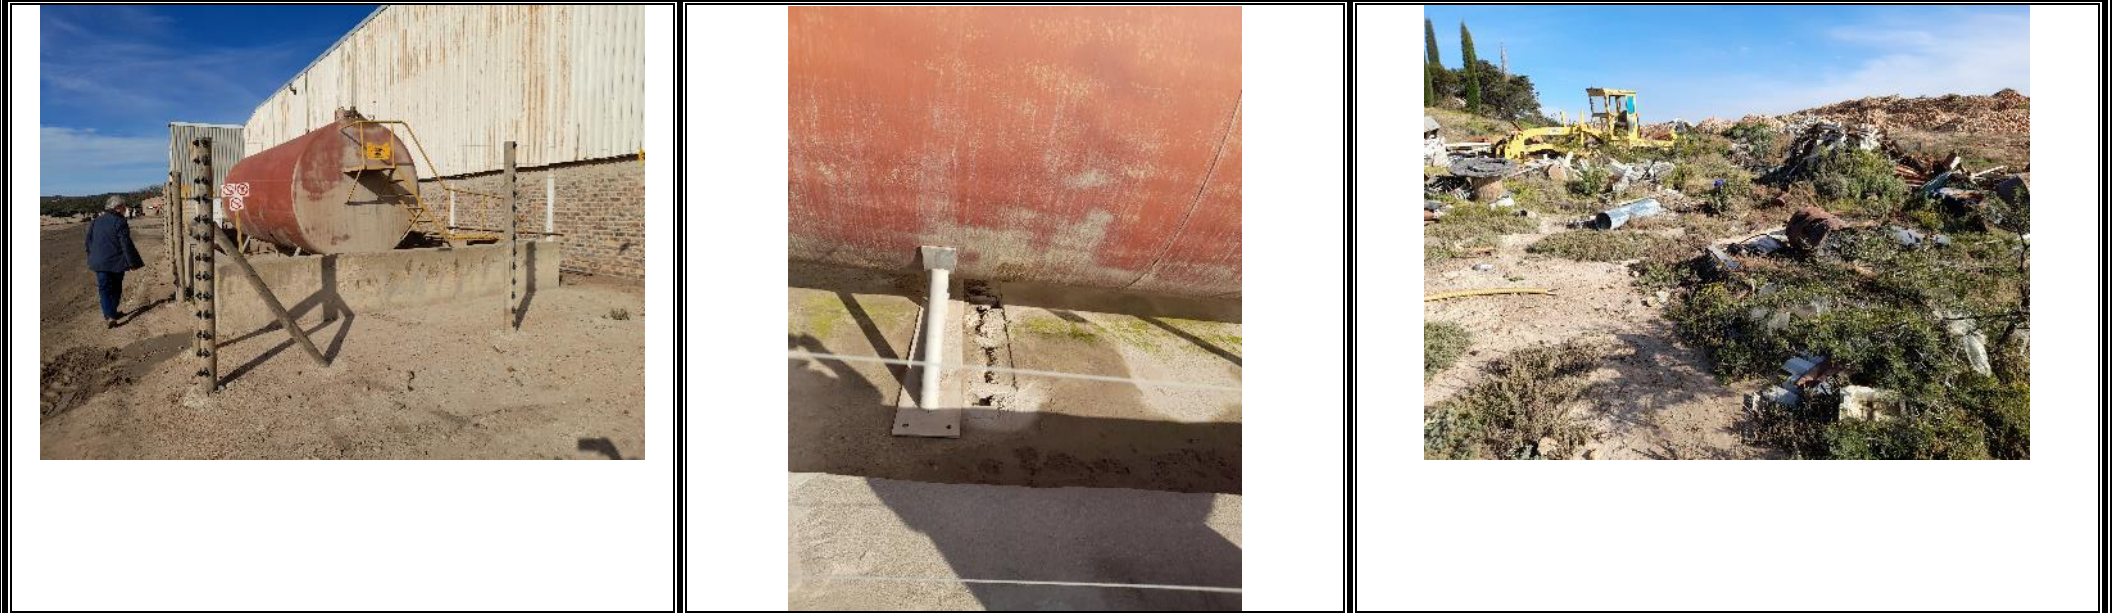
The new waste/scrap storage area is neatly fenced, and mainly used for the storage of scrap material. Site management mentioned that the old scrap yard will also be sorted, and the materials moved to the relevant divisions of the new storage area.

Bunded area to be sealed

Scrap yard that will be sorted

- All chemicals stored on site must be kept within bunded areas.
- Any used-oil tanks must be kept in a formal bund wall with a lined surface, and no containers holding chemicals/hydrocarbons may be placed directly on the soil.
- All the bund walls must be sealed.

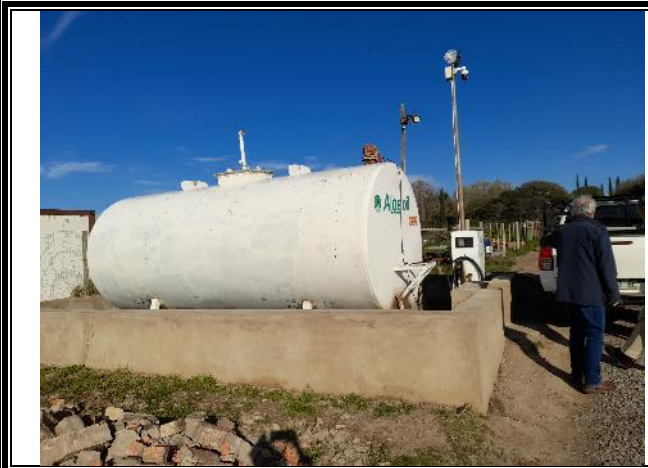
**Bunded area to be sealed**

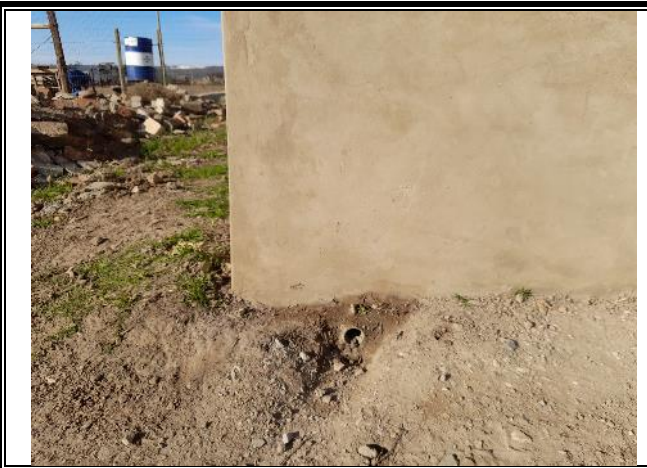
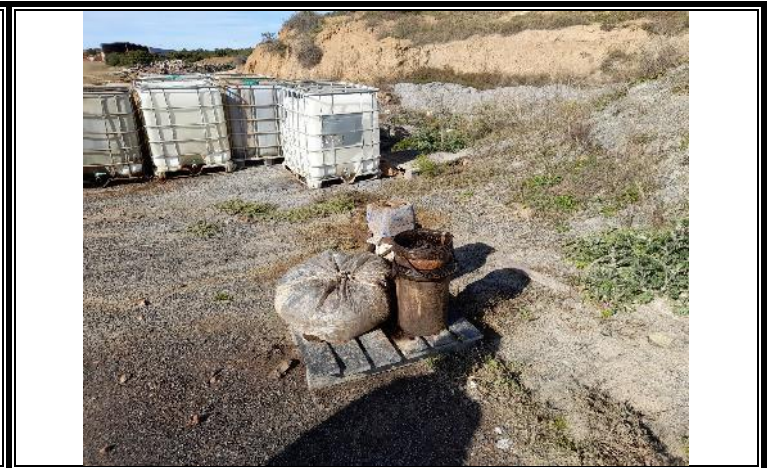
As mentioned, all contaminated waste must be kept inside bunded areas. The site continues with the separation of the waste materials into waste that can be burned at the kiln (in accordance with the air emissions licence), and those that needs to be removed from site. All used oil, oil filters, contaminated soil and such like materials are burned at the kiln and the site therefore does not have any hazardous waste in need of disposal. The burning of waste does not trigger the thresholds of the National Environmental Management: Waste Act, 2008 as the site does not burn/reuse more than 1 ton of waste per day. Although the EMPR does not allow for the burning of waste at the site, the present method implemented by Makana Brick is believed to be in the best interest of the environment, as it reduces the amount of waste that needs to be disposed of at landfill sites (general and/or hazardous) and contributes (in the case of used oil) to the reduction of diesel/fuel usage on site. Further to this, the stack emission results show that the operations comply with the requirements of the air emissions licence.

**Contaminated waste to be placed in bunded area**

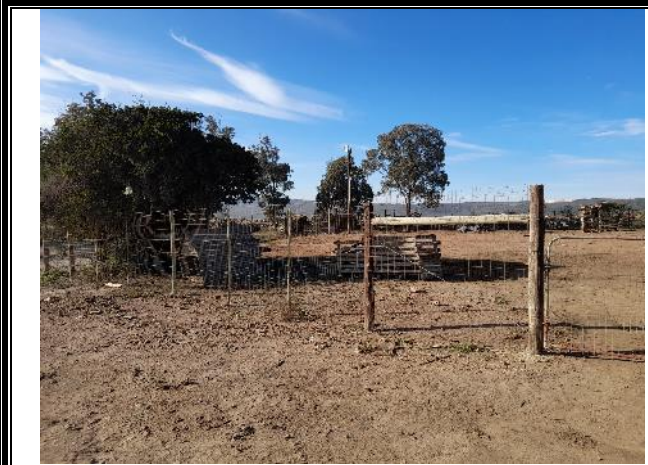
**Pallet repair area – neatly managed**

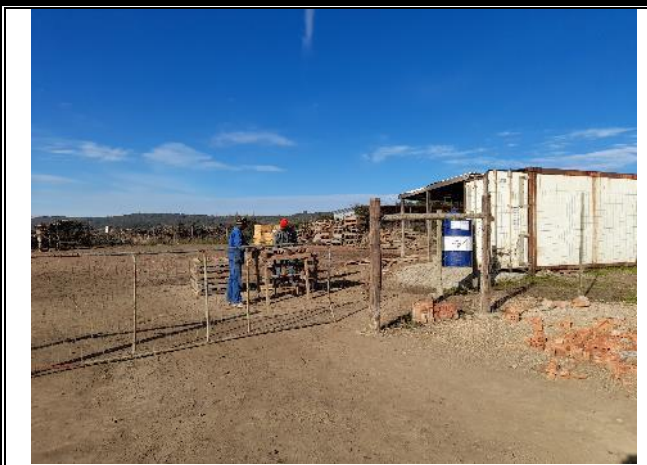
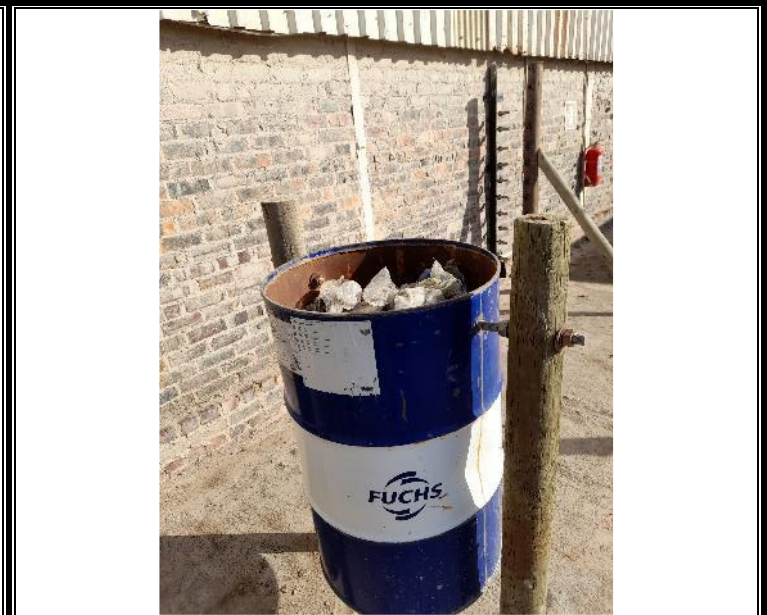
At the time of the inspection some waste bins still needed lids, and the black plastic noted in the stormwater channels and along the eastern fence needs to be picked up. Site management must ensure that the plastic is daily removed from the operational areas to prevent it blowing/being washed into the stormwater channels.

**Bin to be fitted with a lid**

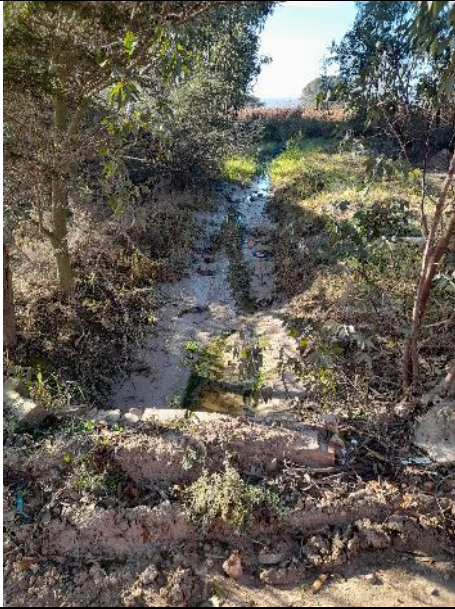
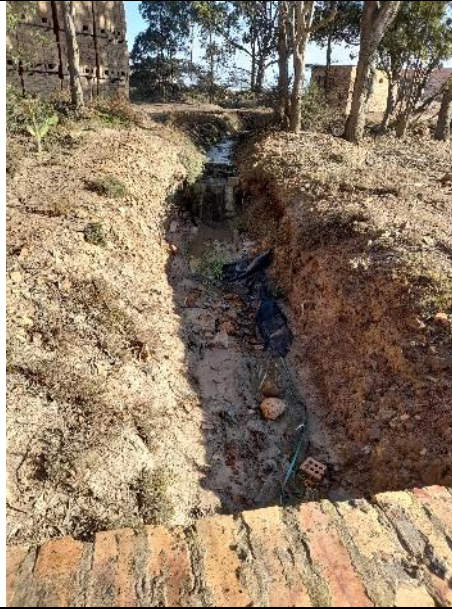
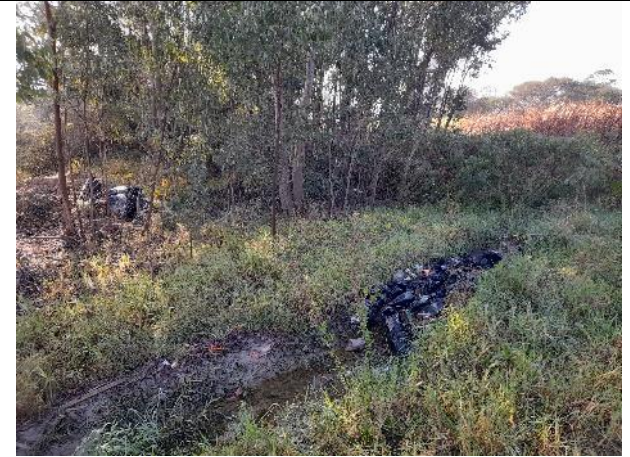
Plastic to be removed from stormwater drains

1. Update the mine plan and keep a copy available on site;
2. Replace all long drops with abluitions that drains into septic tanks;
3. Increase the sampling locations and frequency of water quality monitoring to once a year;
4. Remove the tumbleweed from the site;
5. Prepare and implement the procedures and plans as listed in this report;
6. Attend to the slope of the rehabilitated area;
7. Improve the storm water control of the site as listed above;
8. Line the surface of the vehicle service area, formalise the wash bay and ensure all runoff water drains into an operational oil sump;
9. Ensure all chemicals and hazardous substances are stored in a bunded area;
10. Seal all the bund walls;
11. Prepare an emergency plan site map as specified above;
12. Cover all refuse bins with lids;
13. Remove the black plastic from the stormwater channels and eastern fence line.

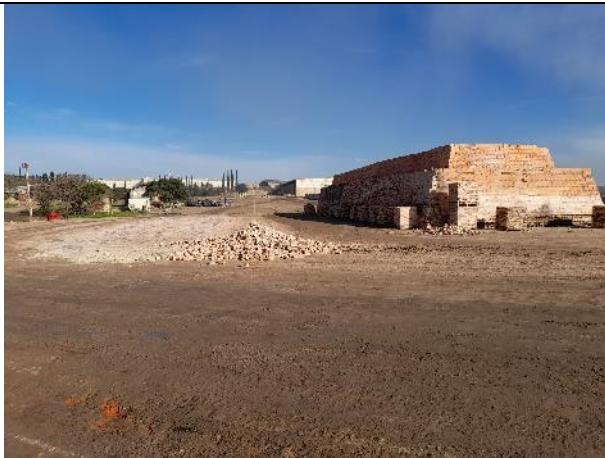
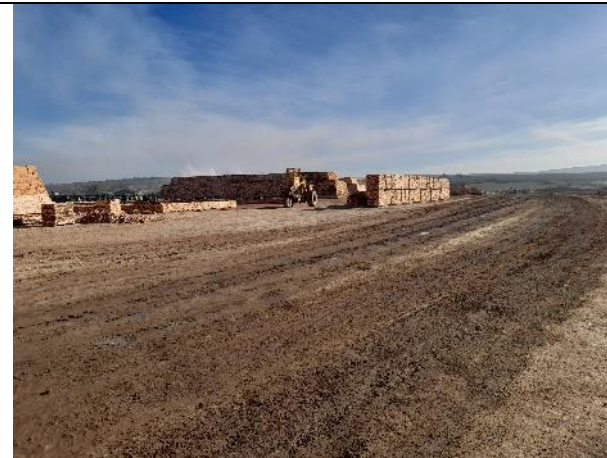
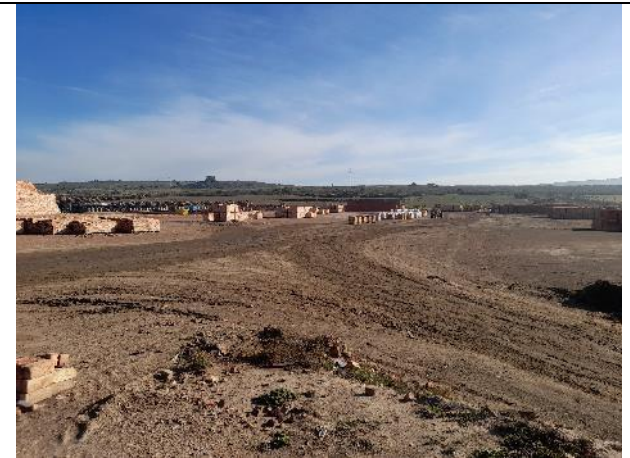
Plant areas neatly managed

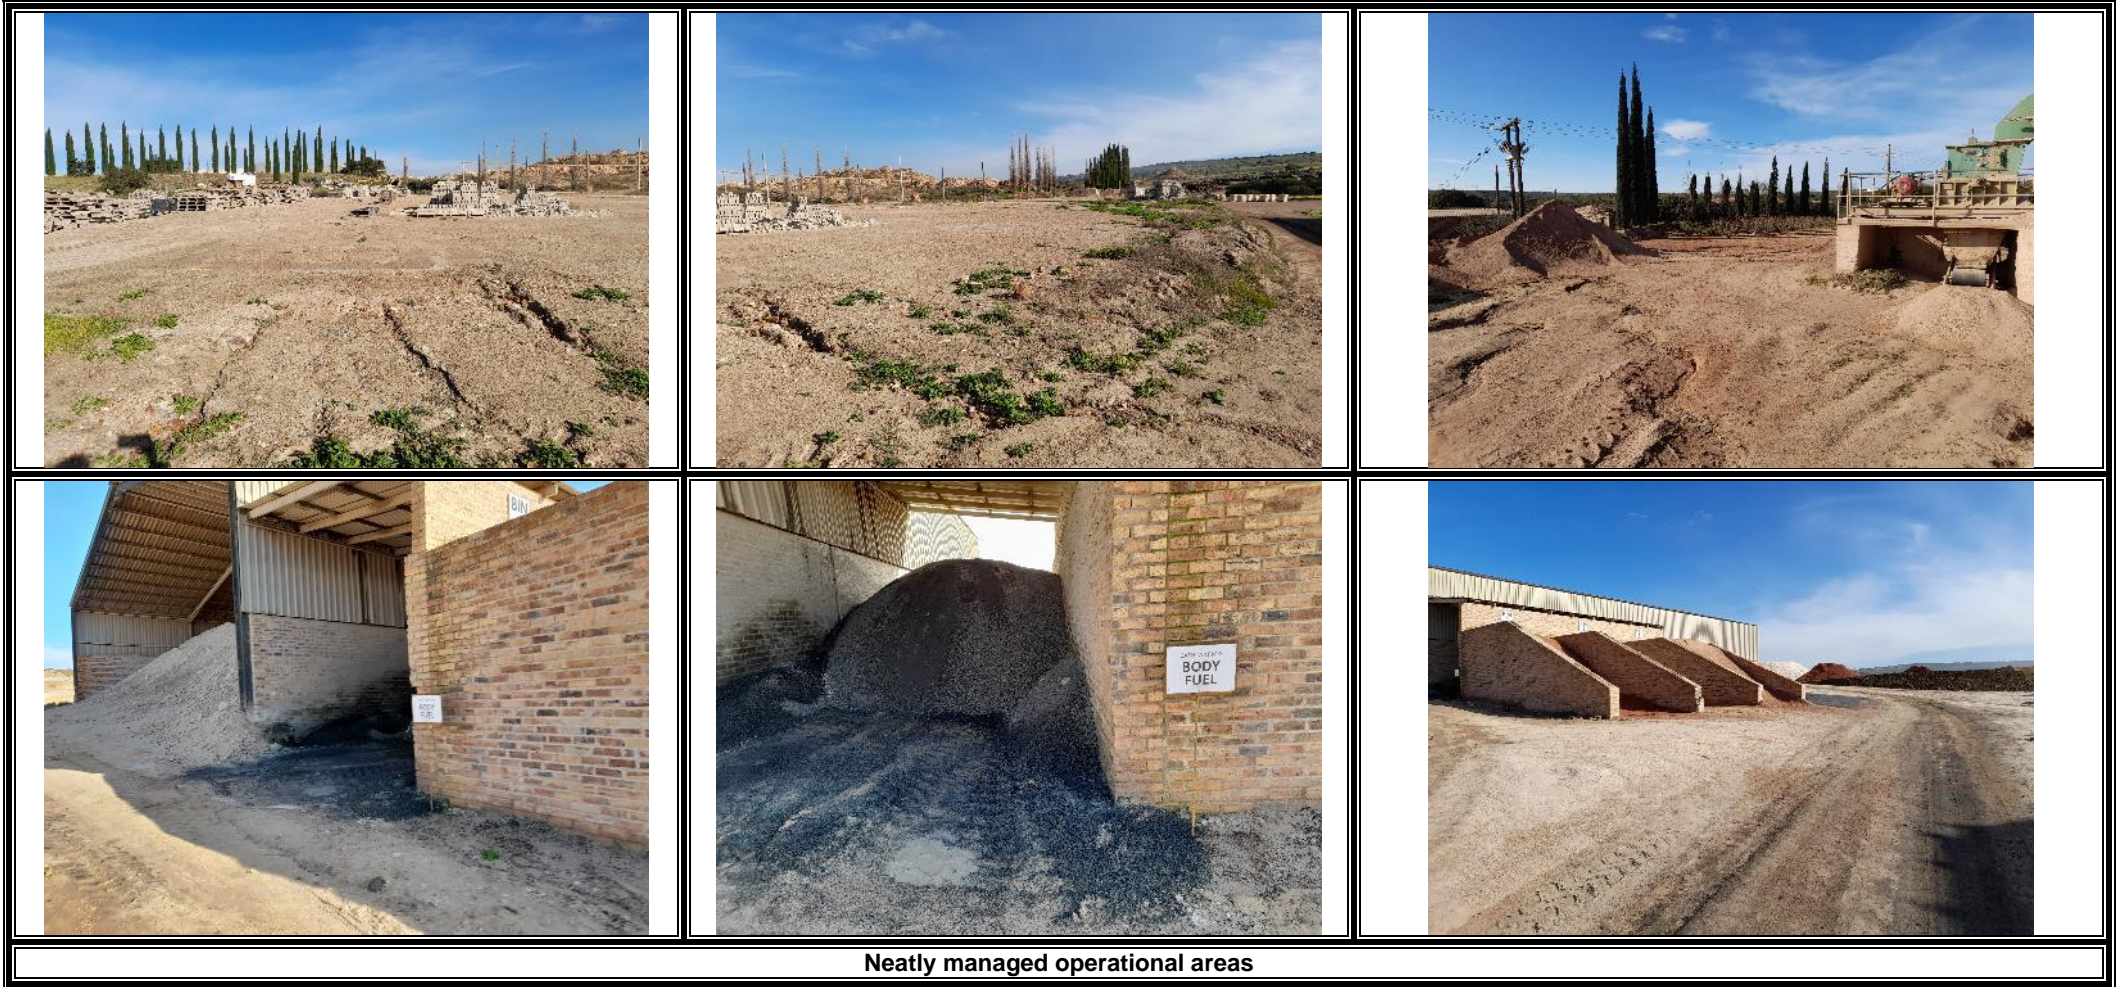
Neatly managed operational areas

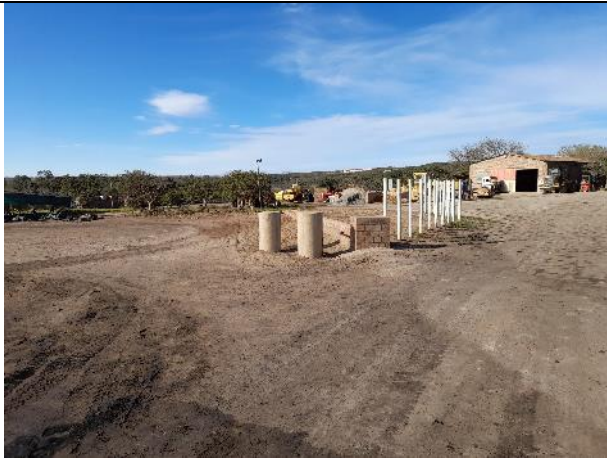
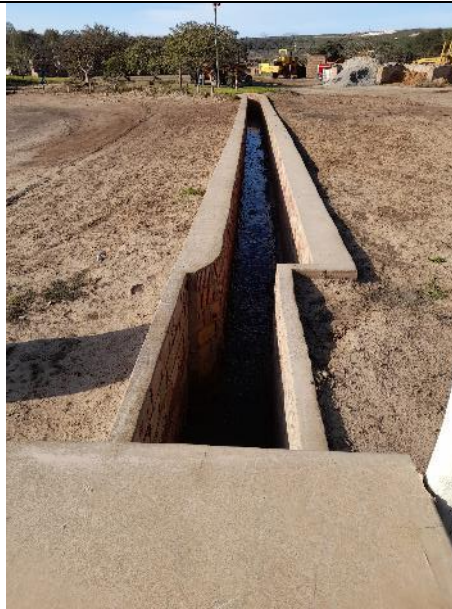
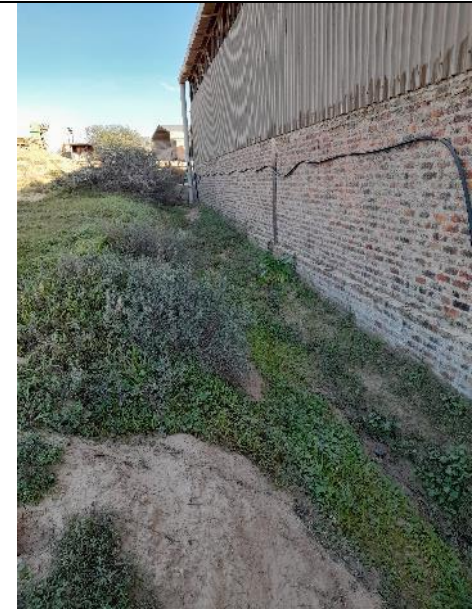
The storm water management of the factory and workshop areas must be improved to separate dirty and clean water. Clean water (e.g. rainwater) must be kept clean and be routed to a natural watercourse by a system separate from the dirty water system. Clean water must be prevented from running or spilling into

Improvement of stormwater drainage

dirty water systems. Further to this, site management must distinguish between dirty water that can be directed to the pollution/settling ponds (e.g. runoff water with a high non-hazardous sediment load for instance the processing area or carbon stockpile) and contaminated water (e.g. wash water from the wash bay and vehicle service areas) that must be directed to an oil separation sump. No water containing hydrocarbons/other non-organic chemicals may be directed to the pollution/settling ponds.

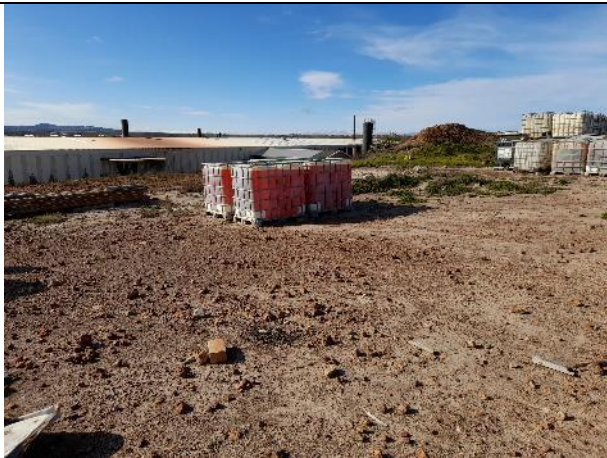
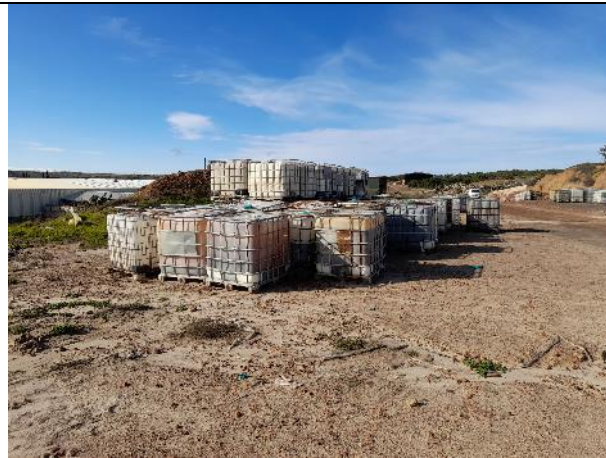
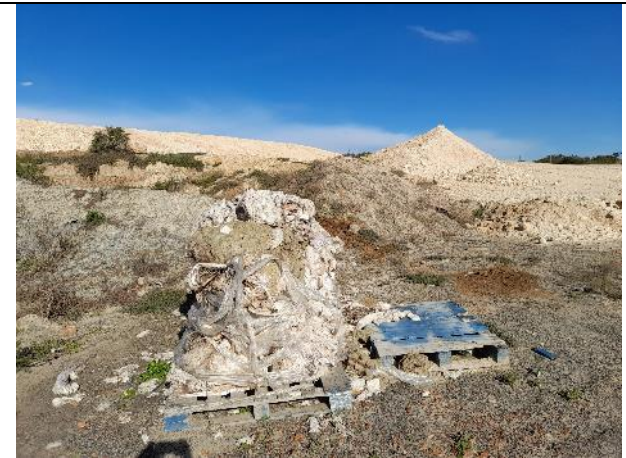
Flow bins to be removed from site

Unused material to be removed

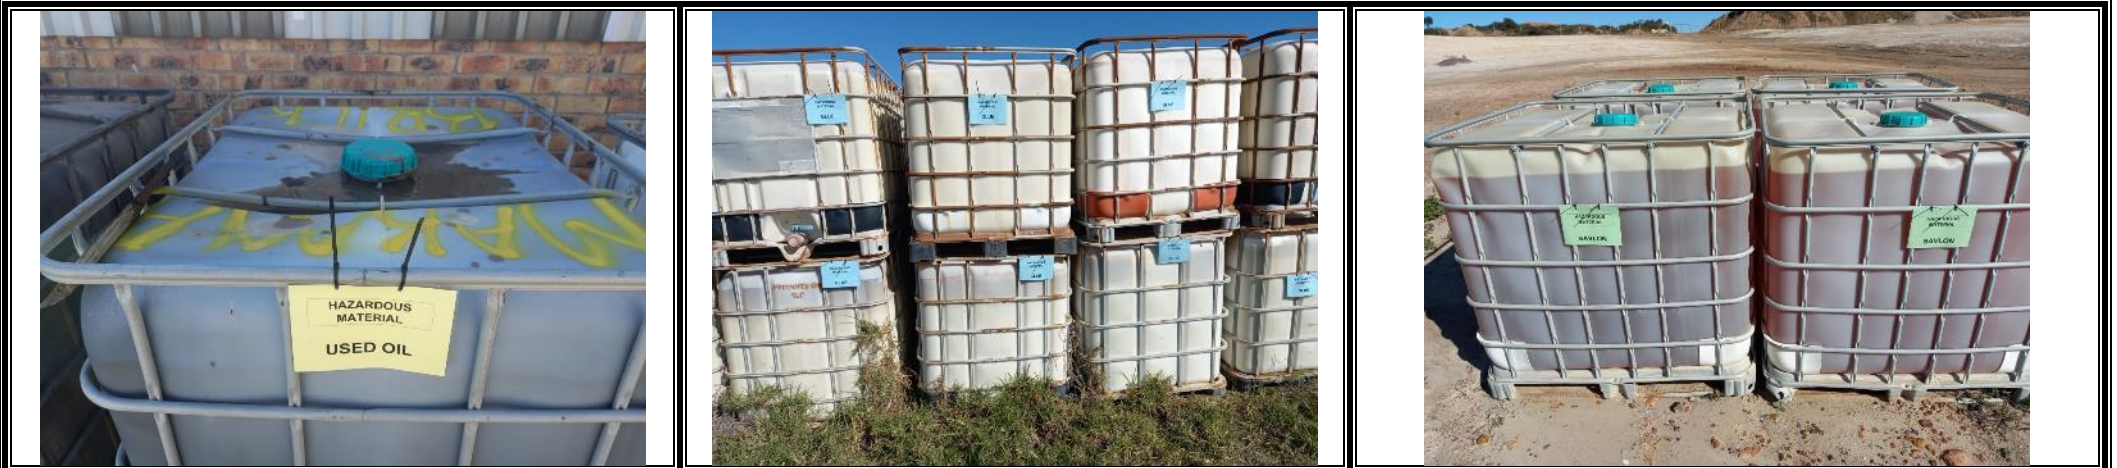
Signs posted on flow bins

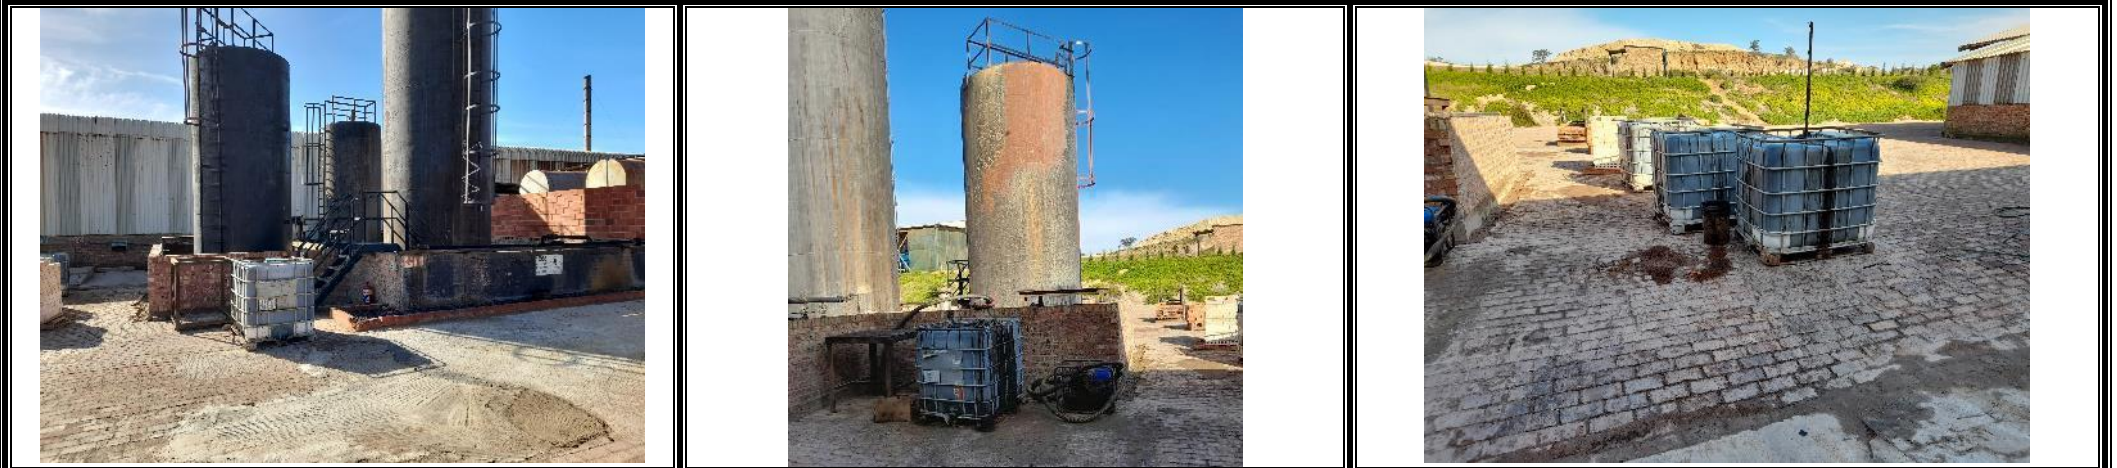
Used oil to be placed inside bunded areas

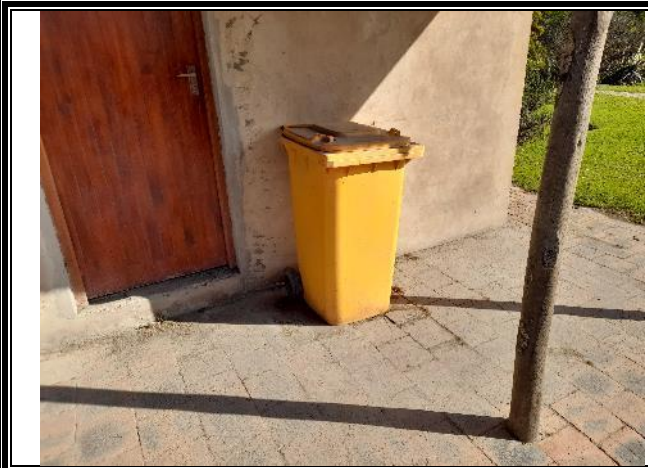
**Oil spill kit**

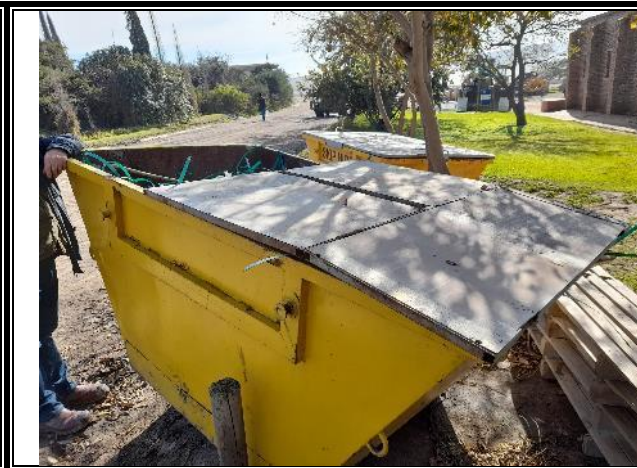
The general waste is still removed from site by SkipGo. As requested in the previous report, the skip was fitted with a lid to prevent litter from blowing out and rainwater accumulating inside.

**Skip fitted with lid**

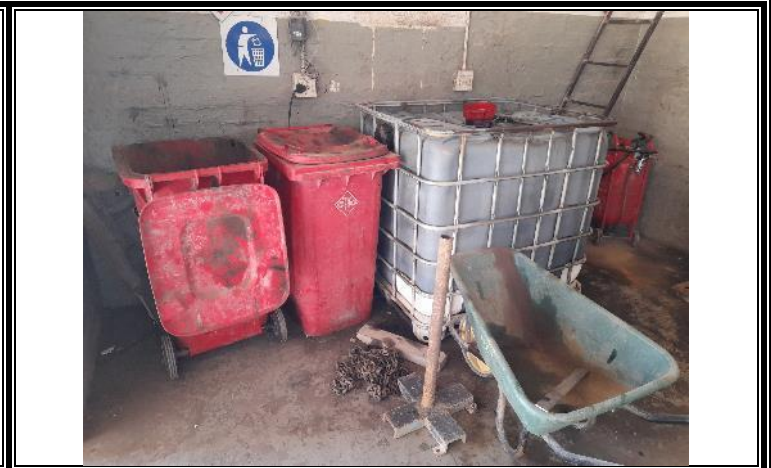
**Hazardous waste contained inside the workshop**

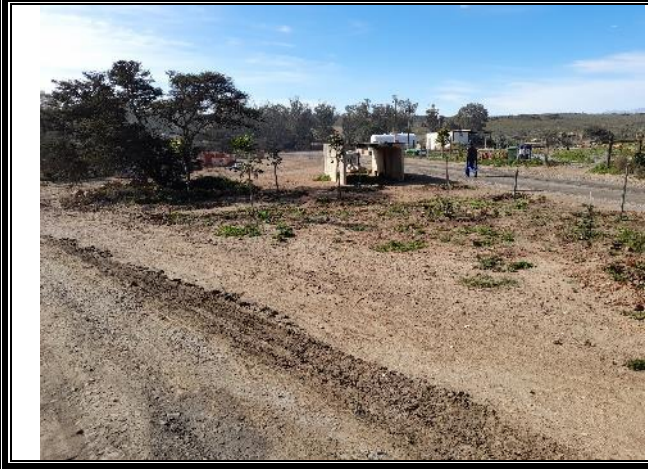
Since the previous audit, numerous trees were planted that will act as windbreaks between the buildings and operational areas.

Trees planted on site

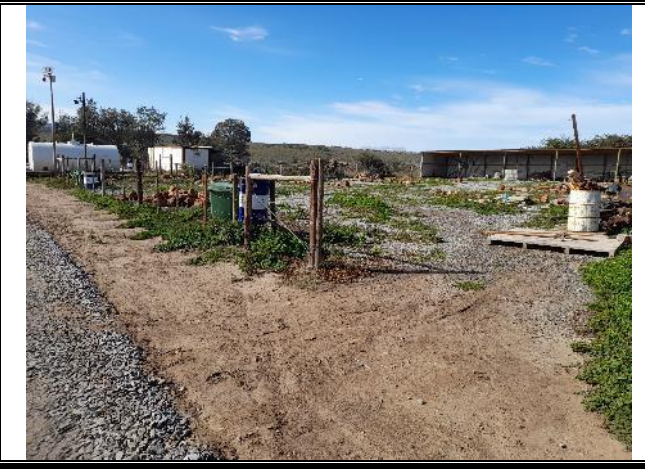
New waste management area

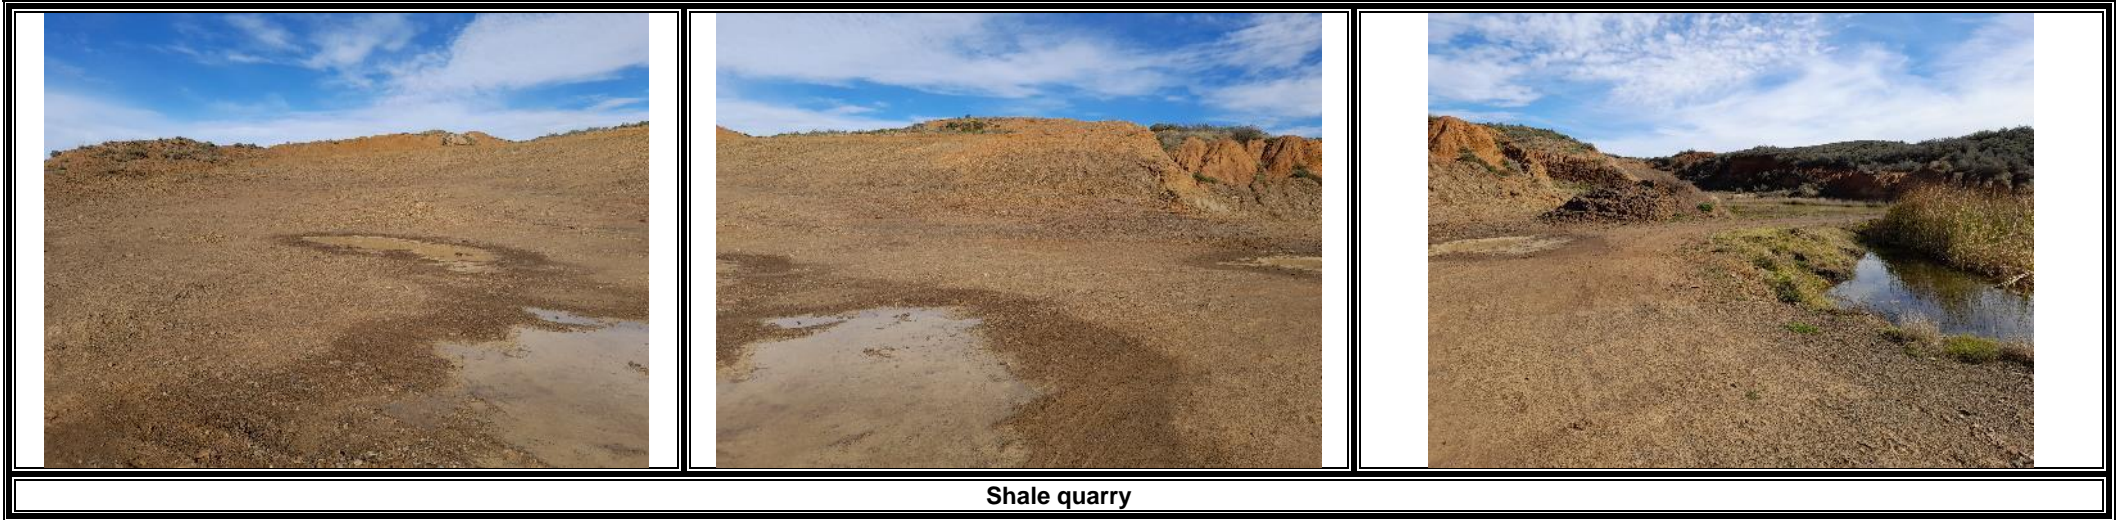
**Shale quarry**

The material from the sand- and shale quarries within the mining right footprint are used on site for non-commercial purposes, and therefore these areas were not included in this report. However, the shale quarry was visited during the inspection and not matters of concern were noted.
