## APPENDIX D: PHOTO REPORT

This photo report provides visual evidence of the current condition of the rectified area subject to the Section 24G application. The photographs were taken during the post-construction phase to illustrate the extent of works completed, the stabilisation of the riparian zone, and the environmental condition following the emergency reinstatement of the retaining structure, fencing, and pool.

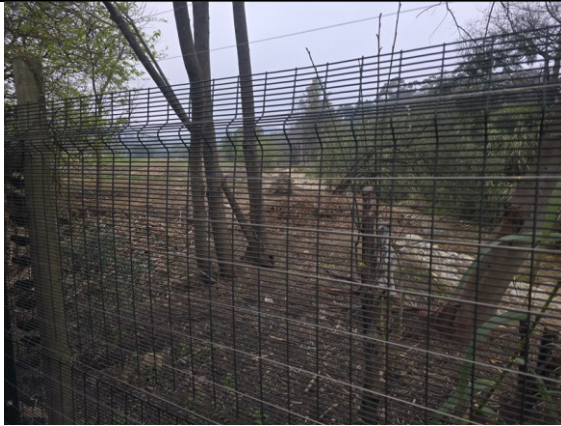
| View of the reinstated riverbank with security fence in the foreground. Shows effective stabilisation of the riparian edge; vegetation regrowth visible. | Close-up of gabion wall visible through fencing. Gabion wall intact, providing erosion control and slope stabilisation. |

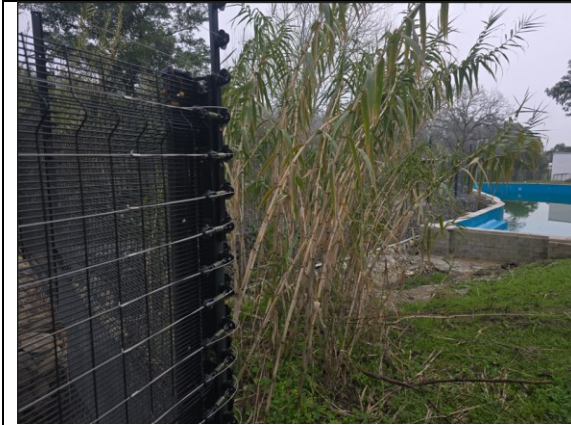
Fence corner adjacent to restored pool structure. Demonstrates integration of fencing and retaining wall for improved safety and aesthetics.

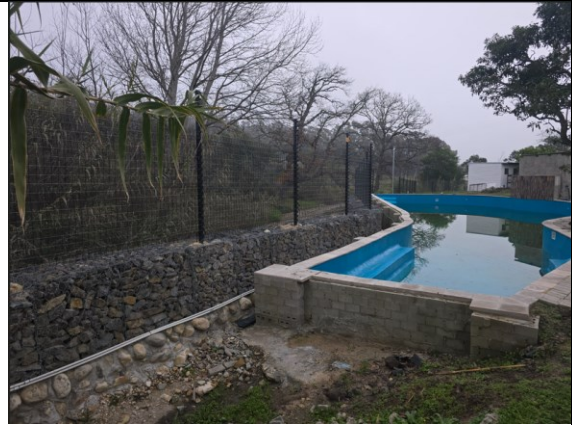
View of pool area with reinforced gabion retaining wall. Pool construction completed; minimal surface disturbance beyond existing footprint.

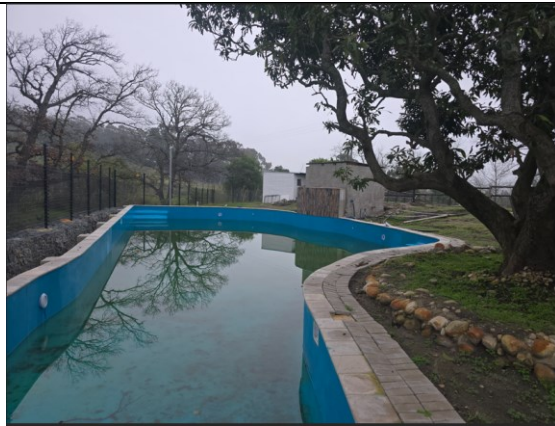
Pool and river interface area. No evidence of erosion or sediment discharge; stable ground cover evident.

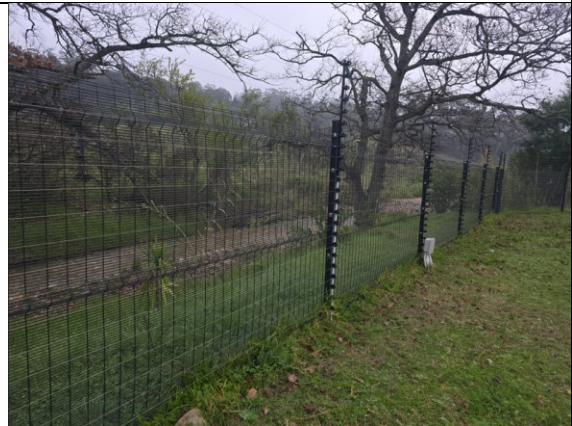
Section of fencing along the riparian corridor. Secure boundary established; vegetation recovery visible beyond fence line.

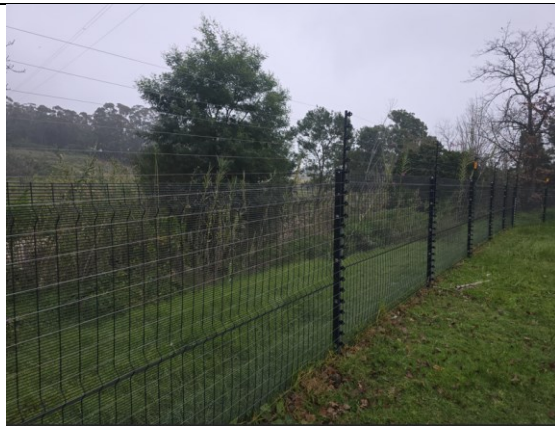
| Downstream view along Spruitrivier fence alignment. No visible pollution or runoff; bank stabilisation successful. | Upstream view showing alignment between pool and fencing. Fencing and retaining structures blend with existing topography. |

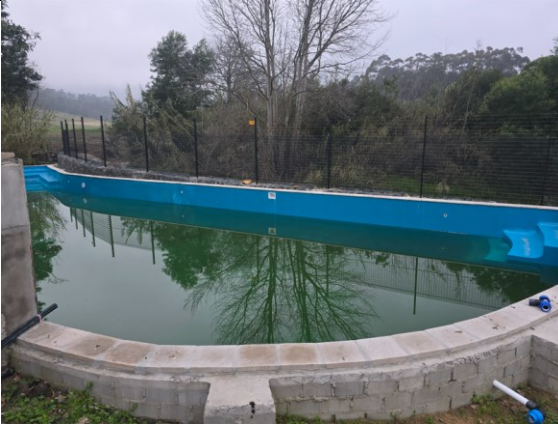
| Pool area. Pool stabilised; water level controlled to prevent overflow into river system. | Utility pole adjacent to rehabilitated area. Infrastructure remains stable and functional post-flood; no additional disturbance. |
