PROSPECTING RIGHT OVER THE REMAINING EXTENT OF THE FARM STEINKOPF NO 22 NAMAQUALAND MAGISTERIAL DISTRICT, NORTHERN CAPE PROVINCE

ENVIRONMENTAL PERFORMANCE ASSESSMENT

DMPR REFERENCE NUMBER:	NC 30/5/1/1/2/11823 PR
AUDIT PERIOD:	SEPTEMBER 2023 – SEPTEMBER 2025

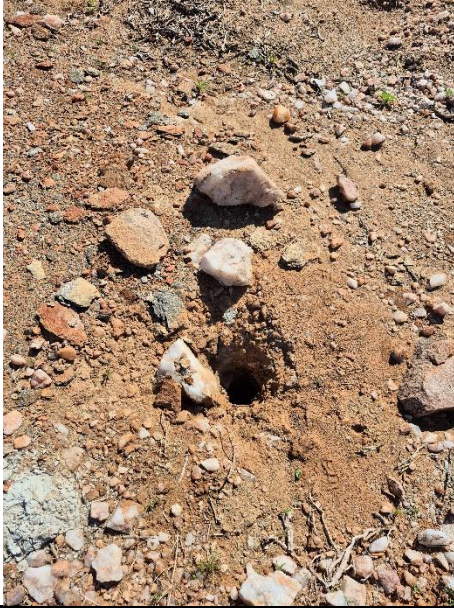
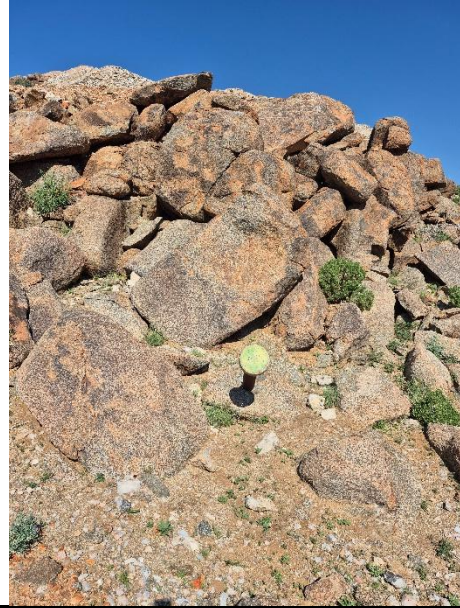
Capped borehole

As mentioned earlier, no prospecting was in progress on the day of the audit, and it is important that site management ensure all boreholes are capped to prevent animals falling in. The rehabilitation of the prospected areas must commence as soon as possible.

1. In future, strip topsoil before an area is prospected. The topsoil must be stockpiled and protected for use during the rehabilitation phase.
2. Cap/close all boreholes.
3. File proof of safe disposal of all waste generated on site.

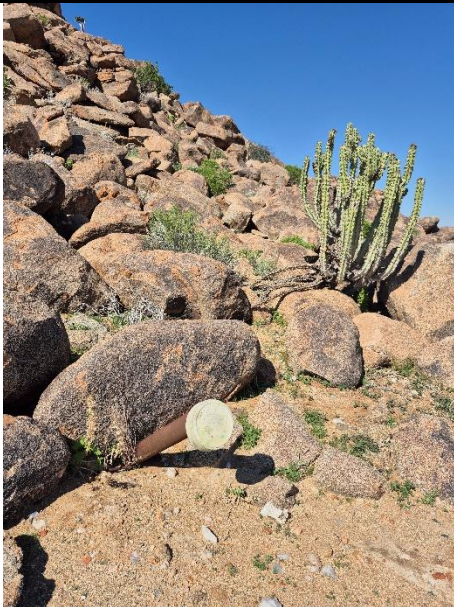
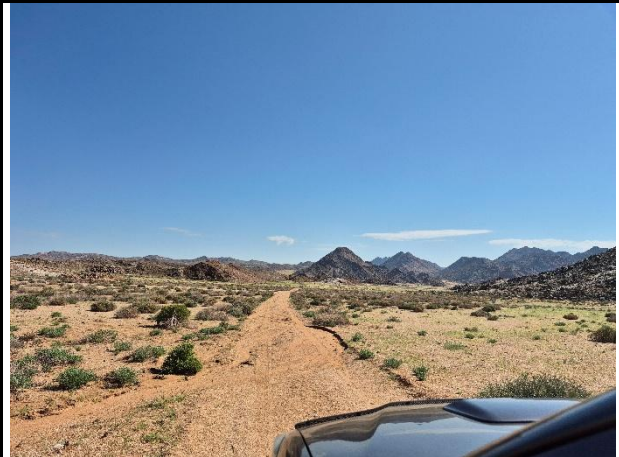
Road in prospecting area
