**MINING OF SAND AND GRAVEL FROM A PORTION OF THE FARM  
DOORNKRAAL 832, MALMESBURY, WESTERN CAPE PROVINCE**

**ENVIRONMENTAL AUDIT REPORT**

<b>DMR REFERENCE NUMBER:</b>	<b>WC 30/5/1/2/2/10096 MR</b>
<b>AUDIT PERIOD:</b>	<b>30 April 2021</b>

**INSPECTION SHEET ENVIRONMENTAL CONTROL OFFICER**

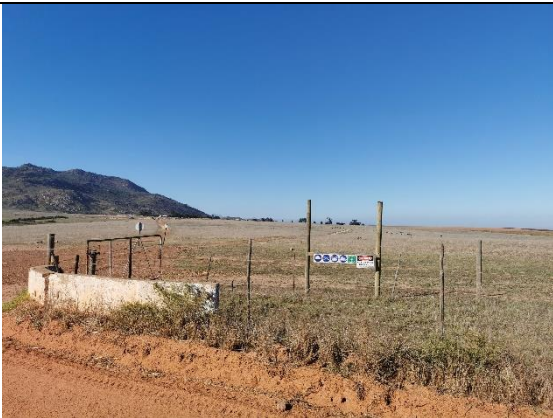
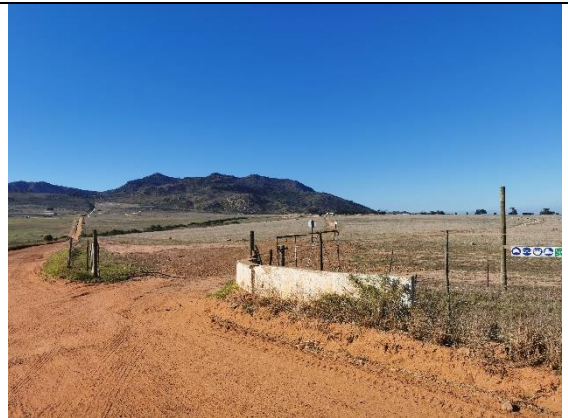
**ENTRANCE TO MINING RIGHT WITH MINING SIGNAGE BOARDS- DOORNKRAAL**

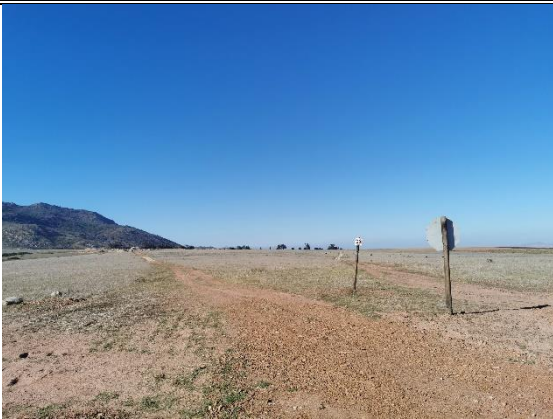
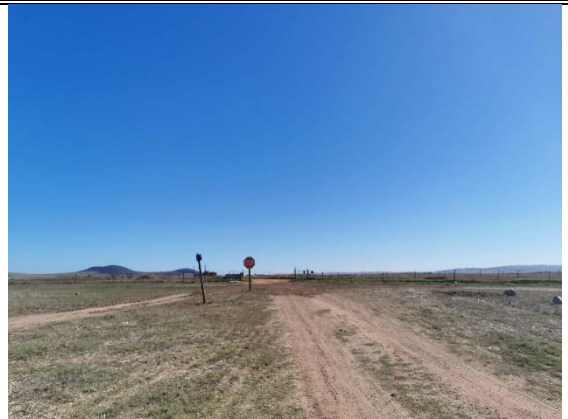
**ACCESS ROADS LEADING TO AND FROM THE CURRENT OPEN MINING AREA**

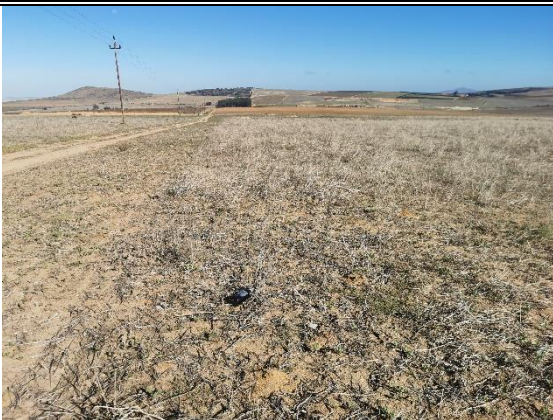
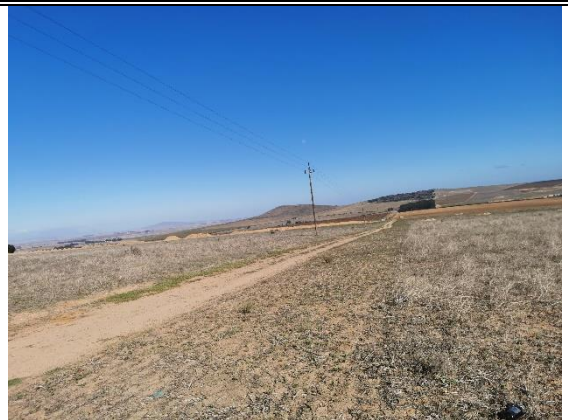
**ESKOM POWER LINES:** Buffers of 10m must be implemented and maintained in respect of the two eskom power lines to ensure that no construction work is executed close to any eskom structure or structures supporting mechanisms. No work or machinery is near to the conductors of the respective power lines and there is an obstruction free zone around all pylons.

- Buffers of 10m must be implemented and maintained in respect of the two Eskom power lines to ensure that no construction work is executed close to any Eskom structure or structures supporting mechanisms. No work or machinery is near to the conductors of the respective power lines and there is an obstruction free zone around all pylons.

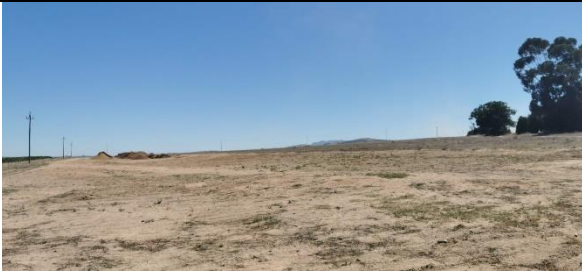
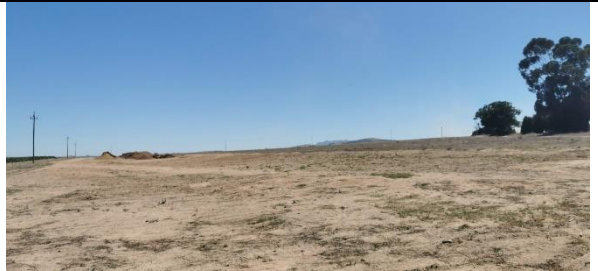
**1<sup>ST</sup> MINING STRIP COMPLETELY REHABILITATED**

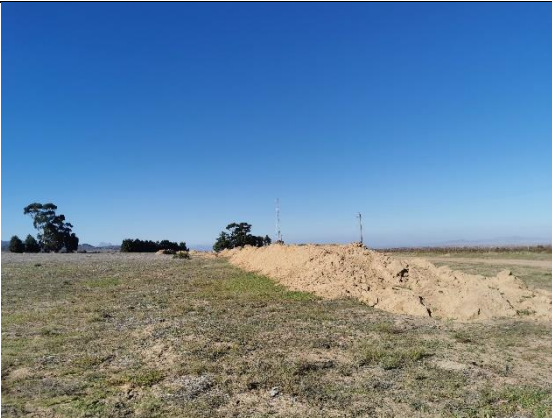
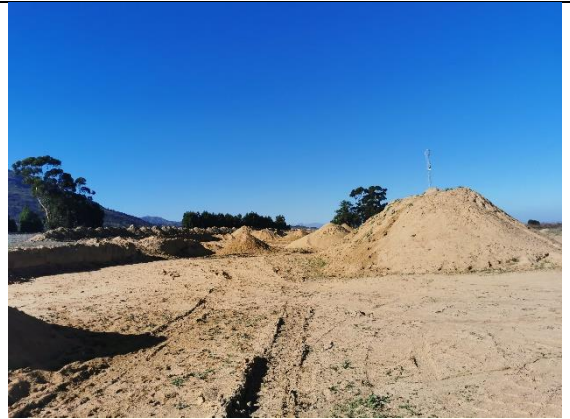
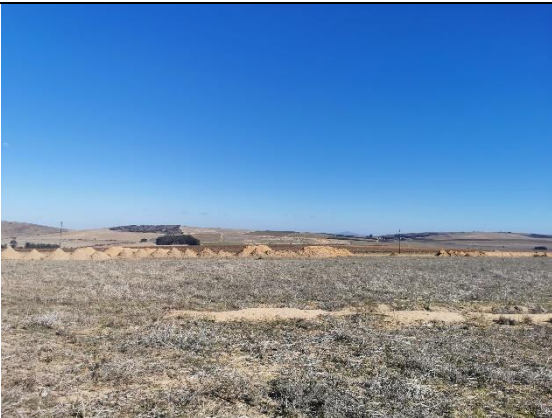
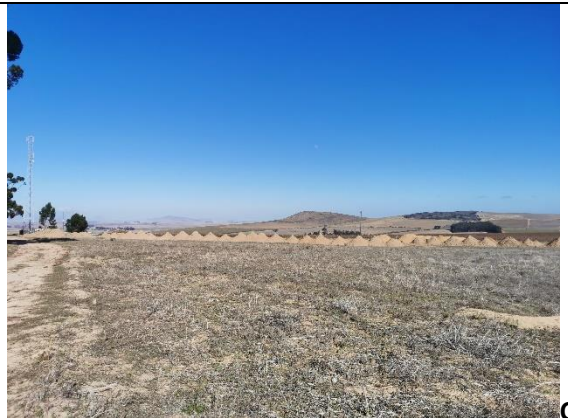
**NEW OPEN STRIP NEXT TO PREVIOUSLY REHABILITATED AREA (0.67 HECTARE OPEN)**

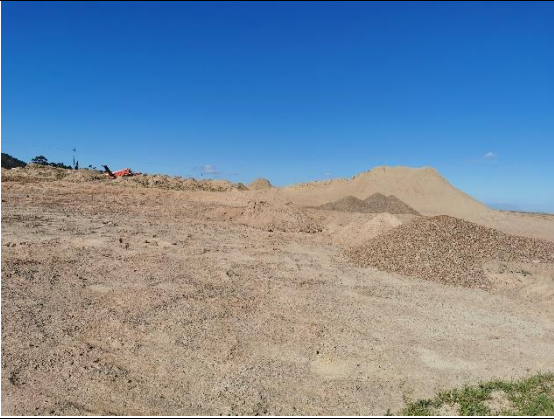
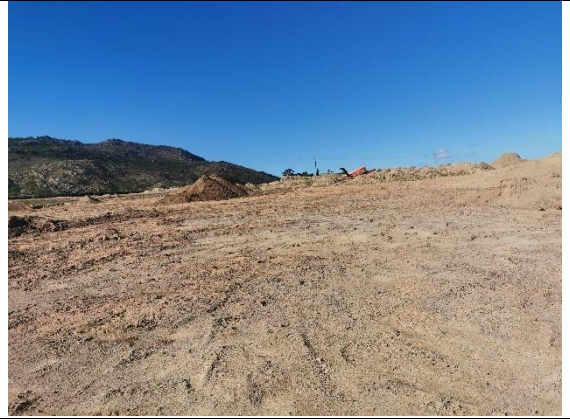
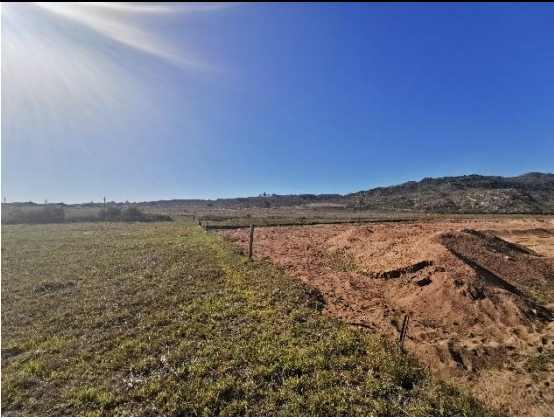
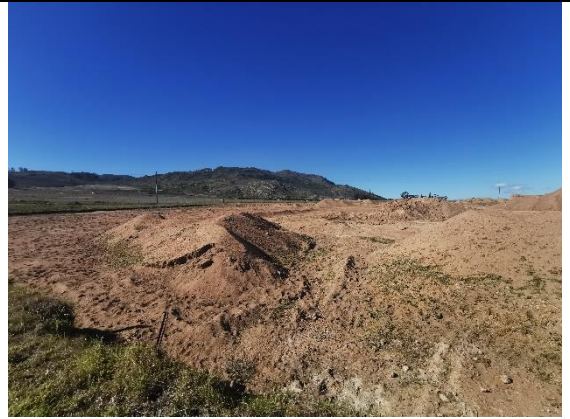
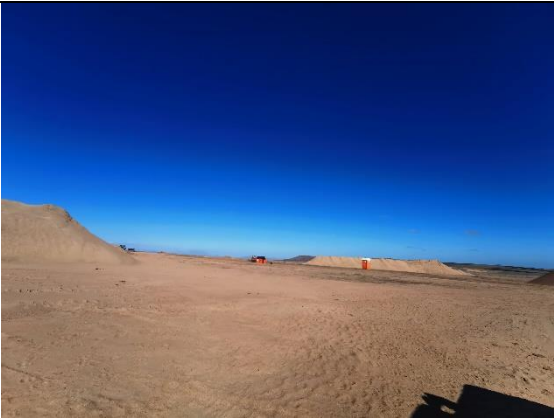
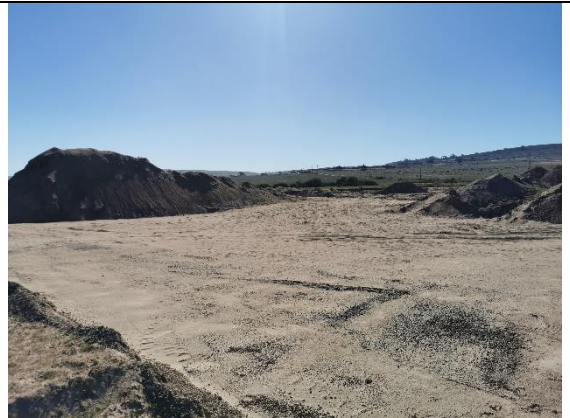
- The approval clearly states that only one hectare may be mined at any given time. **Currently there is 3 open hectares.**
- **The fence between the wetland area and current mining area was taken down and must be replaced immediately.**

- A 40 m buffer area must be demarcated, sign posted and managed as no-go area around areas with natural vegetation. **Currently the open mining strip falls within the 40m buffer area and should be rectified immediately.**

**CURRENT OPEN MINING AREA CLOSE TO WETLAND 1 – (2.11 HECTARES OPEN)**

***Client to erect the fencing between the current mining area and the wetland. A buffer of 40m must be implemented and a no go area sign must be placed. The mining boundaries must be implemented with immediate effect to ensure all mining activities are within the approved mining right area, Google earth currently shows the mining activities are outside of the boundary into the 40m buffer area. The disturbed area within the 40m buffer must be rehabilitated and reinstated as a matter of urgency and compliance will be reported on in next month's ECO report. Currently the site has 3 hectares open and should only be mining 1 hectare at any given time. This will also be reported on in next month's ECO report.***

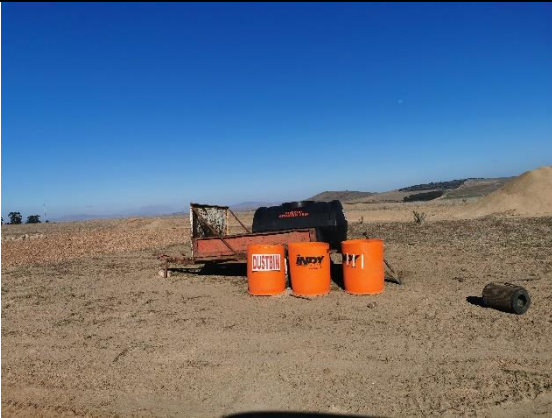
**THREE SEALED BINS – STILL TO BE LABELLED**

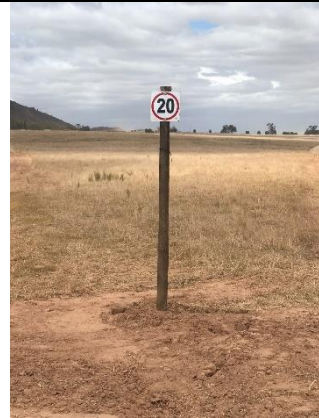
**SPEED LIMIT SIGNAGE IN PLACE**

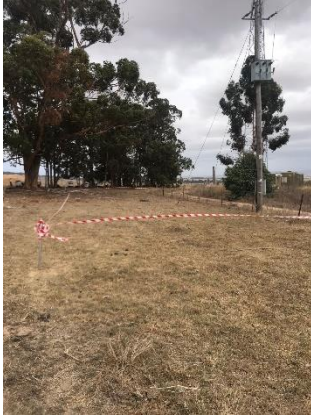
**TELKOM MAST WAS BARICADED IN MARCH TO INCLUDE A SIGNAGE BOARD AS NO GO AREA**

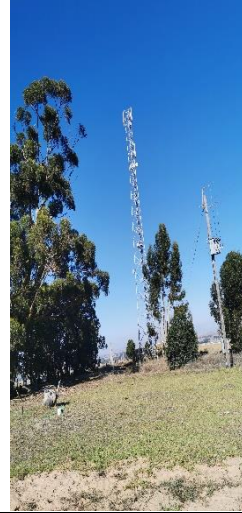
**HOWEVER IN APRIL THE TAPE WAS TORN AND CLIENT IS REQUIRED TO ERECT A MORE PERMANENT BARICADING WITH A SIGNAGE BOARD.**

As the Telkom mast is situated outside the proposed footprint of the mining area, the mining activities are not expected to impact the infrastructure. *The mast must however be managed as a no-go area and should any damage occur Telkom must immediately (within 2 hours) be notified. The area was barricaded with danger tape, due to the weather conditions the tap was damaged/broken. Client is advised to use a more sustainable barricader and erect a no go sign for this section.*

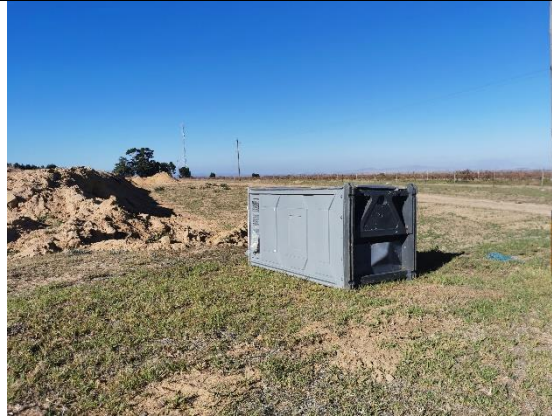
**2<sup>ND</sup> TOILET SITUATED AT THE ADDITIONAL OPEN AREA TIPPED AND MUST BE PLACED ON A STABLE AREA.**

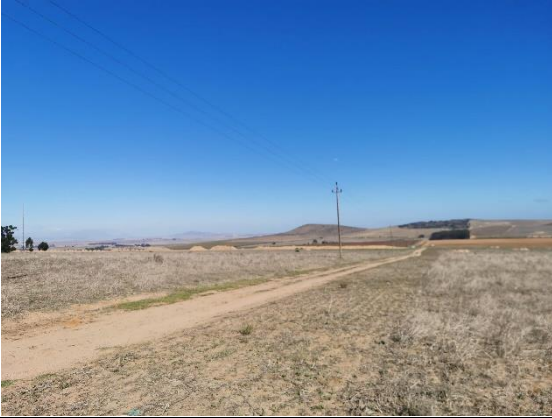
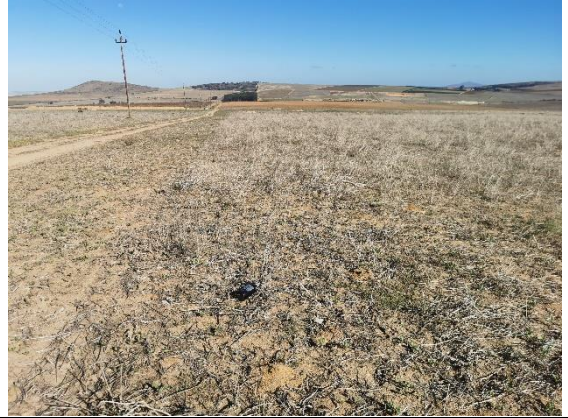
**ESKOM POWER LINES:** Buffers of 10m must be implemented and maintained in respect of the two eskom power lines to ensure that no construction work is executed close to any eskom structure or structures supporting mechanisms. No work or machinery is near to the conductors of the respective power lines and there is an obstruction free zone around all pylons.

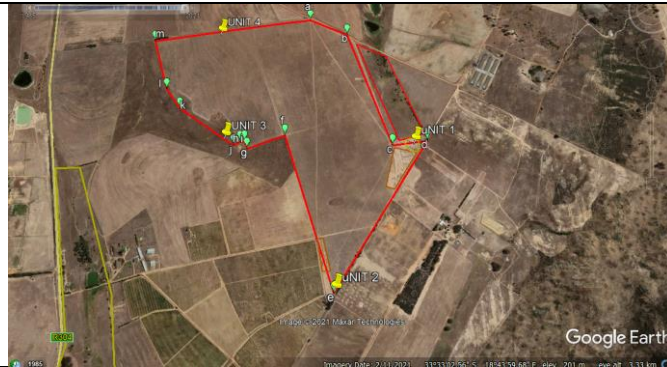
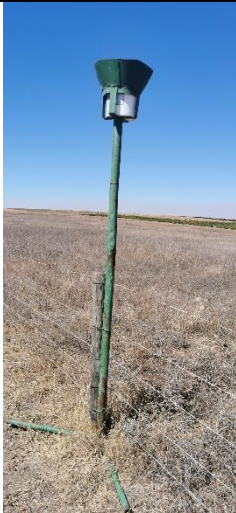
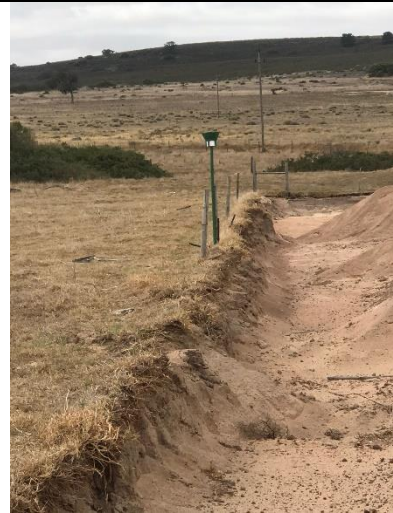
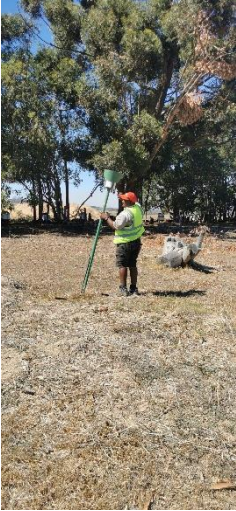
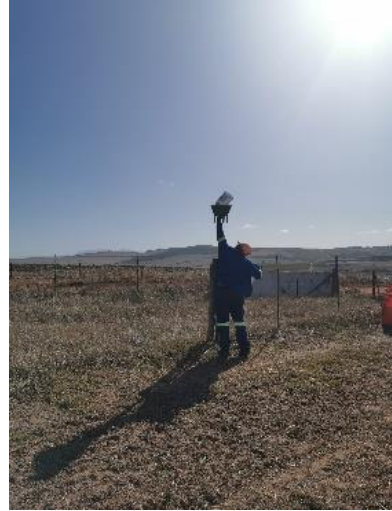
To date all the monitoring results were within the limits. However, all the units were incorrectly allocated and must be re located to the correct unit points as per the provided google image and coordinates.

**DUST MONITORING POINTS, ALL UNITS WERE INCORRECTLY PLACED AND MUST BE MOVED ACCORDINGLY**
