BOTSHABELO QUARRY
PORTION 0 OF THE FARM BOTSHABELO NO 286,
MANGAUNG METRO MUNICIPALITY
FREE STATE PROVINCE

ENVIRONMENTAL PERFORMANCE ASSESSMENT /
ENVIRONMENTAL AUDIT REPORT

DMPR REFERENCE NUMBER	FS 6/2/2/2/628 ML
AUDIT DATE	June 2026

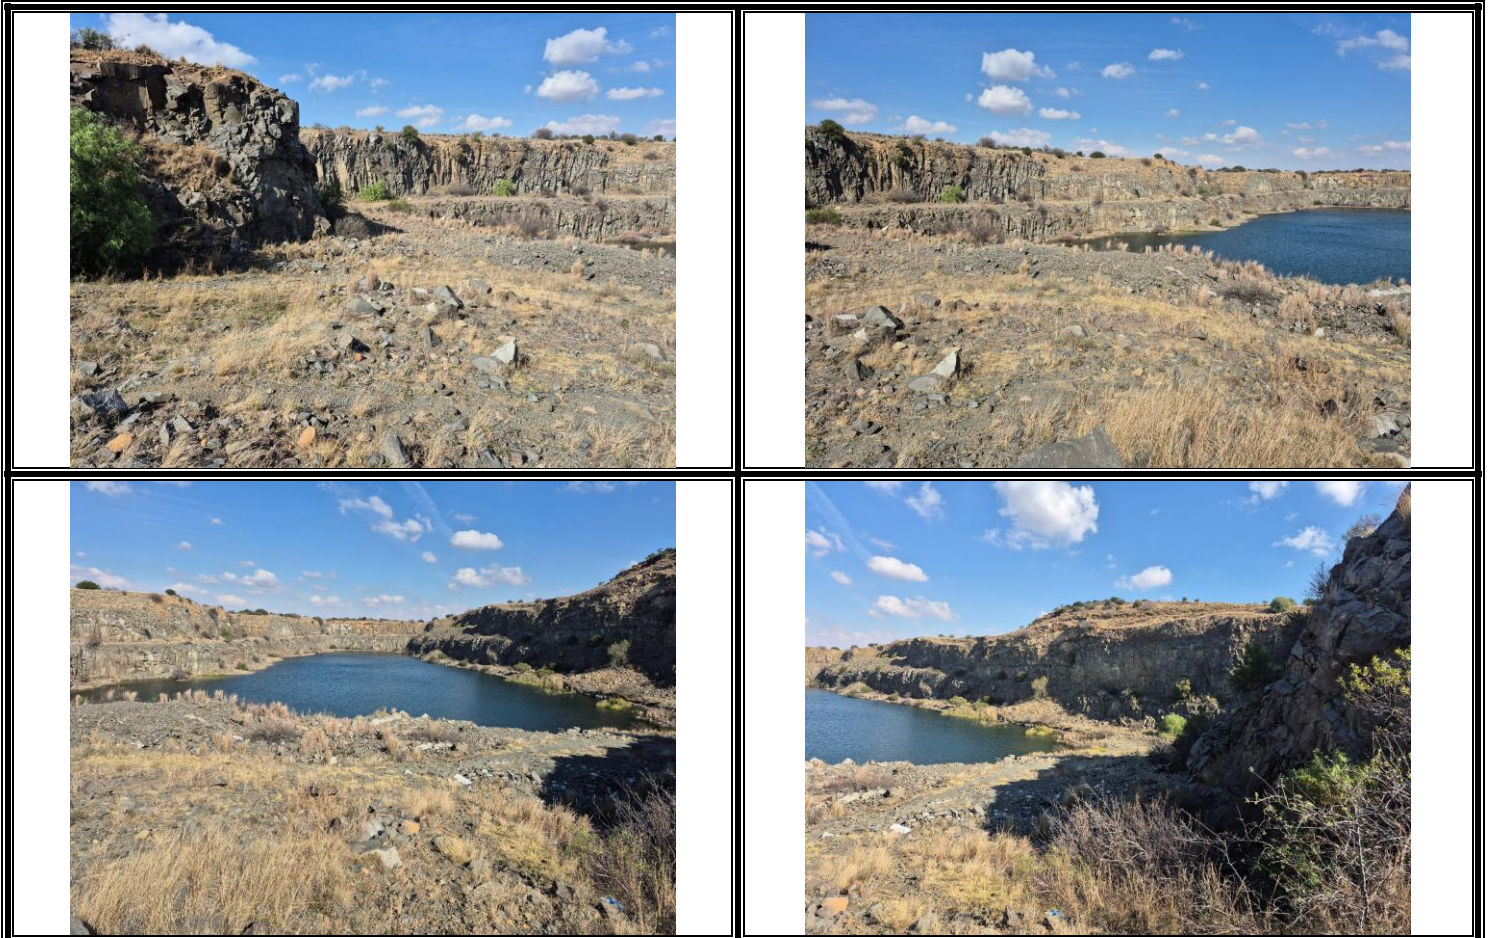
Excavation with established vegetation cover

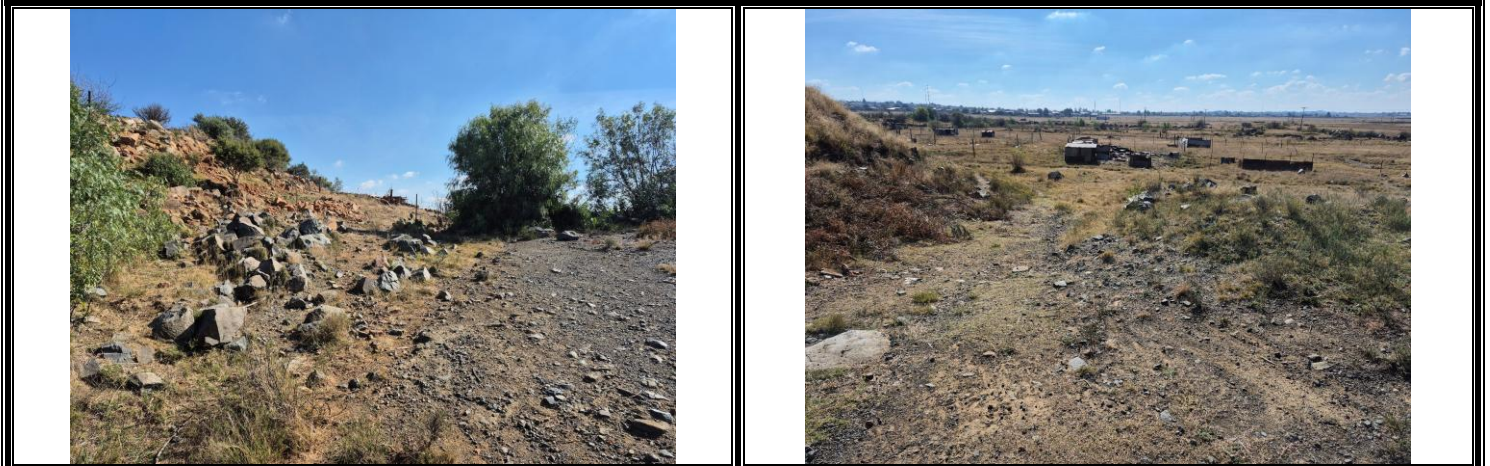
Community structures established along the northern boundary of the quarry
