**THABA STONE QUARRY
PORTION 2 AND REMAINING EXTENT OF THE FARM
UITKOMST NO 558, THABA NCHU
FREE STATE PROVINCE**

ENVIRONMENTAL PERFORMANCE ASSESSMENT

| AUDIT PERIOD: | September 2022 |

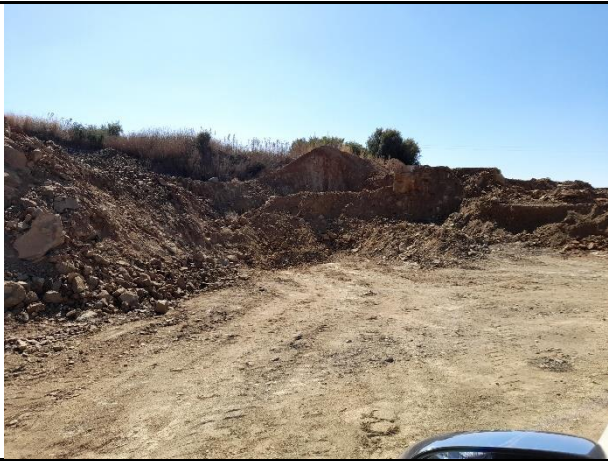
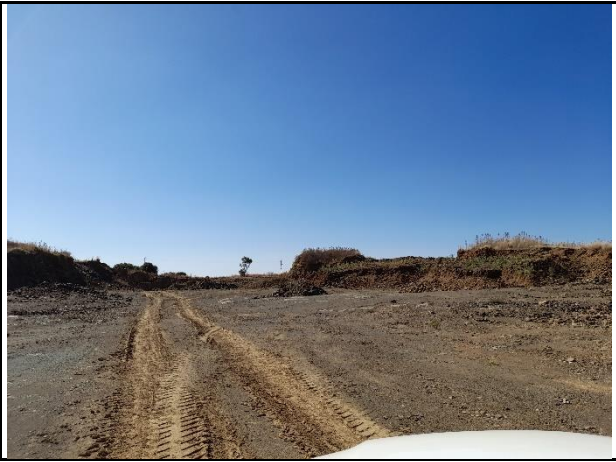
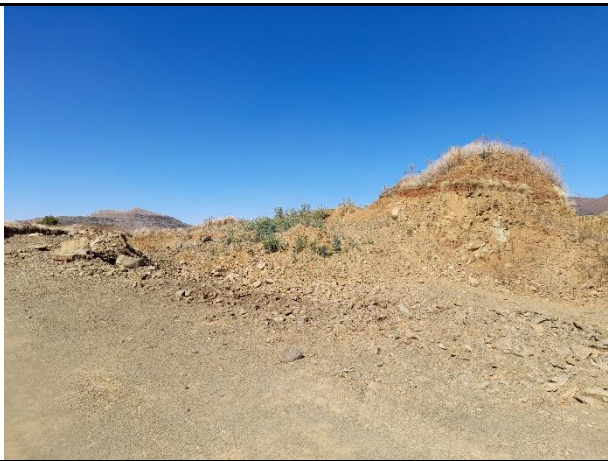
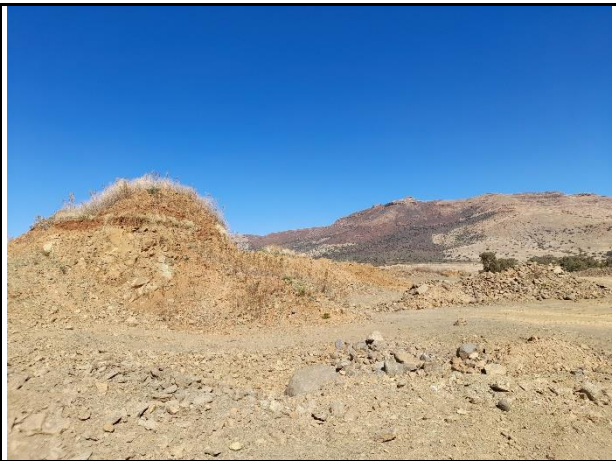
GRAVEL MINING AREA – BORROW PIT

Some of the unwanted overburden stockpiled south of the quarry was crushed and sold to new clients. Following this, the Mexican Poppy plants (*Argemone mexicana*) germinated on the remaining soil heaps. This needs to be addressed and the plants removed before setting seed.

Mexican Poppy plants to be removed from site

1. Remove the empty Fuchs containers from the salvage yard;
2. Waste registers must be implemented on site to proof the safe disposal of all waste;
3. The Mexican Poppy plants must be removed from site;
4. Prevent the mixing of general- and hazardous waste;
5. Blasting notifications must be in writing; and
6. MSDS's must be obtained for all chemicals on site.

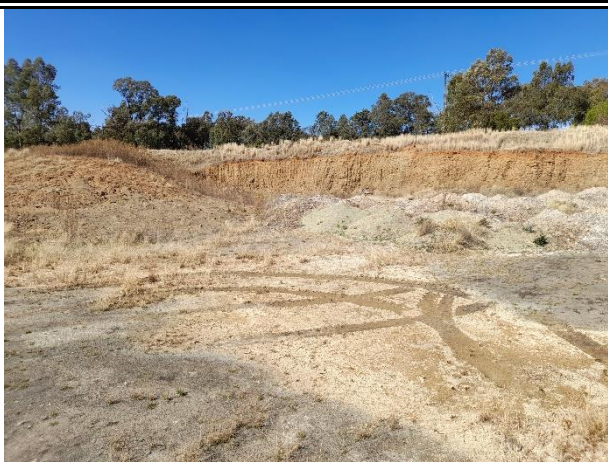
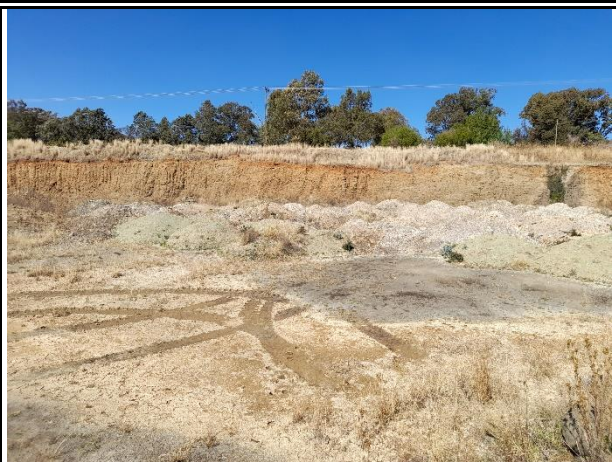
REHABILITATED HISTORIC GRAVEL MINING AREA

Remaining face being rehabilitated

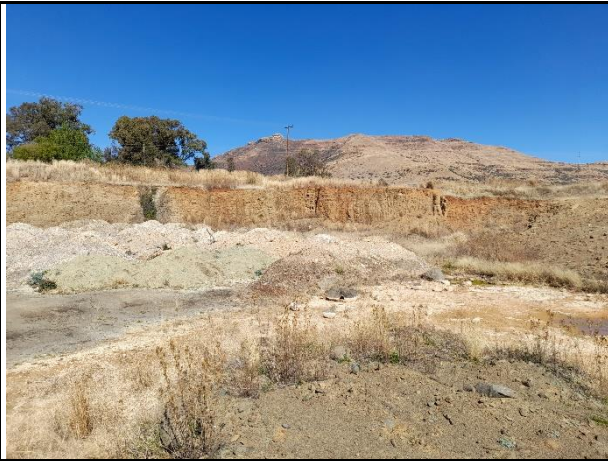
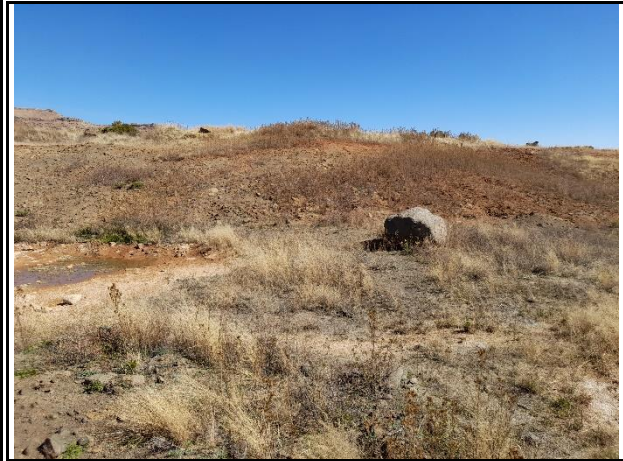
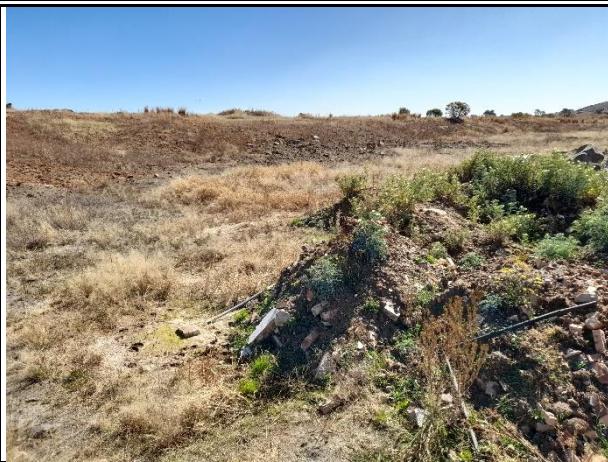
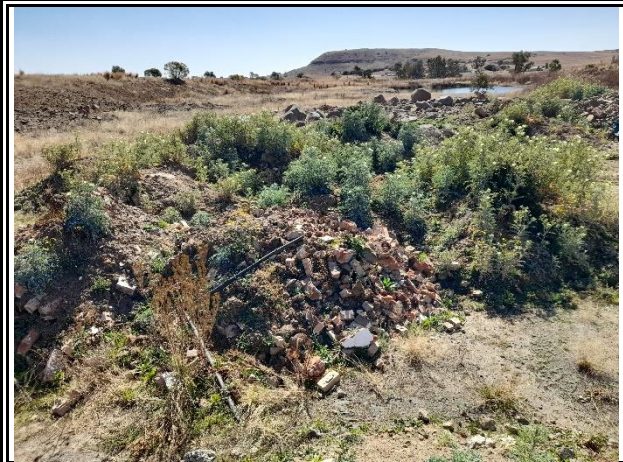
REHABILITATED HISTORIC GRAVEL MINING AREA

The old borrow pit was neatly rehabilitated and large portions are covered with grass. However, the remaining Mexican Poppy plants need to be controlled.

Rehabilitated slopes – Mexican Poppy plants to be removed

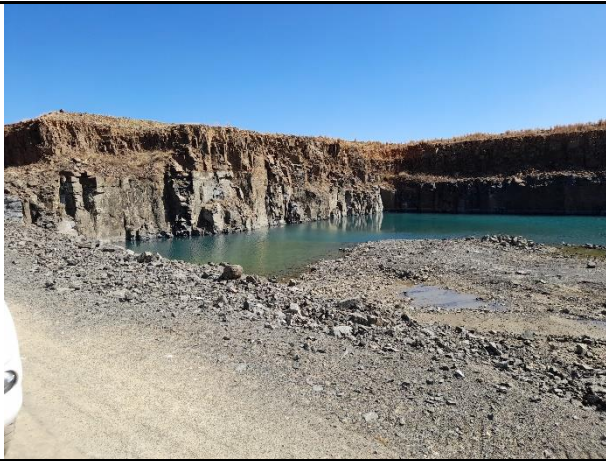
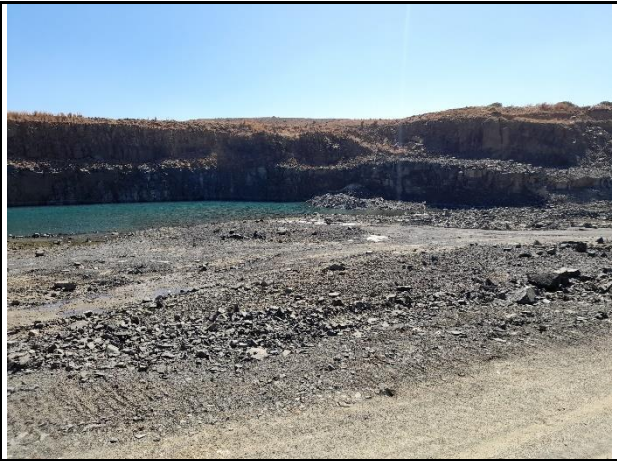
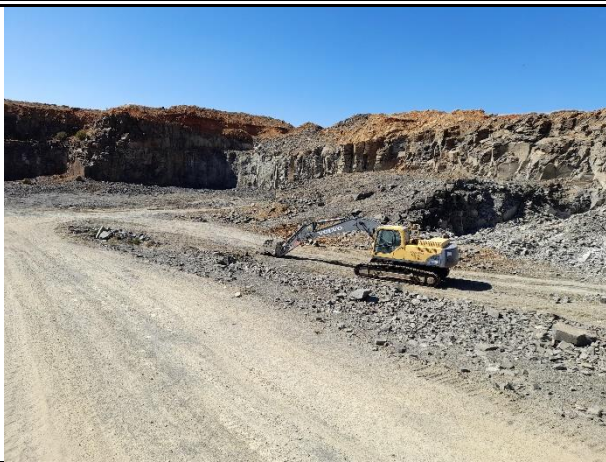
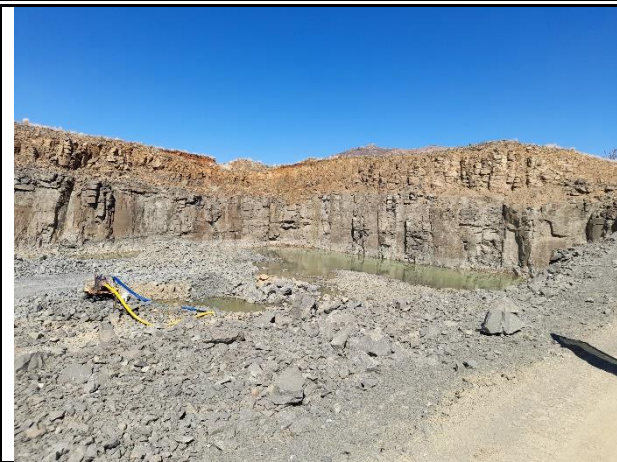
HARD ROCK QUARRY PIT

Quarry area neatly managed

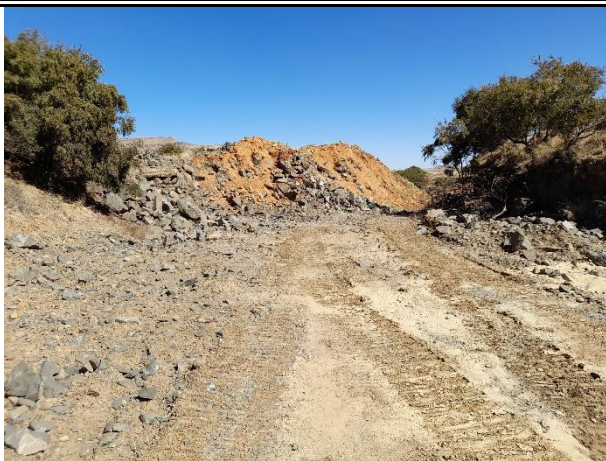
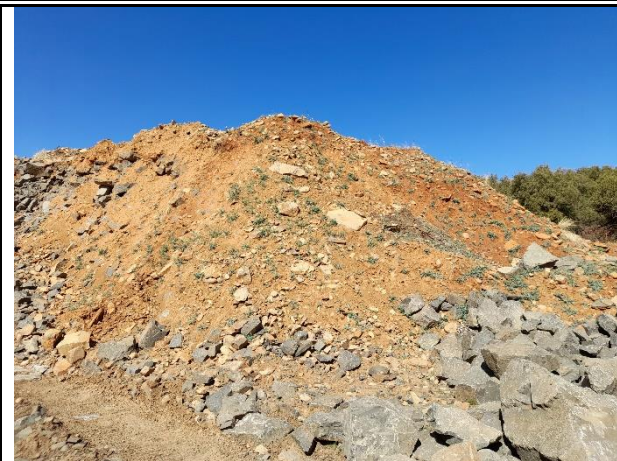
OVERBURDEN STORAGE, STOCKPILE AND PROCESSING AREA

Overburden storage area where Mexican Poppy plants must be removed

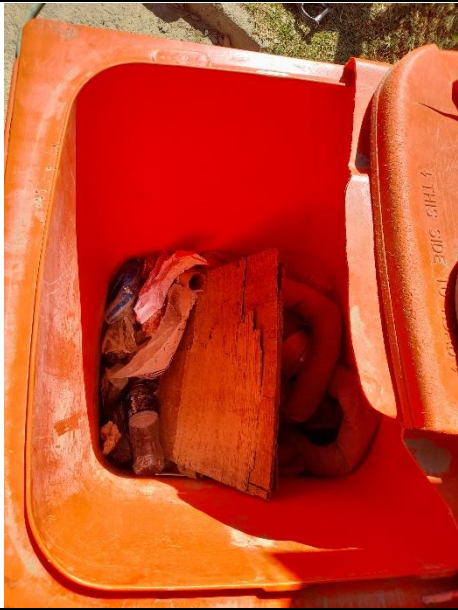
| DESCRIPTION | COMPLIANCE SCORE | NON-COMPLIANCE SCORE | STATUS | COMMENTS |
|--|---|---|---|--|
| Complete oil spill kit available on site | 4 | 3 | To be addressed | The bin of the oil spill kit may not be used for the disposal of general waste. |

General waste to be removed from the spill kit

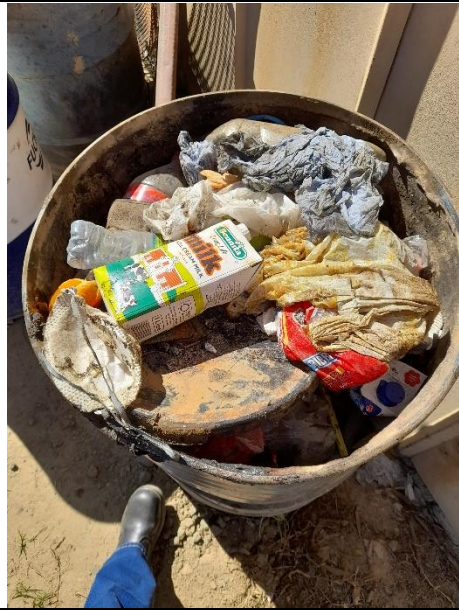
| DESCRIPTION | COMPLIANCE SCORE | NON-COMPLIANCE SCORE | STATUS | COMMENTS |
|--|---|---|---|--|
| Waste collected in sealable containers | 4 | 3 | To be addressed | At the time of the inspection, the general and hazardous waste was mixed in the various drums. This needs to be stopped, the waste be disposed of as hazardous waste, and the employees re-inducted. |

General- and hazardous waste being mixed

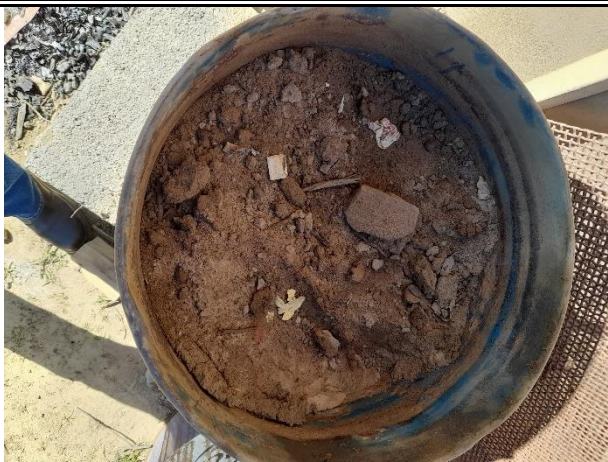
Contaminated soil contained in a designated drum

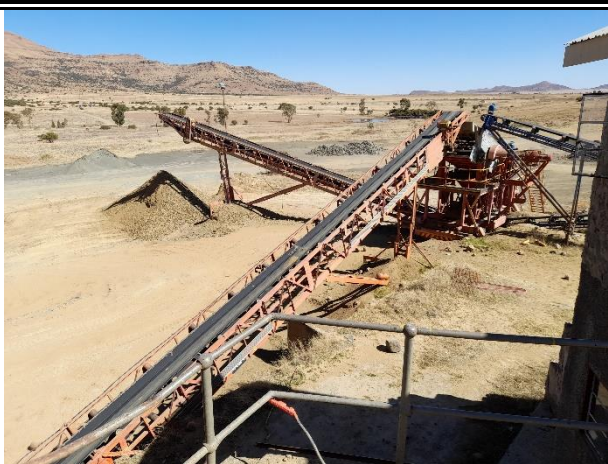
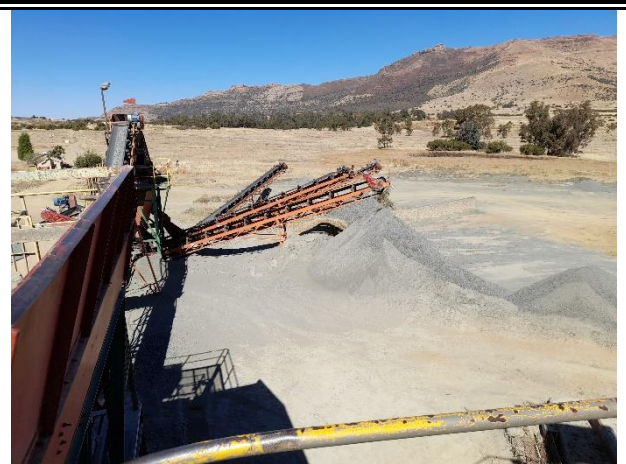
Processing area neatly managed
