**SAND MINE ON A PORTION OF THE FARM DE
KLERKSKRAAL 231 IN THE THEUNISSEN DISTRICT,
FREE STATE PROVINCE**

**ENVIRONMENTAL PERFORMANCE ASSESSMENT /
ENVIRONMENTAL AUDIT REPORT**

DMR REFERENCE NUMBER:	FS30/5/1/3/2/10207MP
AUDIT PERIOD:	June 2021 – May 2022

Permit Number:	FS30/5/1/3/2/10207MP	Date of Commencement:	November 2019
Site Name:	De Klerkskraal Sand Mine	Inspection Date:	03 June 2022
Permit Holder:	Blazecor 226 CC	Other Authorisations:	WUL: 27/2/1/C1142/101
Report Number:	23 (EPA Report 03)

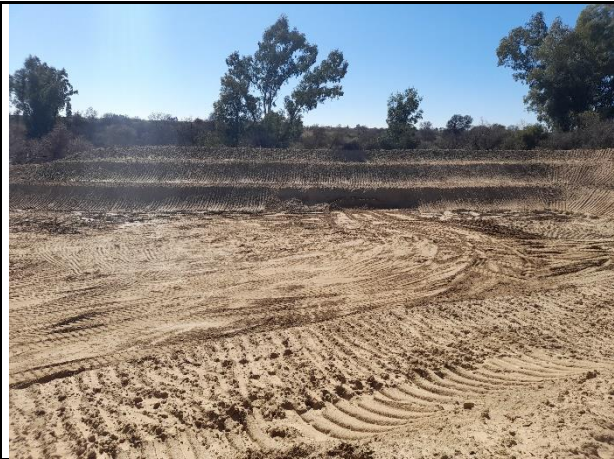
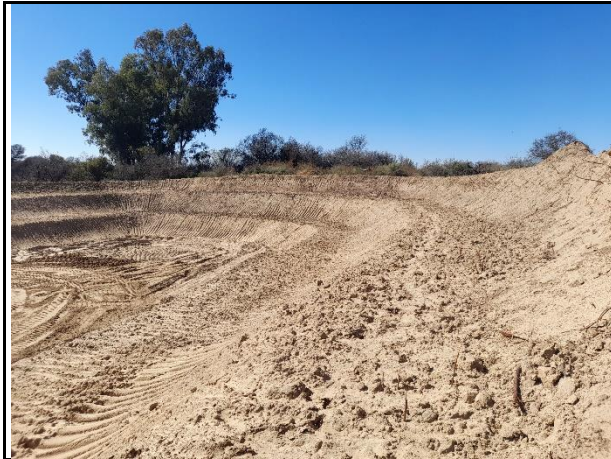
Neatly sloped mining benches

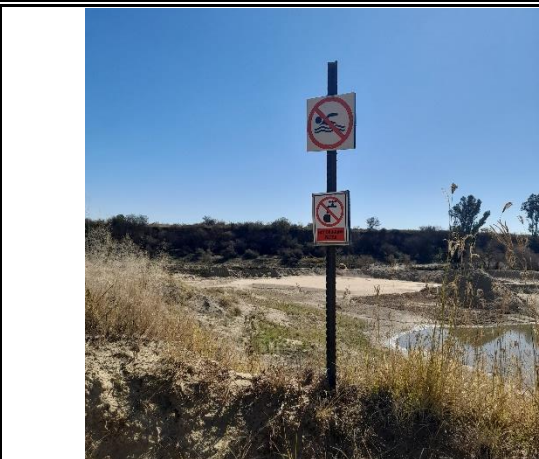
Signage added to mining area

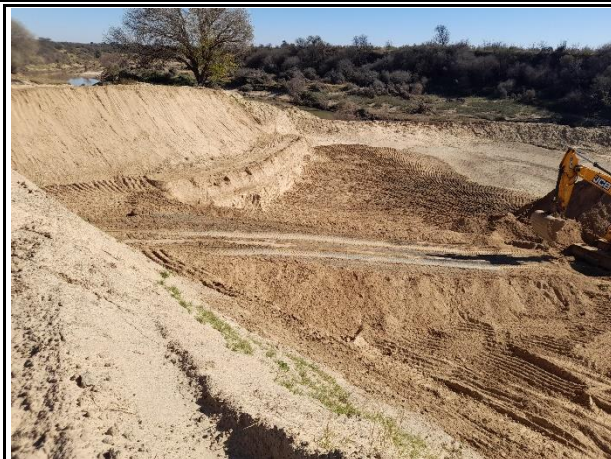
Rehabilitation of mining area in progress

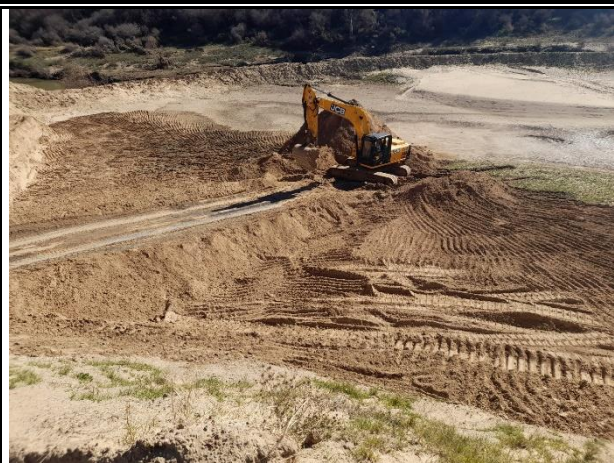
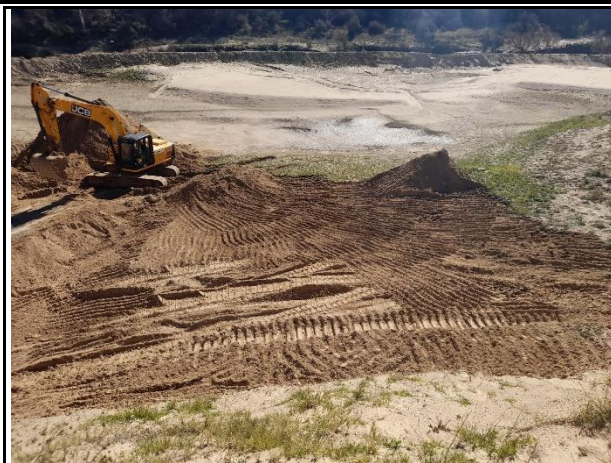
Rehabilitation of mining area in progress

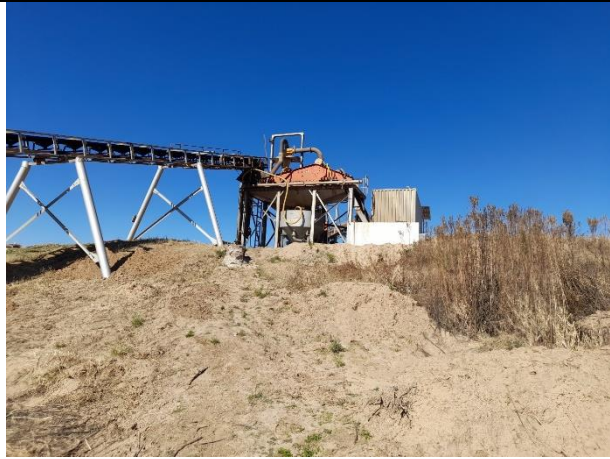
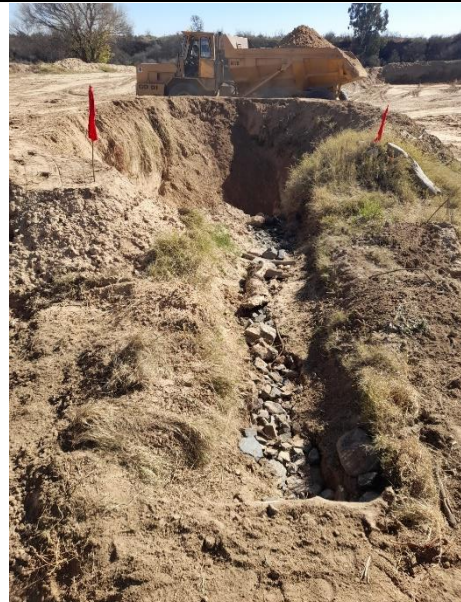
Drain to contain the runoff water from the washing plant

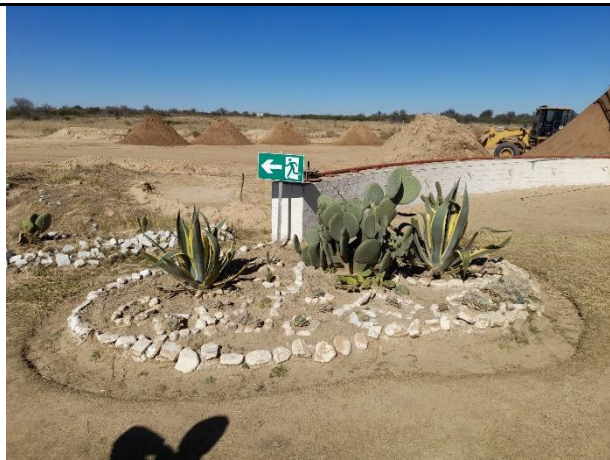
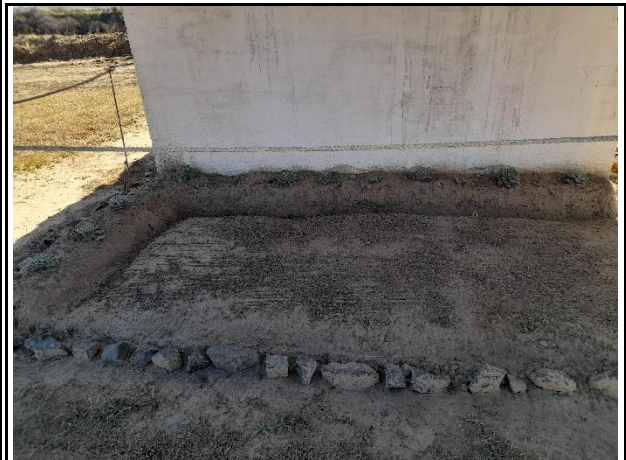
Imbricate Cactus (*Cylindropuntia imbricata*) removed from site
