CONTRACT NO: C918

FINAL PERFORMANCE ASSESSMENT REPORT

ENVIRONMENTAL RISK REPORT

CLOSURE PLAN

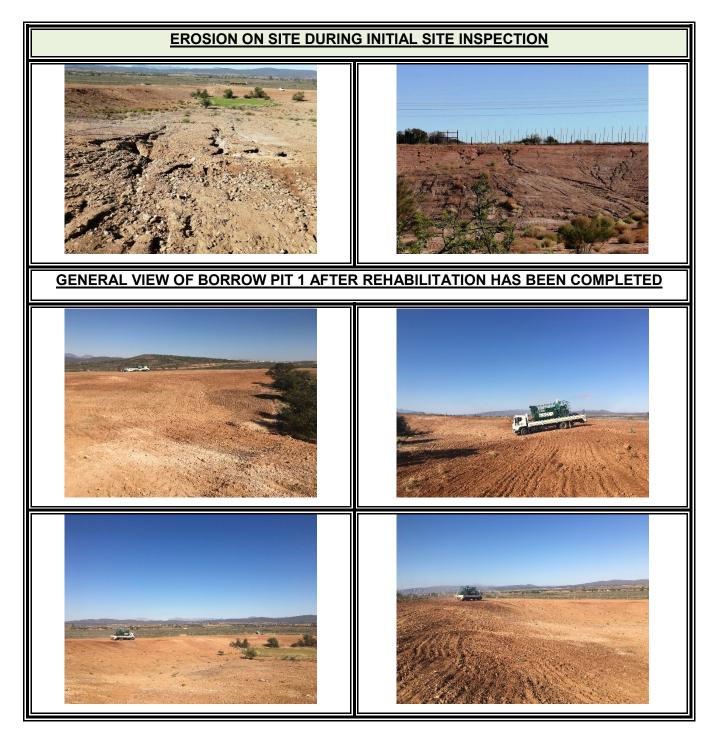
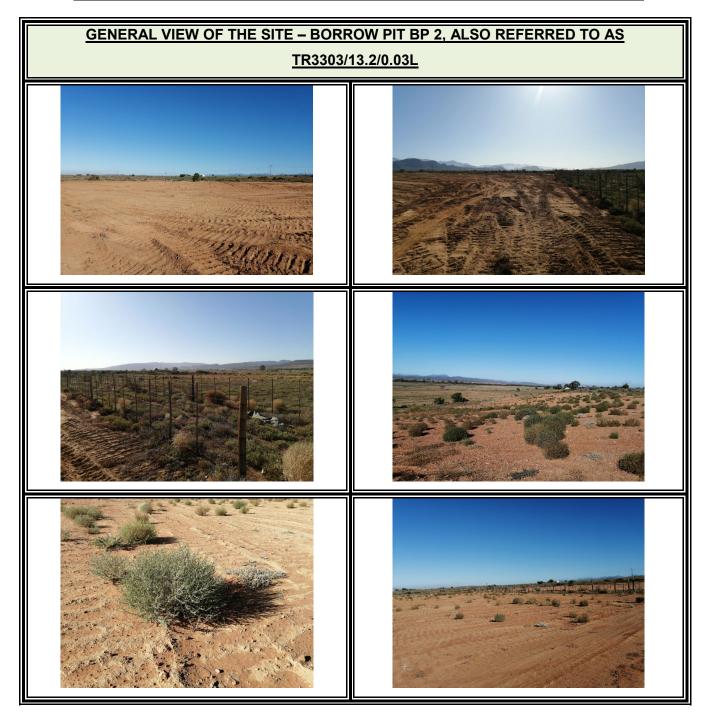
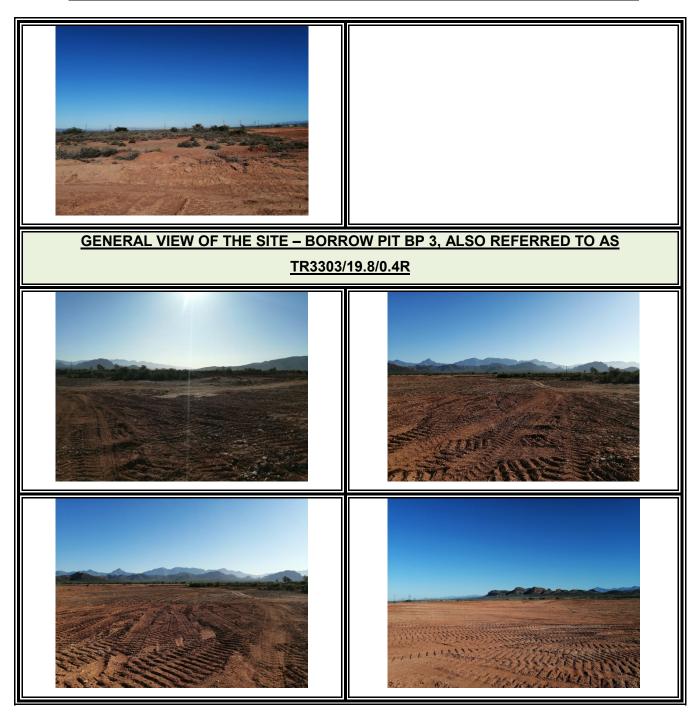
PHOTOGRAPHS

- This matter was addressed and proof thereof is submitted to this report.
- Borrow pit 1 some slopes are steeper than 1:3.
 - This matter was addressed and proof thereof is submitted to this report.

- This matter was addressed and proof thereof is submitted to this report.
- Borrow pit 1 shows signs of erosion, resulting directly from the previous mining activities were noted. Storm water control and sloping of 1:3 should be implemented.

- This matter was addressed and proof thereof is submitted to this report.
