DOUG JEFFERY
ENVIRONMENTAL CONSULTING AND
FACILITATION SERVICES

BOTANICAL SURVEY OF THE PROPOSED
NORTHERN SECTION OF THE BRIDGETOWN
DOLOMITE QUARRY

AUGUST 1997

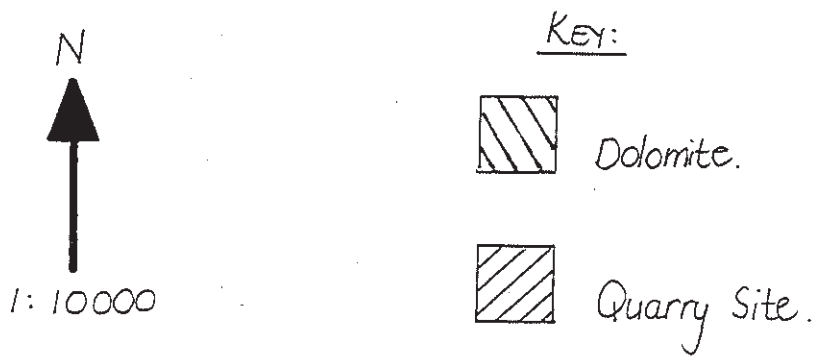
Figure 2. The position of the quarry site and the underlying geology.

A dolomite quarry site has been identified at Bridgetown approximately 20km east of Morreesburg (Figure 1). The quarry site is situated on the western bank of the Berg River near the Misverstand Dam. The proposed quarry is situated on a dolomite outcrop which at present is covered with natural vegetation (Figure 2). The majority of the surrounding areas have been transformed by wheatlands. Very little natural vegetation remains in the surrounding areas. If mining were to occur in the area a large proportion of the remaining natural vegetation on the dolomite outcrop would be permanently destroyed. The aim of this survey was to provide a description of the vegetation on the site and along the river bank and to assess the conservation implications of the proposed quarry on the vegetation of the area.

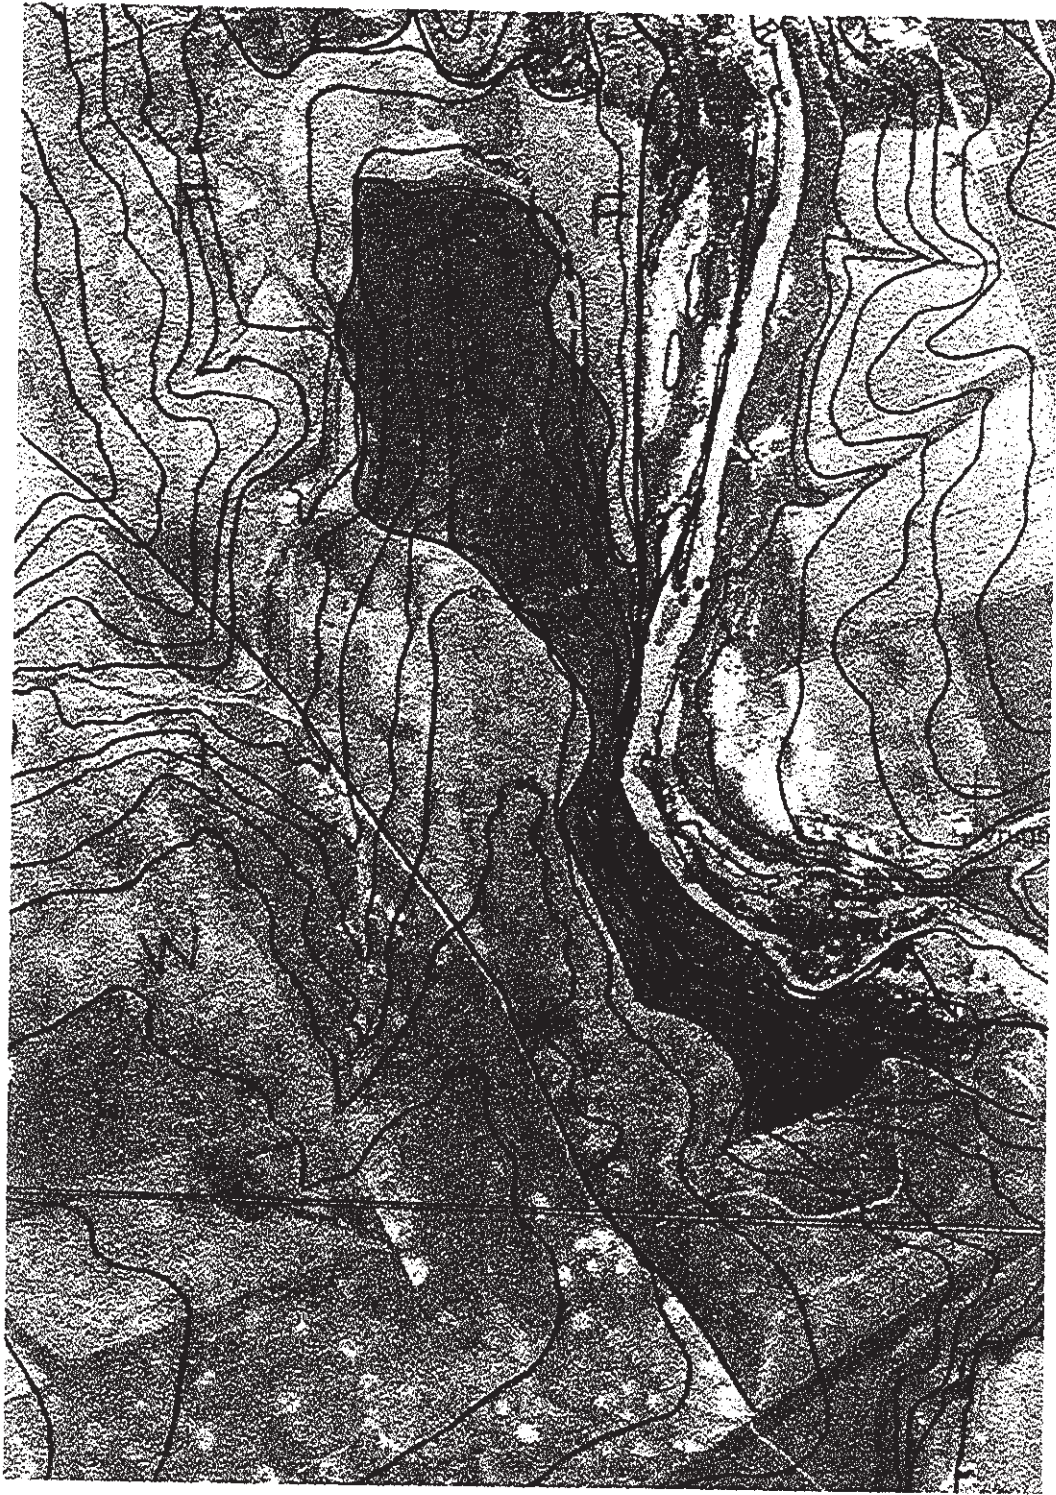
There are two vegetation types in the study area. The vegetation on the dolomite substrate in which the quarry will be situated (Succulent Karoo) and floodplain vegetation along the Berg River (Figure 3).

Figure 3. The natural vegetation of the study area indicating the position of the proposed quarry.

If, notwithstanding the conservation value of the Succulent Karoo vegetation of the site, the quarry is to be situated here then every effort should be made to conserve a viable, representative portion of this rare shrubland habitat. Figure 3 shows the vegetation distribution of the site with the quarry position indicated. If this figure is read with figure 2 then it can be seen that there are areas of Succulent Karoo vegetation on dolomite which will not be mined.
