**DE AAR STONE CRUSHERS  
PORTION 49 AND 50 OF FARM NO 180 DE AAR,  
HANOVER MAGISTERIAL DISTRICT,  
NORTHERN CAPE PROVINCE**

**ENVIRONMENTAL AUDIT REPORT / ENVIRONMENTAL PERFORMANCE  
ASSESSMENT**

<b>DMPR REFERENCE NUMBER:</b>	<b>NC 30/5/1/2/2/10075 MR</b>
<b>AUDIT PERIOD:</b>	<b>January 2025 – February 2026</b>

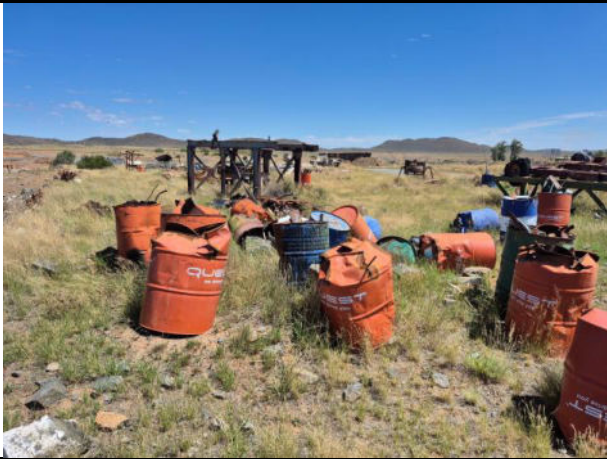
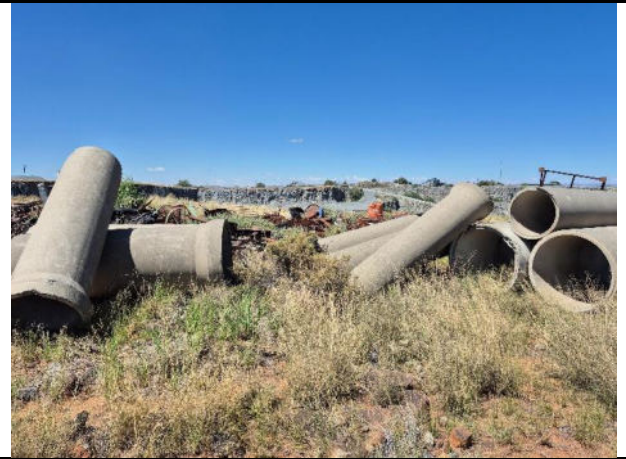
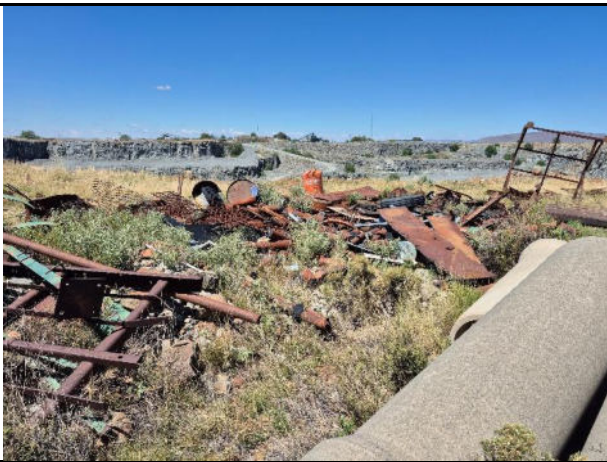
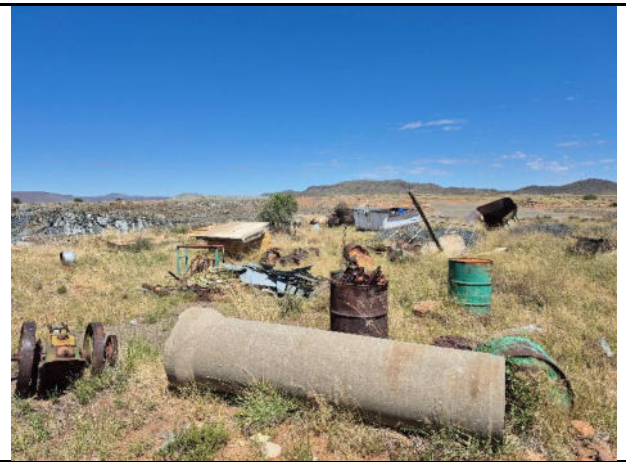
Scrap yard management improved and dangerous goods were removed from site.

Since the 2024 audit, the drums and scrap material previously present at the salvage/scrap yard (north-east of the quarry) have been sorted, and a significant amount of unwanted material has been removed from the site. Alien invasive plants that had germinated in this area have been cleared, and contaminated soil has been removed.

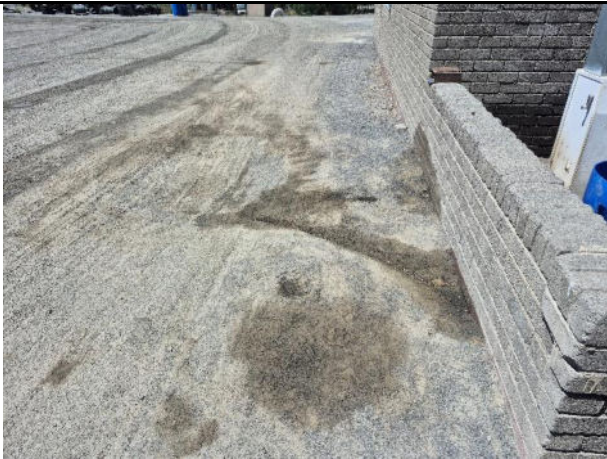
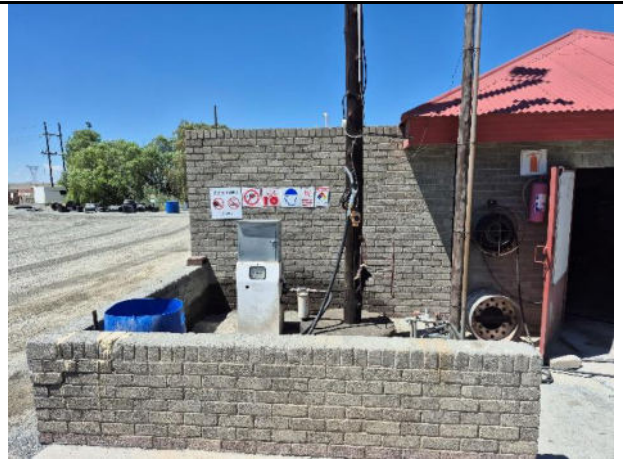
As previously noted, the integrity of the bunded hazardous waste storage area, where used oil drums are stored, requires improvement and ongoing maintenance. The drain plug must remain securely in place, and no contaminated water may be allowed to discharge into the surrounding environment. The spillage observed during the site inspection must be cleaned without delay.

**Spillages to be cleaned**

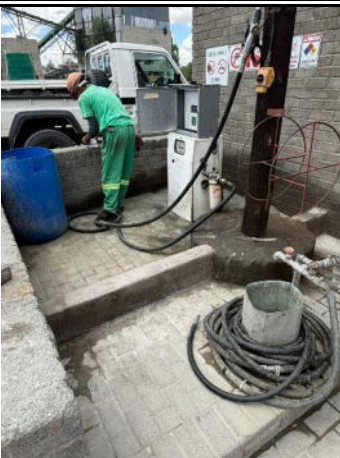
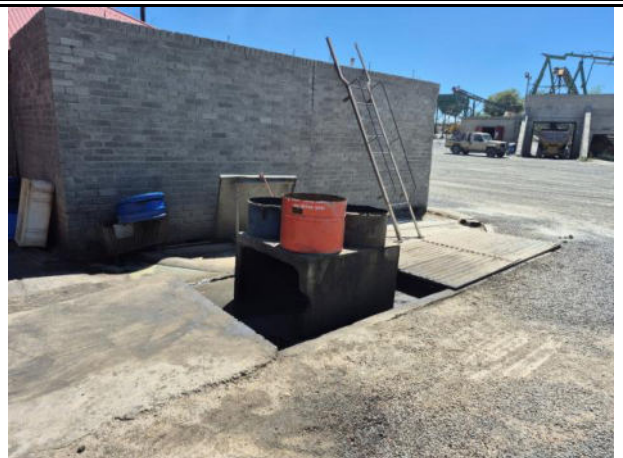
**Diesel storage area**

**Improvement of diesel storage bund**

Since the audit inspection, the bunded area of the fuel depot has been upgraded and sealed to ensure adequate containment of spillages and/or contaminated water.

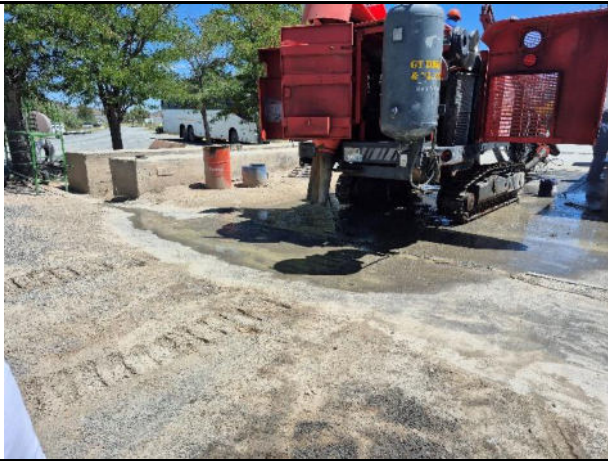
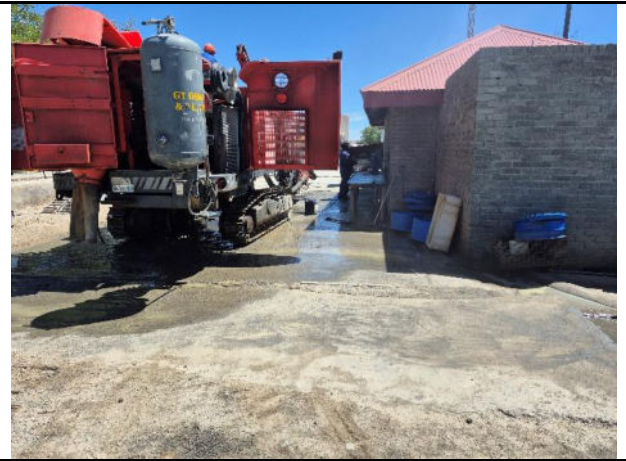
**Oil sump at wash bay**

**Washbay runoff to be directed to the oil sump**

Runoff from the wash bay must be directed into the oil sump and may not be allowed to drain into the surrounding environment. Similarly, any water accumulating within the bund of the diesel tank must be directed into the oil sump. Under no circumstances may contaminated water be allowed to infiltrate the surrounding veld or soil.

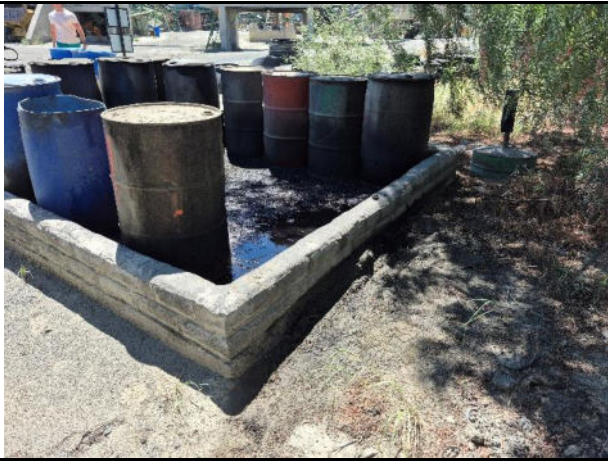
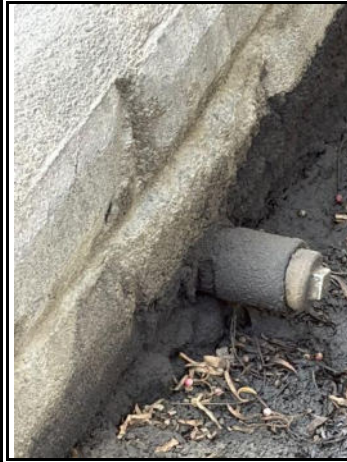
**Hazardous waste storage area where bund wall integrity needs constant management**

5. Direct the wash water at the wash bay and from the diesel tank bund to the oil sump;
6. Improve the integrity of all the bund walls on site;
7. Obtain an opinion from an archaeologist regarding the need for an HIA.
