DPR

Wetland Assessment for a proposed mining permit application on Portion 15 of the Farm Rietspruit 437 near the town of Ermelo, Mpumalanga Province.

February 2022

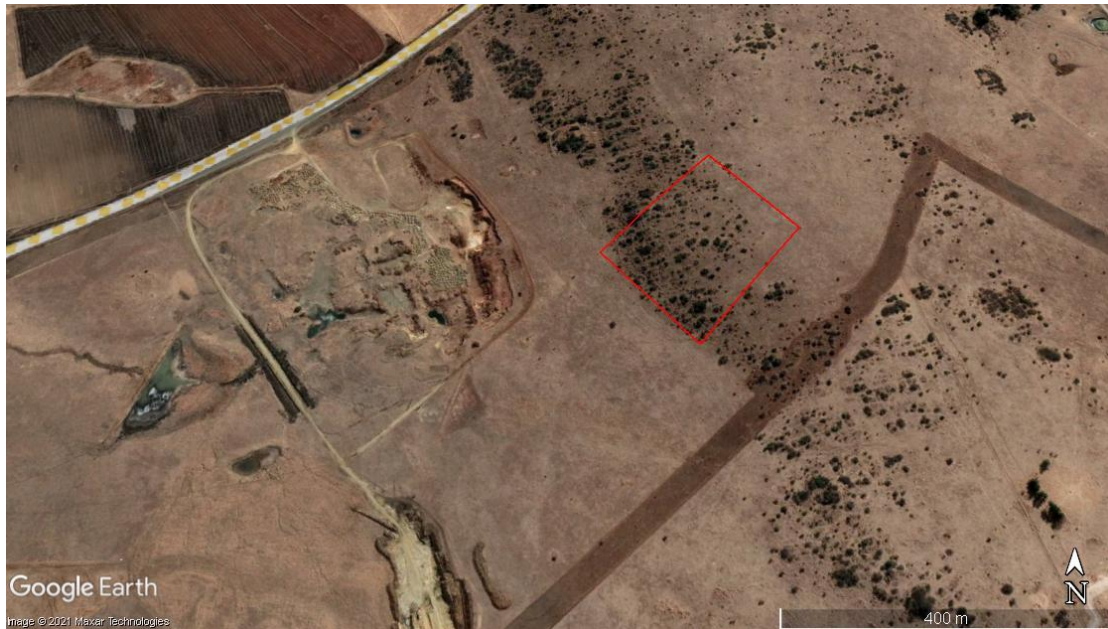
Figure 1: Aerial view of the proposed site (Google Earth 2021). The site consisting of scattered trees and grass layer is visible and situated along a low rocky ridge. Note extensive transformation to the south and west, associated with previous mining activities.

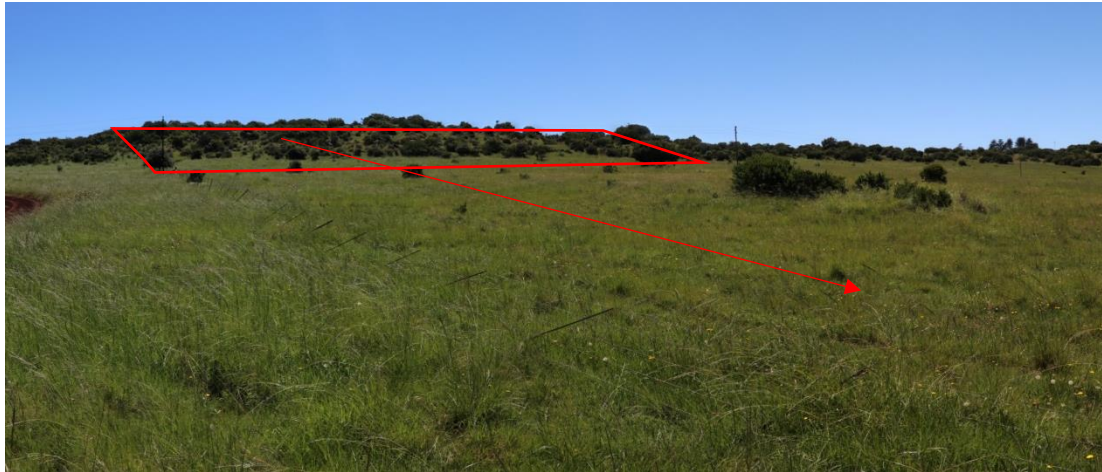
Figure 2: View of the site (red) which is clearly situated on a low rocky ridge, being dominated by scattered trees and a grass layer. The site also clearly drains toward the south west (arrow).

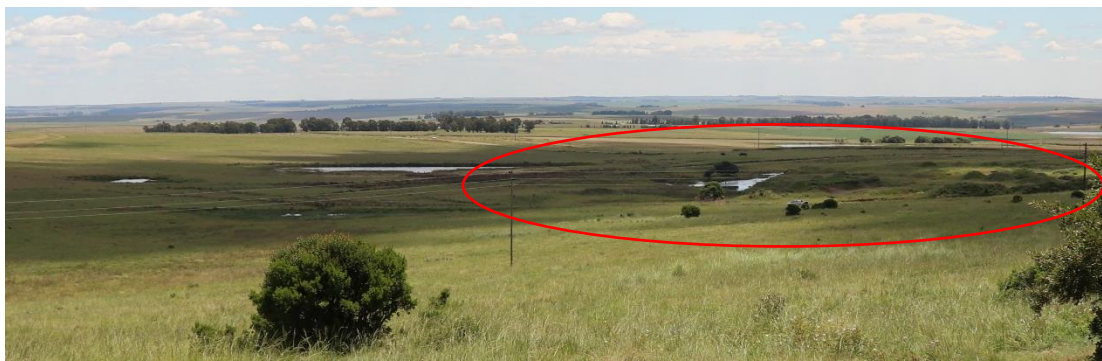
Figure 3: The surroundings are dominated by natural grassland although previous mining to the south west of the site has caused transformation of the vegetation and topography (red).

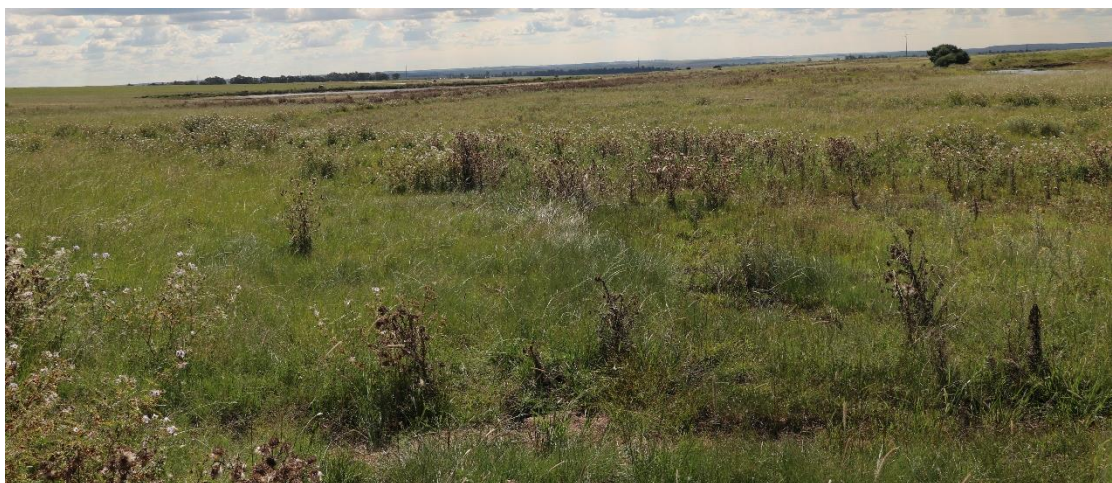
Figure 4: Areas where previous mining had occurred has also promoted the establishment of exotic weeds and modification of the surface drainage pattern.

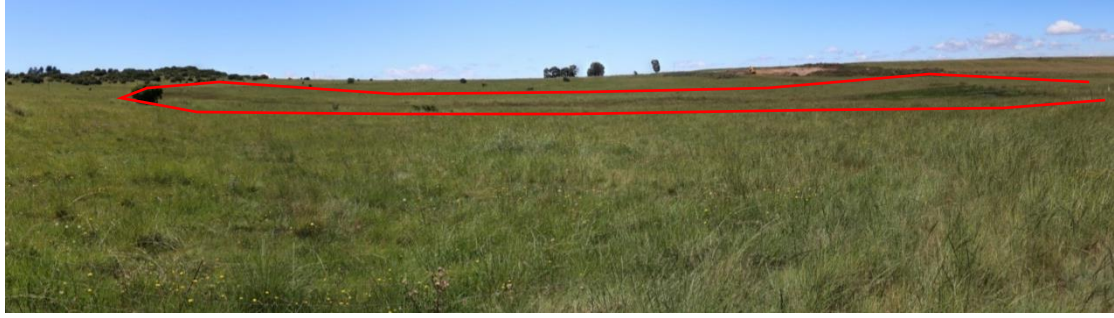
Figure 5: Coupled to the topography and surface drainage, a clearly defined wetland area originates to the south of the site.

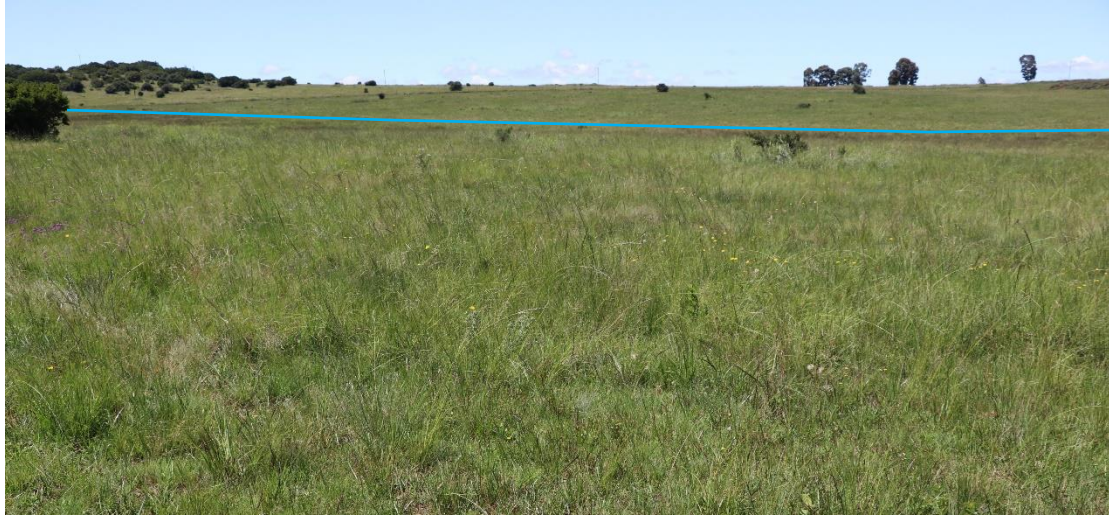
Figure 7: Fairly natural grassland dominated the catchment of the valley-bottom wetland (blue) and will aid in alleviating any anticipated impacts on it.

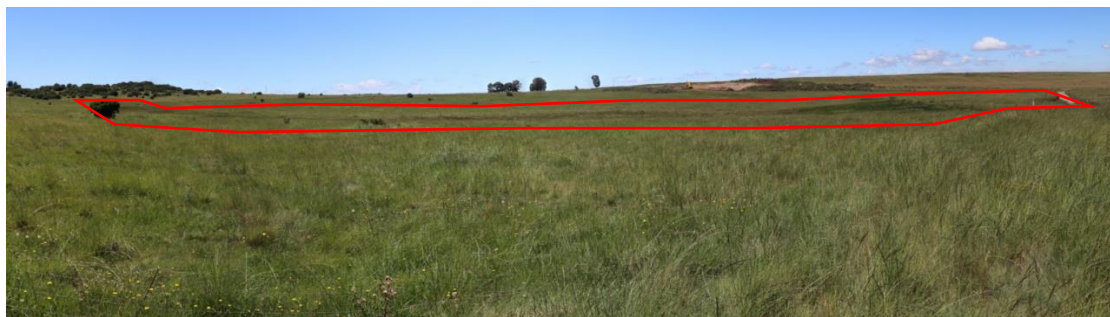
Figure 10: View of the valley-bottom wetland (red) as seen from the direction of the site.

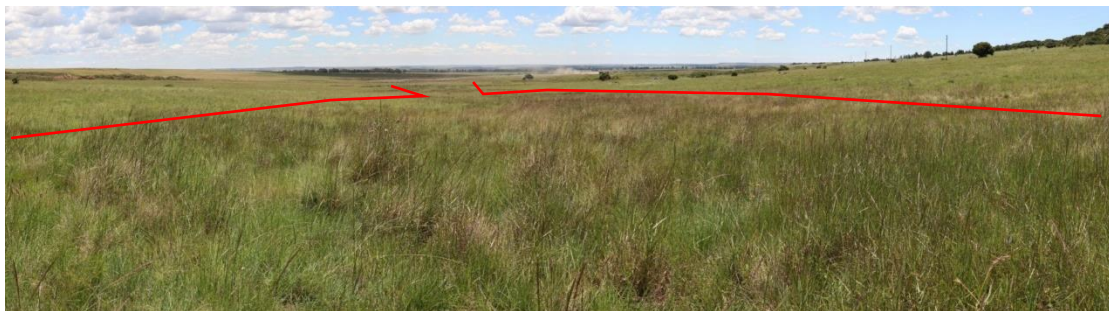
Figure 12: View of the wetland as seen from its origin. It clearly slopes downwards and is situated within a shallow valley.

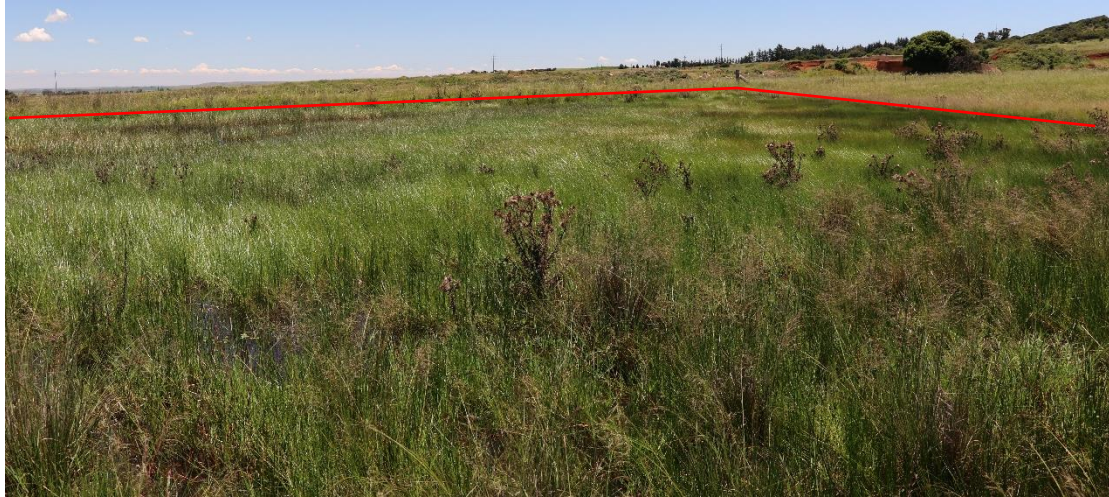
Toward the western portion of the valley-bottom wetland it is being confined by a small artificial berm, forming a small impoundment. This causes significant disturbance and modification of the wetland. Because diffuse flow is being confined here, surface water accumulates and forms a perennial saturated area. As a result, vegetation within this dam is dominated by obligate wetland plants also being able to withstand prolonged periods of inundation. These include the sedges, *Schoneoplectus* sp., *Eleocharis dregeana* and the aquatic grass, *Paspalum distichum*. Due to this modification of the system, disturbance is quite evident, especially seen as an abundance of exotic weeds. This disturbance may also be influenced by the current mining area to the south. These weeds include *Cirsium vulgare*, *Solanum panduriforme*, *Schkuhria pinata*, *Bidens pillosa* and *Verbena rigida*.

Figure 13: A small artificial impoundment (red) at the western end of the wetland results in significant modification and disturbance of the system.

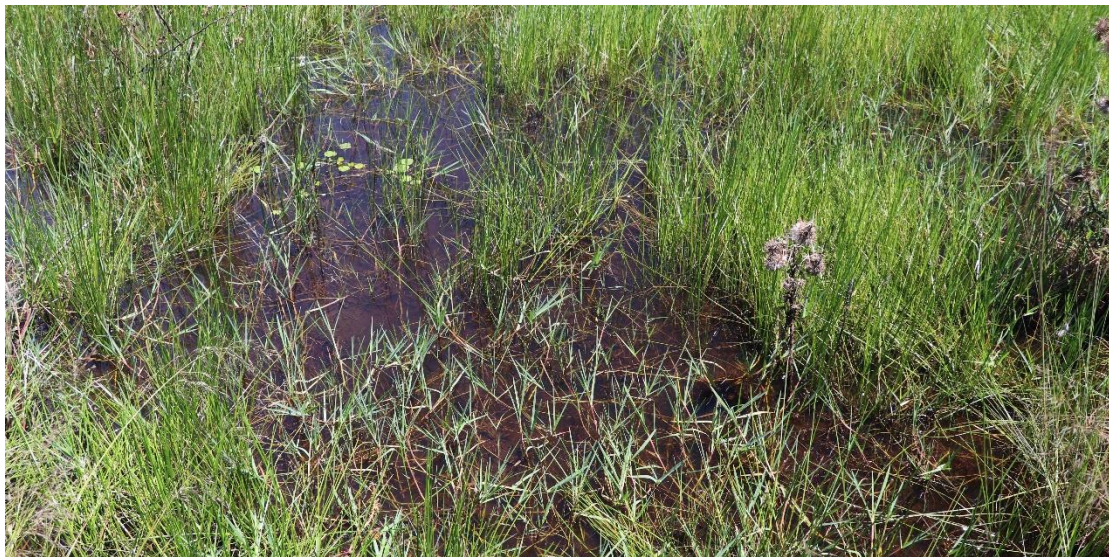
Figure 14: This small dam will contain shallow surface water for long periods and consequently the vegetation here is much modified from the upstream, more natural section.

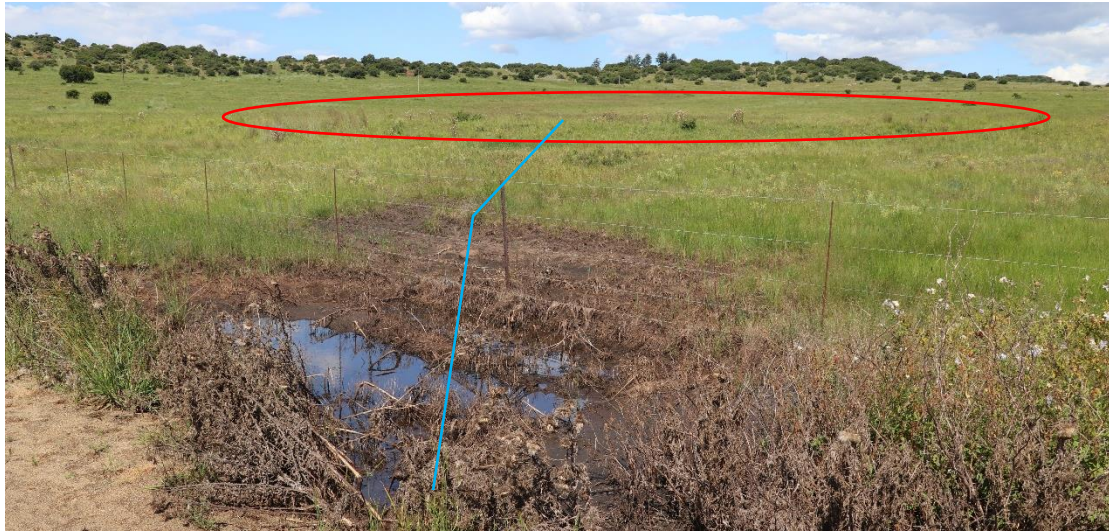
Downstream of the small impoundment, discussed in the previous paragraph, the wetland becomes extensively modified and degraded. A large haul road, dirt tracks and adjacent areas will have a large impact on the system. This is also visible in the vegetation, containing a high degree of exotic weeds, and in the modification of the geomorphology of the wetland.

Figure 15: Downstream of the small impoundment (red), the wetland becomes exceedingly disturbed and modified.

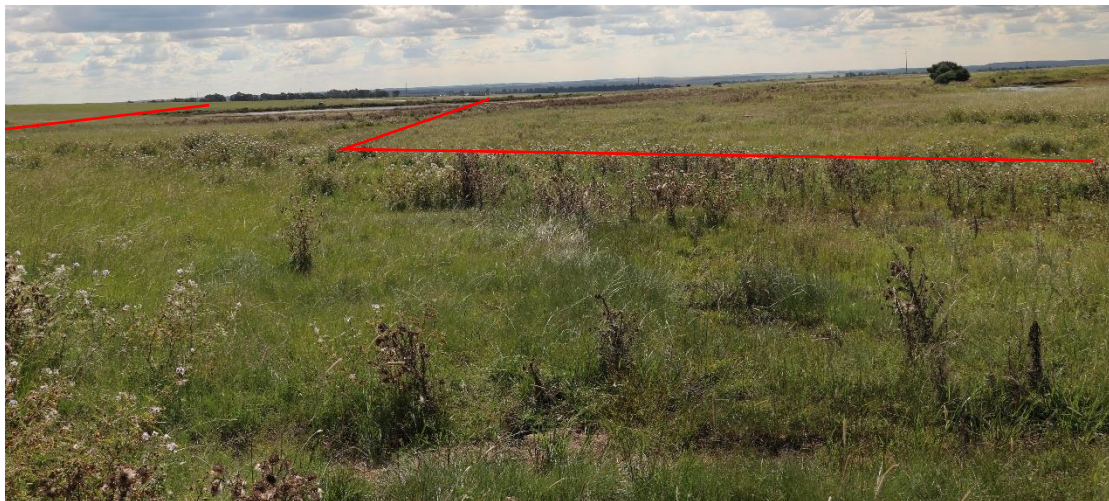
Figure 16: Downstream of the small impoundment the wetland contains a large degree of exotic weeds.

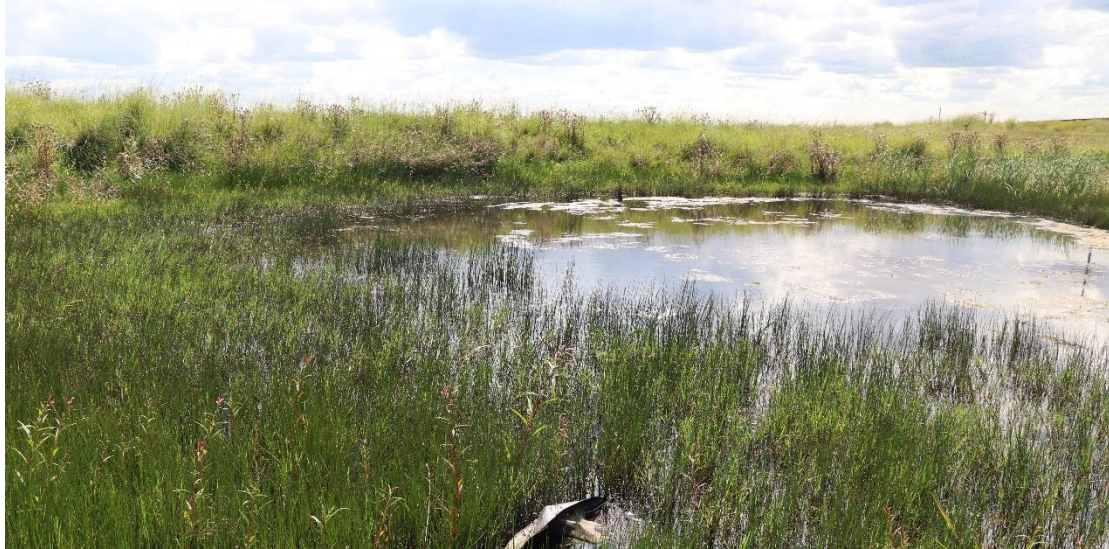
A small artificial dam and wetland areas forming in previous excavations occur approximately 450 meters to the west of the site. These artificial wetland areas also fall within a separate catchment, upstream of the site and therefore the proposed mining area will not be able to have any affect on these artificial wetland areas. These two small depressions contain surface water and has formed artificial wetland conditions, most likely of a perennial nature. Vegetation is dominated by wetland plants adapted to prolonged inundation and soils also exhibit a prominent grey matrix and mottling. The soils are however also dominated by gravels, further substantiating that these wetland areas are a result of previous mining disturbance. As these areas are completely artificial and will not be affected by the proposed mining operations, they are not of consequence to the development and will therefore not be assessed in this study.

Figure 17: A small excavation caused by previous mining activities, now forms a small artificial wetland area to the west of the site.

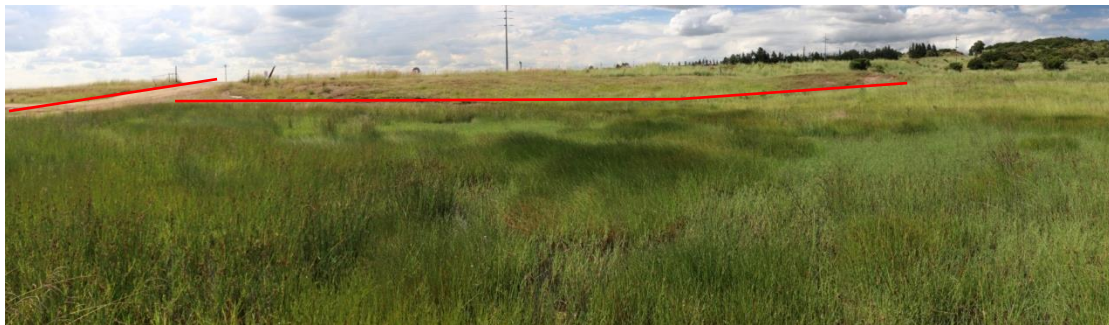
Figure 18: A second small artificial wetland has also formed as a result of mining activities but is also likely linked to flow obstruction caused by gravel roads (red) caused obstruction of flow and consequently the accumulation of surface water.

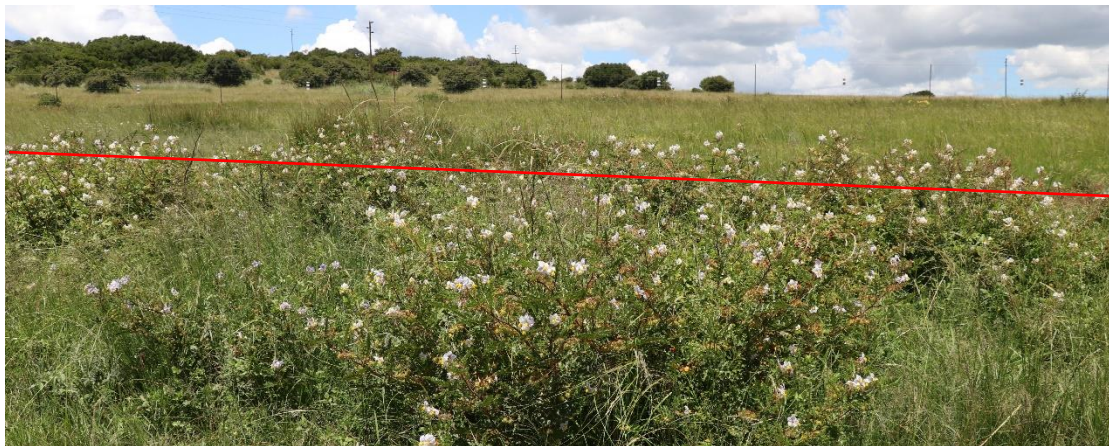
A few small dirt tracks cross over the wetland, one at its origin and one below the small artificial dam. In both instances these tracks clearly influence the flow regime with concentrated flow becoming evident and the tracks themselves act as flow obstructions. Exotic weeds are also abundant within the wetland where these tracks cross it and includes *Cirsium vulgare* and *Solanum sisymbriifolium*. This is also a clear indication that though these tracks are small and the impact local, they do cause some disturbance of the wetland system.

Figure 19: Dirt track crossings (red) clearly cause some local disturbance of the wetland and the proliferation of exotic weeds.

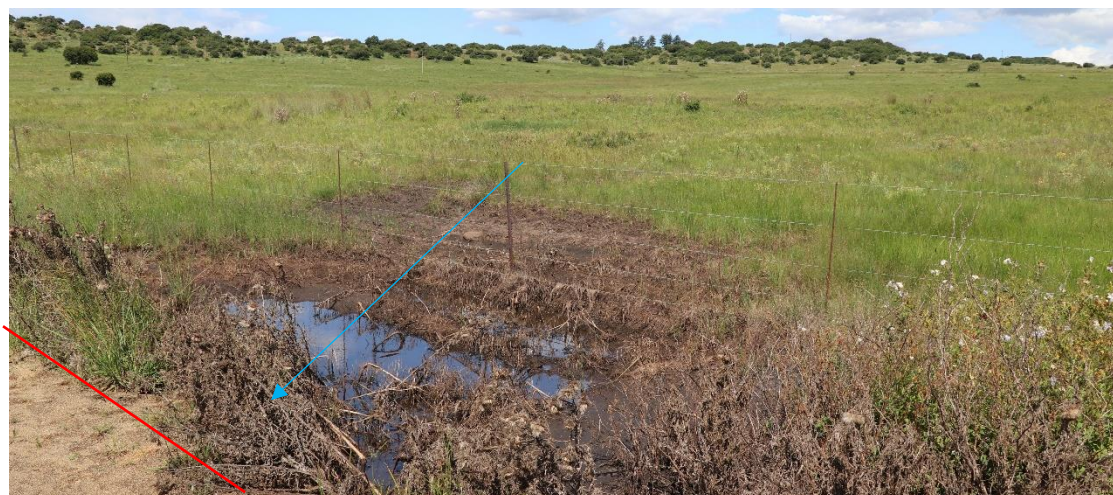
Figure 20: Dirt tracks (red) also clearly act as obstruction to natural flow.

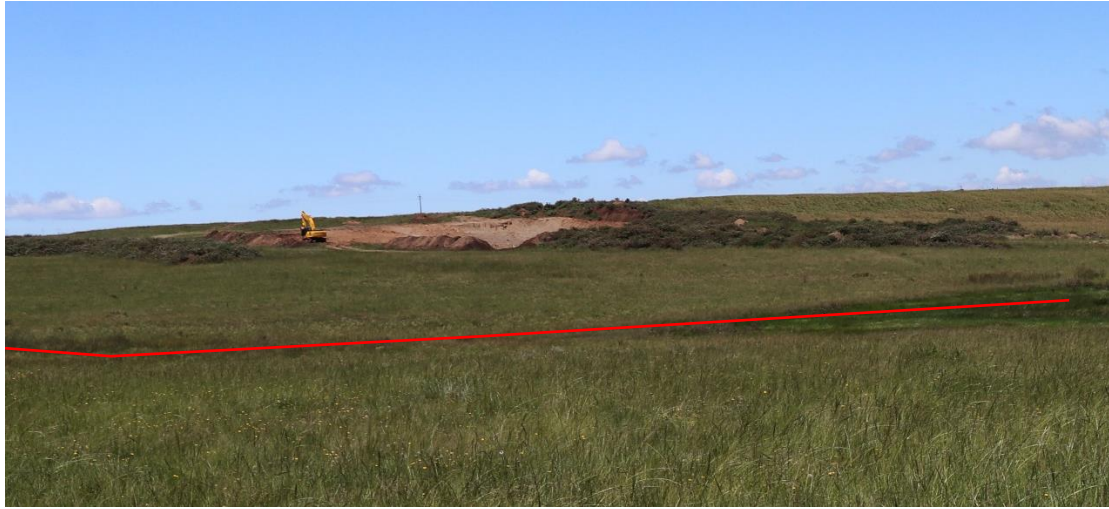
Current and previous mining operations to the south of the wetland as well as downstream will most certainly have significant impacts on the wetland. The mining excavations to the south of the wetland will mostly have an impact in terms of increased sediment runoff, though natural vegetation should act as a suitable buffer to this. Another significant impact will be associated with the modification in surface runoff due to the modification in the surface topography. Previous mining operations downstream of the site has clearly had a much higher impact on the wetland but since these areas are located downstream of the proposed mining area it has not been taken into consideration here.

Figure 21: Mining activities to the south of the wetland (red) will certainly have at least some impacts on the wetland.

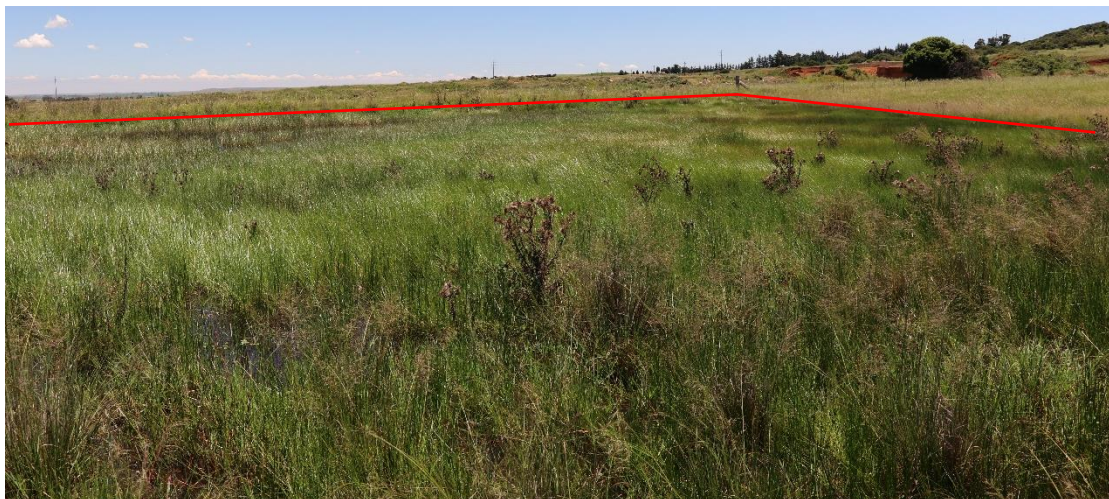
Probably the most significant impact on the wetland (other than mining operations downstream of the site) is a small impoundment in the western portion of the wetland. This impoundment clearly has a significant impact on the hydrology of the wetland, where the natural, diffuse flow, is impounded and surface water accumulates. This also significantly modifies the natural vegetation from hygrophilous grasses adapted to saturated soils to a sedge dominated vegetation adapted to prolonged inundation.

Figure 22: A small artificial impoundment (red) at the western end of the wetland results in significant modification and disturbance of the system.

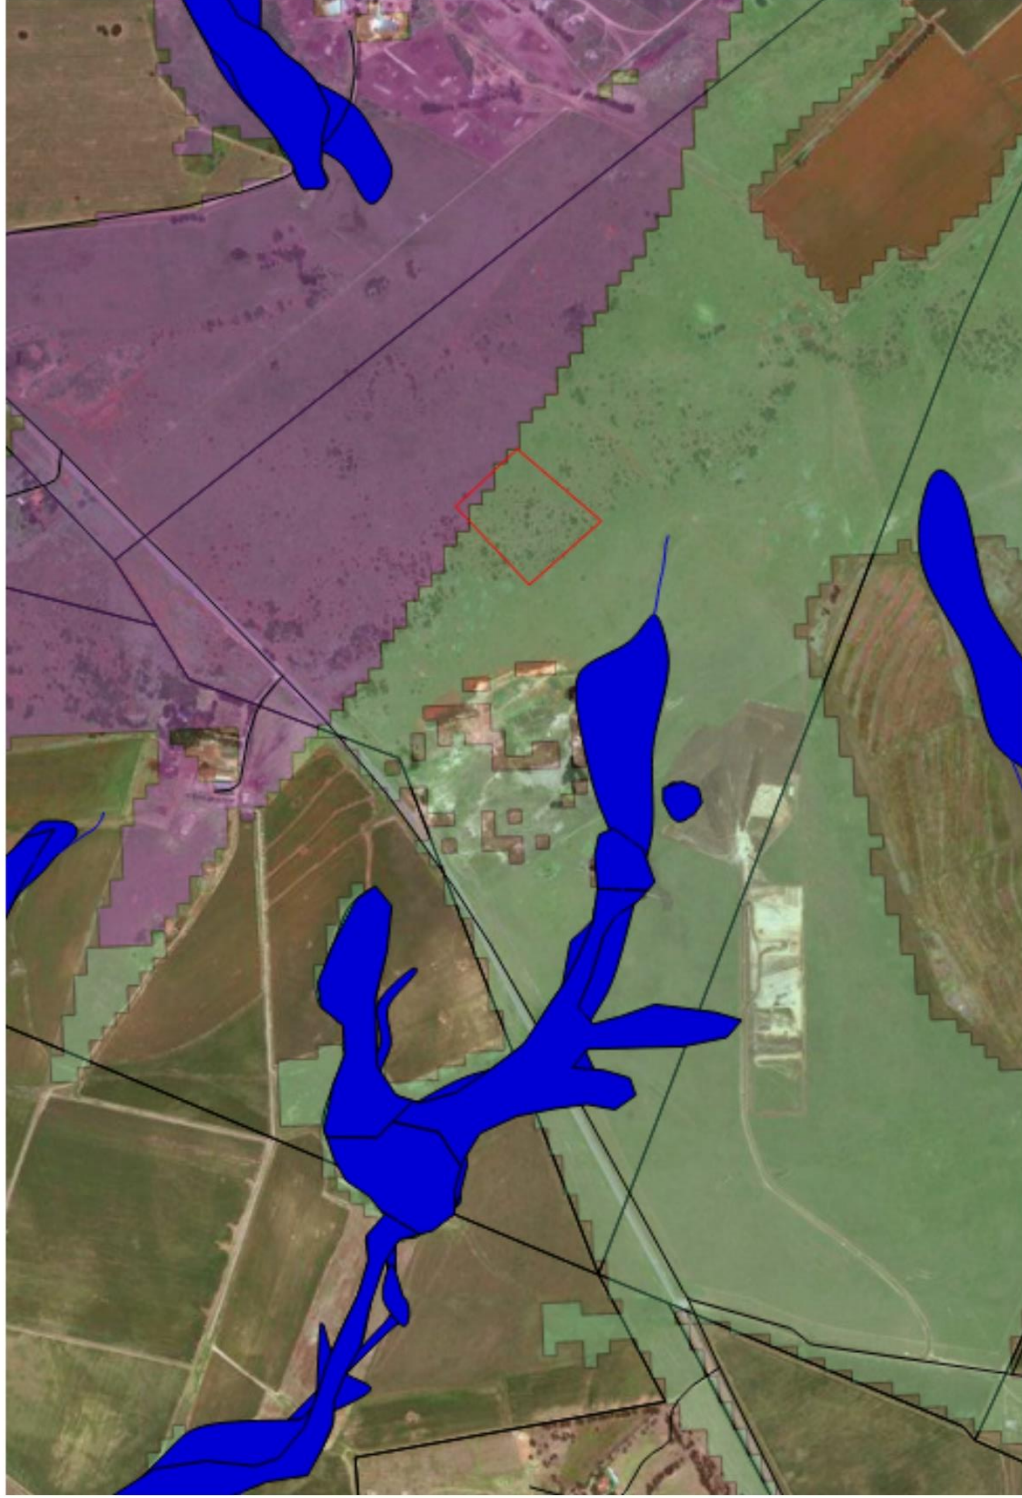
Map 1: Locality and general ecology map of the proposed mining permit application on Portion 15 of the farm Rietspruit 437. The vegetation types in the area are indicated, note that large areas around the site still consists of natural grassland. The site and wetland system consist of Amersfoort Highveld Clay Grassland while the site marginally intrudes into the Soweto Highveld Grassland. Using available spatial resources, the anticipated wetlands, watercourses and impoundments in the area are indicated. It is clear that a wetland system occurs to the south of the site. This also corresponds with the on-site delineation although the boundaries of the wetland system could be determined with much higher accuracy (See Map 2).

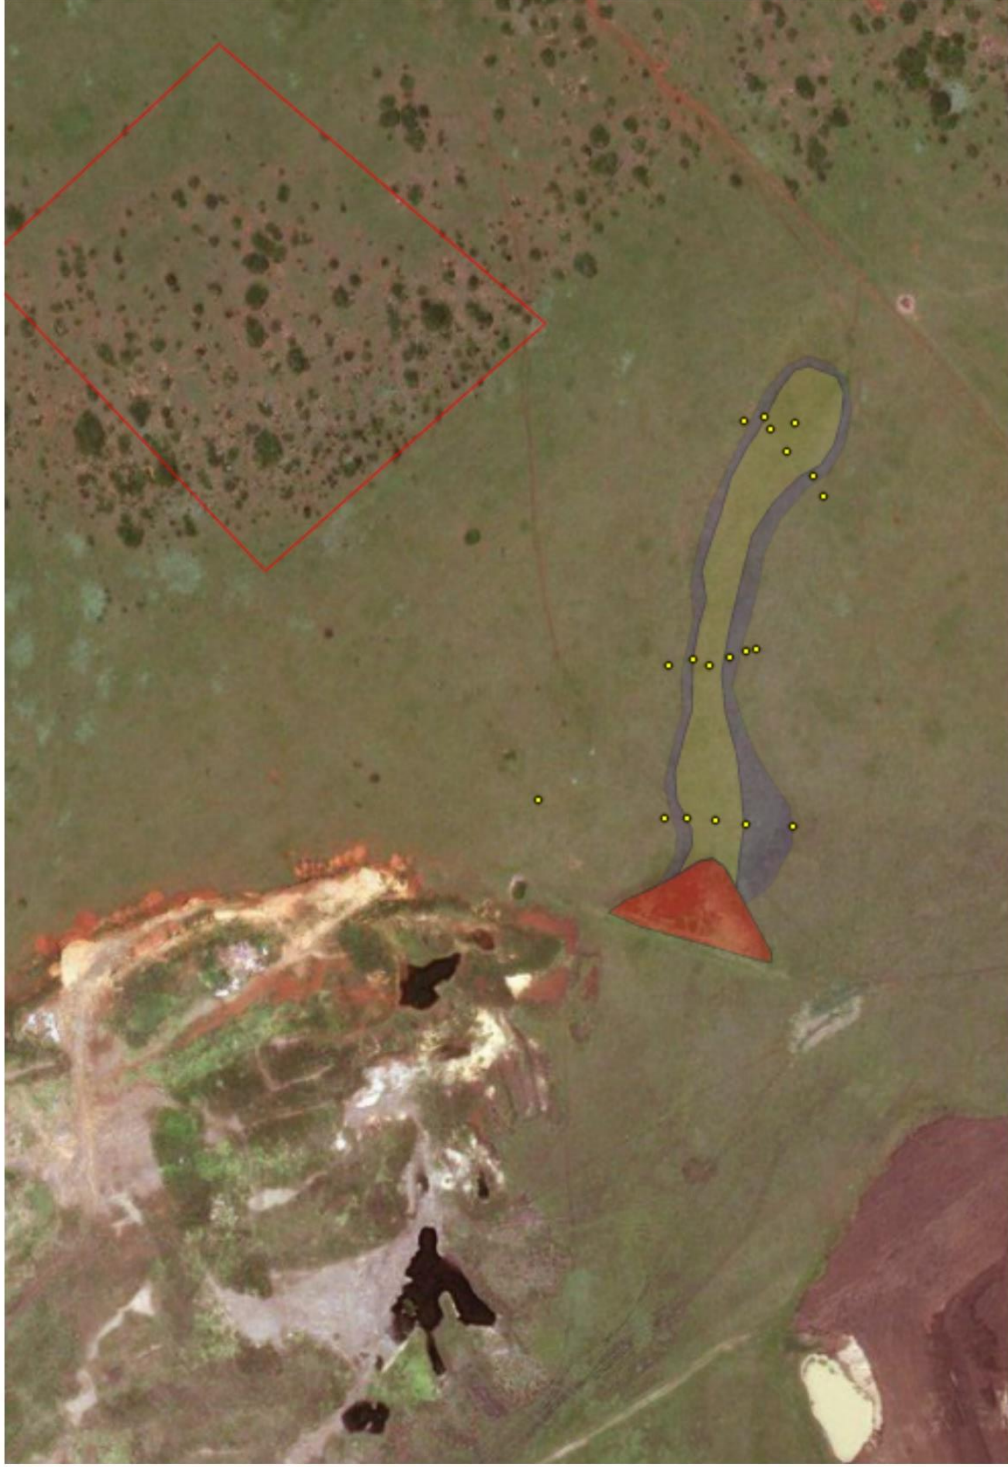
Map 2: Wetland delineation map of the proposed mining permit application on Portion 15 of the farm Rietspruit 437. The application area is indicated to the north of a small unchanneled valley-bottom wetland approximately 130 meters from it. This wetland, the seasonal zone and temporary zone (indicating the wetland boundary) is indicated as well as a small artificial dam into which it flows, representing a permanent zone of wetness. The sampling sites along the wetland is also indicated along three separate transects. Note also extensive transformation downstream and to the south of this wetland caused by previous mining operations. The proposed site is clearly situated along a low rocky ridge.

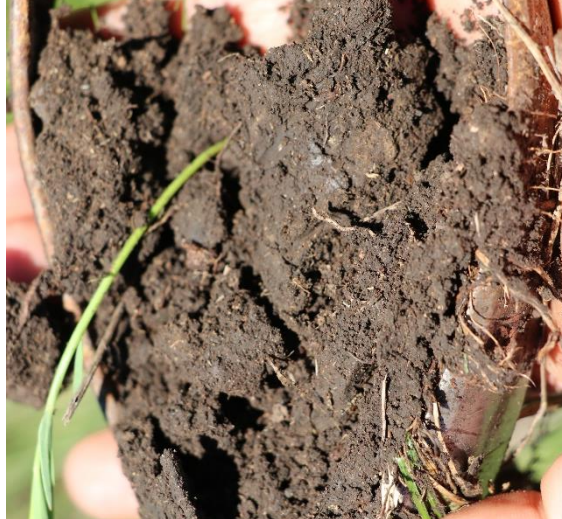
<p>Soil sample taken along the northern border of the valley-bottom wetland. A grey matrix is not discernible and only a few very indistinct mottles are visible. This is taken as the temporary zone of wetness and indicates the border of the wetland.</p>	<p>Soil sample taken to the north and well outside the border of the wetland. This sample is taken as a reference for the terrestrial surroundings. Note a reddish colouration, no mottles, being a mixture of clay and loam.</p>

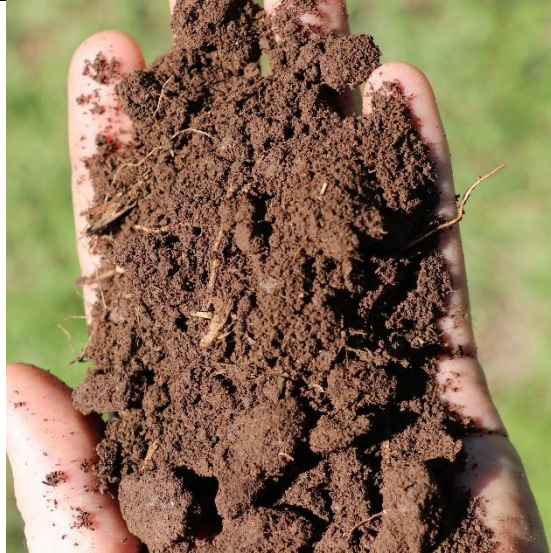
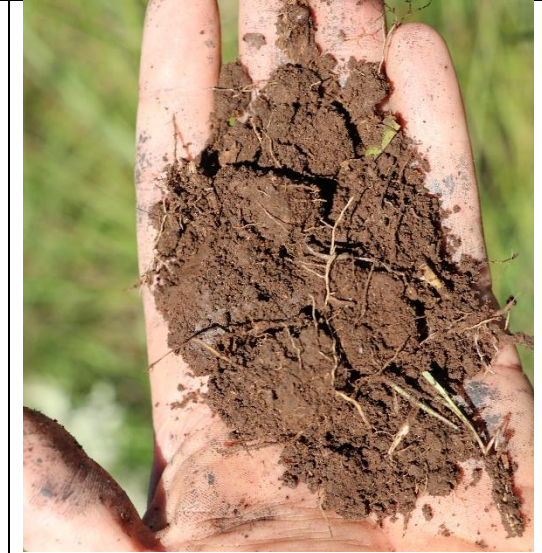
<p>Soil sample taken to the north and outside the border of the wetland. A reddish colour, absence of mottles and a clay-loam content clearly indicates the absence of wetland conditions.</p>	<p>Soil sample taken at the northern border of the wetland. Soils contain a somewhat higher clay content but with a reddish colour and no mottles and indicate the absent of wetland conditions.</p>

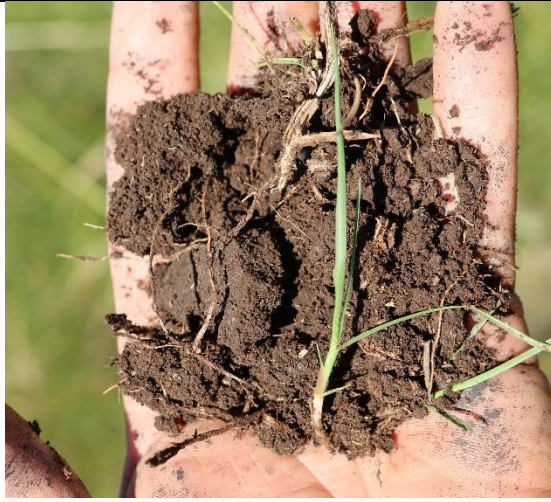
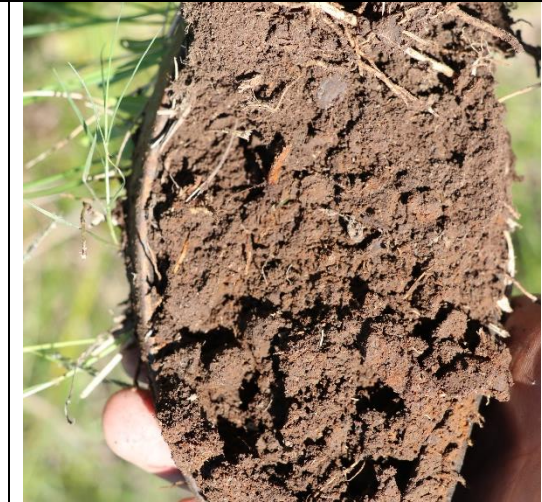
<p>Soil sample taken just inside the border of the valley-bottom wetland. Soils contain a significant clay content and with a few feint mottles visible. This is taken as the temporary zone of wetness and indicates the border of the wetland.</p>	<p>Soil sample taken in the central portion of the valley-bottom wetland. A grey matrix is not prominent though a high clay content is present with several reddish, clearly visible mottles indicating a seasonal zone of wetness. Wetland conditions are therefore clearly present.</p>

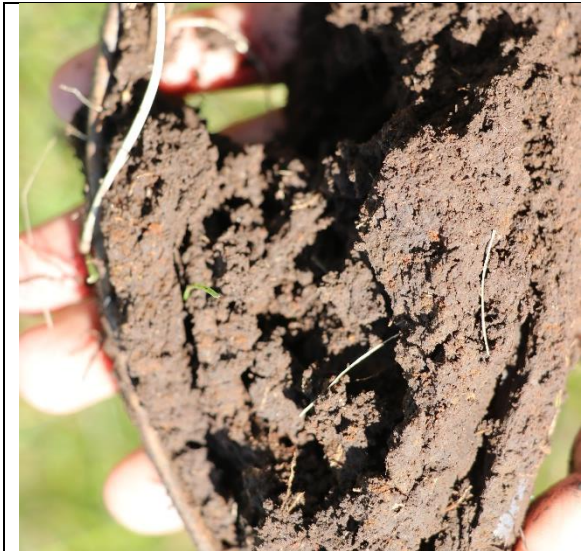
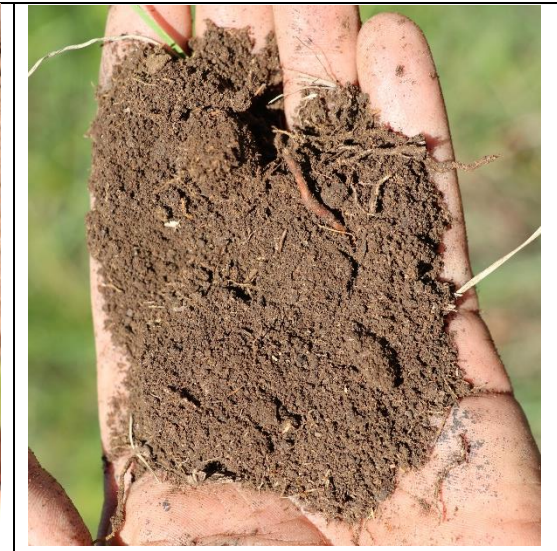
<p>Soil sample taken toward the southern border of the valley-bottom wetland. A grey matrix is not prominent (<10%) though mottling remains clearly visible and seasonal wetland condition are therefore still present.</p>	<p>Soil sample taken outside the southern border of the wetland. A reddish colour, absence of mottles and a clay-loam content clearly indicates the absence of wetland conditions.</p>

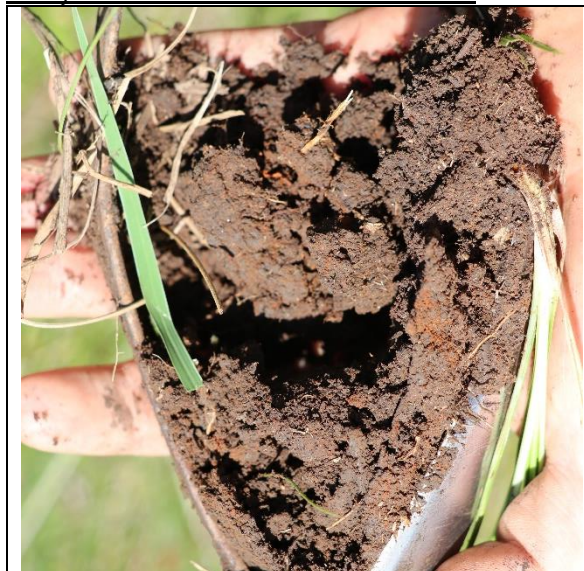
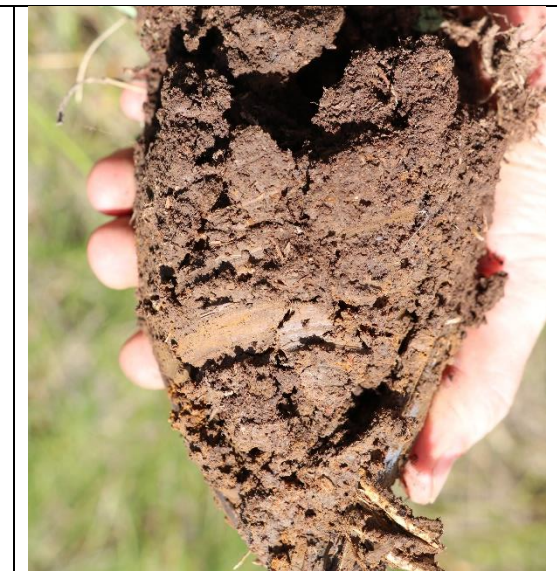
<p>Soil sample taken in the central portion of the valley-bottom wetland. A grey matrix is not prominent though a high clay content is present with several reddish, clearly visible mottles indicating a seasonal zone of wetness. Wetland conditions are therefore clearly present.</p>	<p>Soil sample taken toward the north border of the valley-bottom wetland. A grey matrix is not prominent (<10%) though mottling remains clearly visible and seasonal wetland condition are therefore still present.</p>

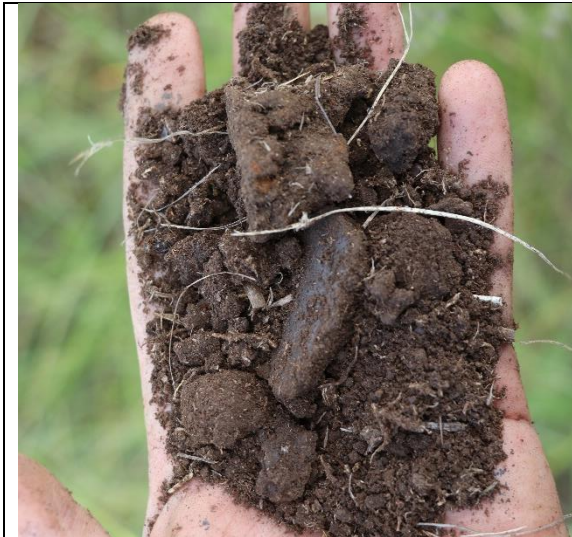
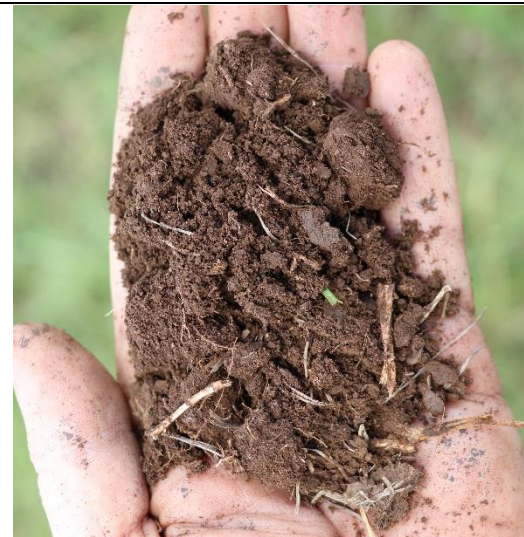
Soil sample taken along the northern border of the valley-bottom wetland. A grey matrix is not discernible and only a few very indistinct mottles are visible. This is taken as the temporary zone of wetness and indicates the border of the wetland.
