**ASSESSMENT OF THE WETLANDS AND  
WATERCOURSES IN THE VICINITY OF A  
PROPOSED NEW DOLERITE MINE NEAR  
PIETERMARITZBURG, KWAZULU-NATAL**

**MARCH 2021  
REVISION 0**

**JG AFRIKA (PTY) LTD**

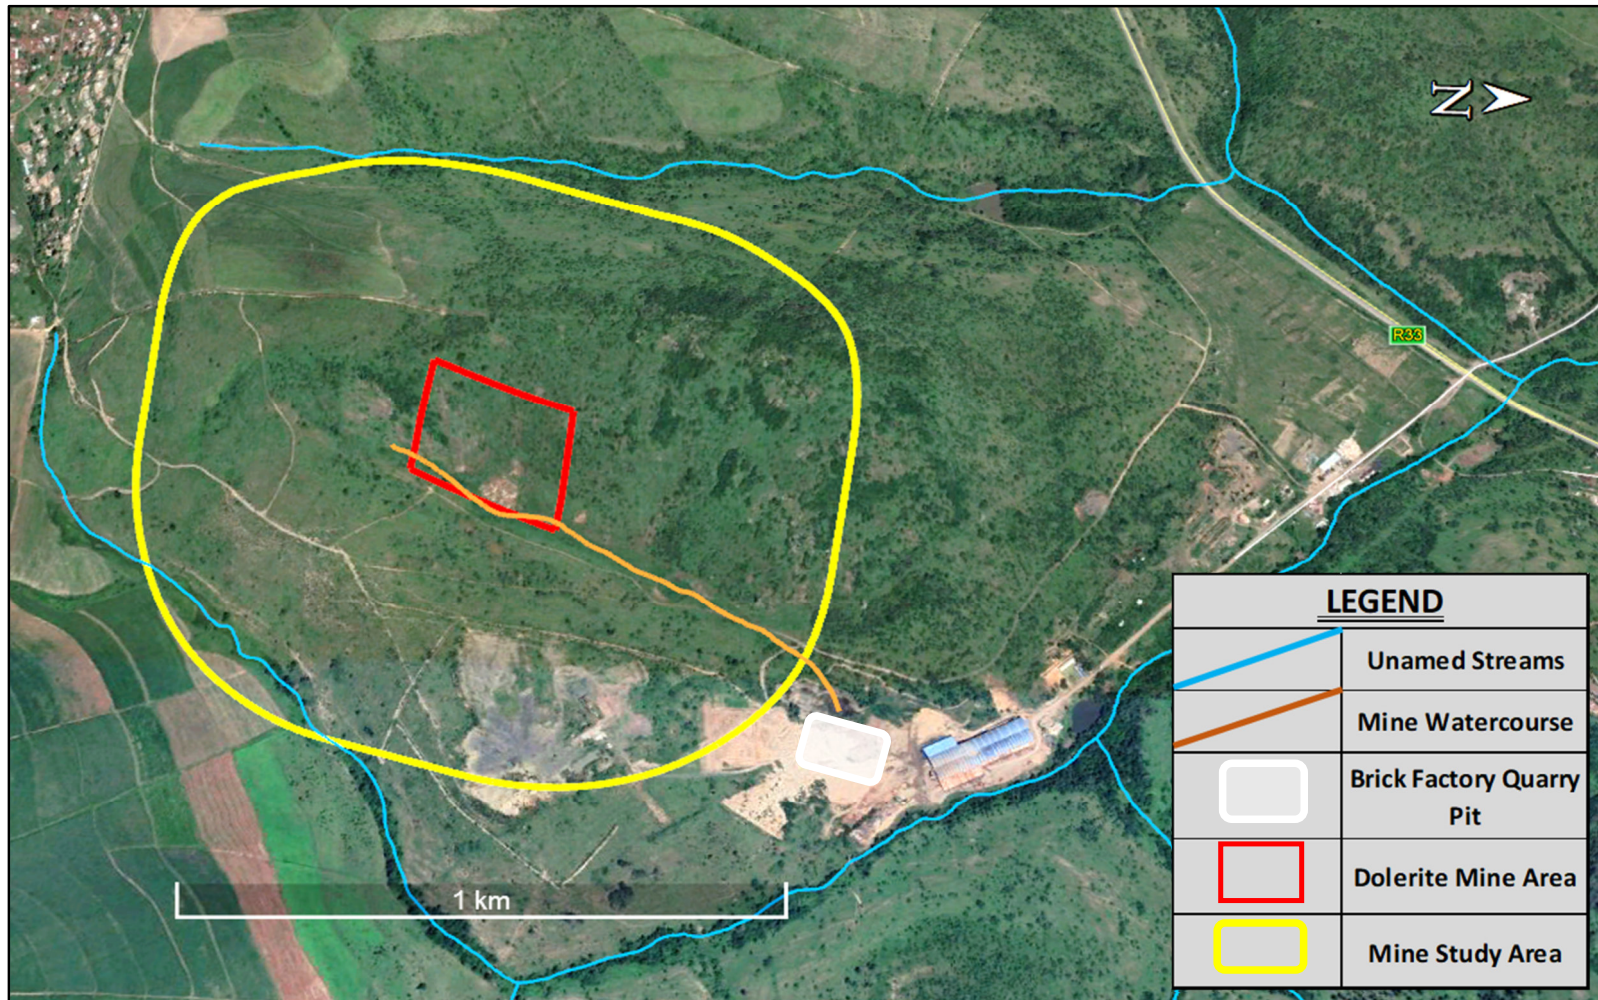
Figure 3: Watercourses in the vicinity of the dolerite mine

The results of the watercourse identification and mapping are shown in Figure 3. While Surveyor General mapping was used for most of the channels, and accorded with the Google Earth imagery, the alignment of the watercourse which originates near the mine area was problematic, as the detail of its lower reaches have been lost as a result of the development of a shale quarry. The changes started in the late 1900s as a part of a now-defunct brickworks and by 2006 the watercourse was being affected. An aerial image dated 2013 shows the shale quarry to be well developed. As the present brickworks was initiated in 2016 it is likely that it had no role in the earlier changes.

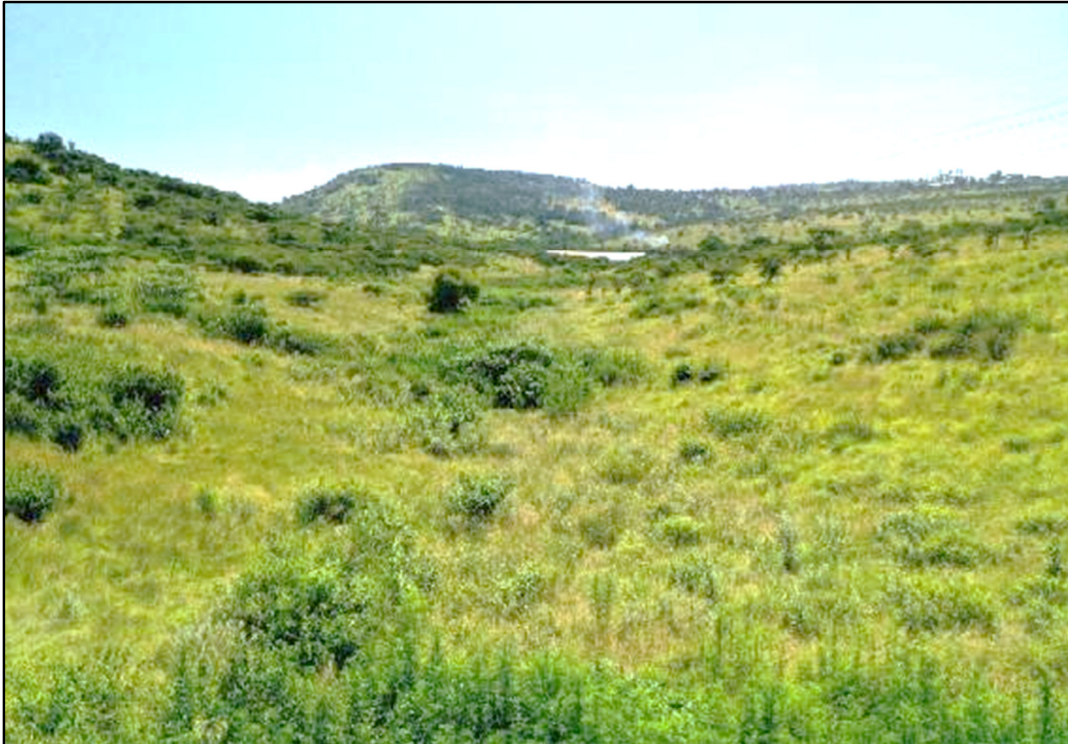
**Plate 1:** View downstream toward the brickworks along the mine watercourse valley

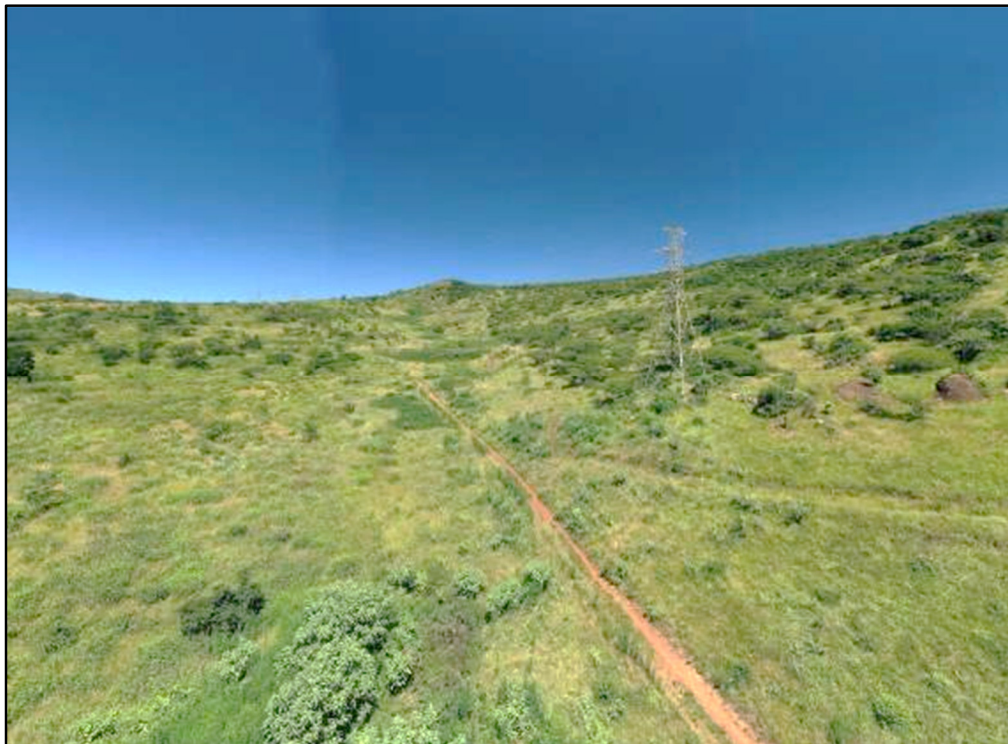
**Plate 2:** View upstream along the mine watercourse

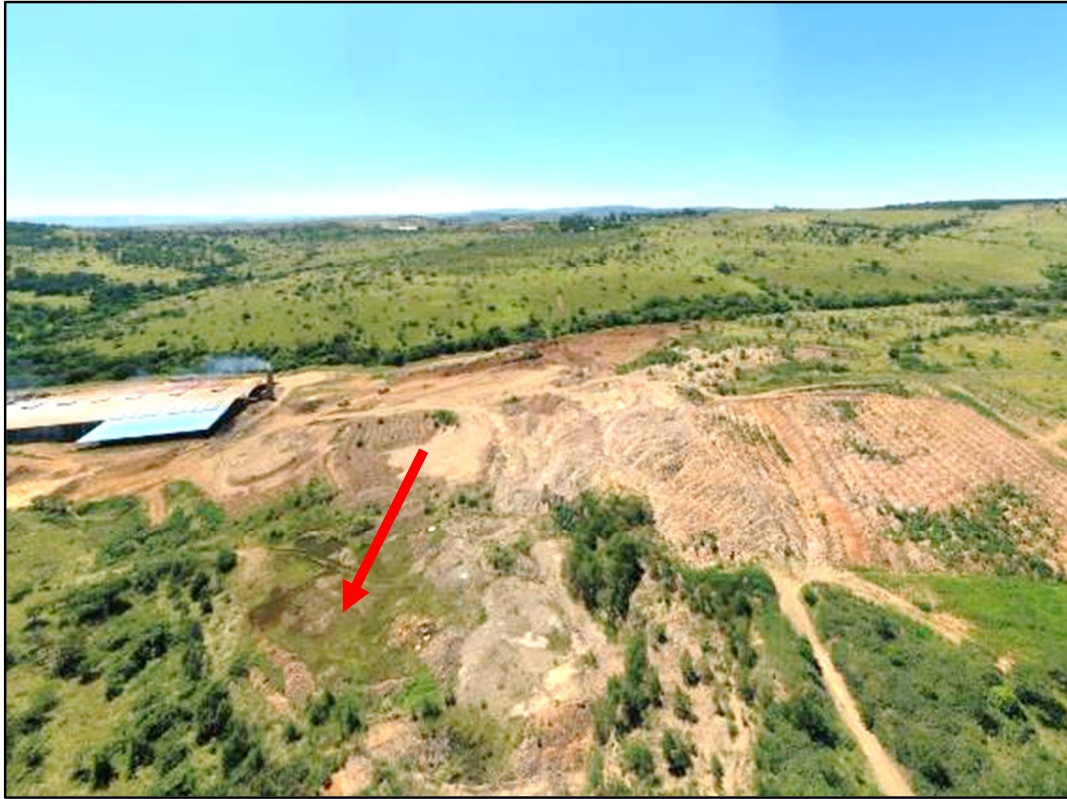
**Plate 3:** View over the brickworks quarry area showing the pit where the mine watercourse now ends

- The watercourse which proceeds from the mine site no longer discharges directly into the unnamed stream, which flows northwards to join the Umgeni River. The lower part of the channel has, for many years, been diverted as the result of development of a quarry which yields shale for brick making. The original lower course is now not distinguishable on the ground and, instead, the watercourse flows into a disused part of the shale quarry where any surface water could accumulate;

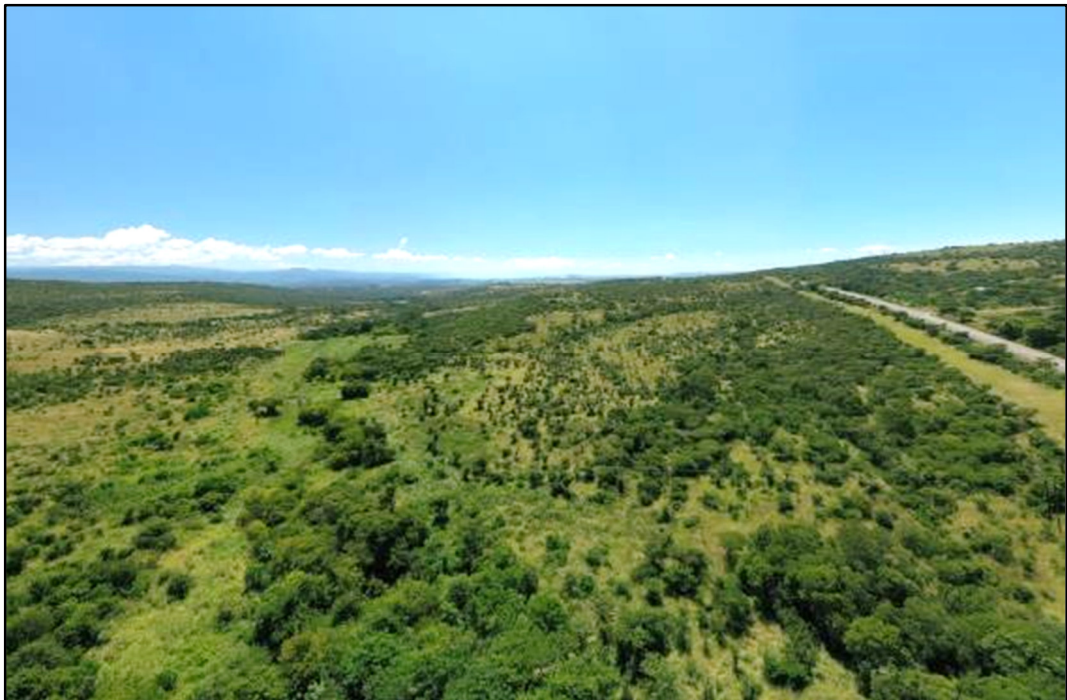
**Plate 4:** View of the unnamed watercourse downstream of Road R33

above. A short distance downstream from the brickworks site the stream channel appears to have been canalised at some time in the past. The reason for this and the time of it happening are both unknown. The stream is joined by numerous tributaries and so is a third order system by the time it reaches the larger river. Along its length it passes through six small farm dams which will be serving as sediment traps. The gradient is generally low and so much of the channel is very densely vegetated and wetland conditions appear in places, especially in the lower reaches. These too will also be capable of trapping suspended solids and assimilating dissolved nutrients or toxicants. A large right bank dam located some 3km from the Umgeni confluence receives runoff from an animal feedlot and was at one time severely eutrophic as a result. The outflow contaminated the lower stream at that time but it is believed to have been at least partially rectified now.

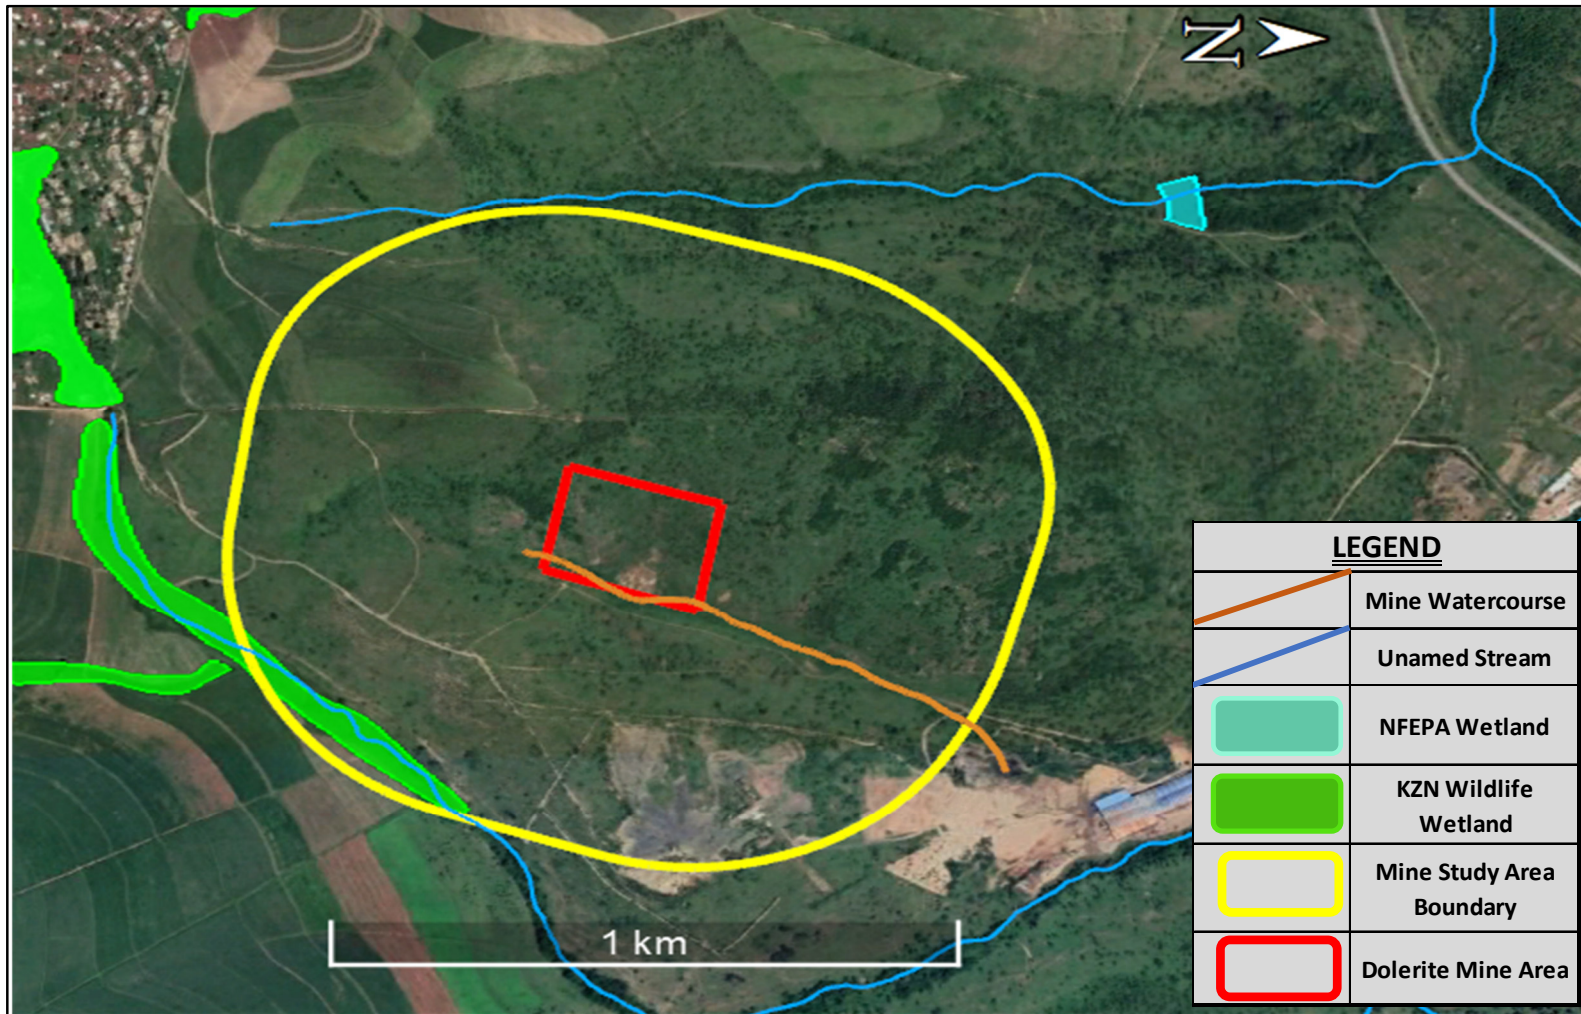
Figure 5: Wetlands located in the vicinity of the dolerite mine

Neither the desktop study nor the field survey revealed any wetlands within the 500 m wide surrounding strip whose presence was not already known. The wetlands in the vicinity of the mine are shown in the NFEPA and Ezemvelo KZN Wildlife wetland databases, as indicated in Figure 5. Only one such wetland exists and it is located along the unnamed stream to the east of the mine area. It is on the extreme edge of the 500 m wide strip mandated for wetlands under the National Water Act (Section 4 above) and is shown in further detail in Figure 6. In accordance with Ollis *et al* (2013) it is a Channelled Valley Bottom Wetland.

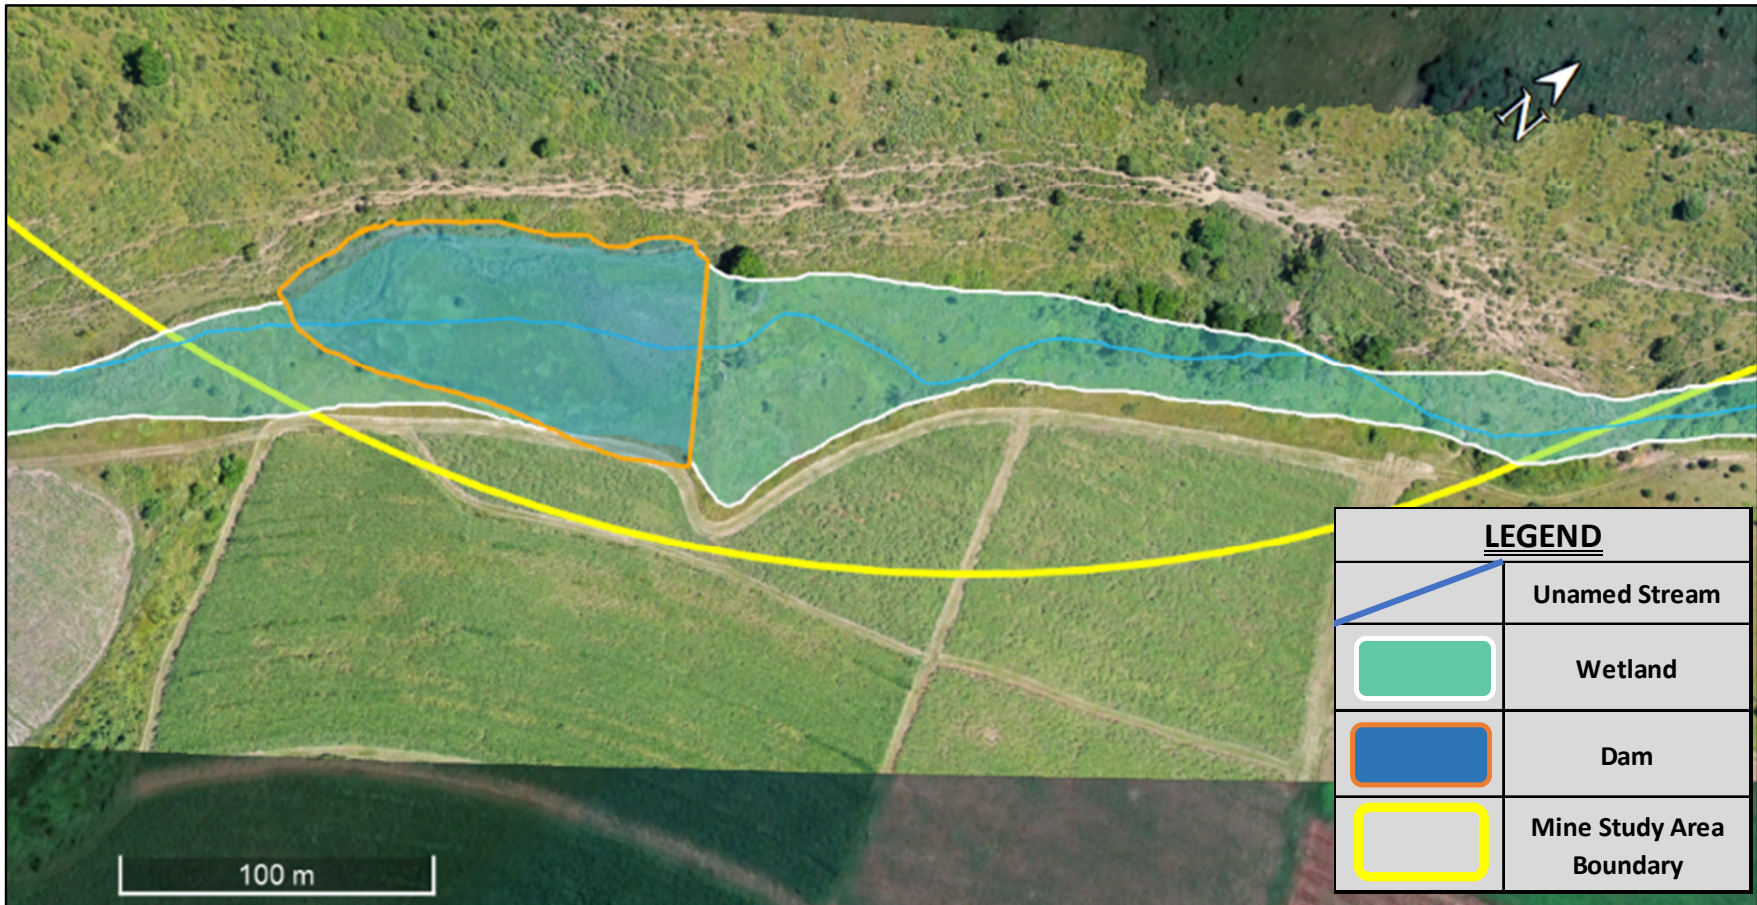
Figure 6: Portion of the wetland, including a dam, located within 500 m wide strip around the dolerite mine

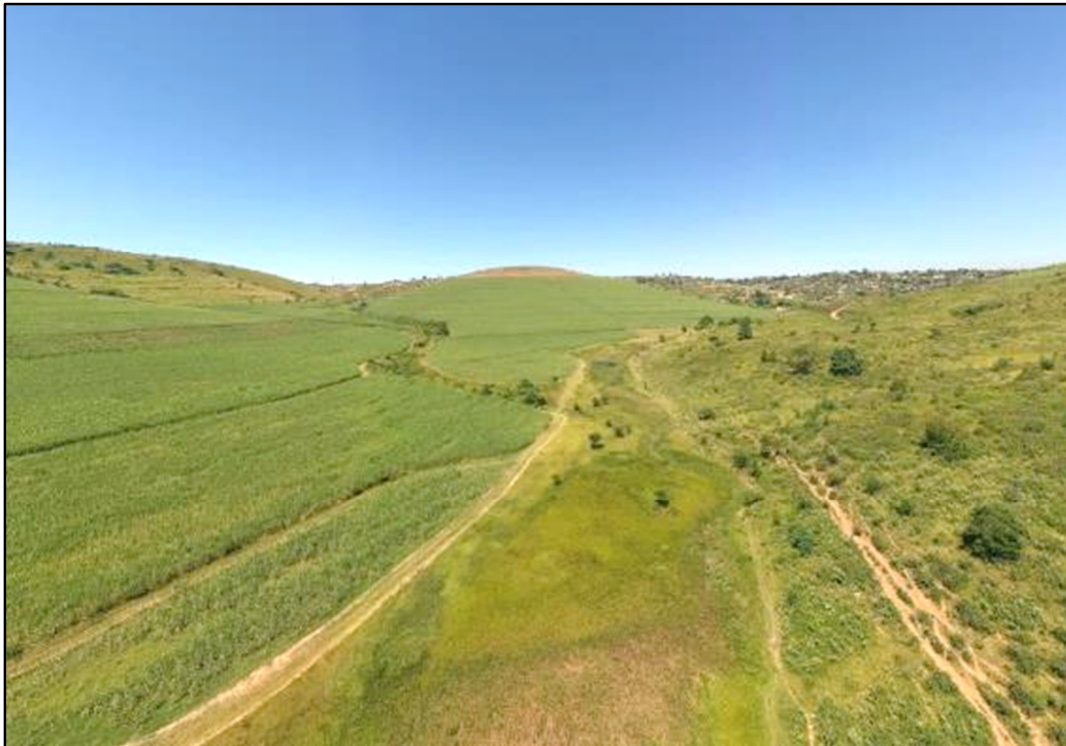
**Plate 5:** View upstream over the unnamed stream wetland with the dam basin in the Foreground

The outline of a small dam may be seen within it but it appears to have either been filled with sediment or to be leaking as no water was visible, and the basin area contained wetland vegetation. The condition of the wetland is indicated in Table 2 below. As with the assessment of the watercourse, the wetland was not actually delineated and modelled but the condition is based on observations made both in the course of the present and past studies, and on professional experience and opinion.

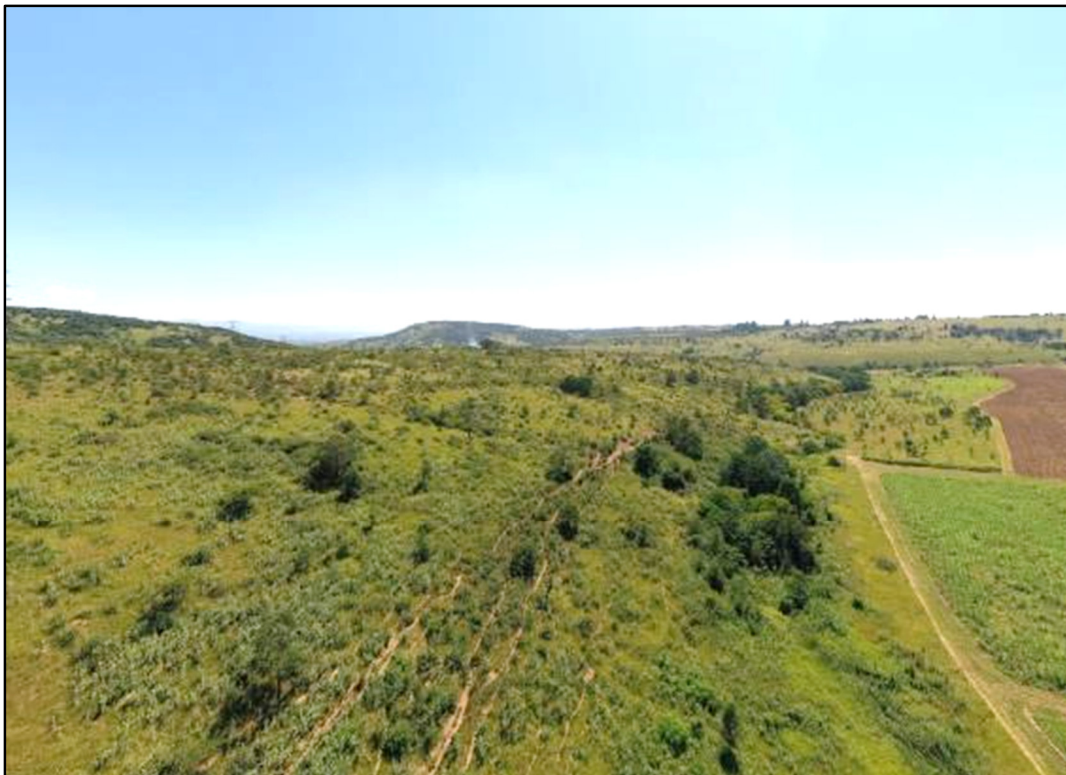
**Plate 6:** View downstream along the unnamed watercourse

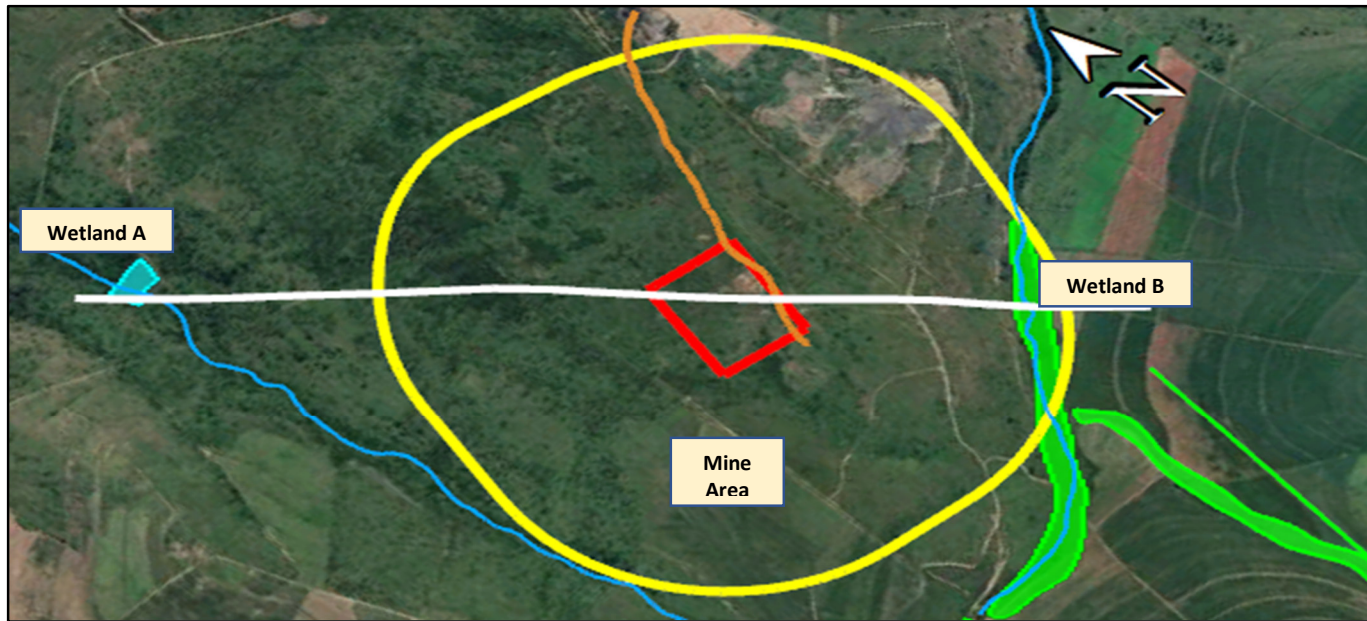
However, despite the wetland being partially within the 500 m wide strip around the mine site it is most unlikely that it will be affected by the mine as it is in a separate catchment area. Figure 7 shows the catchment divides between the mine area and the closest wetlands. It is apparent that the watercourse at the mine area lies in a sub catchment which is separate from the unnamed stream to the east. The two do eventually join but well downstream from the wetland area. Similarly, the two wetlands, which are actually dams, on the watercourse which flows to the west of the mine site, are on the opposite side of a ridge and so will not be affected.

Figure 7: Longitudinal profile through the mine area showing wetlands, watercourse, mine area, and catchment divides

- The channel of the watercourse which flows from the dolerite mine area is dry and contains no wetlands;
- There is only one wetland within 500 m of the mine site. It is a Channelled Valley Bottom system and is associated with the unnamed stream which flows in the vicinity of the project area. The shortest distance between this wetland and the mine site is approximately 460 m;
- The wetland is in a separate sub catchment and so is hydrologically isolated from the mine, as shown in Figure 7 above; and
