**GEOHYDROLOGICAL ASSESSMENT FOR
PROPOSED NAAZ QUARRY SITE,
PIETERMARITZBURG, KWAZULU-NATAL**

April 2021
Ref: 005532R01.2

SYNOPSIS
Specialist geohydrological site assessment of proposed Naaz Quarry site in support of the Water Use Licence Application

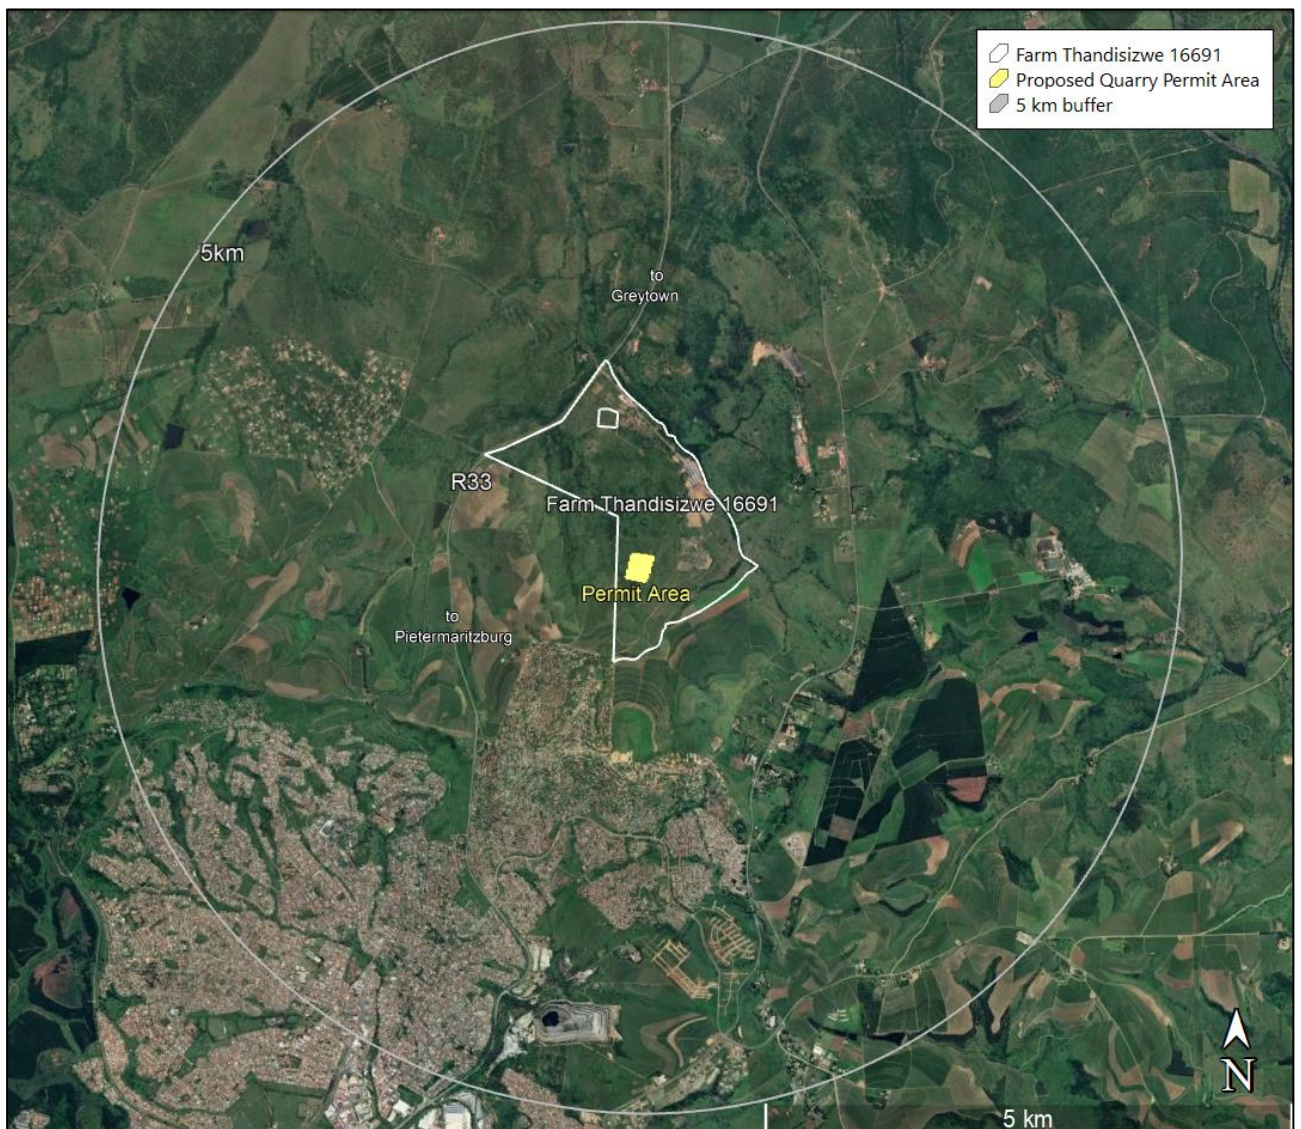
Figure 2: Project Area

Application for environmental authorisation to mine dolerite has been made for the permit area. The proposed mining method will make use of blasting in order to loosen the hard rock. The material will be loaded and hauled to the crushing plant where it will be screened to various sized stockpiles. The aggregate will be stockpiled until it is transported from site using tipper trucks. The mining related activities will be contained within the approved mining permit boundaries. The permit area is shown in Figure 2.
