GRANITE/SYNEITE MINE ON A PORTION OF PORTION 2 AND REMAINING EXTENT OF THE FARM AROAMS 57, AGGENEYS NORTHERN CAPE PROVINCE.

ENVIRONMENTAL PERFORMANCE ASSESSMENT REPORT

REFERENCE NUMBER	NC 30/5/1/3/2/10746 MP
AUDIT PERIOD	March 2026

ENVIRONMENTAL PERFORMANCE ASSESSMENT AROAMS QUARRY- LIME SALES

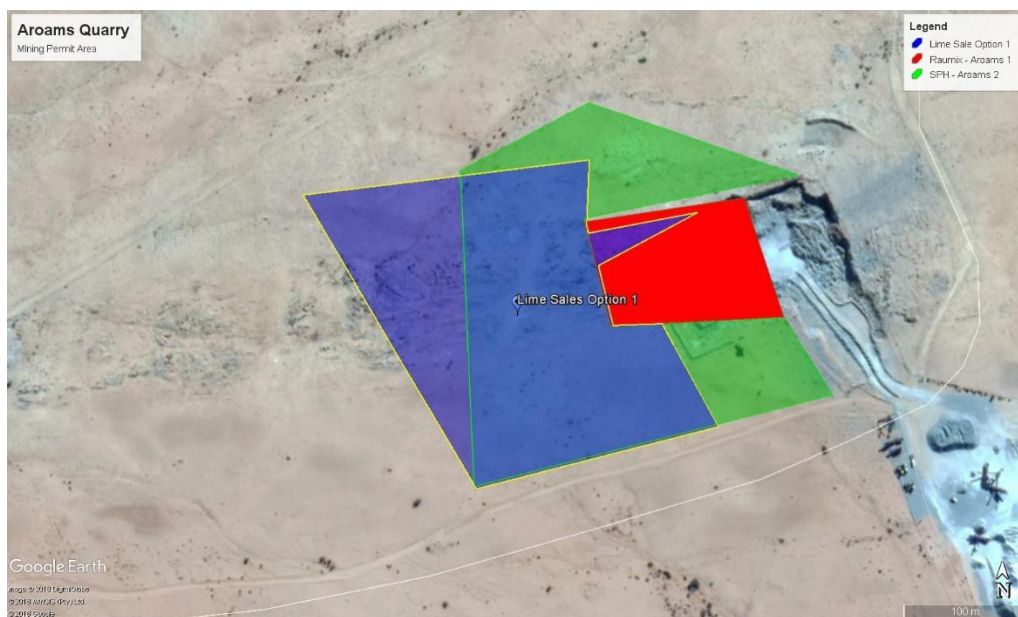
Figure 1: Location of the Lime Sales Mining Permit (No. 10746MP), indicated by the blue polygon, forming the basis of this audit. (Image source: Google Earth) The green area indicates the previous permit held by SPH Kundalila (SPHK), while the red areas represent the previous permit area held by Raumix. These areas remain unrehabilitated and not formally closed.

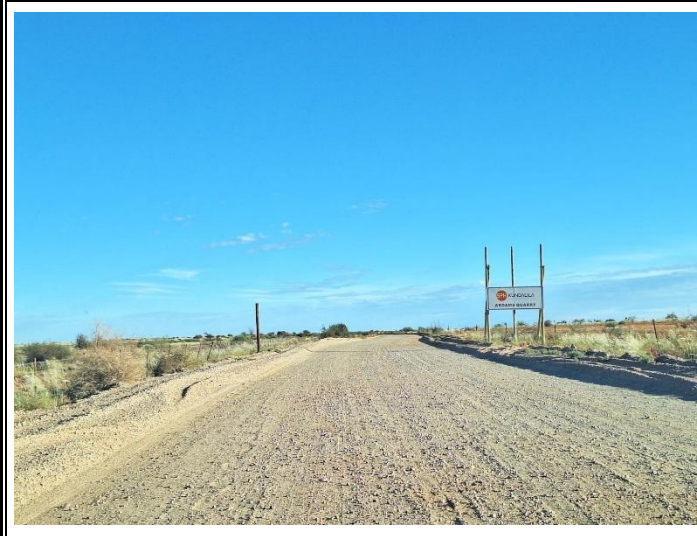
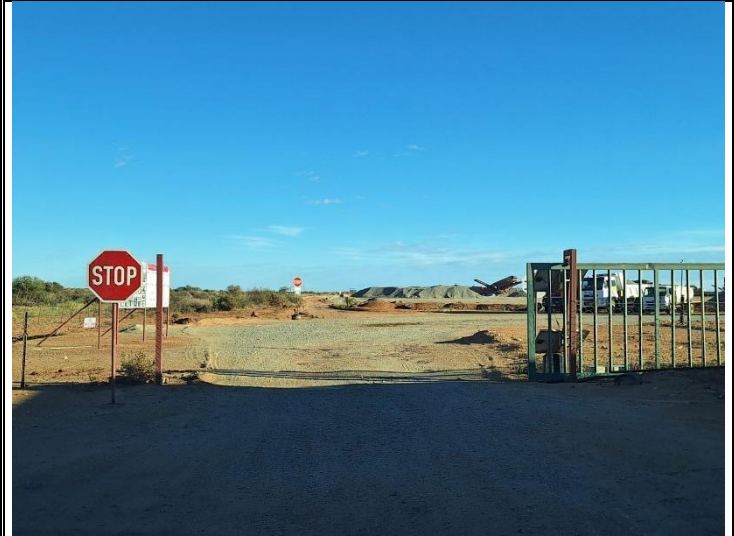
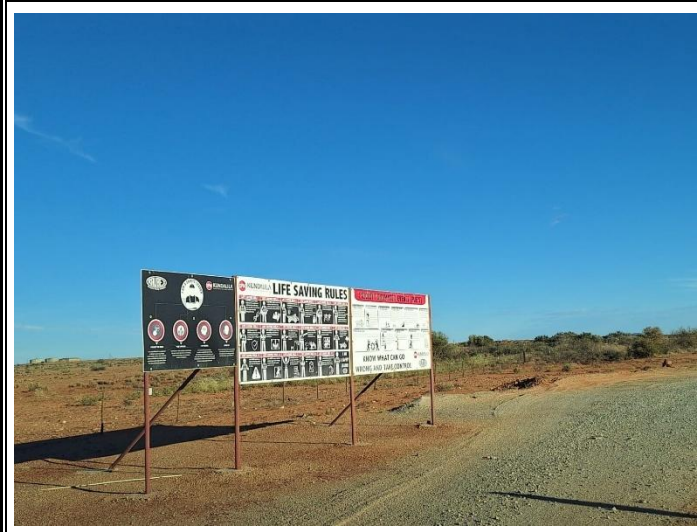
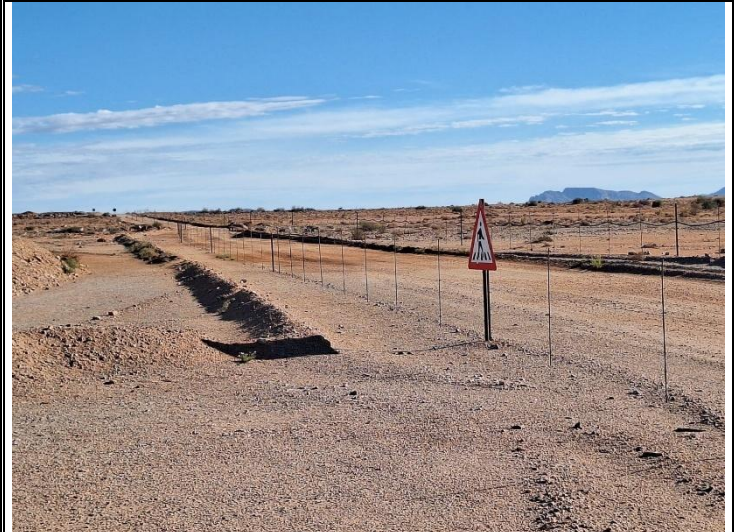
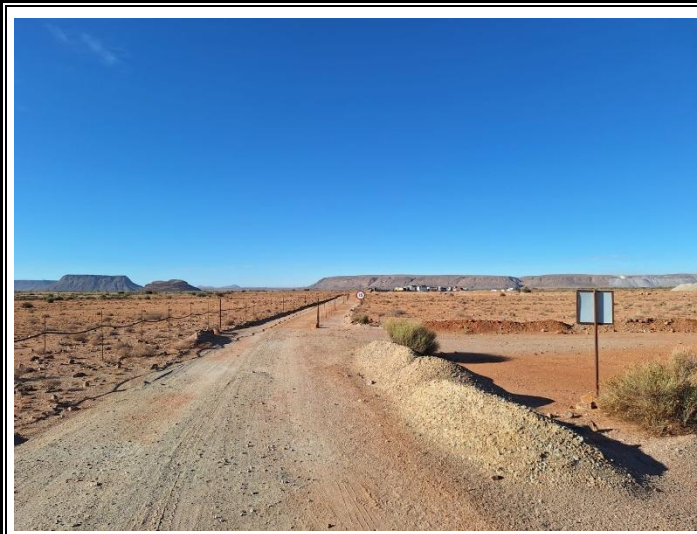
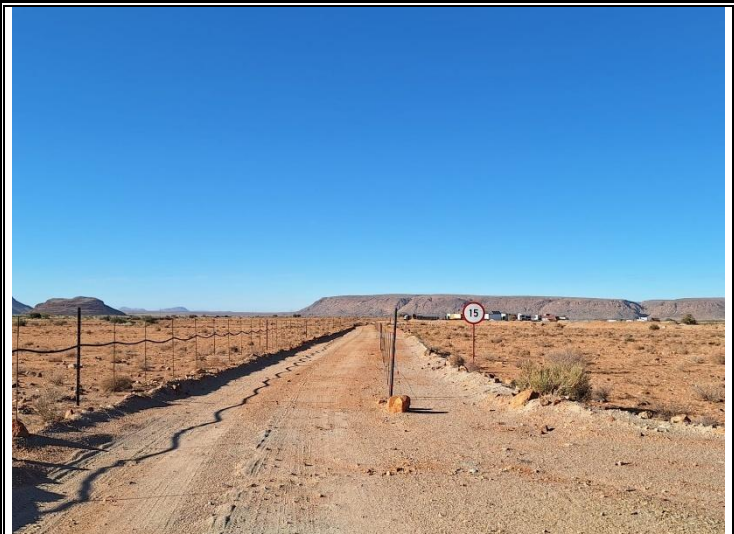
MINE ENTRANCE, ACCESS ROAD AND SIGNAGE BOARDS

The signage board that was blown over must be properly secured to withstand strong wind conditions.

- Clean oil spills noticed during inspection
- Drip trays were not observed beneath all stationary vehicles, indicating non-compliance with spill prevention protocols, and must be implemented urgently.
- A renewal application for the plant permit must be submitted.
- Water damming at the water point must be addressed and controlled.
- All signage boards must be adequately secured to prevent them from being dislodged by wind.

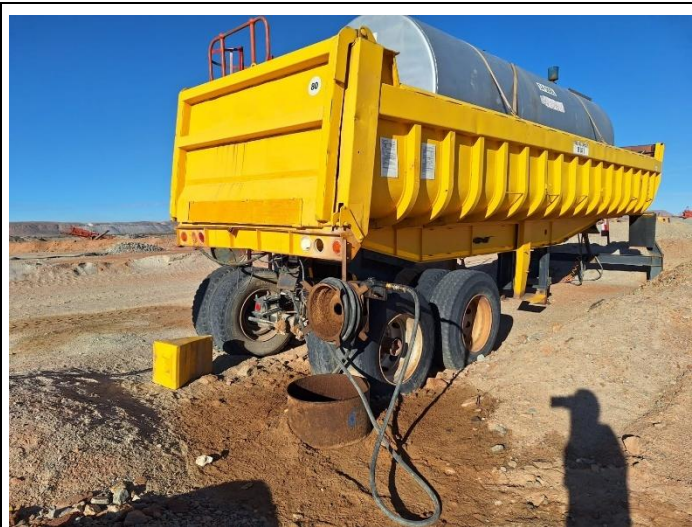
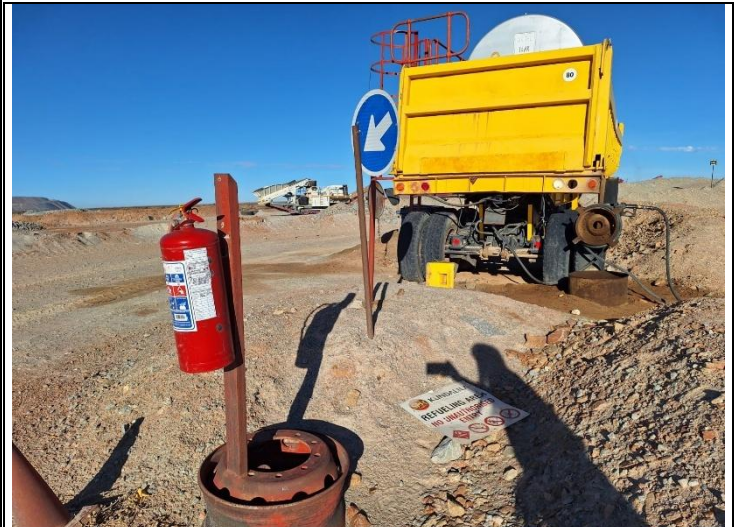
FORMALISED BUND AREA

The generators are equipped with formal bunding designed to contain 110% of the stored volume. Contaminated soil was observed on site, and immediate remediation was instructed. Drip trays were not observed beneath all stationary vehicles, indicating non-compliance with spill prevention protocols.

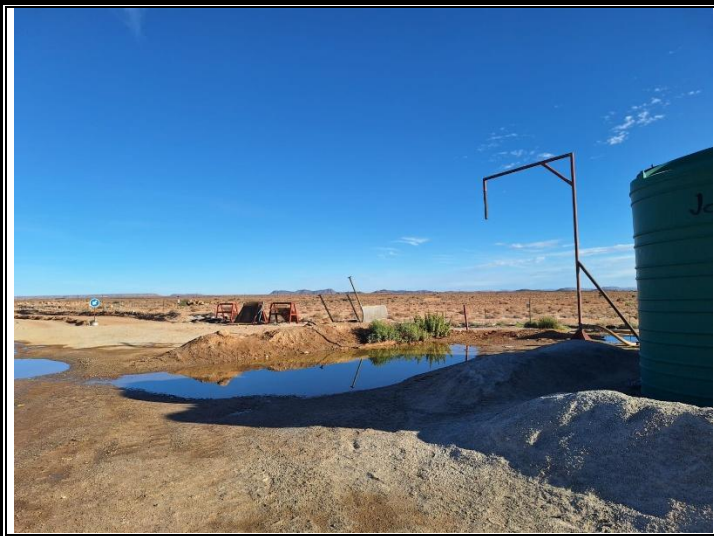
JOJO TANK AND WATER FILL STATION

The site was generally observed to be in good condition; however, attention is required regarding water damming at the water point. Drip trays must be placed beneath all parked and serviced vehicles, and all oil spills must be cleaned up as a matter of urgency.

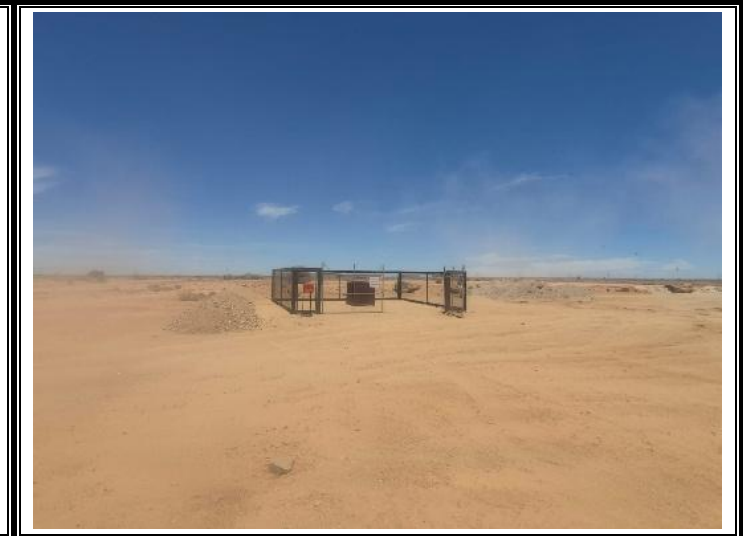
EXPLOSION DESTRUCTION BAY – WITHIN THE MINING PERMIT AREA

In accordance with instructions received from Law Enforcement, a designated explosives destruction bay has been constructed within an already cleared area inside the approved mining permit boundary. This structure complies with the Blasting Regulations and ensures the safe disposal of explosive-related waste in a controlled environment.

Empty explosive cardboard boxes and plastic bags must be thoroughly inspected and flattened to ensure they are free of explosives or related accessories prior to disposal. These materials may only be burned in the designated Burning Bay by the appointed Blaster. This process must be documented in writing, and records must be retained for a minimum period of three (3) years.
