GRANITE/SYNEITE MINE ON A PORTION OF PORTION 2 AND REMAINING EXTENT OF THE FARM AROAMS 57, AGGENEYS NORTHERN CAPE PROVINCE

ENVIRONMENTAL PERFORMANCE ASSESSMENT REPORT

REFERENCE NUMBER	NC 30/5/1/3/2/10746 MP
AUDIT PERIOD	MARCH 2023

ENVIRONMENTAL PERFORMANCE ASSESSMENT AROAMS QUARRY- LIME SALES

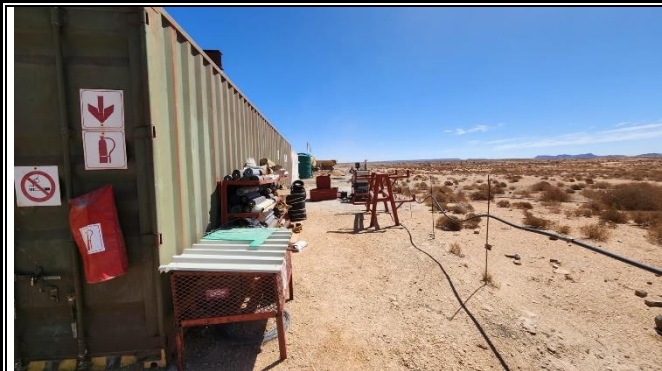
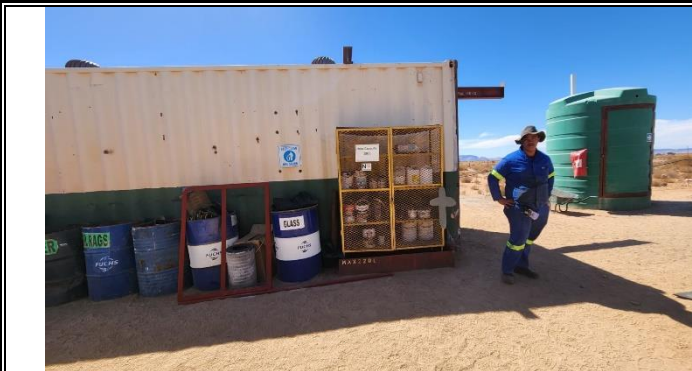
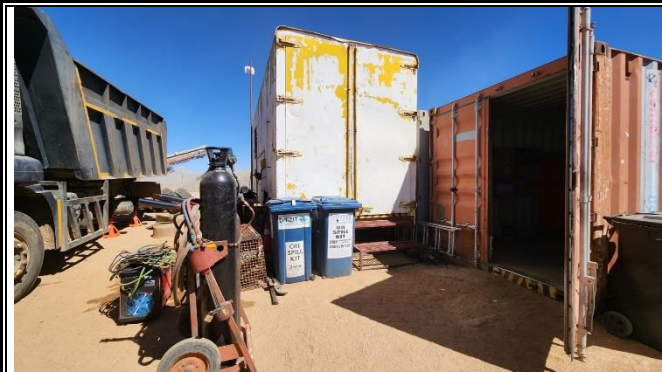
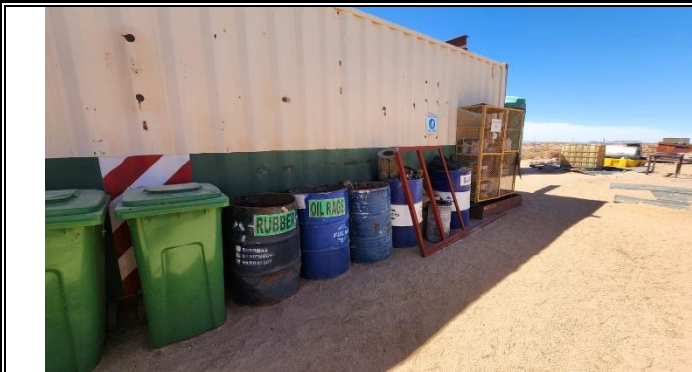
WORKSHOP AND STORAGE AREA

The site was in pristine condition at the time of inspection, the salvage yard is well kept, and all storage areas were neat.

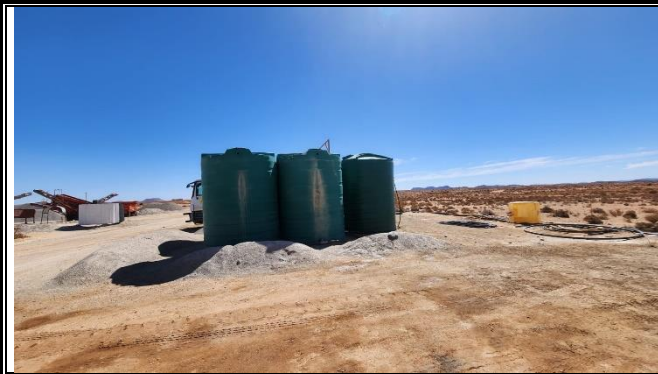
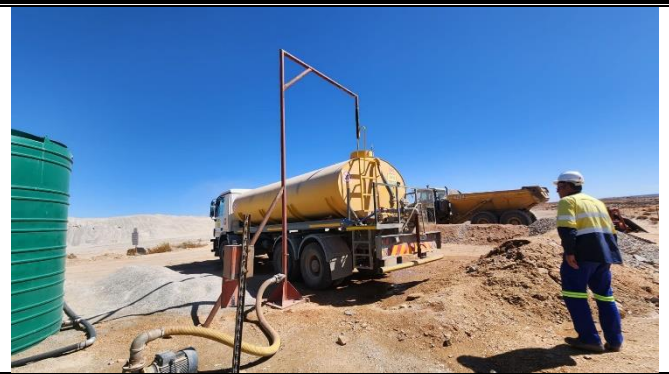
JOJO TANK AND WATER FILL STATION

National Water Act, 1998 (Act 36 of 1998)	5	-	Compliant	Water is obtained from the Municipal source, Sedibeng Municipality. Water is piped and stored in the 5 jojo tanks located at the workshop area.
Copy of Water Use Authorisation available on site.	N/A	-	-	Not applicable – Site makes use of Municipal Water
National Environmental Management: Biodiversity Act, 2004 (Act No 10 of 2004) (NEM:BA)	5	-	Compliant	Plant permit approved: Flora 0002/2021 No plants were visible at the time of inspection.
