**GRAHAMSTOWN BRICK (PTY) LTD T/A MAKANA BRICK**  
**PORTION 3 OF THE FARM ORCHARDS 233**  
**GRAHAMSTOWN, EASTERN CAPE PROVINCE**

**ENVIRONMENTAL PERFORMANCE ASSESSMENT**

<b>DMRE REFERENCE NUMBER:</b>	<b>EC 30/5/1/3/2/10397 MP</b>
<b>AUDIT PERIOD:</b>	<b>AUGUST 2019 – JULY 2021</b>

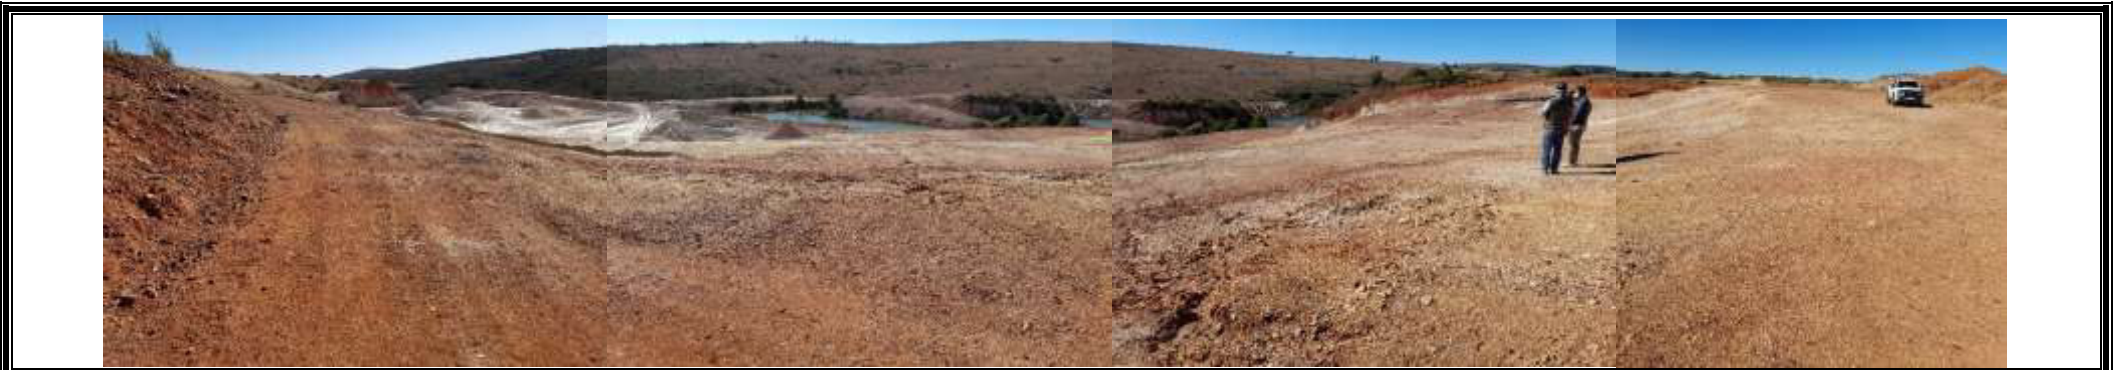
View of the Phase 1 mining area where the existing quarry (outside the mining footprint) can be seen at the back. Photo taken in north-western direction.

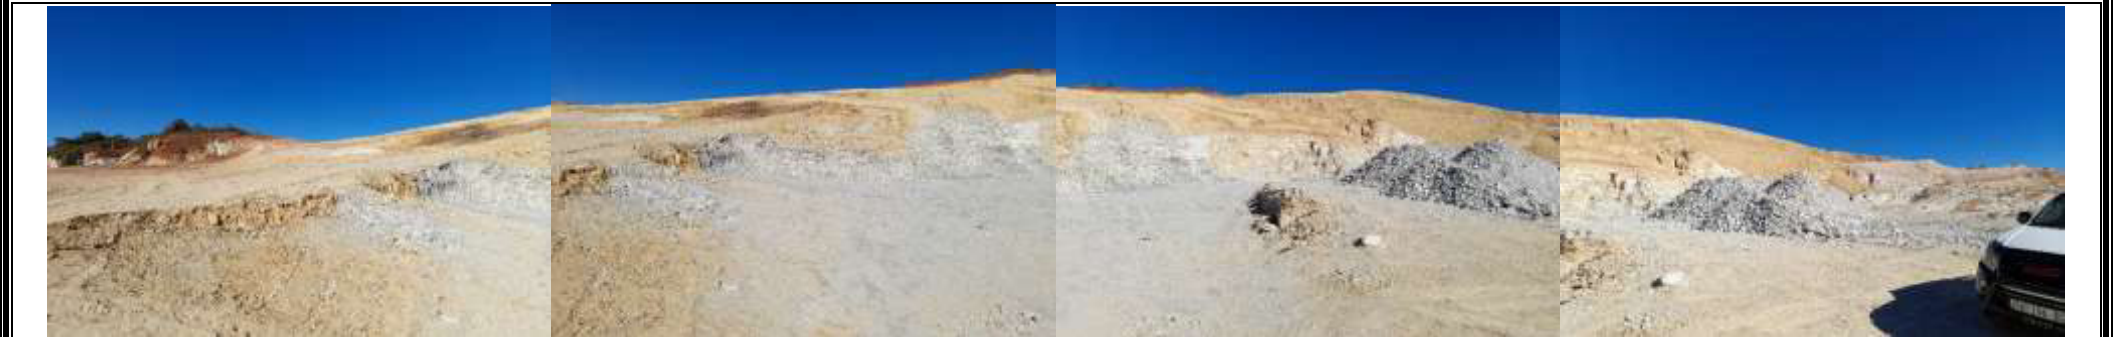
View of the Phase 1 mining area from the existing quarry (outside the mining footprint). The clay heaps in the front of the photo is not part of the MP Holder's operations. Photo taken in a south-eastern direction.

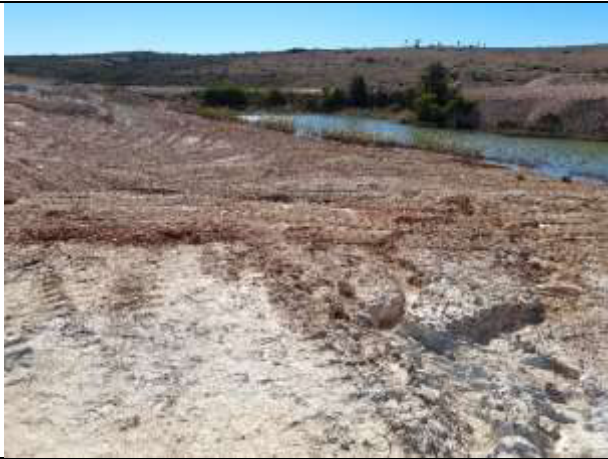
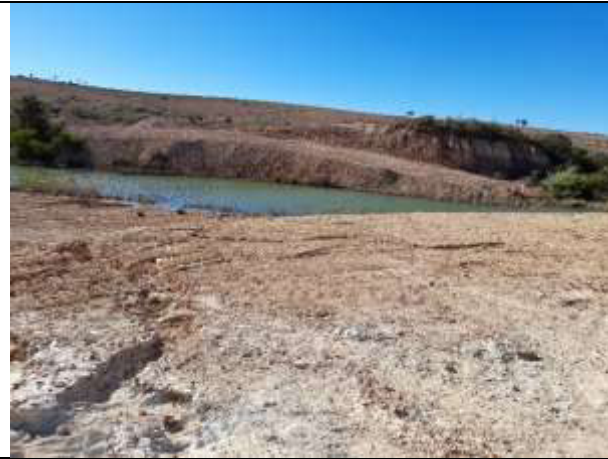
View of the nearby retention pond.

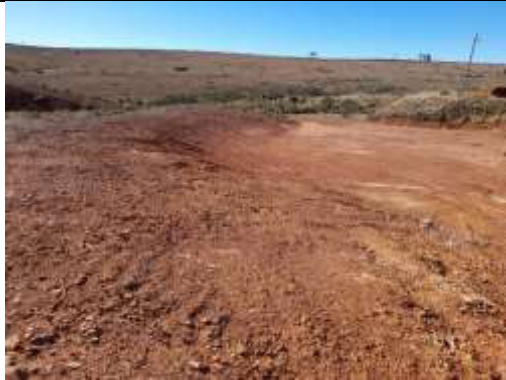
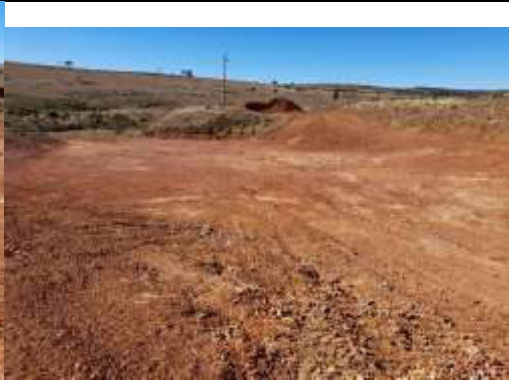
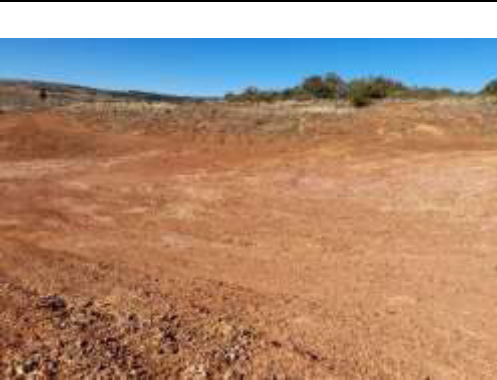
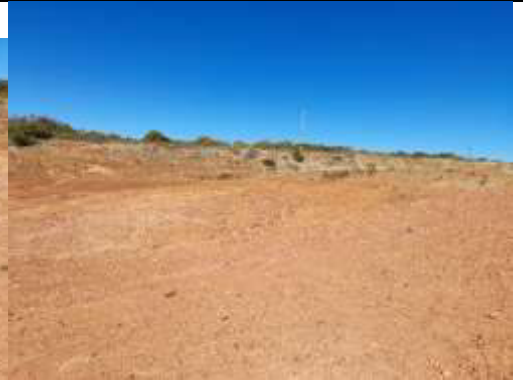
View of the Phase 2 mining area.

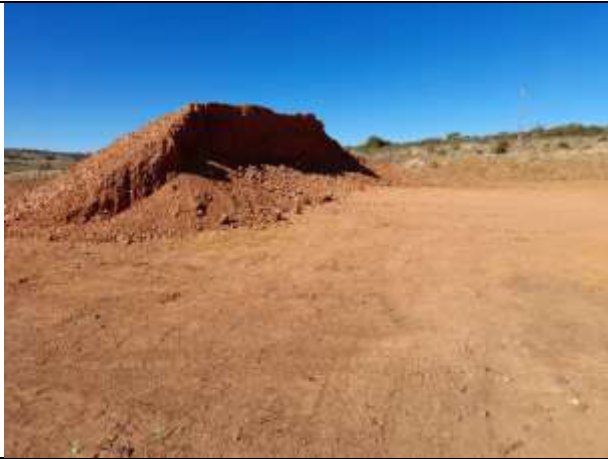
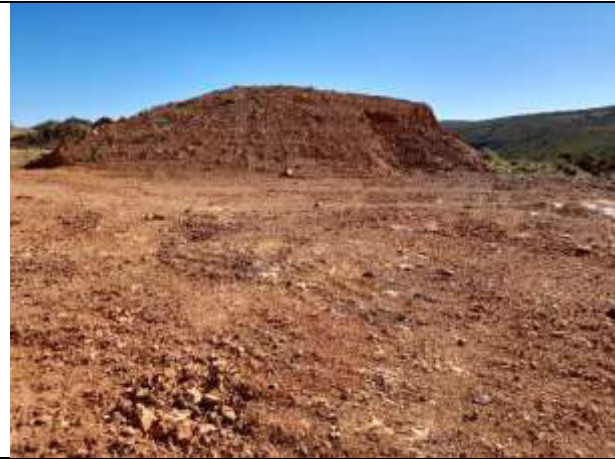
Overburden stripped	5	-	Compliant	-
Overburden storage	5	-	Compliant	-
Product stockpiles lower than 2 m	5	-	Compliant	At the time of the inspection, very little material was stockpiled, and the heaps were below 2 m.

Product stockpiles at the mining area.
