Riverine Ecology Assessment for the Proposed Pure Source Mine Project

Parys, Free State Province

February 2019

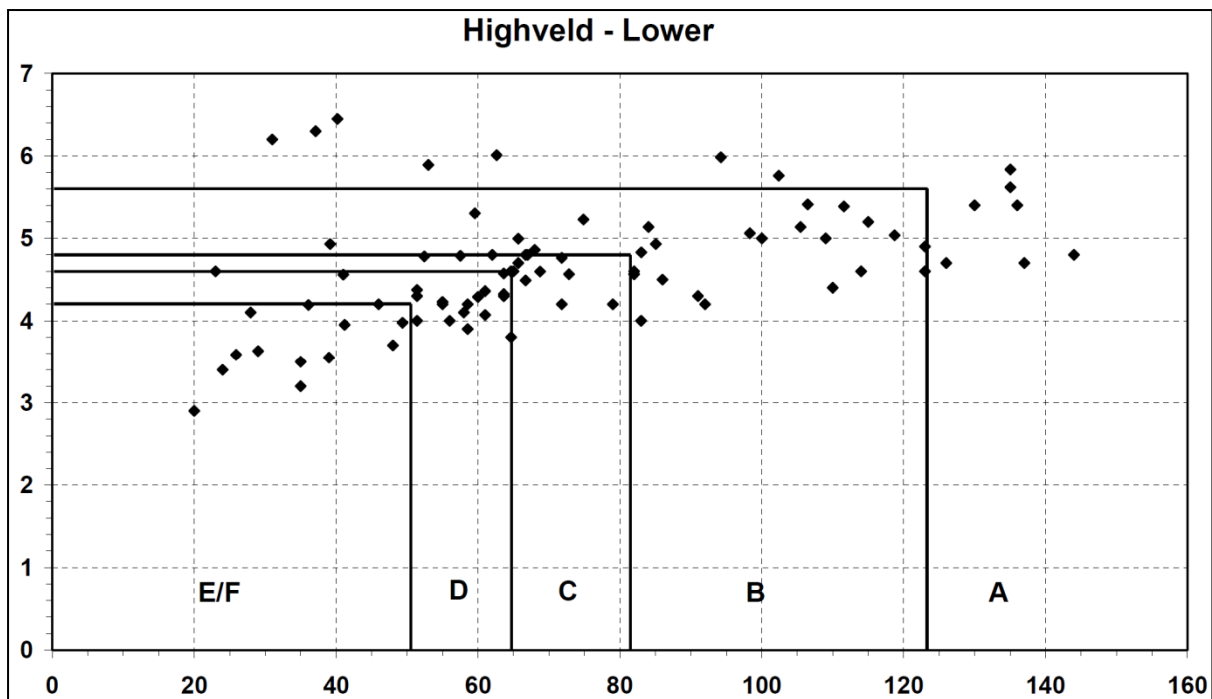
Figure 4-2: Biological Bands for the Highveld Lower Ecoregion (Dallas, 2007)

All SASS5 and ASPT scores are compared with the SASS5 Data Interpretation Guidelines (Dallas, 2007) for the North Eastern Coastal Belt - upper ecoregion (Figure 4-2). This method seeks to develop biological bands depicting the various ecological states and is derived from data contained within the Rivers Database and supplemented with other data not yet in the database.

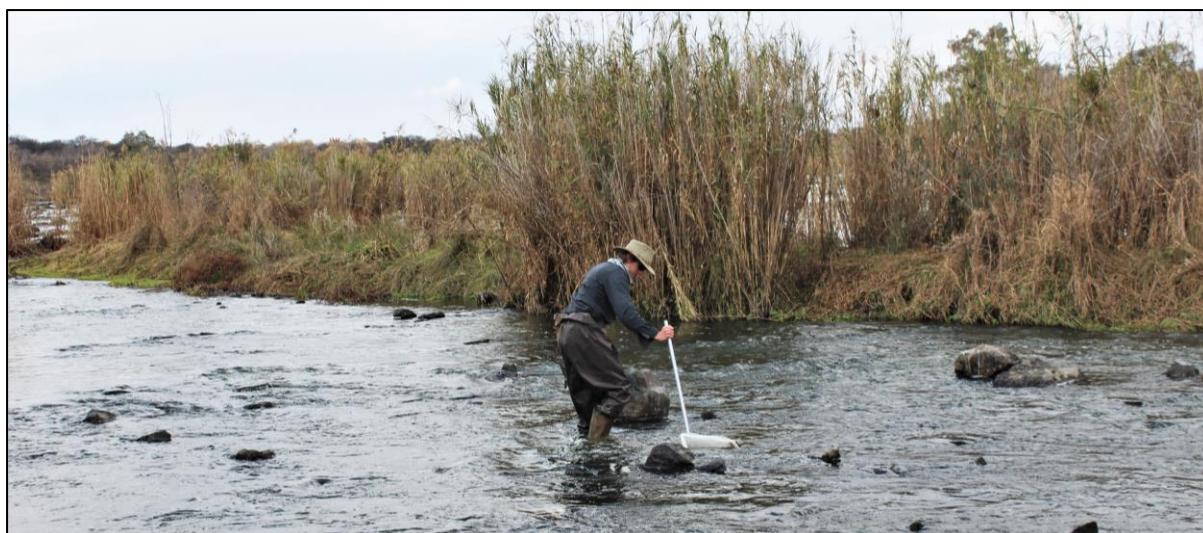
Figure 4-3: Standard kick and sweep invertebrate sampling in the Vaal River (July 2018)

The assessment of the watercourse was completed using standard invertebrate sampling methods which have been adapted to suit the nature of the considered watercourse. In the case of this study, the wide and deep nature of the Vaal River system has presented poor invertebrate biotopes. In order to compensate for this and provide a high level assessment of the current conditions, an adapted method which will provide an overall data set which can withstand robust statistical analysis was conducted in this study. This involved the selection of four sampling points which represented a single grouped site. Standard SASS5 sampling methods were completed at a total of four sites which represent the larger macro site.

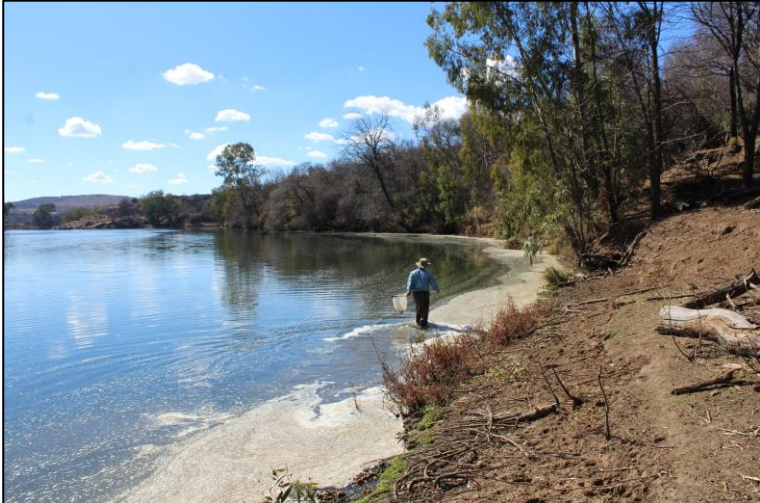
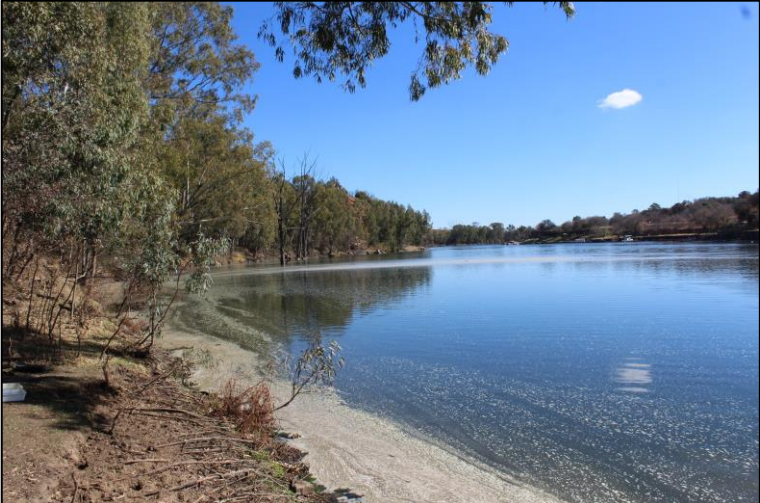
Downstream Site	Upstream	Downstream
Low Flow

A photograph showing an upstream view of a river at low flow. The water is calm and reflects the blue sky. A person in a blue shirt and hat stands on a sandy bank, looking towards the water. The background shows a line of trees under a clear blue sky with a few clouds.

A photograph showing a downstream view of a river at low flow. The water is calm and reflects the blue sky. A sandy bank is visible in the foreground, with some sparse vegetation. The background shows a line of trees under a clear blue sky with a few clouds.

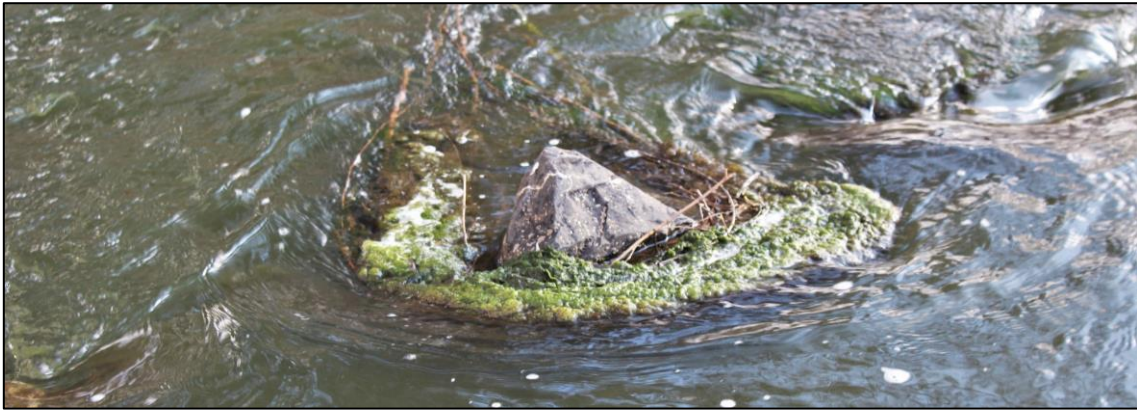
Figure 7-1: Algae observed in the Vaal River (Adjacent Site, July 2018)

Nutrient concentrations were determined to be at eutrophic levels, with nitrates observed above the 2.5 mg/l threshold (2.5-10 mg/l, DWAF, 1996). It is noted that the analysis did not include the nitrite and ammonia concentrations in the total interpretation and therefore it is anticipated that the level of eutrophication is likely greater. The incidence of eutrophication was confirmed through the direct observation of extensive algal mats covering rocks and foam during the survey (Figure 7-1 and Figure 7-2).

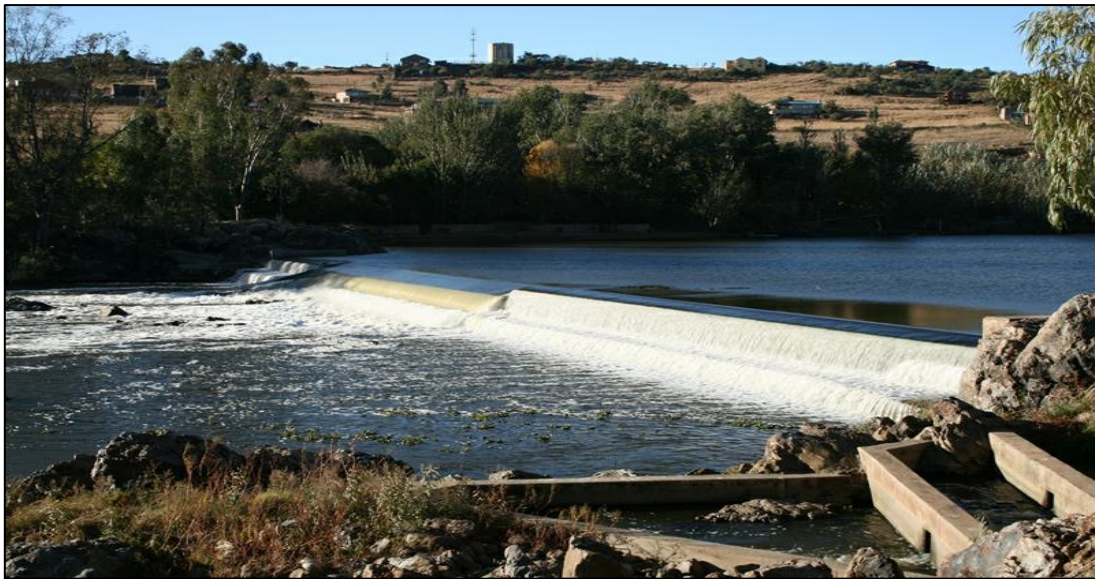
Figure 7-3: Goosebay gauging weir (Hydrospatial, 2019)

The results of the IHIA for the Vaal River reach considered in this study indicated largely modified instream and riparian habitat. The instream habitat of the Vaal River has been extensively modified through the development of instream barriers and water transfers which have ultimately resulted in the direct modification of the natural flows in the Vaal River system. Although the watercourse largely emulates natural hydrological patterns, artificial releases from the Vaal barrage have ultimately modified natural flow patterns and subsequently negatively effected the instream condition of the watercourse. As noted in the water quality component of this assessment, significant water quality impacts were observed during the survey, this has acted to cumulatively reduce the instream habitat condition of the river reach considered. The incidence of the Goosebay gauging weir has resulted in the inundation of aquatic habitats in the project area and has further altered natural instream habitats (Figure 7-3).

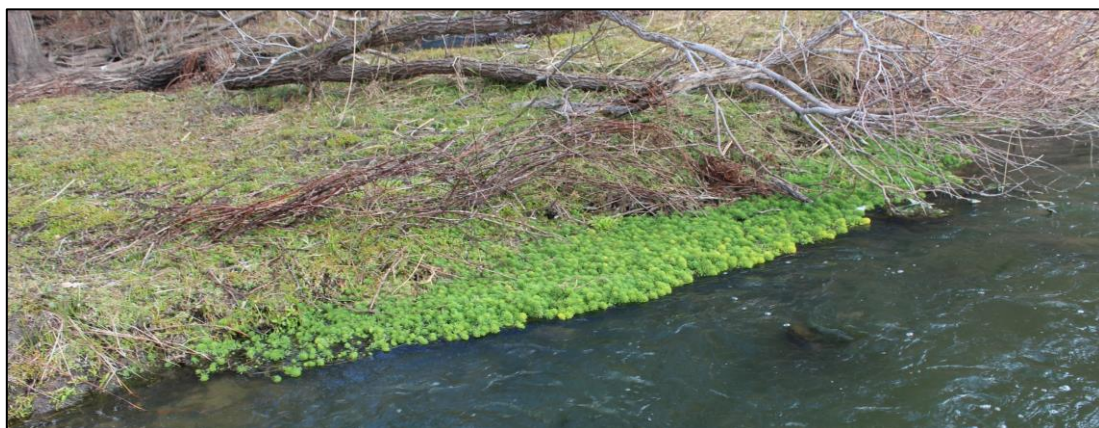
Figure 7-4: Marginal habitat modification and the presence of alien vegetation species Myriophyllum aquaticum (July 2018)

Riparian habitat was extensively modified through the presence of alien invasive species (Figure 7-3 and Figure 7-5) and this was compounded by the complete loss of riparian habitat within the Goosebay way inundation zone which has significantly altered riparian habitats (Figure 7-6).

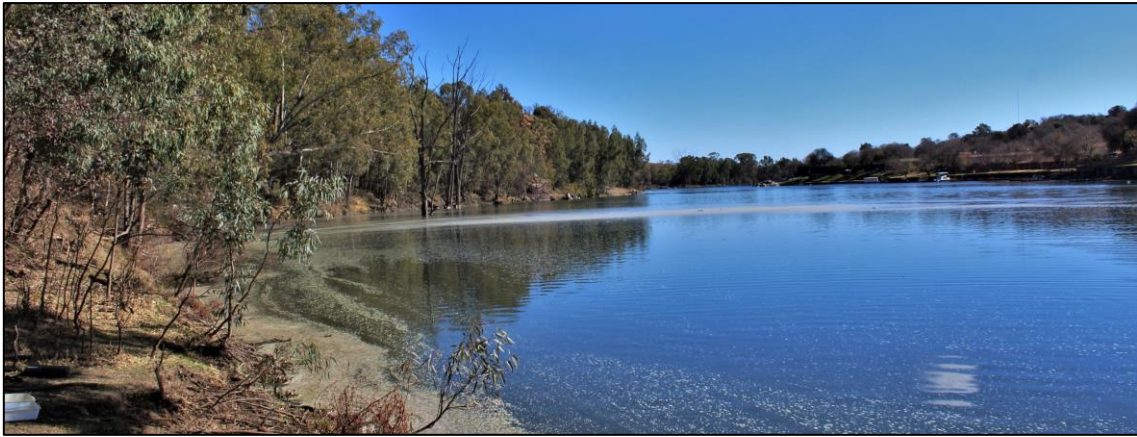
Figure 7-5: Riparian habitat modification showing extent of alien invasive plant species, *Eucalyptus globulus* (July 2018)

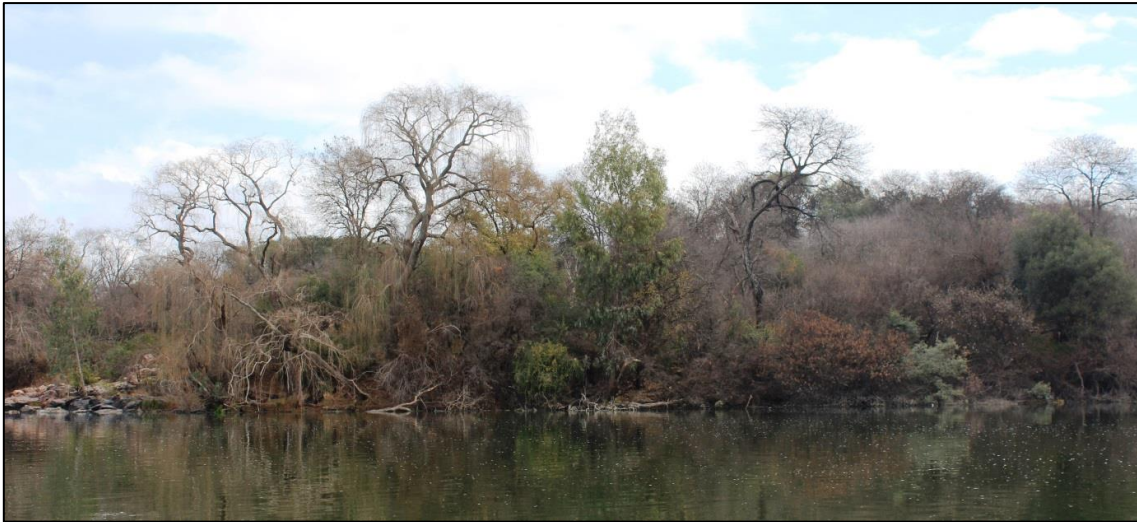
Figure 7-7: Typical Riparian Vegetation along the Vaal River within the Project Area (July 2018)

The riparian assessment was completed during the winter period with limited emergent vegetation available for the confirmation of the riparian area. The macro-channel of the Vaal River system was delineated via desktop data and confirmed in the field. The riparian zone of the Vaal River within the project area was confined to the macro-channel with the delineation provided in Figure 7-8. The marginal and lower riparian zones of the Vaal River are extensively populated with alien vegetation, including *Eucalyptus globulus* and *Salix babylonica* in the lower zone and *Eichhornia crassipes*, *Myriophyllum aquaticum* and *Nasturtium officinale* in the marginal and instream zone.

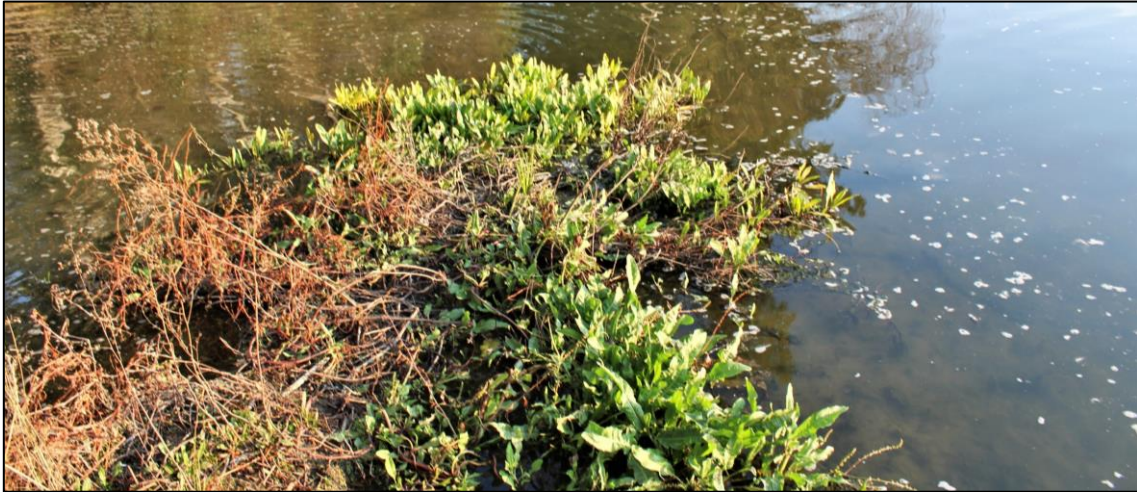
Figure 7-9: Typical vegetation biotopes in the Vaal River (July 2018)

Within the upstream and downstream sampling points, biotopes available were typically marginal and aquatic vegetation as depicted in Figure 7-9, and muddy substrates with an absence of fast/moderate flowing water and stone biotopes. Within the Adjacent Site, the invertebrate biotopes were well represented and would not be a limiting factor for aquatic biodiversity (Figure 7-10).

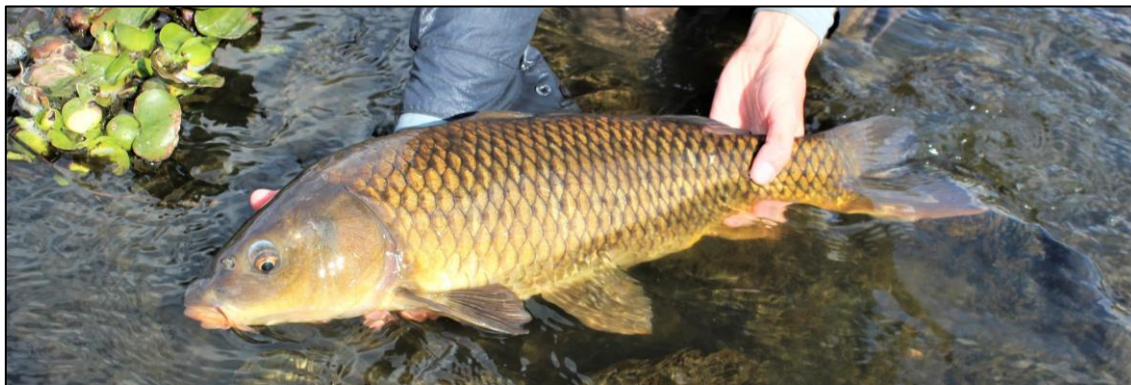
Figure 7-11: Alien taxa *Cyprinus carpio* observed in July 2018 throughout the project area

a single individual of a species. This was the case for *Enteromius anoplus*, *E. paludinosus*, *Labeobarbus aeneus*, *Labeo umbratus* and *Labeo capensis*, the conclusion drawn in this case is that toxic water quality had reduced the abundance and biomass within the fish community. The most abundant fish observed during the survey were *Cyprinus carpio* (Figure 7-11), a species known to be resistant to ammonia toxicity (USEPA, 2013).
