**NAMLI EXPLORATION AND MINING (PTY) LTD,
PORTION OF THE FARM STEINKOPF NO. 22, NAMA KHOI MUNICIPAL
AREA, NORTHERN CAPE PROVINCE**

ENVIRONMENTAL PERFORMANCE ASSESSMENT REPORT

DMPR REFERENCE NUMBER	NC 30/5/1/3/2/10950 MP
AUDIT PERIOD	September 2025-March 2026

Permit Number	NC 30/5/1/3/2/10950 MP	Date of Commencement	February 2023
Site name	Steinkopf Mine	Inspection Date	24 March 2026
Permit Holder	Namli Exploration and Mining (Pty) Ltd	Other Authorisations	N/A
Report Number	05

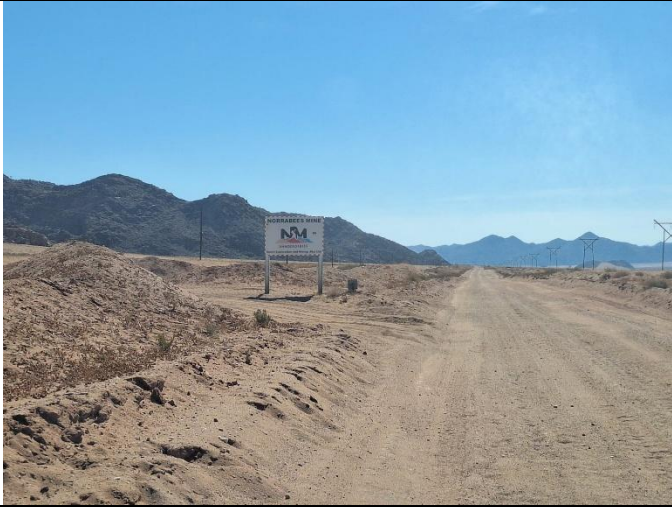
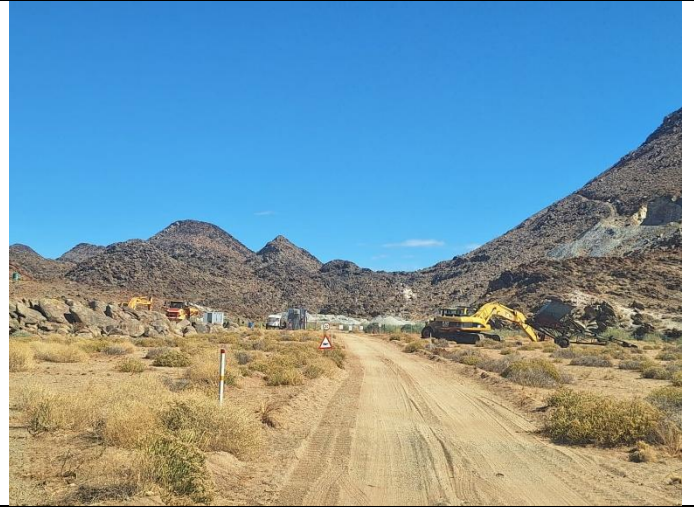
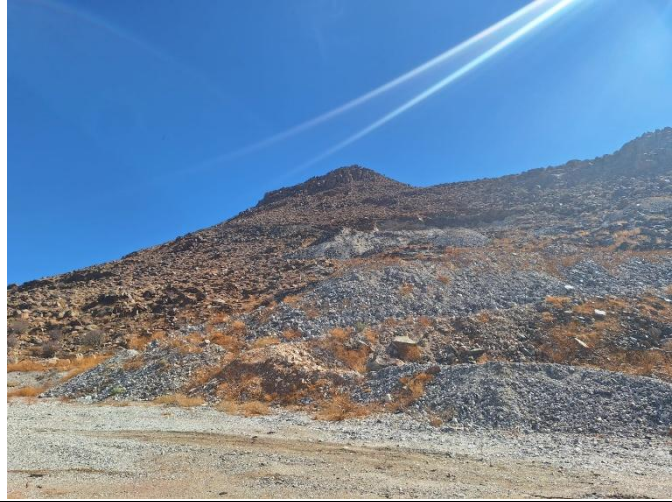
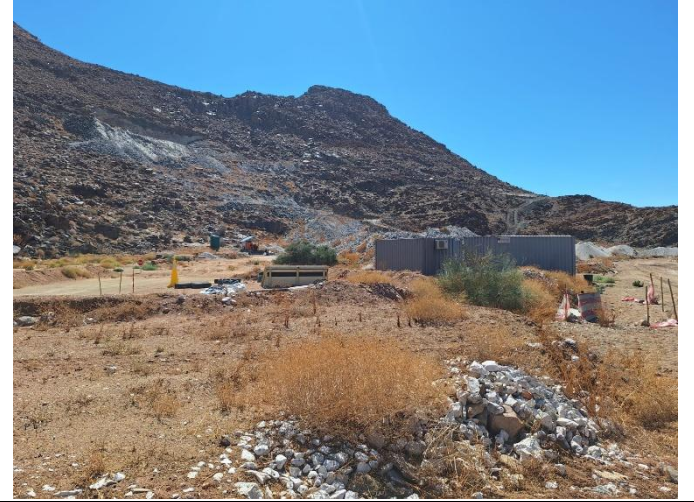
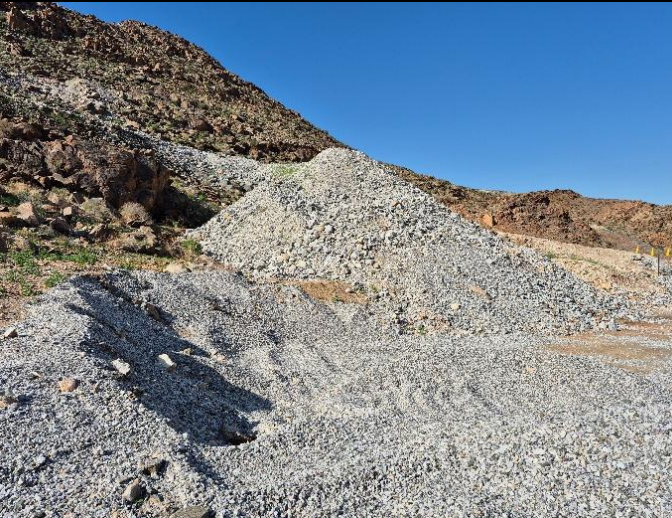
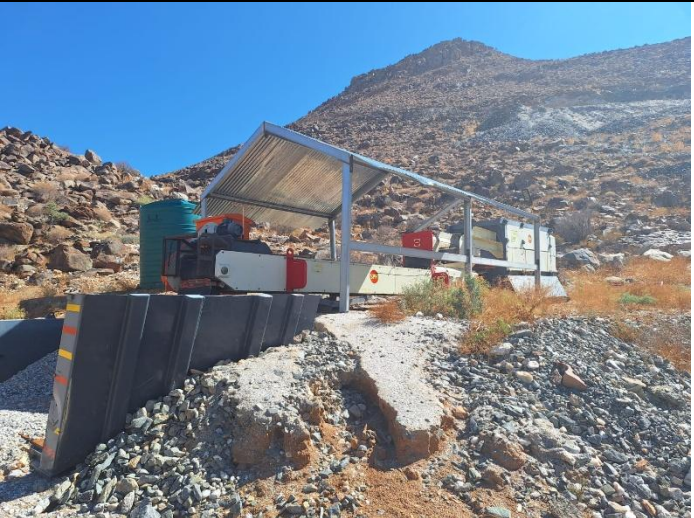
MINE AREA

As mentioned earlier, mining ceased temporarily in October 2024 to date. Security guards continue to protect the mining infrastructure, but all other employees left the mine. Mining has to date only entailed the reworking of previously stockpiled tailings, and no mining progressed into the excavations.

The area experienced heavy downpours during the audit period, which led to stormwater flowing through the stockpile area and damaging the security fence. The erosion that ensued must be addressed and the areas landscaped. The boundary fence must be repaired, and the stormwater management of the mine must be improved. It is especially important that clean runoff water be diverted around the chemicals/hydrocarbon storage and parking areas.

- Reinstate the erosion that occurred on site and improve stormwater control structures to prevent clean water flowing over dirty areas.
- Clean all hydrocarbon spills and dispose of the contaminated soil as hazardous waste. File proof.
- Equip all stationary machinery/vehicles and generators with drip trays that are constantly monitored.
- Repair the site fence.
- Place an oil spill kit on site and train employees in its application.
- Place signs on the general- and hazardous waste bins to prevent mixing of waste and fit all bins with lids.
- Implement the use of waste registers to proof safe disposal of all waste generated on site.
- Ensure the site has a Complaints Register and Incident Register that is always available.

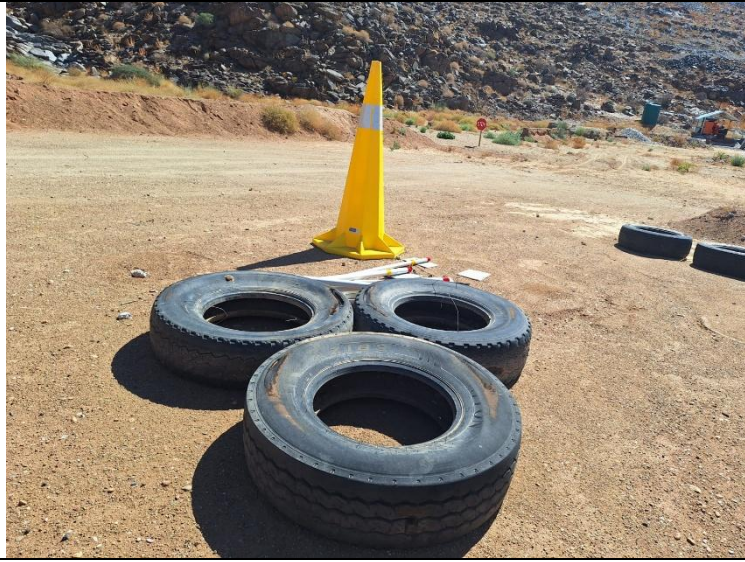
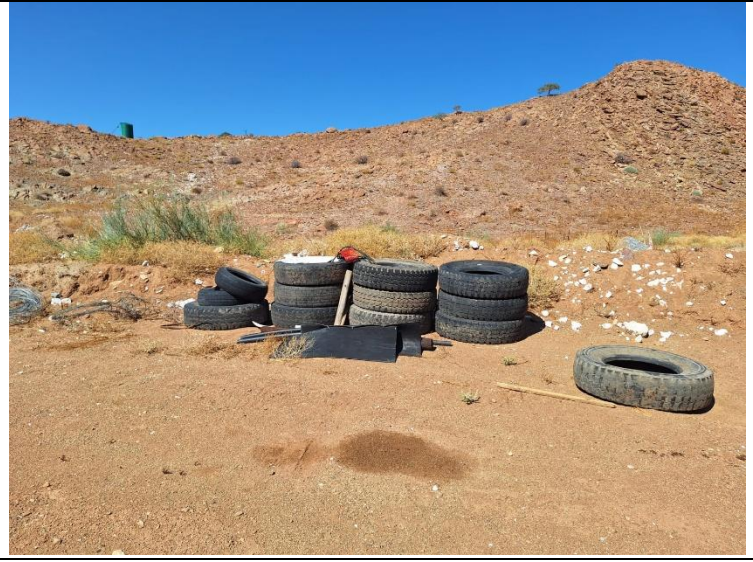
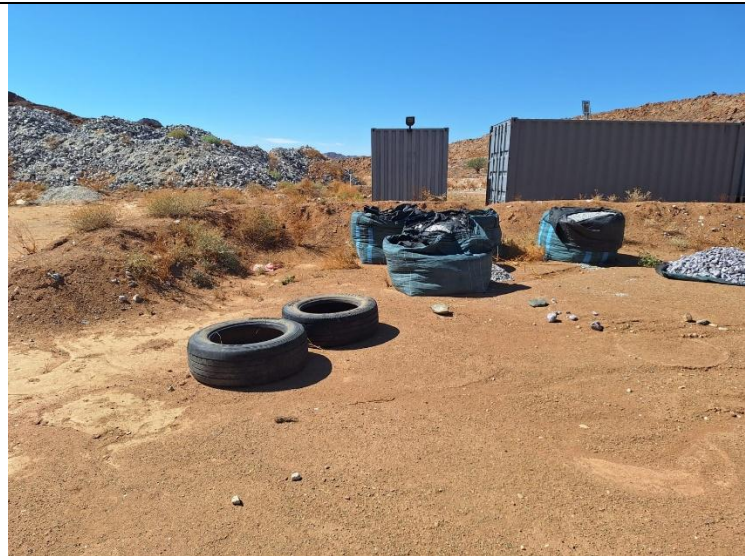
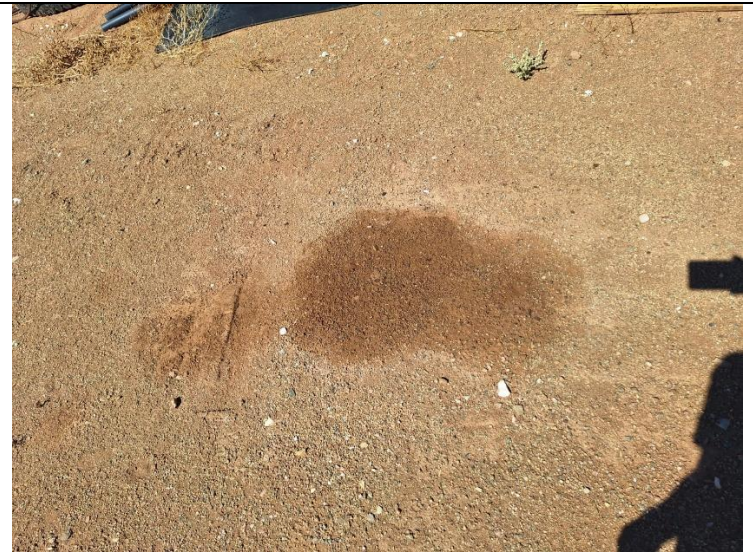
SPILLAGE AREAS AND POOR HOUSEKEEPING

DESCRIPTION	COMPLIANCE SCORE	NON-COMPLIANCE SCORE	STATUS	COMMENTS
EXISTING INFRASTRUCTURE (ACCESS ROAD MANAGEMENT EMPR PG 140)				
When applicable, divert storm water around the access road to prevent erosion.	3	3	Mining Inactive	Mining has been ceased since October 2024 to date, should mining recommence the stormwater control of the site needs to be improved.
Restrict vehicular movement to the existing access road to prevent crisscrossing of tracks through undisturbed areas.	5	-		
Repair rutting and erosion of the access road caused as a direct result of the mining activities.	5	-		
Prevent the overloading of the trucks and file proof of load weights for auditing by relevant officials.	5	-		
Restrict the speed of all mining equipment/vehicles to 40 km/h on the access roads.	5	-		
GENERAL (WASTE MANAGEMENT EMPR PG 140)				
Ensure regular vehicle maintenance, repairs and services only take place at the workshop and service area. Ensure drip trays are present if emergency repairs are needed on equipment not able to move to the workshop. Dispose all waste products in a closed container/bin to be removed from the emergency service area (same day) to the workshop to ensure proper disposal. Treat this as hazardous waste and dispose of it at a registered hazardous	5	-	Mining Inactive	Mining operations ceased in October 2024 and the site remains inactive (care and maintenance).However, oil spills were noted on site and should be cleaned.

All hydrocarbons and chemicals must be stored in bunded areas that comply with the specifications of the EMPR, and drip trays must be present under all stationary machinery/vehicles. The hydrocarbon spills must be cleaned, and the contaminated soil must be treated as hazardous waste. Site management must ensure that the generator/s are fitted

with drip trays and that the drip trays are monitored and regularly emptied. The mixing of general and hazardous waste may not be allowed, and the separate storage containers must be clearly marked.
