ENVIRONMENTAL PERFORMANCE ASSESSMENT REPORT STEINKOPF MINE

**NAMLI EXPLORATION AND MINING (PTY) LTD, PORTION OF THE FARM  
STEINKOPF NO. 22, NAMA KHOI MUNICIPAL AREA, NORTHERN CAPE  
PROVINCE.**

**ENVIRONMENTAL PERFORMANCE  
ASSESSMENT REPORT**

<b>REFERENCE NUMBER</b>	<b>NC30/5/1/3/2/10950MP</b>
<b>AUDIT PERIOD</b>	<b>30 June 2023</b>

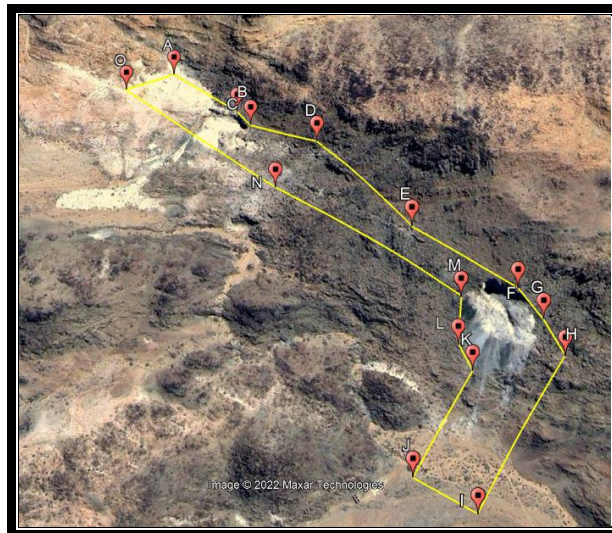
Site map:

(2) Operational phase that will entail the processing of the Norrabees 1 tailings first, upon which the mining of the in-situ hard rock will follow. The mining method will make use of blasting to loosen the hard rock; upon which the loosened material will be transported to an on-site processing plant.

The existing roads and tracks can be used to access the proposed mining area, and no new roads needs to be made.

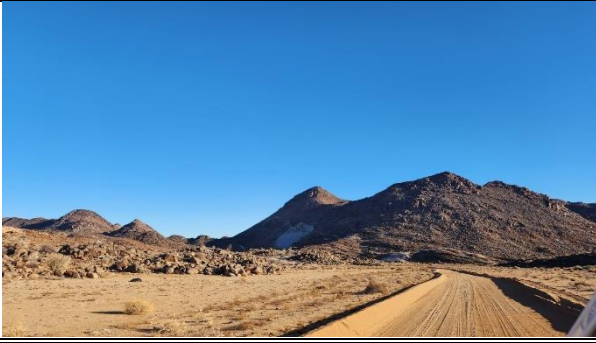
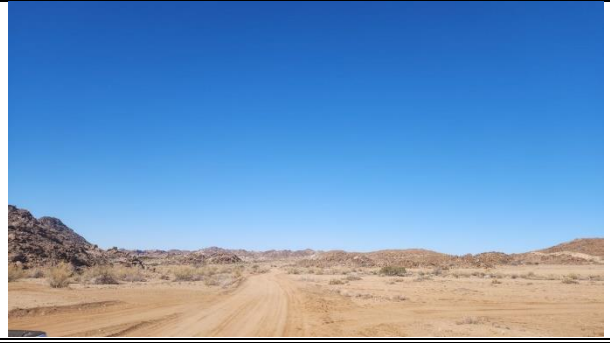
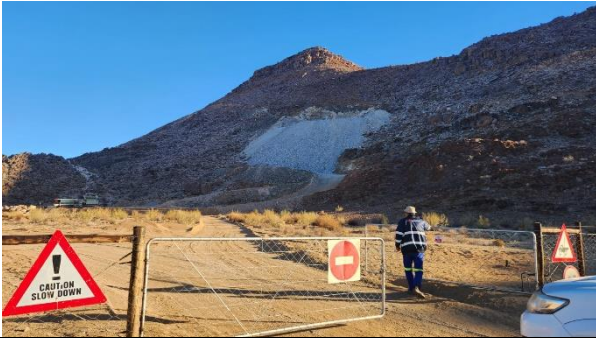
**MINE ENTRANCE, ACCESS ROAD AND SIGNAGE BOARDS**

A lockable entrance gate, guard with sign in register controls access and prevent unauthorised entry 24/7hrs per day. At the time of the inspection the overall condition of the site was neat and well managed, the signage boards were erected.

Regularly maintained

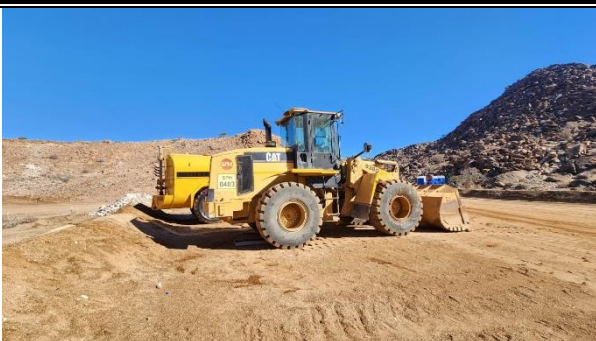
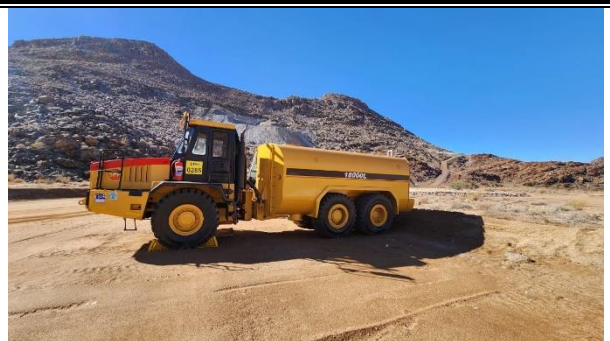
**MACHINERY PARKING AREA WITH DRIP TRAYS**

The fuel tanks are fitted with formal bunds with a 110% capacity. No contaminated soil was seen on site. Drip was placed under diesel bowzer and visible under all stationary vehicles.

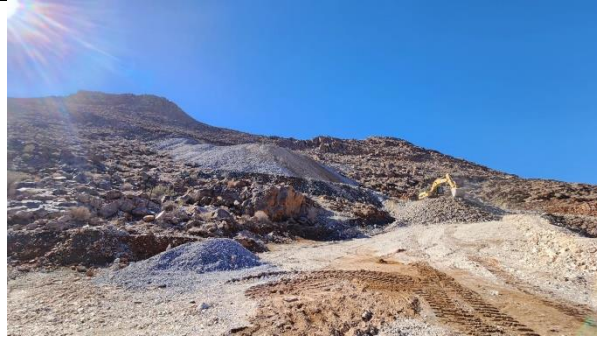
**CURRENT MINE AREA – REMOVING WASTE PRODUCT (PERIOD OF 6+ MONTHS)**

Both Norrabees 1 and 2 have extensive excavations that were historically mined. Current activities include removal of existing tailings at Norrabees 1. The operation is estimated for a 6-month period, after which blasting and extraction of in-situ material from the mining areas will become necessary. Such in-situ reserves from the Norrabees 1 and 2 mining pits is expected to adequately support the operation for an additional 18 months.

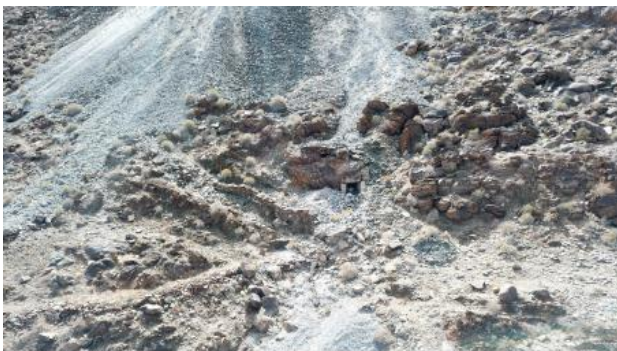
**FEATURE 1 – FOUND TO BE COVERED BY TAILINGS**

Feature 1 : adit (prior to mining)

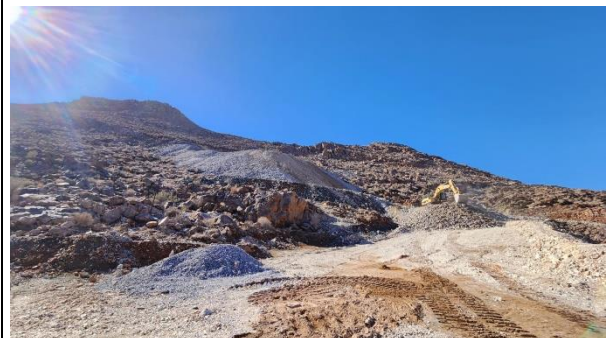
The HIA identified (4) four features of importance during the site survey. These features were discussed with site managers but during the June inspection it was found that feature 1 was covered by the tailings and feature 2 was used as the platform for the sorting plant. This was communicated to the Heritage specialist who now needs to advise on the way forward and if a destruction permit can still be made and if the sorting plant must be moved.

Feature 1 covered with tailings

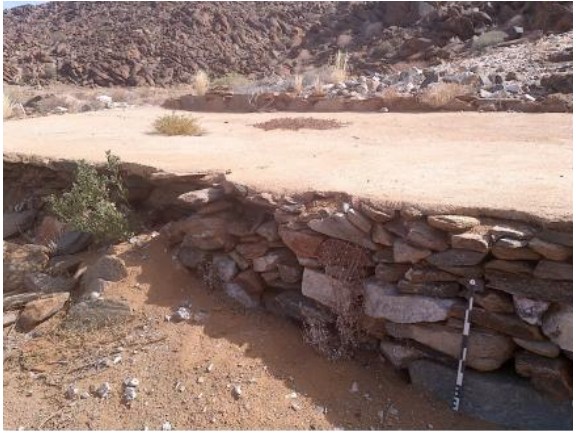
**FEATURE 2 – FOUND TO BE COVERED BY TAILINGS**

Feature 2- prior to mining

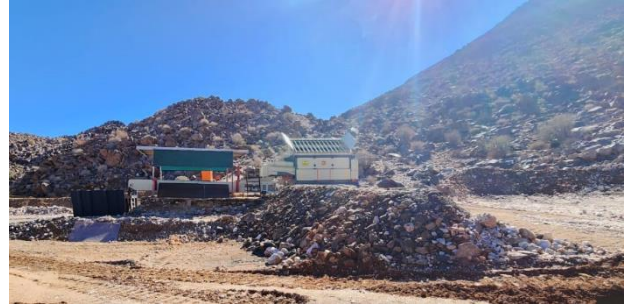
Feature 2 – used as platform for sorting plant

- Allocate a salvage yard
- Place a 30m buffer around feature 3.
- Feature 2 is being used as the platform for the sorting plant. (requested HIA specialist input on way forward)
- Feature 1, adit covered with tailings. (requested HIA specialist input on way forward)
- Move two toilets to screening area closer to workers.
- Place clear boundary markers where possible.
- Prior to more employees ensure sufficient general waste receptacles.
