CONSTRUCTION OF AN ASPHALT PLANT ON PORTION 8 OF FARM 1098, HOOGGEKRAAL, DURBANVILLE, WESTERN CAPE PROVINCE.

ENVIRONMENTAL AUDIT REPORT

CASE NUMBER:	70470602
AUDIT PERIOD:	DECEMBER 2020

The construction of an asphalt plant 2812m² on portion 8 of farm 1098, Hooggekraal, Durbanville, Western Cape Province. The proposed project will entail the refurbishing of the plant by replacing old technology components with latest technology components. A second, mobile asphalt plant, consisting of similar new technology components, will be erected on the extended portion of the property to ensure a continuous supply of asphalt to on-going road projects, while the refurbishing of the existing plant is taking place. On completion of the refurbishing the refurbished plant will be erected adjacent to the mobile plant on the extended portion of the property. This report is only based on the construction of activities.

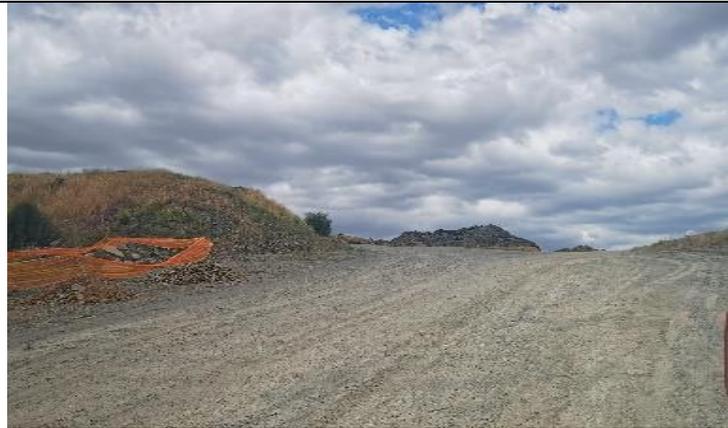
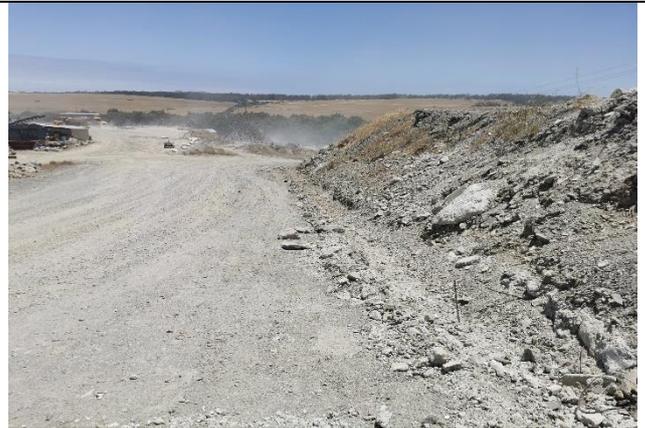
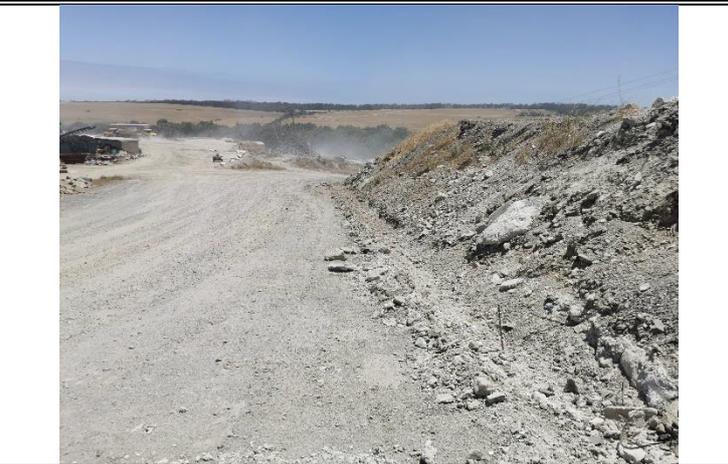
ACCESS ROAD LEADING TO CONSTRUCTION AREA

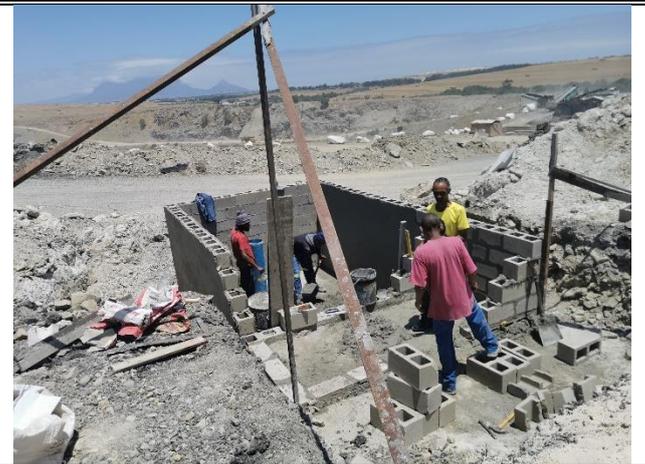
OPEN TRENCH FOR CHANNELS TO BE INSTALLED

If a workshop or washing bay is constructed at the asphalt plant the effluent must pass through an oil trap and treated before released into the natural environment.	5	3	Partially - Compliant	Workers are currently in process with oil trap area. A trench has been opened for the stormwater water channels which will be installed..
Best environmental technologies and practices with regards to oil traps must be implemented.	5	5	Compliant	
WATER MANAGEMENT (EMP PG. 24) – GROUNDWATER				
Site surface must be compacted and or paved to prevent leaching of contaminated effluent into soil and ground water.	5	5	Compliant	Approved and fenced area is compacted with recycled asphalt.
Hydrocarbon spills cleaned immediately.	5	5	Compliant	No spills seen during inspection.
WATER USAGE (EMP PG. 24)				
Municipal water use for consumption	5	5	Compliant	Construction team brings own water or can collect in bottles at the office area.

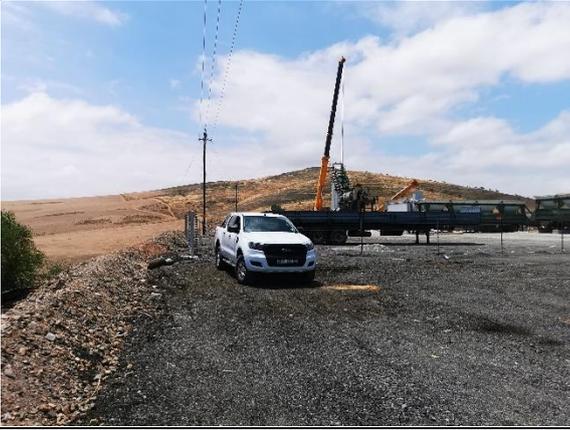
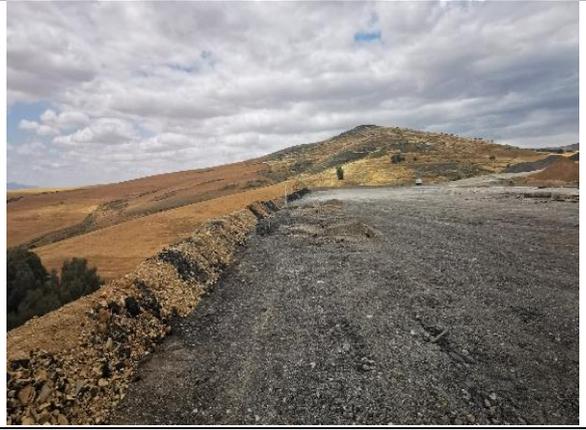
OIL TRAP AREA IN PROCESS

BERMS SURROUNDING CONSTRUCTION AREA

Contaminated effluent /waste should be contained on site and disposed of as hazardous waste.	5	5	Compliant	The Berms surrounding the site ensures for containment and no run off water.
SEWAGE (EMP PG 21)				
Chemical toilets should be used on the interim. (while sewage tank is being installed)	5	5	Compliant	A chemical toilet is placed closer to the site and is used by less than 15 workers

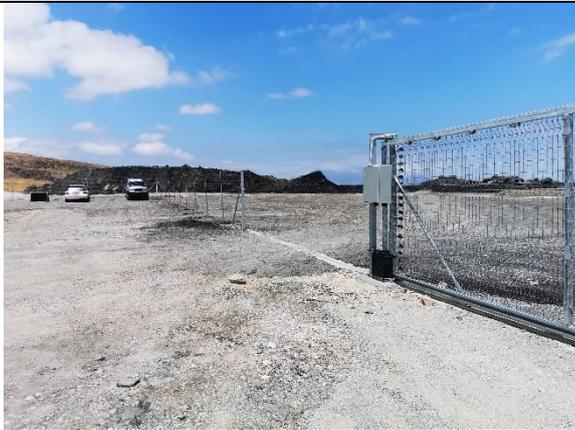
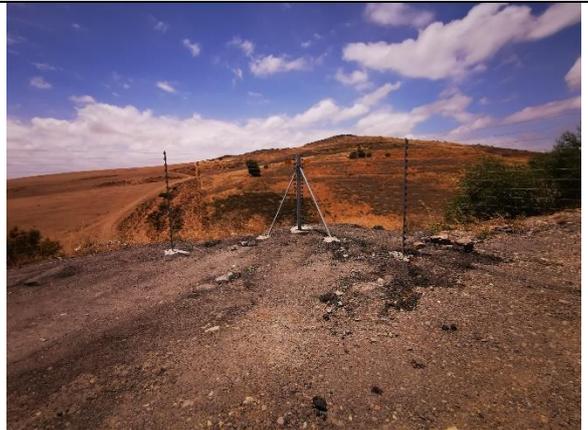
CONSTRUCTION AREA - ELECTRIC FENCING AND TWO ACCESS GATES

1. Stormwater Management plan to be implemented
2. Hazardous area signage to be erected.
3. Netting for dust management – Client unable to put in place netting due to the electrical fencing surrounding the site area.
4. Implement Landscaping plan

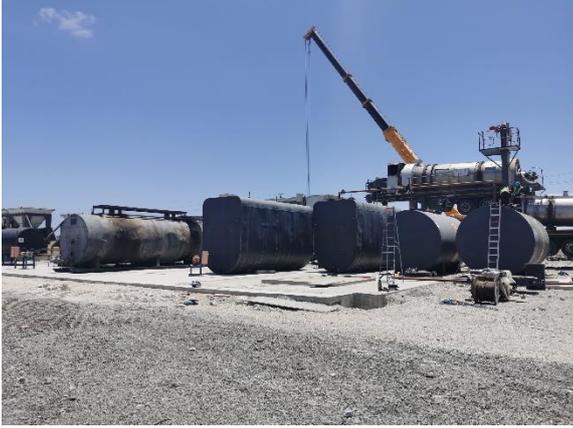
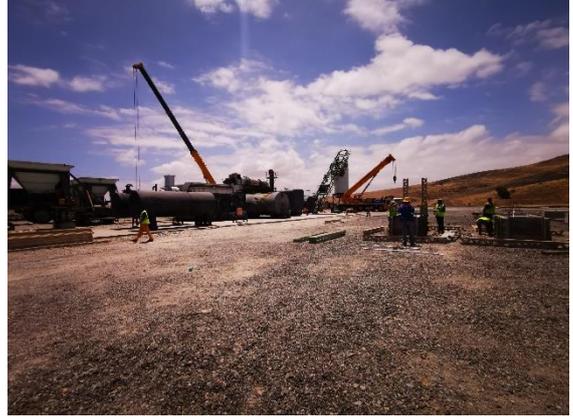
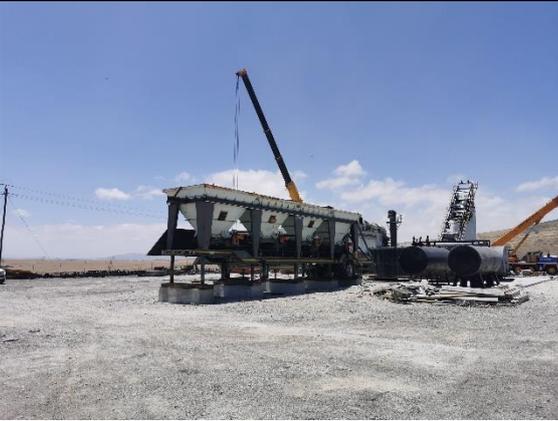
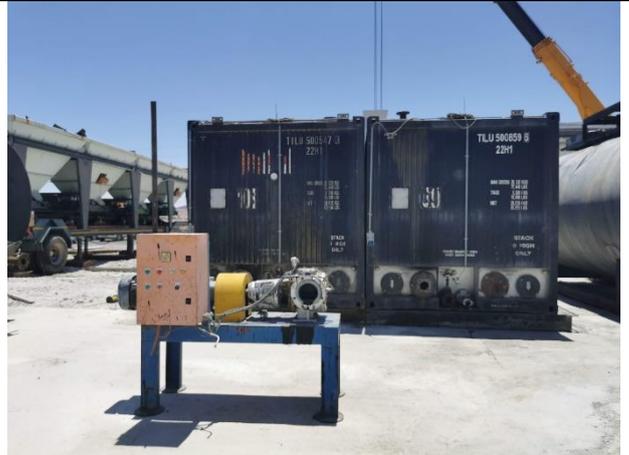
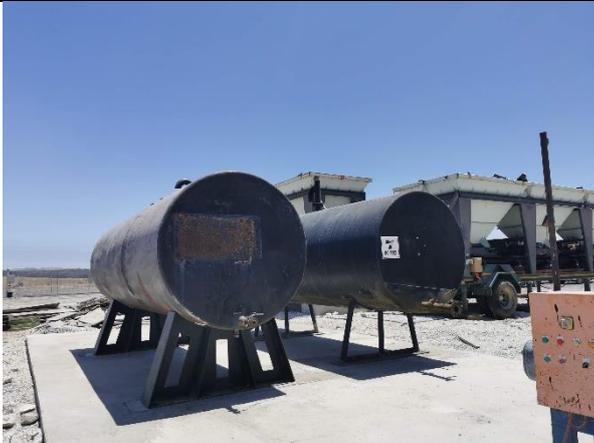
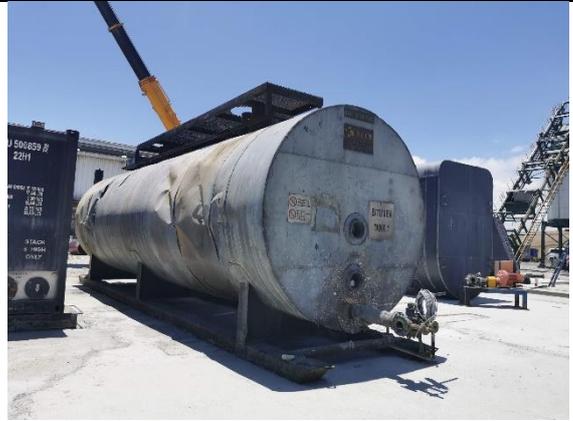
ESKOM POWER SUPPLY UNIT

**DIESEL AND PARAFIN ON CONCRETE FLOOR
WILL BE BUNDED OFF SEPERATELY**

BITUMAN TANK ON CONCRETE FLOOR

HAZARDOUS WASTE (EMP PG. 20)				
Hazardous waste containment area should be demarcated	5	5	Compliant	A concrete floor was installed for the hazardous area, the next step will be to install two separate bunding walls which will demarcate the paraffin and diesel from the rest.
Bins for hazardous disposal should be centrally placed on site	5	5	Compliant	Very little to no hazardous waste is generated during construction, however a spill kit is centrally placed on site.
Bins should be regularly emptied into skips in the demarcated area.	5	5	Compliant	The Site has an appointed waste management service, Averda who will be responsible for all waste related removals.
Hazardous waste collection and disposal service provider should be contracted and waste disposal documentation filed.	5	5	Compliant	The appointed contractor for removal of all related waste is the Waste management service, Averda.
WASTE EFFLUENT (EMP PG. 20-21)

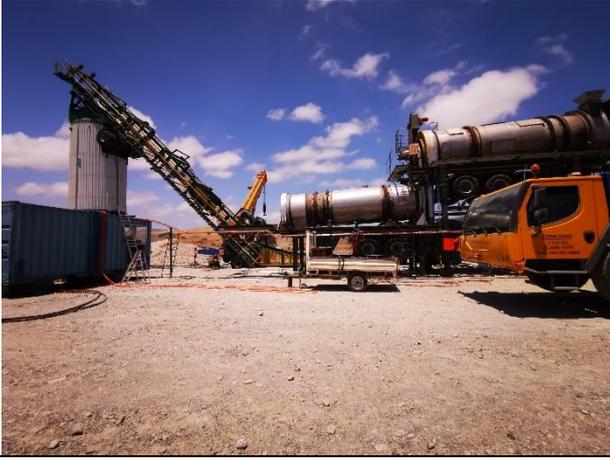
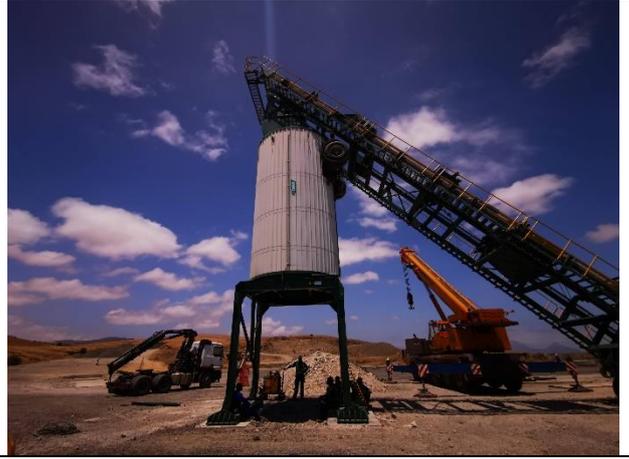
HAZARDOUS AREA – BUNDING WALL TO BE INSTALLED SURROUNDING ENTIRE CONCRETE AREA

DESCRIPTION	COMPLIANCE SCORE	NON-COMPLIANCE SCORE	STATUS	COMMENTS
Storage of dangerous goods should be banded, either with permanent or temporary banded storage facility.	5	4	Partially Complete	The concrete flooring has been installed. Bunding walls will be installed shortly. Currently no dangerous goods are stored.
Drip trays to be used at all dangerous good decanting points.	5	-	N/A	This is not applicable during construction phase.
Spill kits should be made available to clean small spillages.	5	5	Compliant	A Spill kit is placed centrally on site.
Areas should be compacted/paved to prevent leaching of dangerous goods into sub-soils	5	5	Compliant	The entire approved and fenced area has been compacted with recycled asphalt.
Storm water system must be developed to prevent erosion. A non-permeable berm should be constructed on the perimeter of the site as to contain storm water generated on site and prevent storm water generated outside the site to flow through the site.	5	3	Compliant	Berms have been erected surrounding the perimeters of the site. The Storm water management plan will be implemented by an Engineer and will be in place before commencement of operational phase..

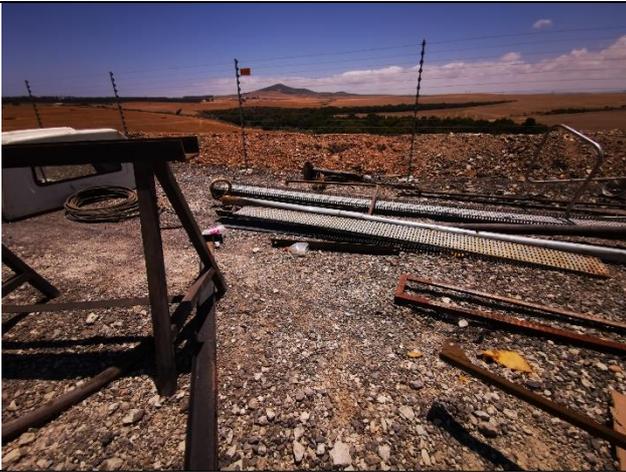
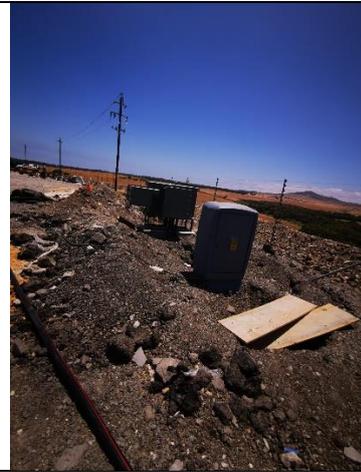
MATERIAL STORAGE AREA

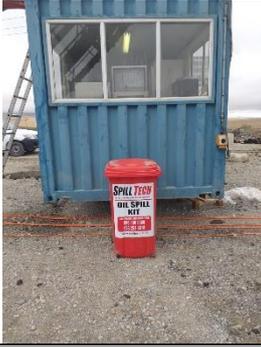
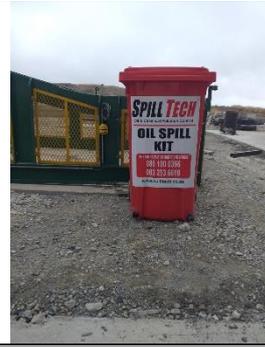
PROOF GENERAL WASTE AND OIL SPIL KIT BINS PLACED ON SITE

Up to date no hazardous waste was generated on site. A register must be kept on site with proof of waste removals. ***An oil spill kit must be kept on site.***
