CLOSURE REPORT – OUWERF BOERDERY SAND MINE

MINING OF SAND PORTION OF THE FARM SEWE OLIENE NO. 657 (PORTION OF THE REMAINDER OF FARM 567), CLANWILLIAM MAGISTERIAL DISTRICT, WESTERN CAPE PROVINCE.

**FINAL PERFORMANCE ASSESSMENT REPORT (REGULATION 55)
& ENVIRONMENTAL RISK REPORT (REGULATION 60)
& CLOSURE PLAN (REGULATION 62)**

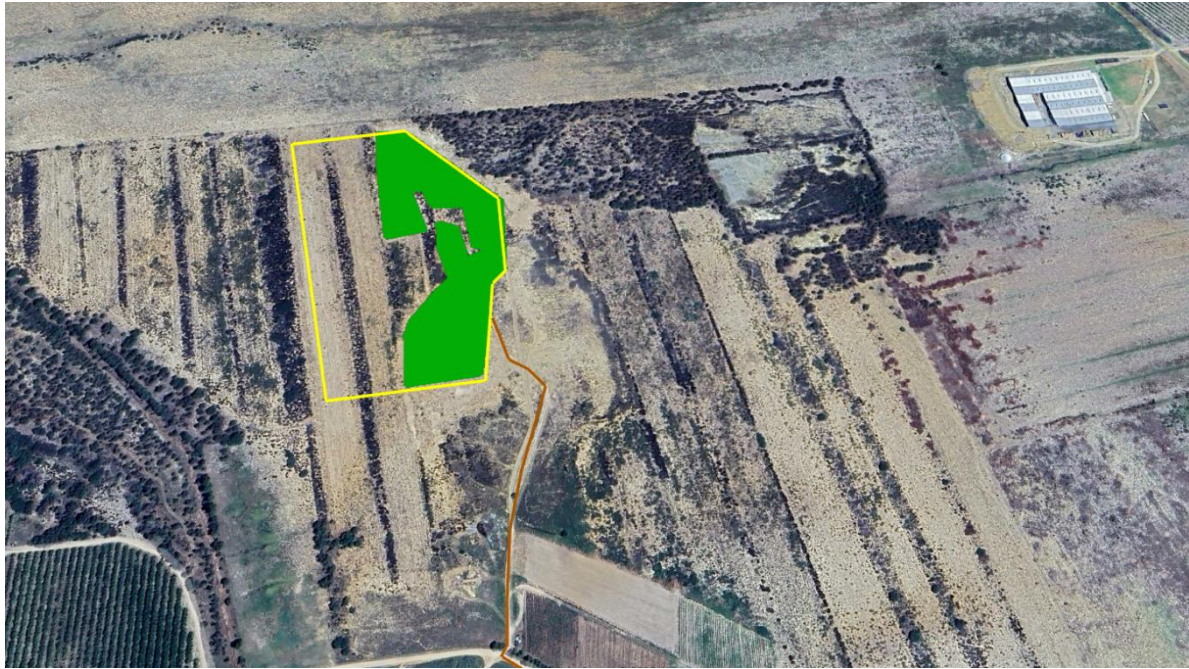
*Figure 1: Image taken from the Google Earth 2026 showing the mining area with the disturbed and rehabilitated area. The approved mining area was 4.9 ha in extent with **approximately 2 hectares** thereof disturbed. The Rehabilitation, Decommissioning and Mine Closure Plan details the closure objectives, -actions, relinquishment criteria, monitoring, auditing and reporting commitments for the earmarked area. The green polygon was added to indicate the affected and rehabilitated areas.*

The mining permit area was confirmed to be neat and clear of litter and well rehabilitated. The access road was well maintained,

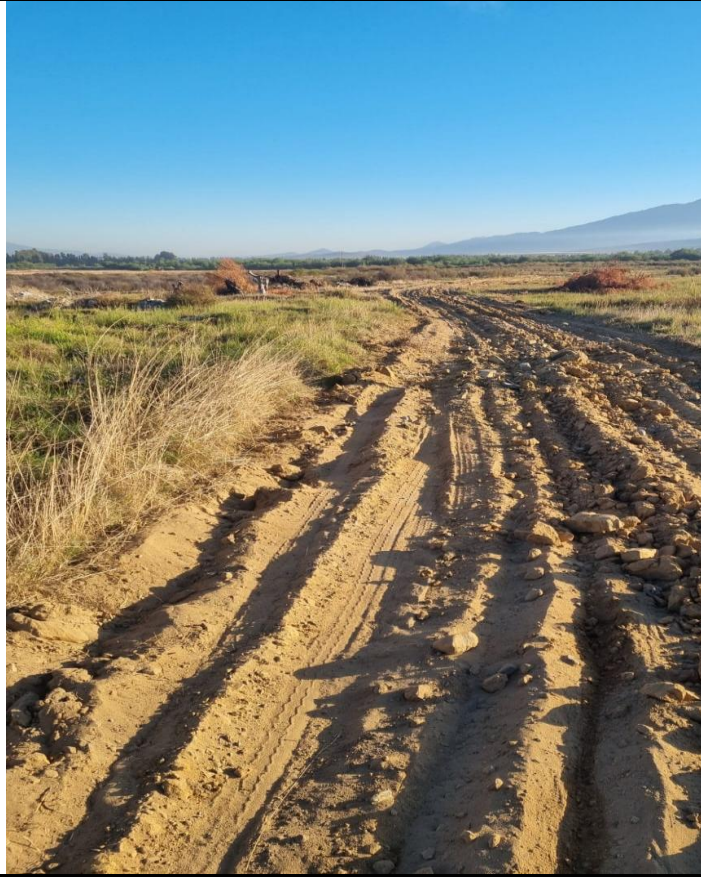
PROOF OF REHABILITATED MINING AREA

It is confirmed that of the approved 4.9-hectare mining area, approximately 2 hectares were disturbed during the operational phase. The entire disturbed area has been rehabilitated in accordance with the approved Environmental Management Programme and associated rehabilitation requirements.

Rehabilitation included concurrent mining and rehabilitation, shaping and profiling of slopes, and the re-application of stockpiled topsoil to promote vegetation establishment. Vegetation establishment through seeding on approximately 0.54 hectares remains ongoing.

- Mining permit area – Slopes shaped and profiled topsoil replaced, and slopes revegetated in accordance with the landowners requirements.
- Rehabilitation complete on the disturbed area.

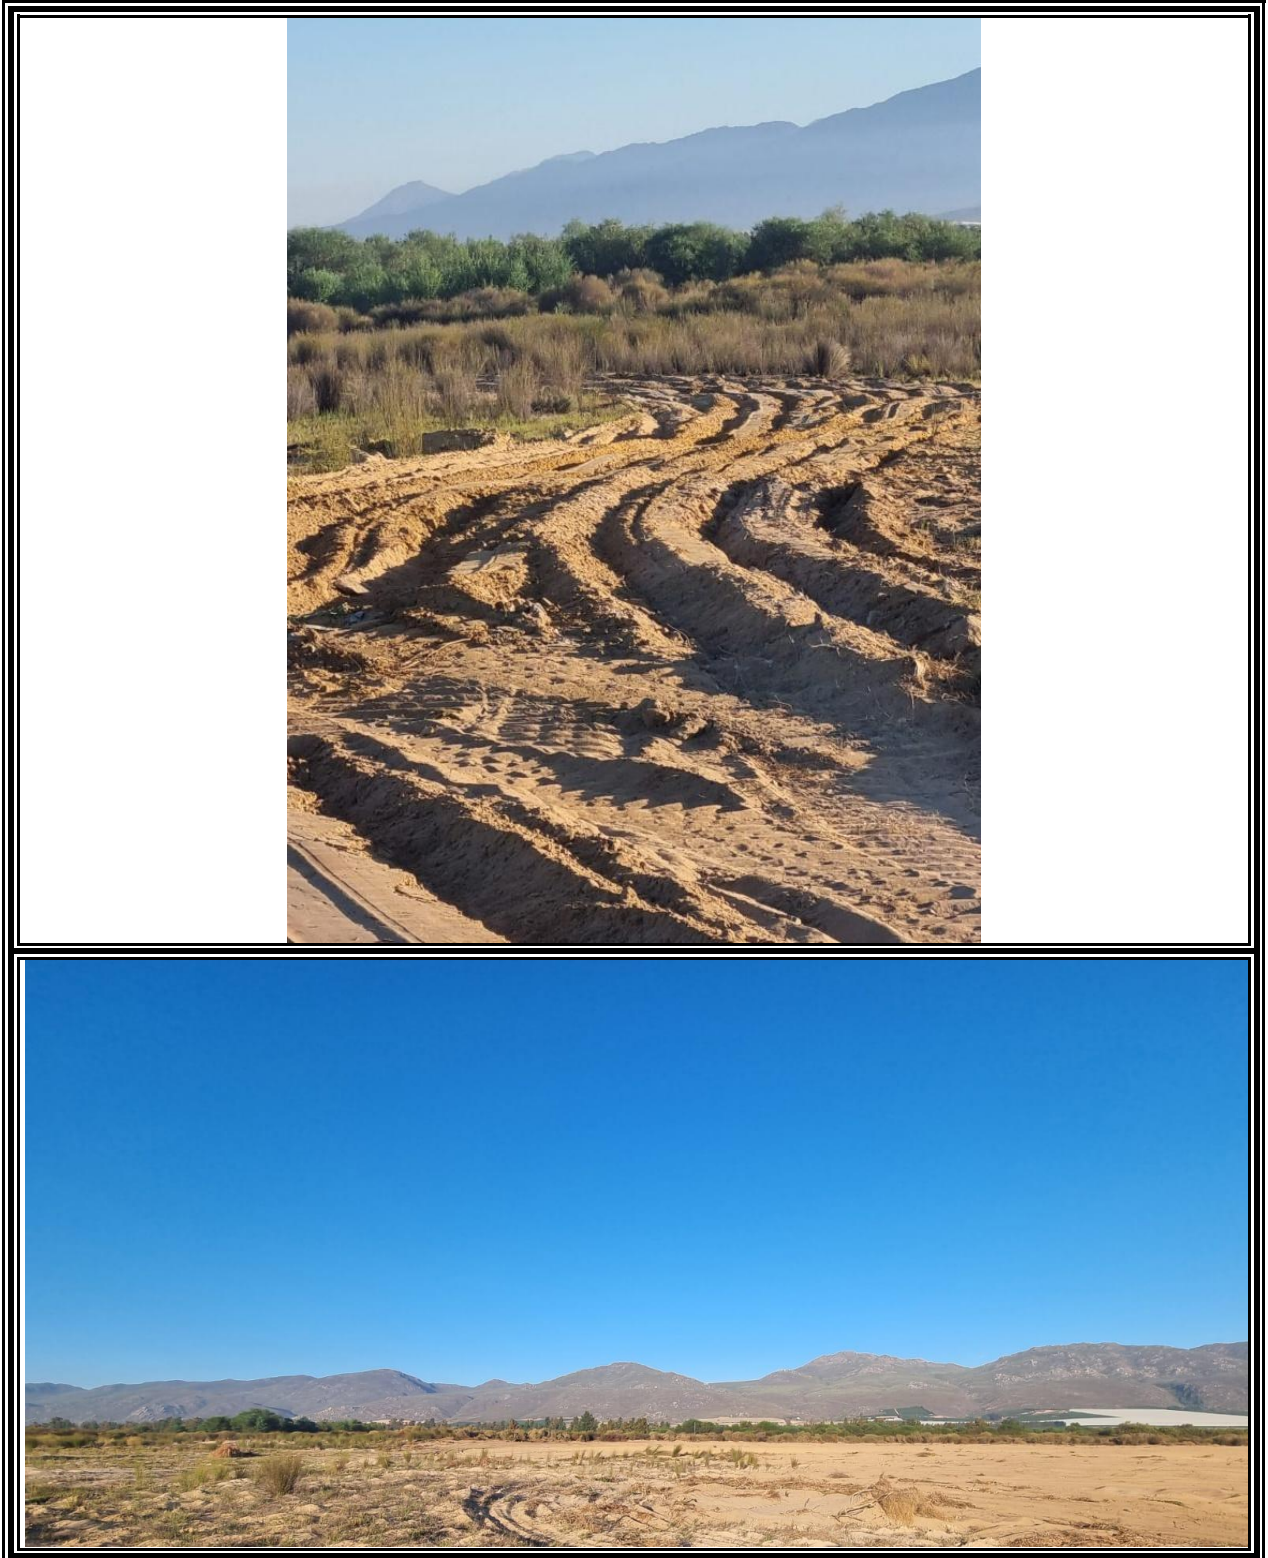
It should be noted that approximately 2 hectares of the initially approved 4.9-hectare mining area were disturbed, and this disturbed portion has been fully rehabilitated.
