**MINING OF SAND AND GRAVEL FROM A PORTION OF THE FARM
DOORNKRAAL 832, MALMESBURY, WESTERN CAPE PROVINCE**

ENVIRONMENTAL AUDIT REPORT

DMR REFERENCE NUMBER:	WC 30/5/1/2/2/10096 MR
AUDIT PERIOD:	24 March 2021

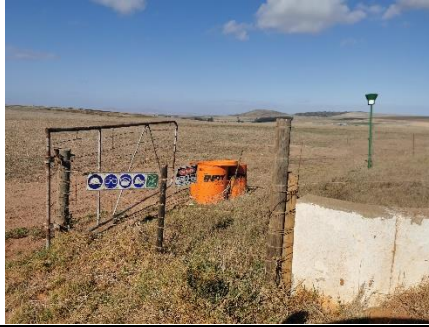
MINING SIGNAGE BOARDS

Workers were inducted and informed of EMP conditions. All workers signed as confirmation of understanding the induction. Appropriate notification signage was erected at the mining site. This gives a clear warning to the public about the hazard around the mining site and presence of heavy vehicles and machinery.

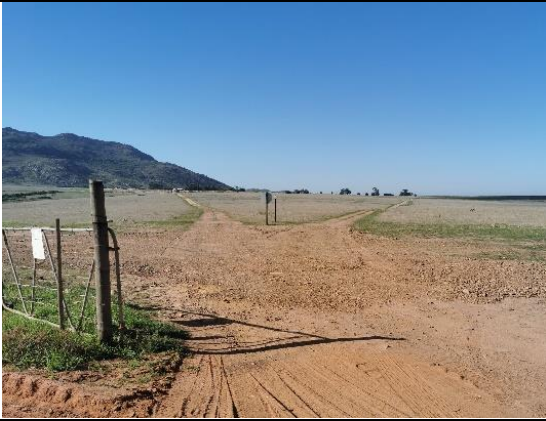
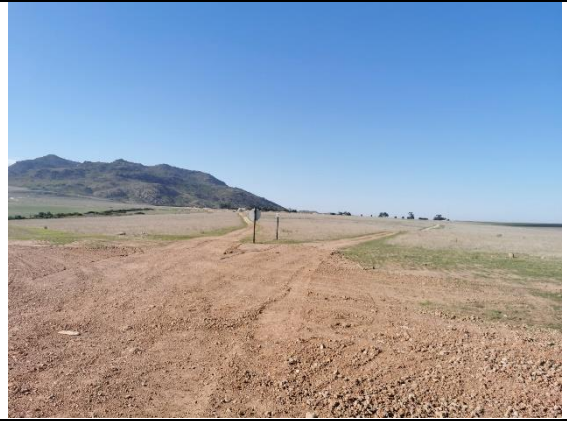
ACCESS ROADS

Vehicles utilising the access road must restrict speed to 40km/h.

These restrictions were erected and placed in all the areas which are highly visible.

Hauling routes for construction vehicles and machinery is clearly marked and appropriate signalling was posted.

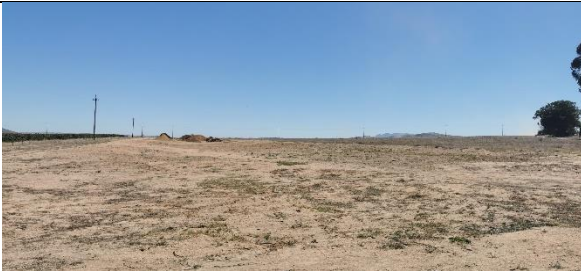
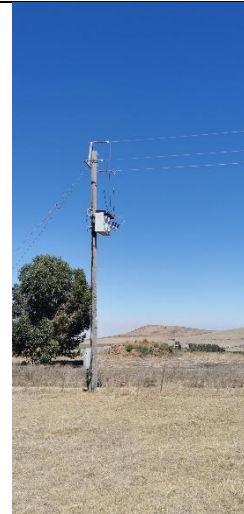
Eskom: Client still needs to implement barricading

ESKOM POWER LINES: Buffers of 10m must be implemented and maintained in respect of the two eskom power lines to ensure that no construction work is executed close to any eskom structure or structures supporting mechanisms. No work or machinery is near to the conductors of the respective power lines and there is an obstruction free zone around all pylons.

No work is allowed within Eskom reserve areas and servitudes (132kV - 15.5 m & 11kV - 9.0 m either side of centre line);

- No stockpiling of material will be allowed within the servitude areas
- No construction work may be executed closer than 10 meters from any Eskom structure or structure-supporting mechanism;
- No work or no machinery nearer than 3.8 m to the conductors of the 132 kV and 3.0 m to the 11kV;
- Eskom must have at least a 10m obstruction free zone around all pylons; Any development which necessitates the relocation of Eskom's services will be to the account of the developer."

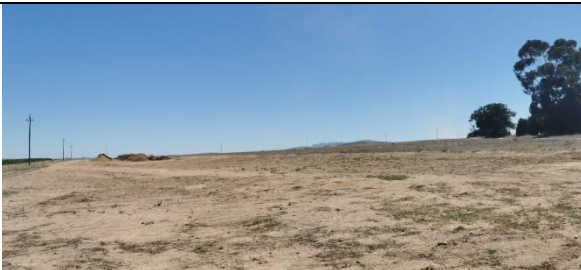
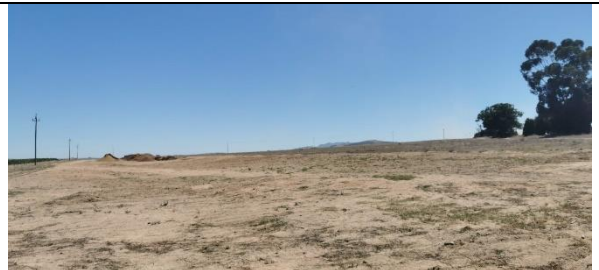
1ST MINING STRIP – COMPLETELY REHABILITATED

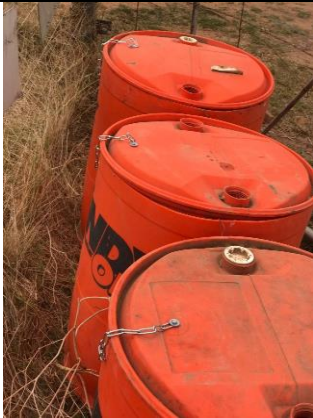
The client has placed three sealable refuge bins on site. For hazardous waste, general waste and Non- biodegradable waste. Up to date no hazardous waste was generated on site. A register must be kept on site with proof of waste removals. **An oil spill kit must be kept on site.**

THREE SEALED BINS – STILL TO BE LABELLED

- Client still to implement clear visible boundary markers,
- Bin labels
- No go area signage boards

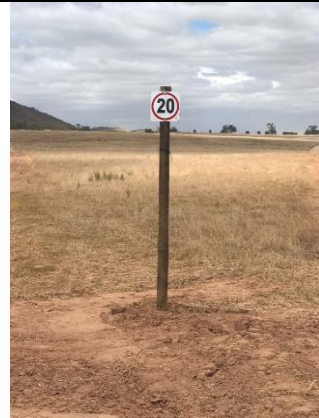
SPEED LIMIT SIGNAGE IN PLACE

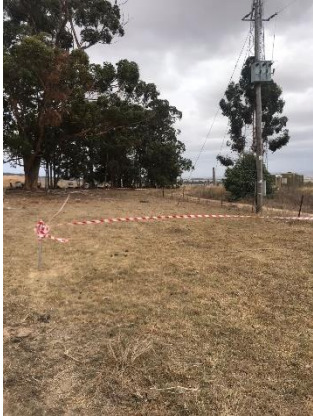
As the Telkom mast is situated outside the proposed footprint of the mining area, the mining activities are not expected to impact the infrastructure. *The mast must however be managed as a no-go area and should any damage occur Telkom must immediately (within 2 hours) be notified. The area is currently barricaded; client must still erect a no go sign for this section.*

TELKOM MAST—AREA BARACADED CLIENT TO INCLUDE A SIGNAGE BOARD AS NO GO AREA

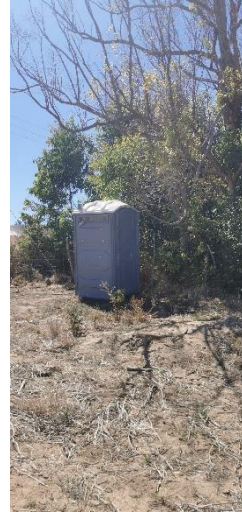
TOILETS – CLOSE TO 1ST MINING STRIP AREA (NOT IN USE AT TIME OF INSPECTION)

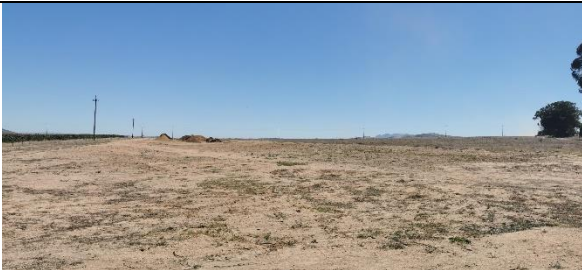
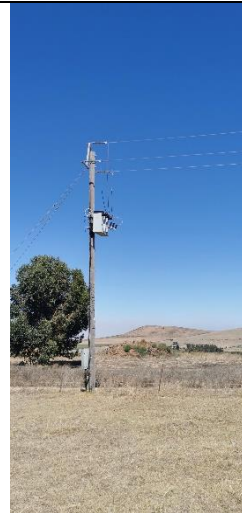
ESKOM POWER LINES: Buffers of 10m must be implemented and maintained in respect of the two eskom power lines to ensure that no construction work is executed close to any eskom structure or structures supporting mechanisms. No work or machinery is near to the conductors of the respective power lines and there is an obstruction free zone around all pylons.

- Buffers of 10m must be implemented and maintained in respect of the two Eskom power lines to ensure that no construction work is executed close to any Eskom structure or structures supporting mechanisms. No work or machinery is near to the conductors of the respective power lines and there is an obstruction free zone around all pylons.
- A 40 m buffer area must be demarcated, sign posted and managed as no-go area around areas with natural vegetation.

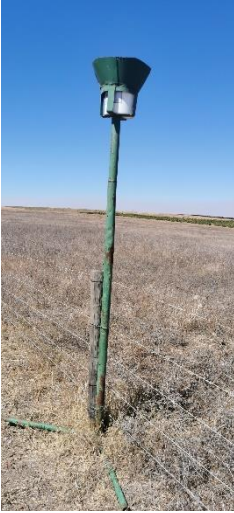
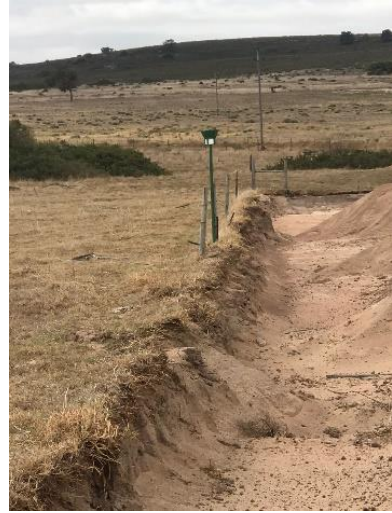
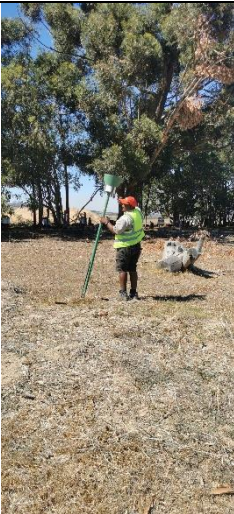
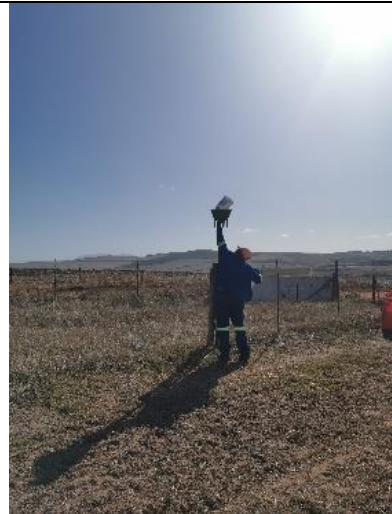
The client incorrectly placed the dust monitoring poles and was instructed to move to the poles to the provided coordinates. Poles are all in the correct positions now.

DUST MONITORING POINTS – UNITS TO BE MOVED
