**VAALPLAAT BORROW PIT  
PORTION 1 OF THE FARM GROOT  
EERSTEGELUK NO 2884, BLOEMFONTEIN  
FREE STATE PROVINCE**

**ENVIRONMENTAL PERFORMANCE ASSESSMENT**

<b>DMRE REFERENCE NUMBER:</b>	<b>FS 30/5/1/3/2/10144 MP</b>
<b>AUDIT PERIOD:</b>	<b>June 2025</b>

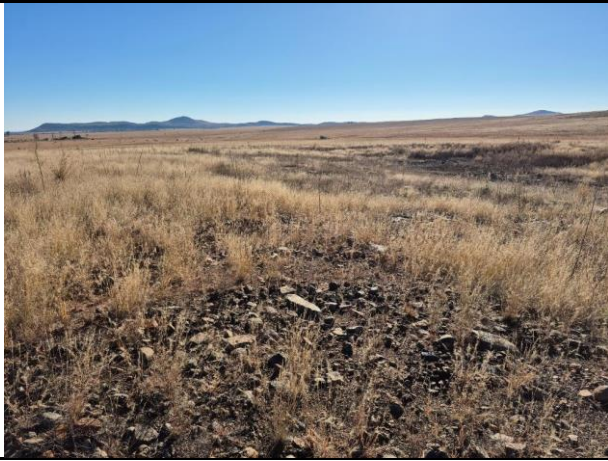
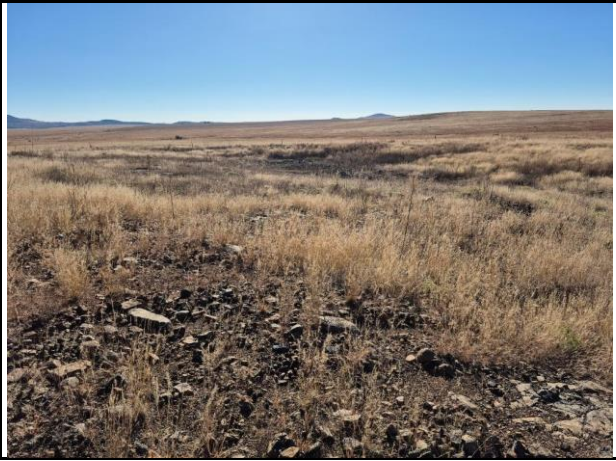
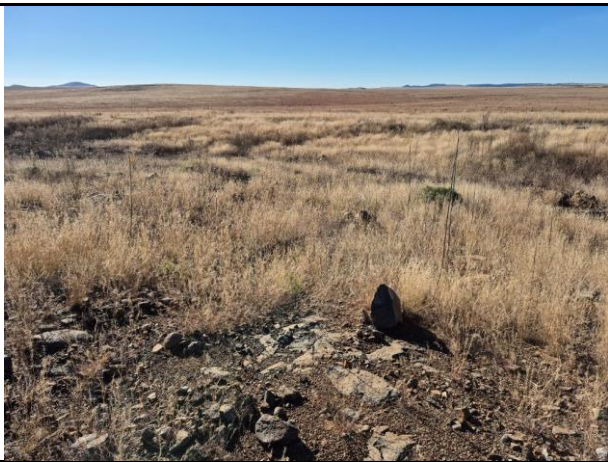
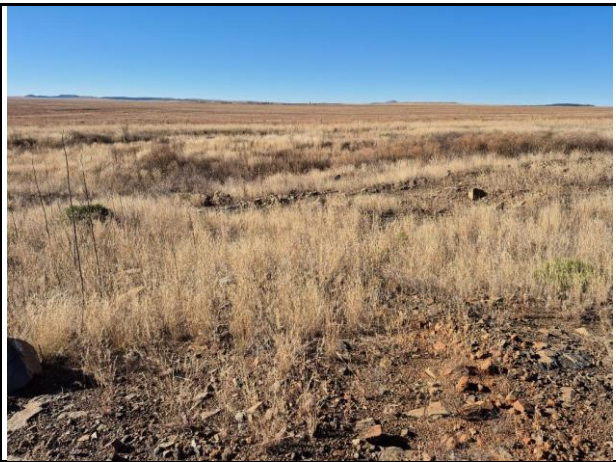
**Rehabilitated  $\pm 0.7$  ha of the excavation**

No mining activities were conducted during the audit period. Due to the substantial rainfall received in the area, the previously disturbed or altered areas are now well vegetated with grass. Approximately 0.7 hectares of the excavated area have been successfully rehabilitated, exhibiting good shaping and a well-established grass cover. It is therefore recommended that this rehabilitated portion be excluded from future mining activities. Should mining resume, extraction should be limited to the remaining 0.8 hectares of the excavation area.

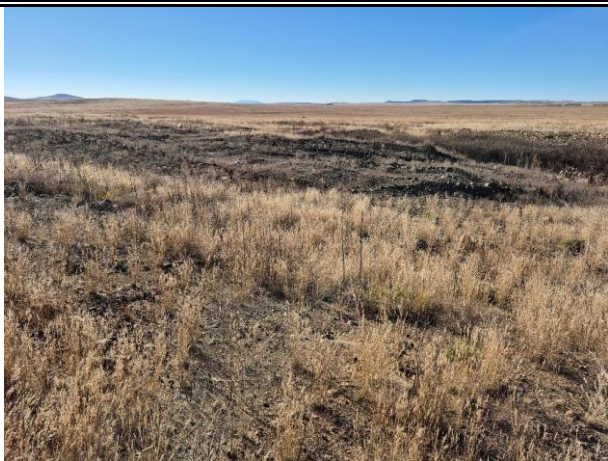
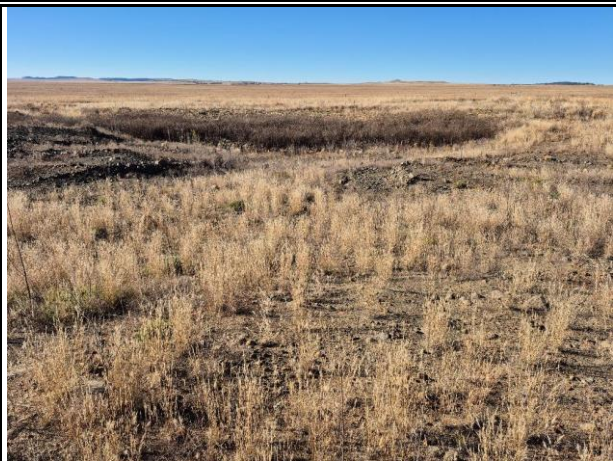
**$\pm 0.8$  ha of the excavation that still require final rehabilitation**

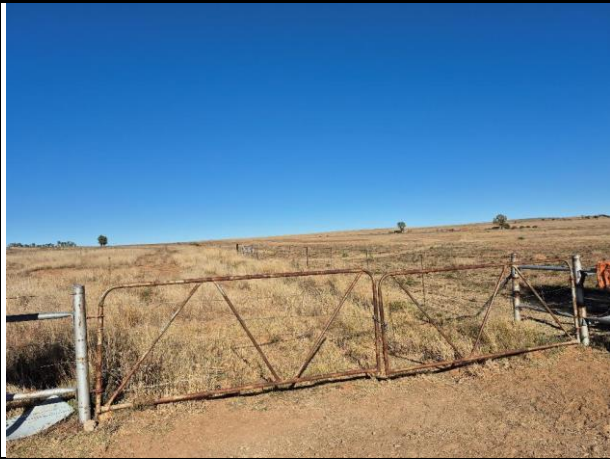
**Access control**

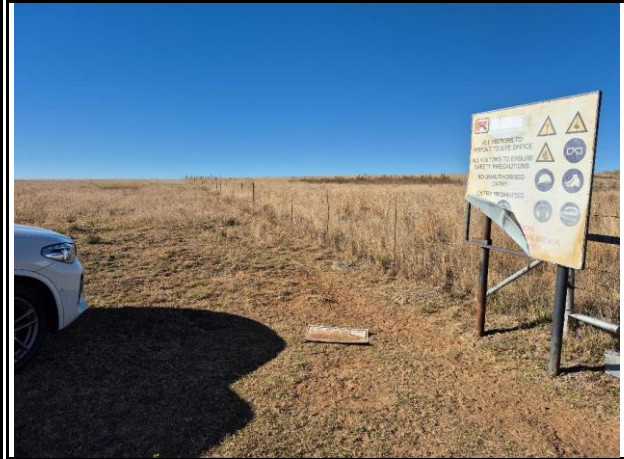
**Signage at the entrance to the site**

DESCRIPTION	COMPLIANCE SCORE	NON-COMPLIANCE SCORE	STATUS	COMMENTS
Movement of project related vehicles and machinery restricted to the approved mining area. No crisscrossing through undisturbed areas.	5	-	Compliant	-
Speed limit enforced within the mining area	5	-	Compliant	-
<b>EMPLOYEE AND SAFETY MANAGEMENT:</b>				
Workers inducted and informed of EMPr conditions	5	-	Compliant	The workers that initially worked at the mine were inducted and proof of training is available.
Proof of training available	5	-	Compliant	
Workers daily transported to site	N/A	-	-	-
Workers provided with PPE	N/A	-	-	No workers on site.
Are there signs present, indicating the mining site and speed restrictions (in 3 languages)	5	-	Compliant	The site has numerous warning signs displayed and access to the site is controlled through two locked gates. Therefore, even though the signs aren't in three languages, it is deemed sufficient for this site.
