SMIT GRONDWERKE (PTY) LTD, ON A PORTION OF REMAINING EXTENT OF PORTION 2 OF THE FARM 199RD, CLANWILLIAM, WESTERN CAPE PROVINCE

ENVIRONMENTAL PERFORMANCE ASSESSMENT / ENVIRONMENTAL AUDIT REPORT

DMR REFERENCE NUMBER:	WC 30/5/1/3/2/10219 MP
AUDIT PERIOD:	17 January 2023

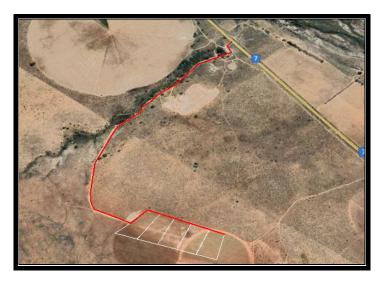
Figure 2: Image based on the Basic Assessment Report, 2019

The image above shows the currently used access road based on the outcome of SANRAL decision. The mining direction have therefore been changed to suite the site structure from block 5 towards block 1. In terms of Section 43(4) of the Mineral and Petroleum Resources Development Act, 2002 (as amended) (hereinafter referred to as the "MPRDA"), an application for a closure certificate must be made to the Regional Manager in whose region the land in question is situated within 180 days of the occurrence of the lapsing, abandonment, cancellation, cessation, relinquishment or completion contemplated in subsection 3. Therefore, the 180-day period as contained in Section 43(4) of the MPRDA already commenced upon the lapsing of the 3nd renewal period.
