THE PROPOSED MINING PERMIT FOR ALL FORMS OF LIMESTONE,  
DIMENSION STONE AND MARBLE ON A PORTION OF PORTION 3  
OF THE FARM WELVERDIEND NO. 511, VANRHYNSDROP,  
WESTERN CAPE PROVINCE

DWS SECTION 21 (C) & (I) WATER USE RISK MATRIX

October 2021

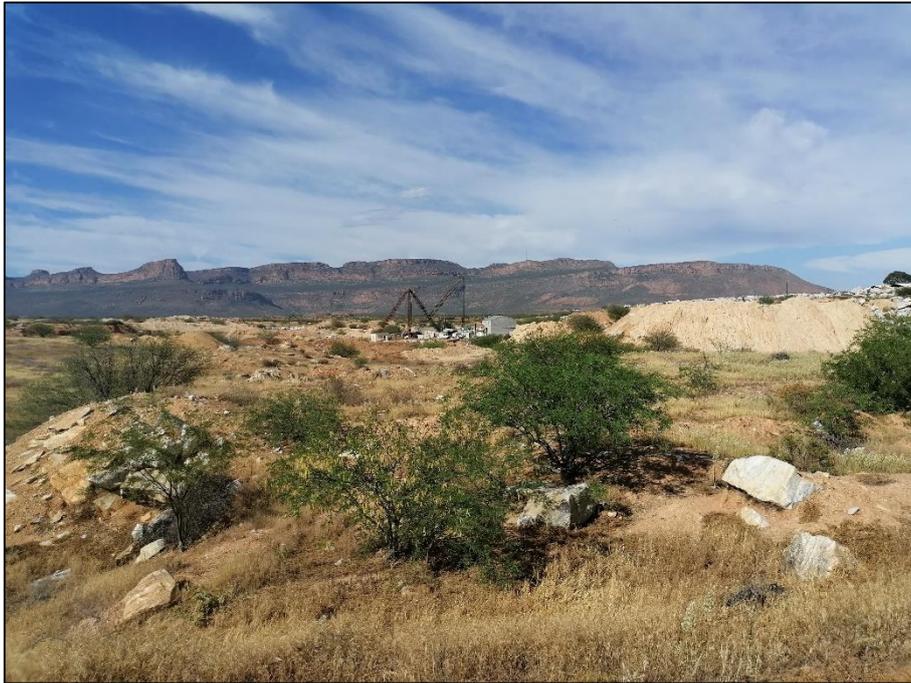
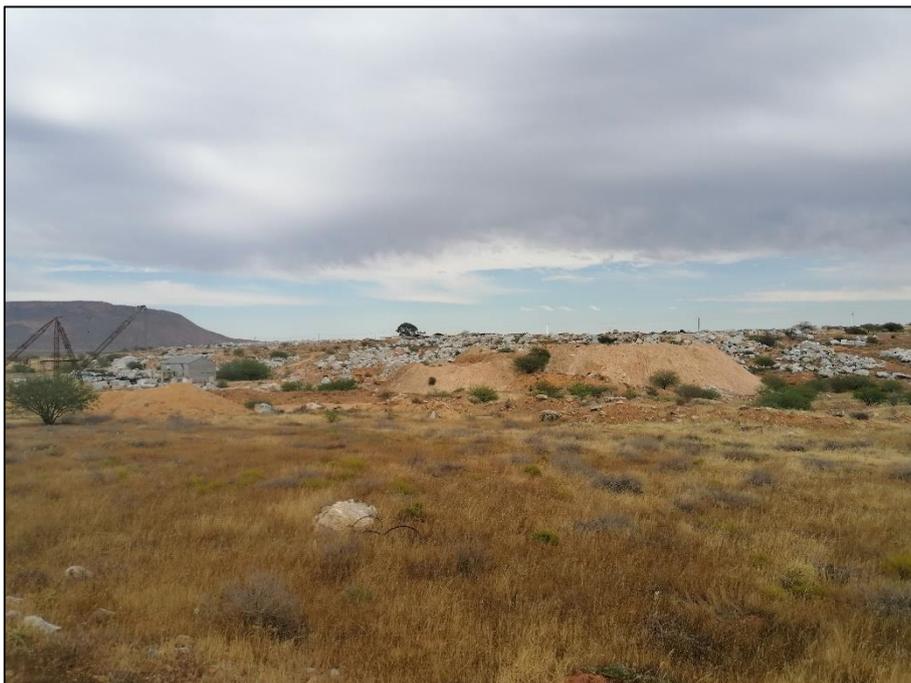
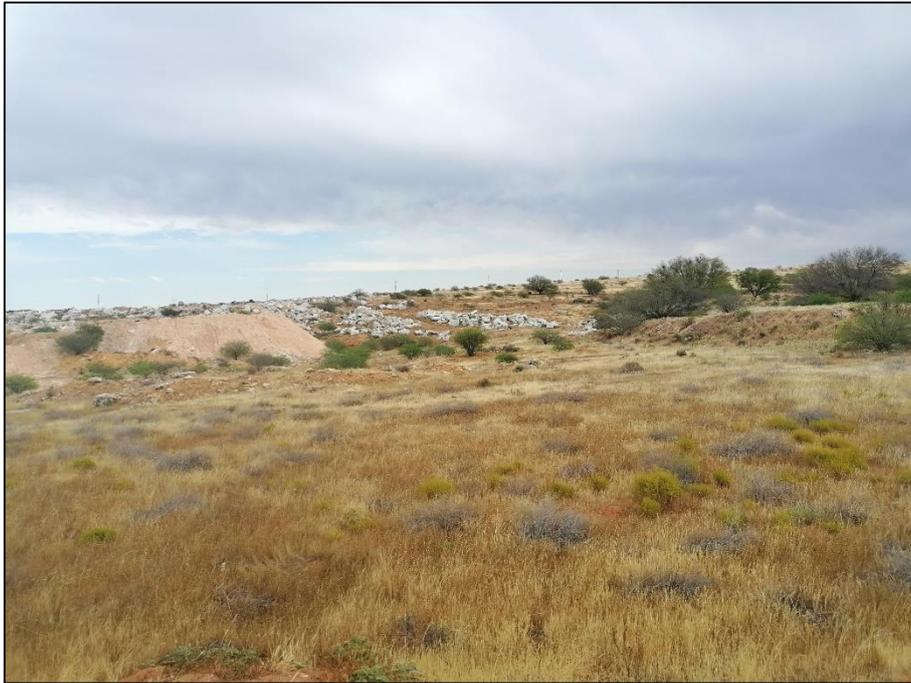
*Figure 27 View from the dam wall where the non-perennial watercourse is expected - now transformed by previous mining activities; dam also impound upstream flow*

*Figure 28 View from the dam wall where the non-perennial watercourse is expected - now transformed by previous mining activities; dam also impound upstream flow*

*Figure 29 View from the dam wall where the non-perennial watercourse is expected - now transformed by previous mining activities; dam also impound upstream flow*

The watercourse map indicate that a non-perennial watercourse flows through the old marble mine (Figure 26). This watercourse has been largely transformed by the previous mining activities, and the dam essentially impounds any surface water flow from upstream (Figures 27 - 29).

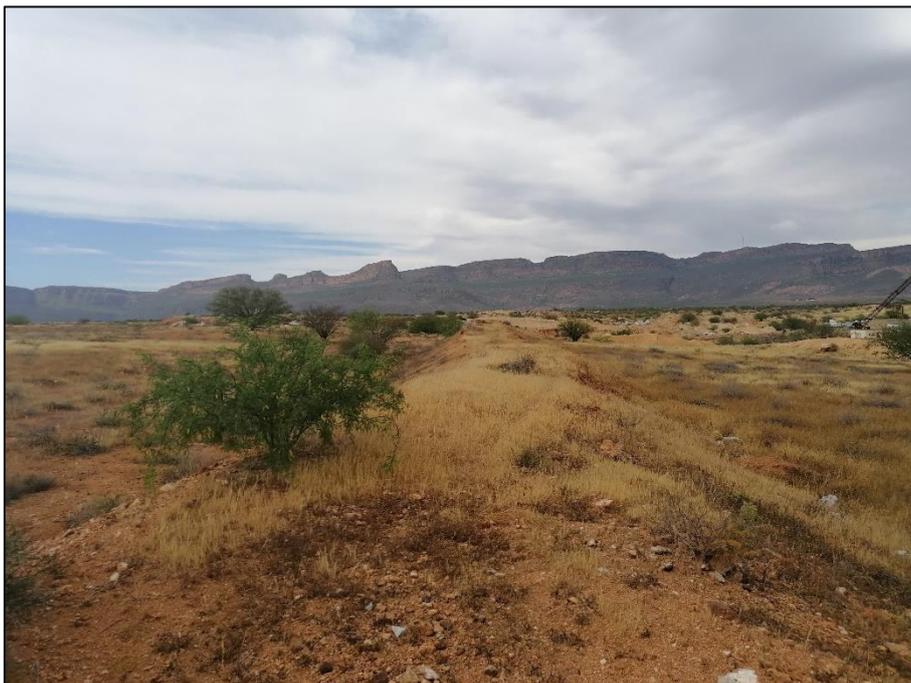
*Figure 30 Berm, adjoining the dam wall, along the eastern boundary of the old mine*

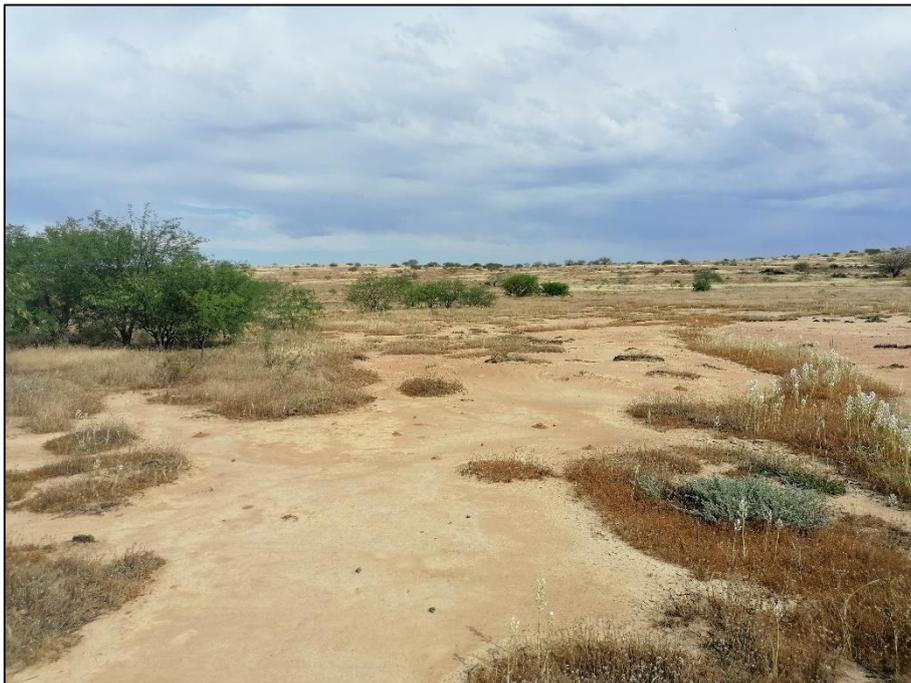
*Figure 34 Wide area with low vegetation cover adjacent to the riparian area*

Some areas with low vegetation cover are adjacent to the riparian area (Figure 34). There is a hard sealed soil surface layer in these areas. There are parts within the bare areas where silt have been deposited and are water affected, i.e. from evidence of cracking (Figure 35).

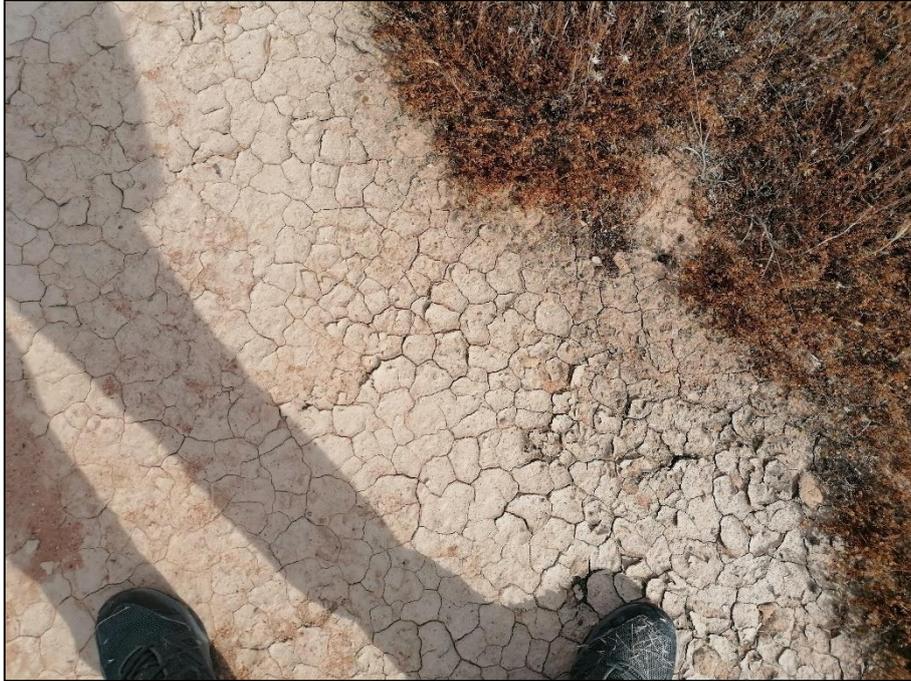
*Figure 35 Bare (low vegetation cover) area upstream from the dam where silt deposits show cracking from being water affected*

Soil sealing or capping is where the bare soil surface is sealed, rainfall cannot penetrate and runs off laterally, even on very gentle slopes (Agriculture Organization of the United Nations. Soil Resources et al., 1993). This soil sealing prevents rainfall infiltration, decreases soil moisture, increases surface run-off and erosion. Soil sealing

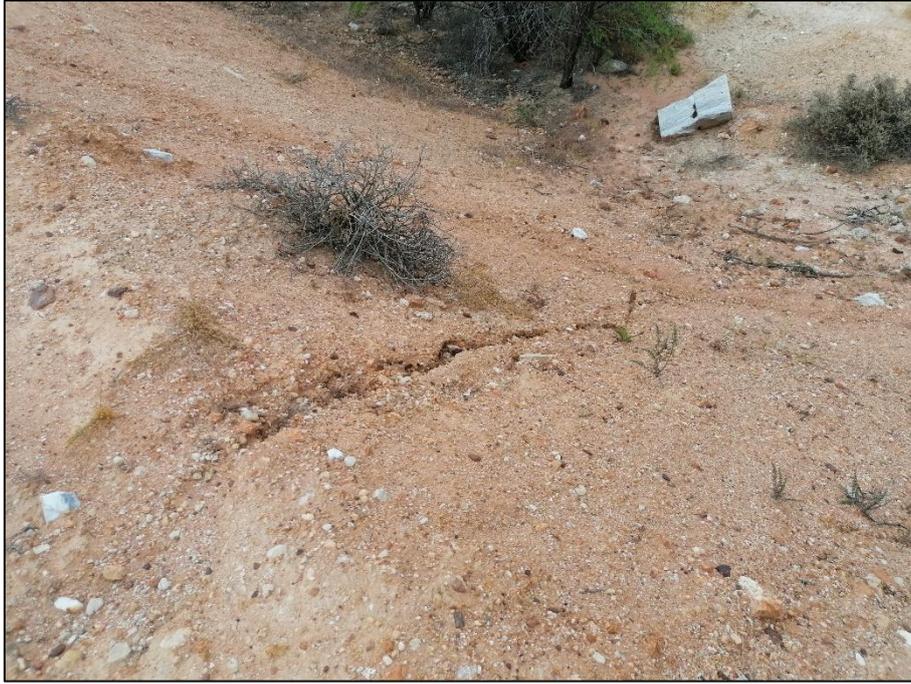
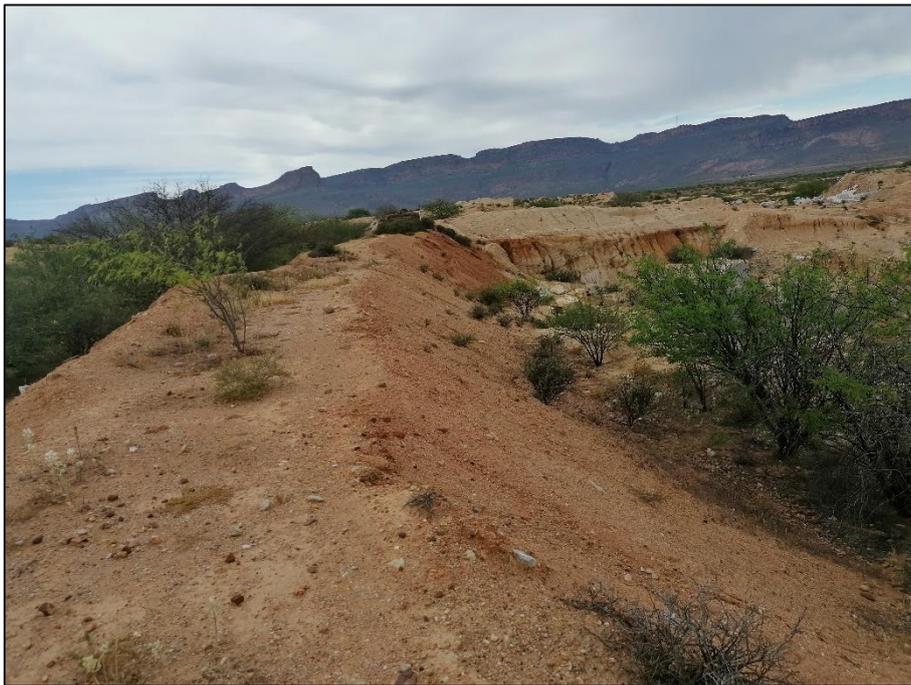
*Figure 36 Soil capping and erosion on the berm around the old mine*

*Figure 37 Soil capping and erosion on the berm around the old mine*

The berm and soil stockpiles around the old mine show similar surface sealing than the bare soil upstream of the dam. Soil erosion features were observed on the berm and soil stockpiles (Figures 36 & 37). The inherent soil properties on the site make them prone to erosion, and this is confirmed by the features of soil capping and erosion observed on the old mine. This means vegetation clearing, soil disturbance and stored soil will require specific management measures to manage and mitigate the impacts of the proposed mine.

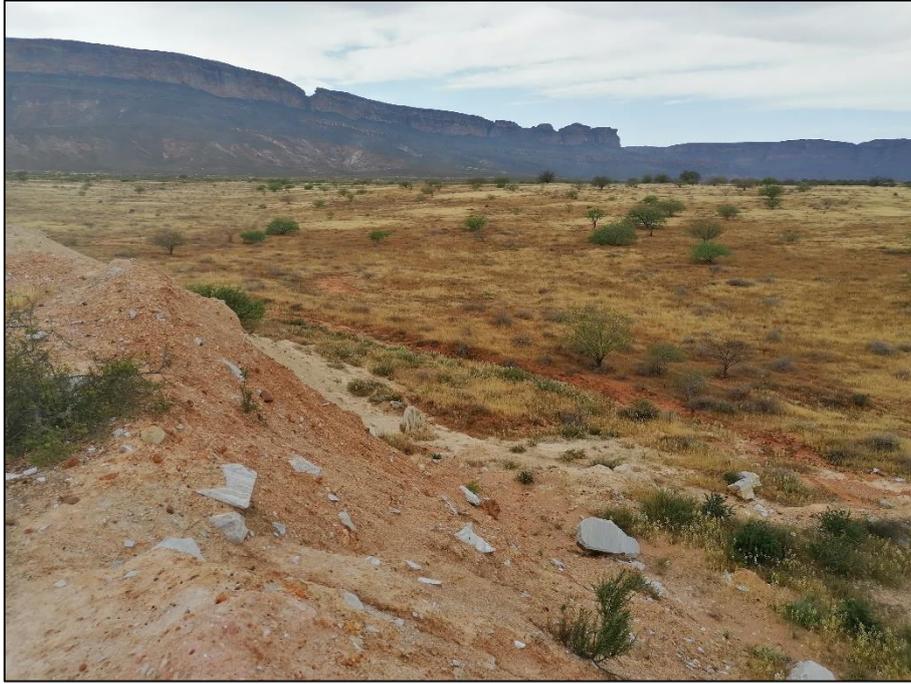
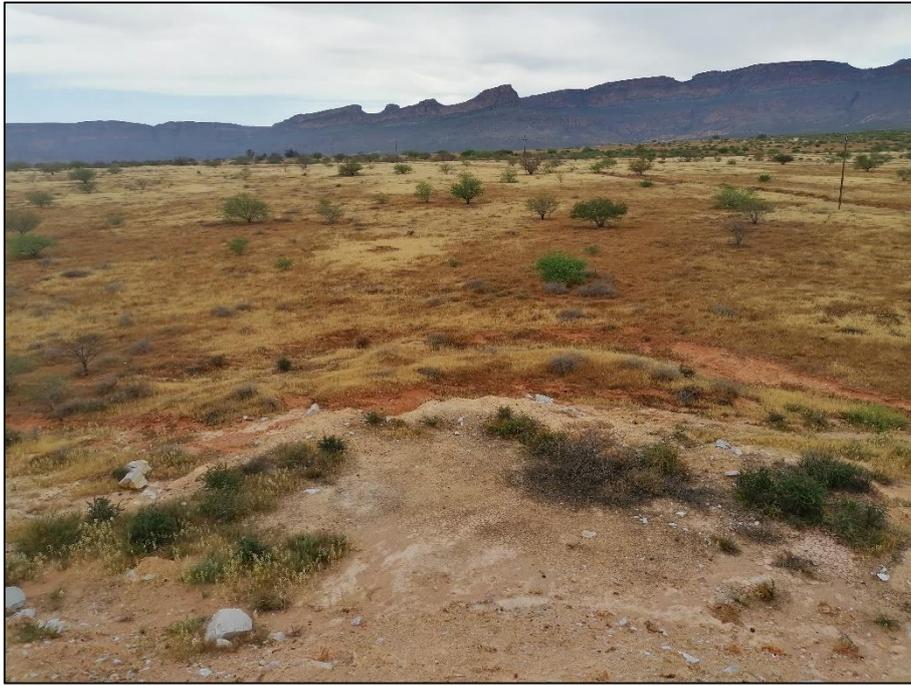
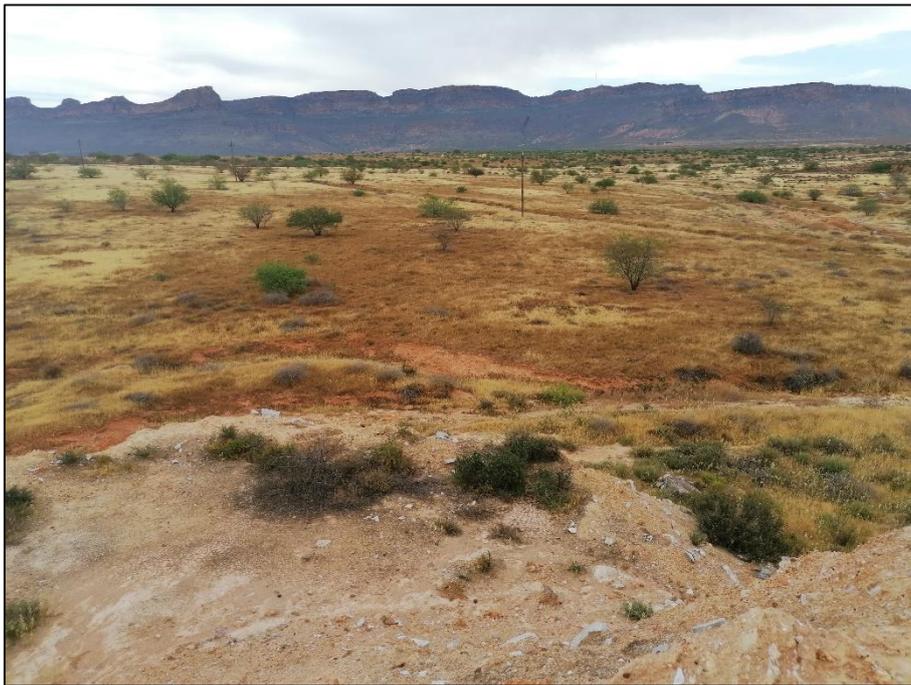
*Figure 40 Water diverted around the old mine by the berm, before it joins the valley downstream from the old mine*

*Figure 41 Water diverted around the old mine by the berm, before it joins the valley downstream from the old mine*

*Figure 42 Water diverted around the old mine by the berm, before it joins the valley downstream from the old mine*

*Figure 43 Water diverted around the old mine by the berm, before it joins the valley downstream from the old mine*

After being diverted around the old mine by the berm, the water flow has created a relatively narrow distinctive channel with a prominent channel and bank (Figure 40 - 43). High surface water flow is expected from the straight diversion created by the berm. Additional surface flow and sediment input is also created by the bare sealed soil with low vegetation cover which the diverted water flow pass through, closer to the south of the old mine (Figure 44). This area is likely a stockpile of the old mine.

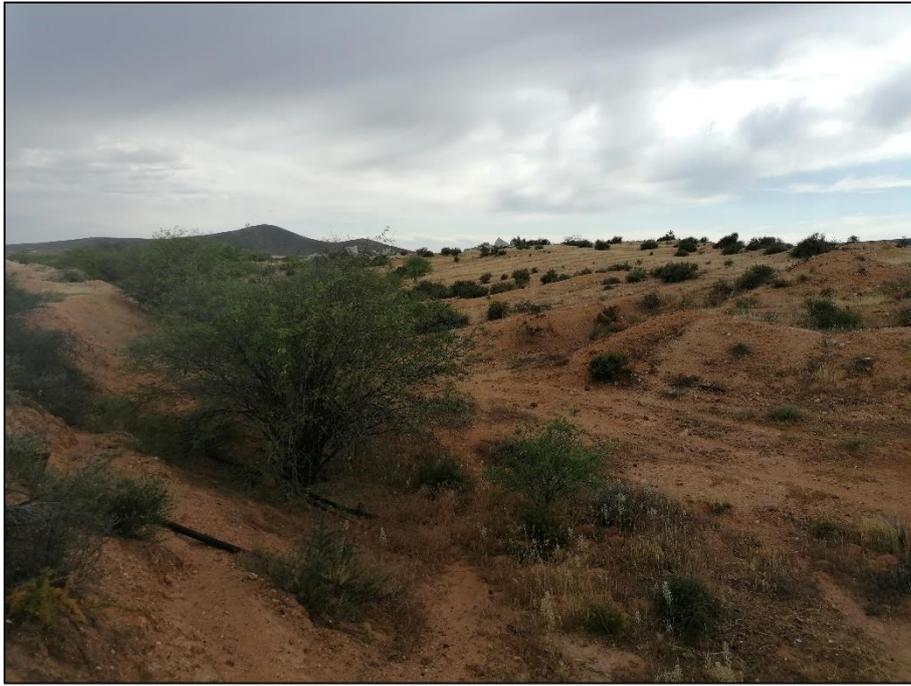
*Figure 44 Old stockpile next to the old mine. Low vegetation cover and sealed soil will likely generate additional surface water run-off and sediments*

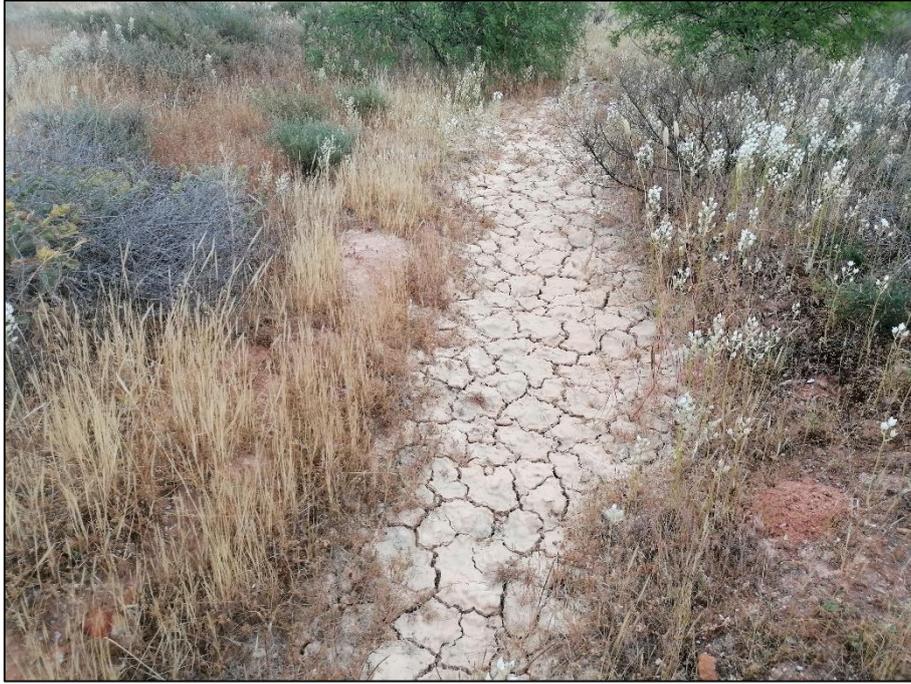
*Figure 46 High sediment load deposited in the watercourse, after it has been diverted around the mine by the berm, downstream from the old mine, and just before it joins the valley's watercourse*

Sediment from the old mine's footprint and stockpiles are deposited in the old roads (preferential flow pathways for water and soil is also compacted and damaged by vehicles) (Figure 45) and where the slope becomes gentler the channel becomes broader with less distinct banks (Figure 46).

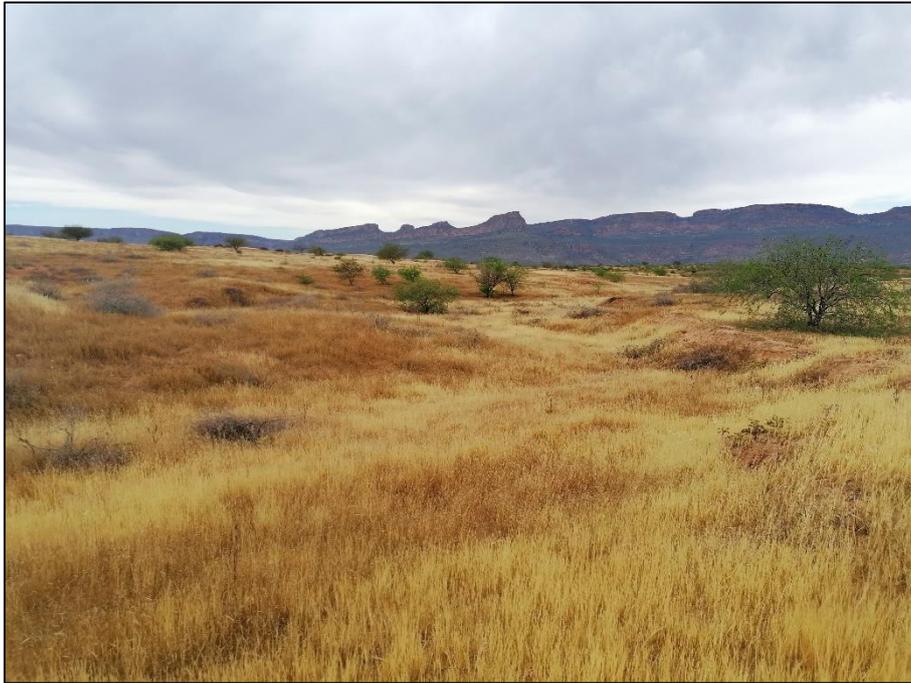
*Figure 47 High vegetation cover in distinct bed and banks of the valley bottom's watercourse*

The ephemeral watercourse below the proposed- and old mining footprint has a distinct channel and banks (Figure 47). Since the upstream dam is impounding a large part of the upstream surface water flow, the watercourse downstream from the old- and proposed mining footprint has experienced significant hydrological changes and will most likely be ephemeral in nature, only flowing in times of extreme rainfall and surface water run-off. Vegetation cover is high within the downstream ephemeral watercourse below the access road south of the old- and proposed mining footprint. Aerial imagery from 1942 indicate a more distinct active channel that is visible (Figure 48) (Department of Agriculture, Land Reform and Rural Development's National Geo-Spatial Information Department, 2021), supporting the statement that the watercourse has experienced hydrological changes from the upstream impoundment.

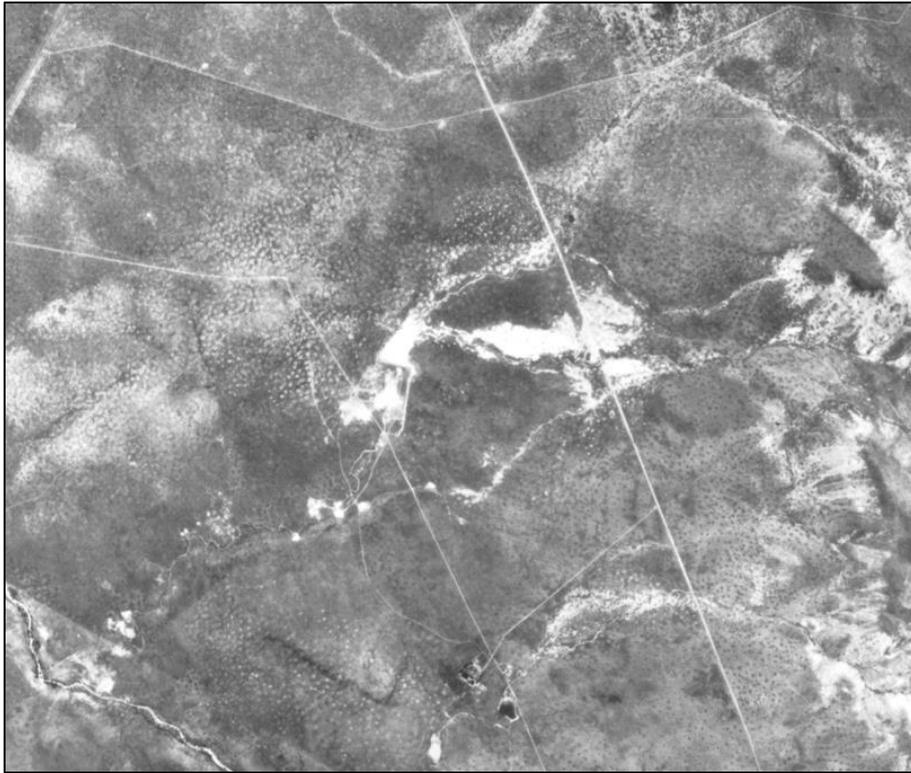
*Figure 52 Aerial imagery of the proposed mining permit area and surrounds from 1976, indicating the old mine; disturbance in the watercourse and its regulated area is visible downstream from the old- and proposed mining footprint*

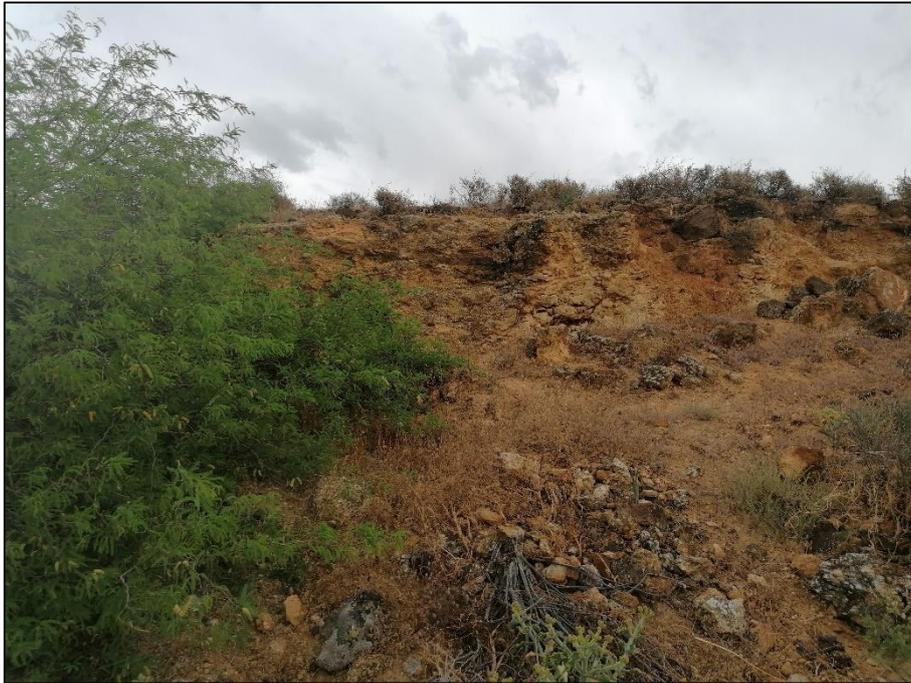
*Figure 55 Some slopes have collapsed or are physically disturbed along the ephemeral watercourse banks/slopes of valley downslope from the proposed mining footprint*

The ephemeral watercourse channel is relatively well defined and covered in relatively high cover of vegetation. The channel varies from a narrow channel (Figure 53) to considerably wider at other sections (Figure 54). The banks show signs of disturbance or erosion (Figure 55 & 56) to more clear signs of past disturbance (Figure 57).

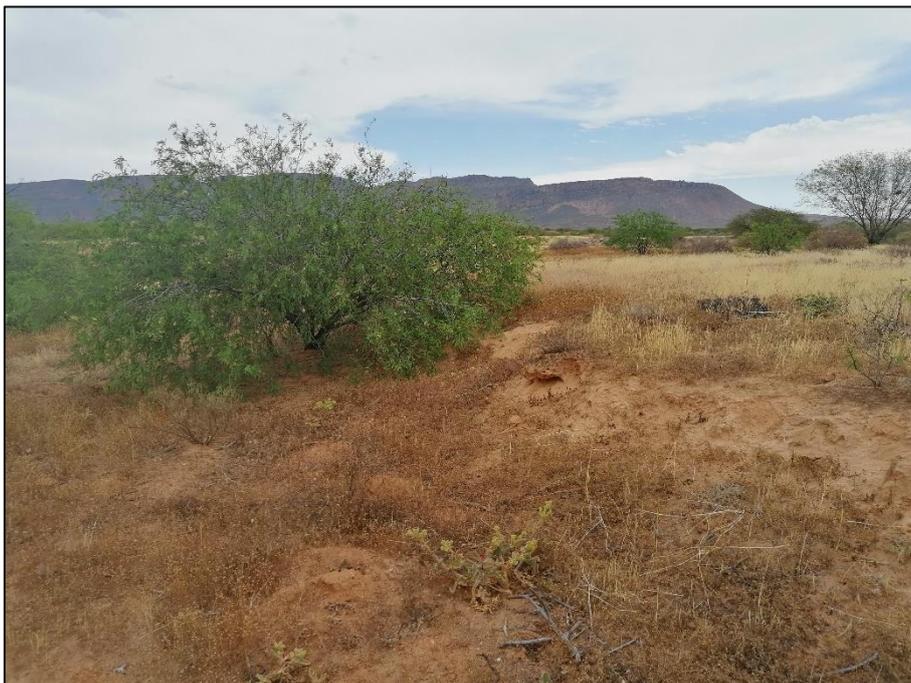
*Figure 56 Some banks indicate water flow (i.e.. erosion) or it could be due to physical disturbance*

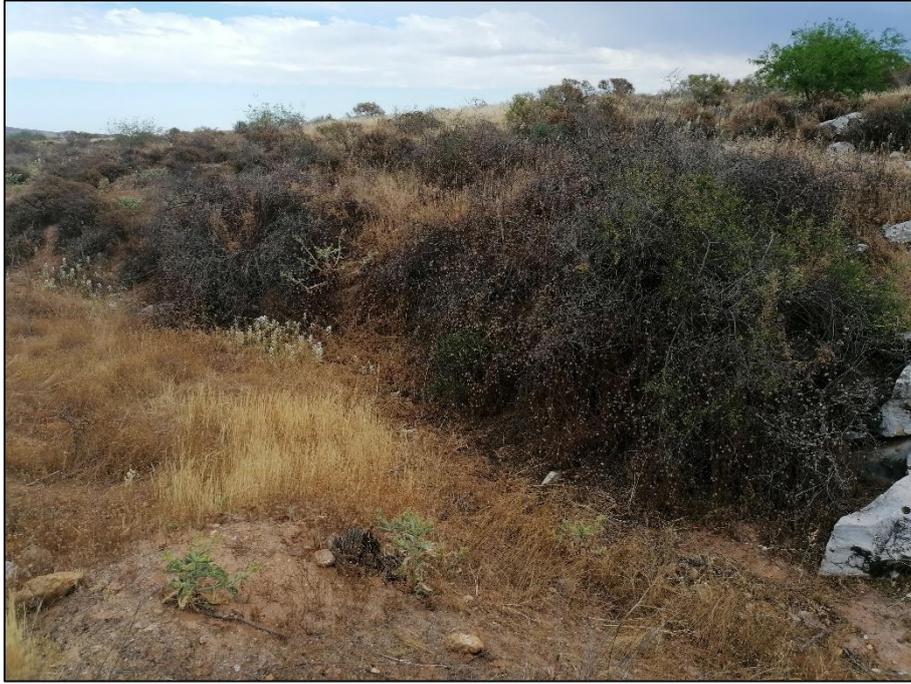
*Figure 57 Relatively steep sites and narrow channel, signs that some parts of this area previously disturbed, most likely by mining*
