WATER USE LICENCE APPLICATION SUMMARY REPORT

THE LAFARGE TSWANA LIMESTONE QUARRY ON A PORTION OF FARM DRIEFONTEIN 46 PORTION 0, FARM RONDEFONTEIN PORTION 0 AND FARM RIETSCHRAAL 58 PORTION 0, NORTH WEST PROVINCE IN WARD 17

Reference No: WU23173

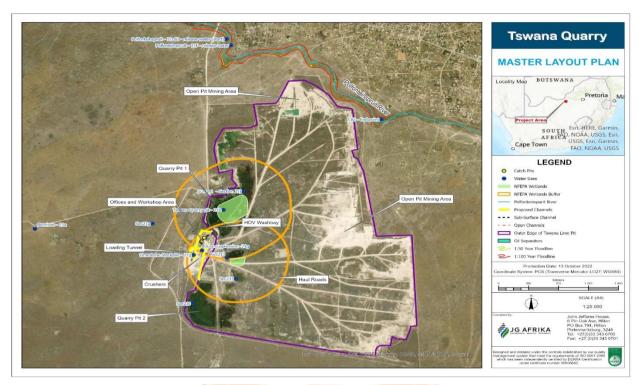
Figure 3: Tswana Limestone Quarry - Master Layout Plan (JG Afrika, October 2022)

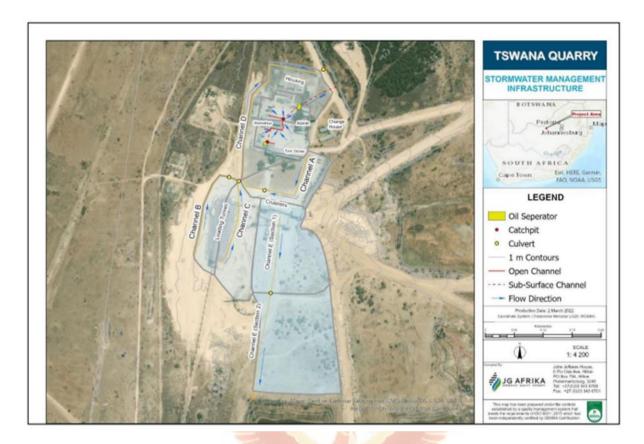
Figure 4: Proposed Stormwater Management Infrastructure (JG Afrika, March 2022)

The contributing catchment areas (also indicated in **Figure 4** below), design rainfall depths and required capacity, based on the 1:50 year return period flood peak, for the channels as taken from the SWMP. The selection of concrete channel lining was in order to assist with maintenance and the transport of sediment which is often contained within the stormwater runoff (JG Afrika, Preliminary SWMP, 2022).

Additionally, due to the flat topography of the quarry site it was necessary to reduce the slopes of the channels to an absolute minimum of 0.25% in some areas, which was necessary in order to prevent excessive channel depths and large top widths. In total the site requires approximately 1.14 km of concrete lined channel, 189 m of grass lined channel, with a short section (32 m in total) of reno-mattress lining on the channel at the start and end of the grass lined sections to provide protection against erosion, particularly at the end of the channel where the slope increases as the channel discharges into the dam. Five culverts are required to convey the water beneath roads and railways (JG Afrika, Preliminary SWMP, 2022).

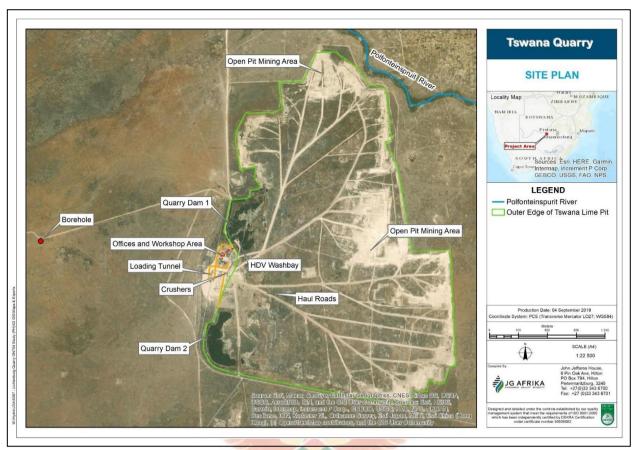
Figure 5: Tswana Limestone Quarry Site Plan

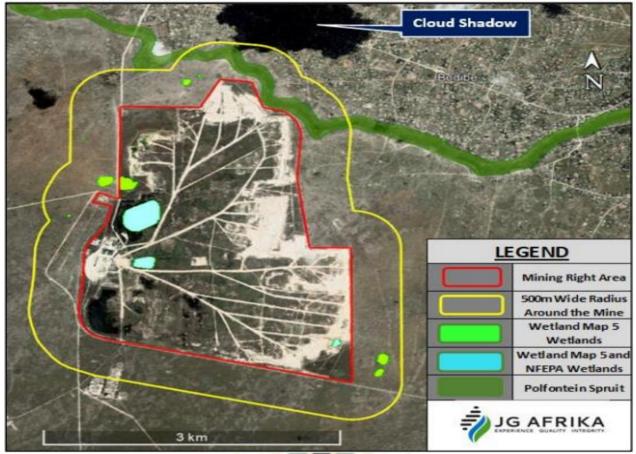
Figure 6: Wetlands in the Tswana Limestone Quarry study area

It is believed that the sites have **Moderately Low to Intermediate** Ecological Importance as they are able to support aquatic biodiversity in a region which is very dry at times. Site W1 is able to function as a refuge at times when other systems are completely dry on the surface, and so act as a source of recolonisation for times of wetter conditions (JG Afrika, Wetland Assessment, 2022).

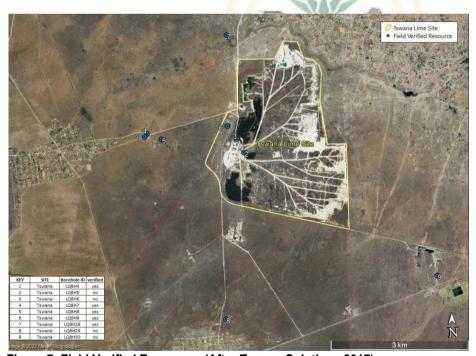
Figure 7: Field Verified Resources (After Tucana Solutions 2017)

The National Groundwater Archive (NGA) of the Department of Water and Sanitation was interrogated to establish the existence of any groundwater resources and groundwater use in proximity to the site. The NGA reported 74 (No.) resources within 5 km of the site. A field verification hydrocensus was also carried out. A total of nine (9 No.) resources were identified during the previous and current survey. One (1 No.) water supply borehole, four (4 No.) monitoring boreholes and three (3 No.) unused boreholes were identified (**Figure 7**). (JG Afrika, Geohydrological Assessment, 2022).

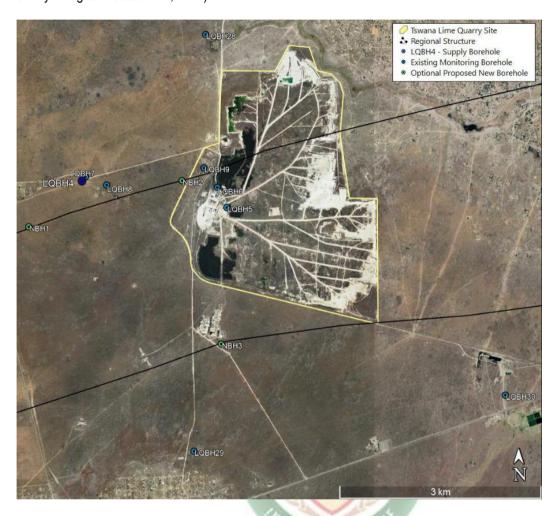
Figure 8: Tswana Lime Quarry Groundwater Monitoring Network

The existing and proposed groundwater monitoring locations are presented in **Figure 8**. It is noted that LQBH5 and LQBH6 need to be reinstated, and additional monitoring boreholes may include NBH1 to NBH3 to augment the data set (JG Afrika, Geohydrological Assessment, 2022).

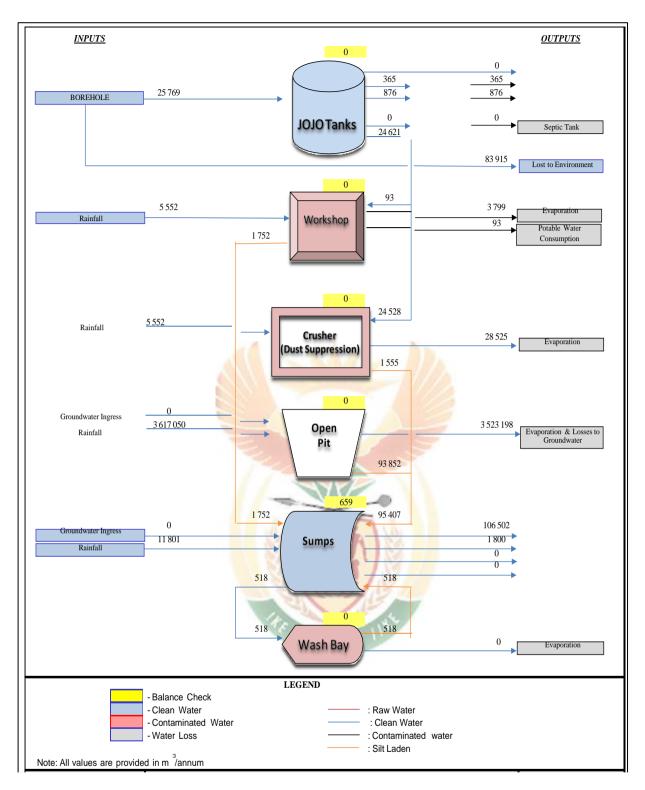
Figure 9: Tswana Lime Quarry Average Annual Water Balance

Borehole. The main source of water to the quarry is pumped from a borehole, located to the east of the quarry. Water is pumped from the borehole to the Jojo Tanks located near the workshop and administrative buildings. A significant amount of water is lost to the environment. This is as a result of leaks along the pipeline between the borehole and the Jojo Tank. Based on discussions with Lafarge, it is noted that community members have been known to puncture the pipeline, which causes a leak and allows them to access water for their livestock (JG Afrika, Water Balance, 2022).

Quarry Sumps. Located within the open pit are several sumps, located along the western edge of the pit. These sumps capture stormwater runoff from within the pit and stormwater from the workshop and administration building areas and the crusher area. Water from Quarry Sumps is used at the HDV wash bay and is also used for dust suppression on the roadways within the pit. Due to the interconnection between the sumps, and the fact that they are all located within the open pit, for the purposes of this water balance they have been considered as a single entity (JG Afrika, Water Balance, 2022).

Wash Bay. The wash bay is located within the open pit, on the southern banks of the Quarry Sump 1. During washing, water is pumped directly from the sump to a high-pressure spray gun. Water from the wash bay then runs off directly back into the sump area. During the site assessment no signs of hydrocarbon contamination were noted in the vicinity of the sump and surrounding vegetation (JG Afrika, Water Balance, 2022).
