INTEGRATED WATER AND WASTE MANAGEMENT PLAN FOR:
THE LAFARGE TSWANA LIMESTONE QUARRY ON A PORTION OF FARM DRIEFONTEIN 46 PORTION 0,
FARM RONDEFONTEIN PORTION 0 AND FARM RIETSCHRAAL 58 PORTION 0, NORTH WEST PROVINCE
IN WARD 17 WITHIN DITSOBOTLA LOCAL MUNICIPALITY, NGAKA MODIRI MOLEMA DISTRICT
MUNICIPALITY, NORTHWEST PROVINCE

Reference No: WU23173

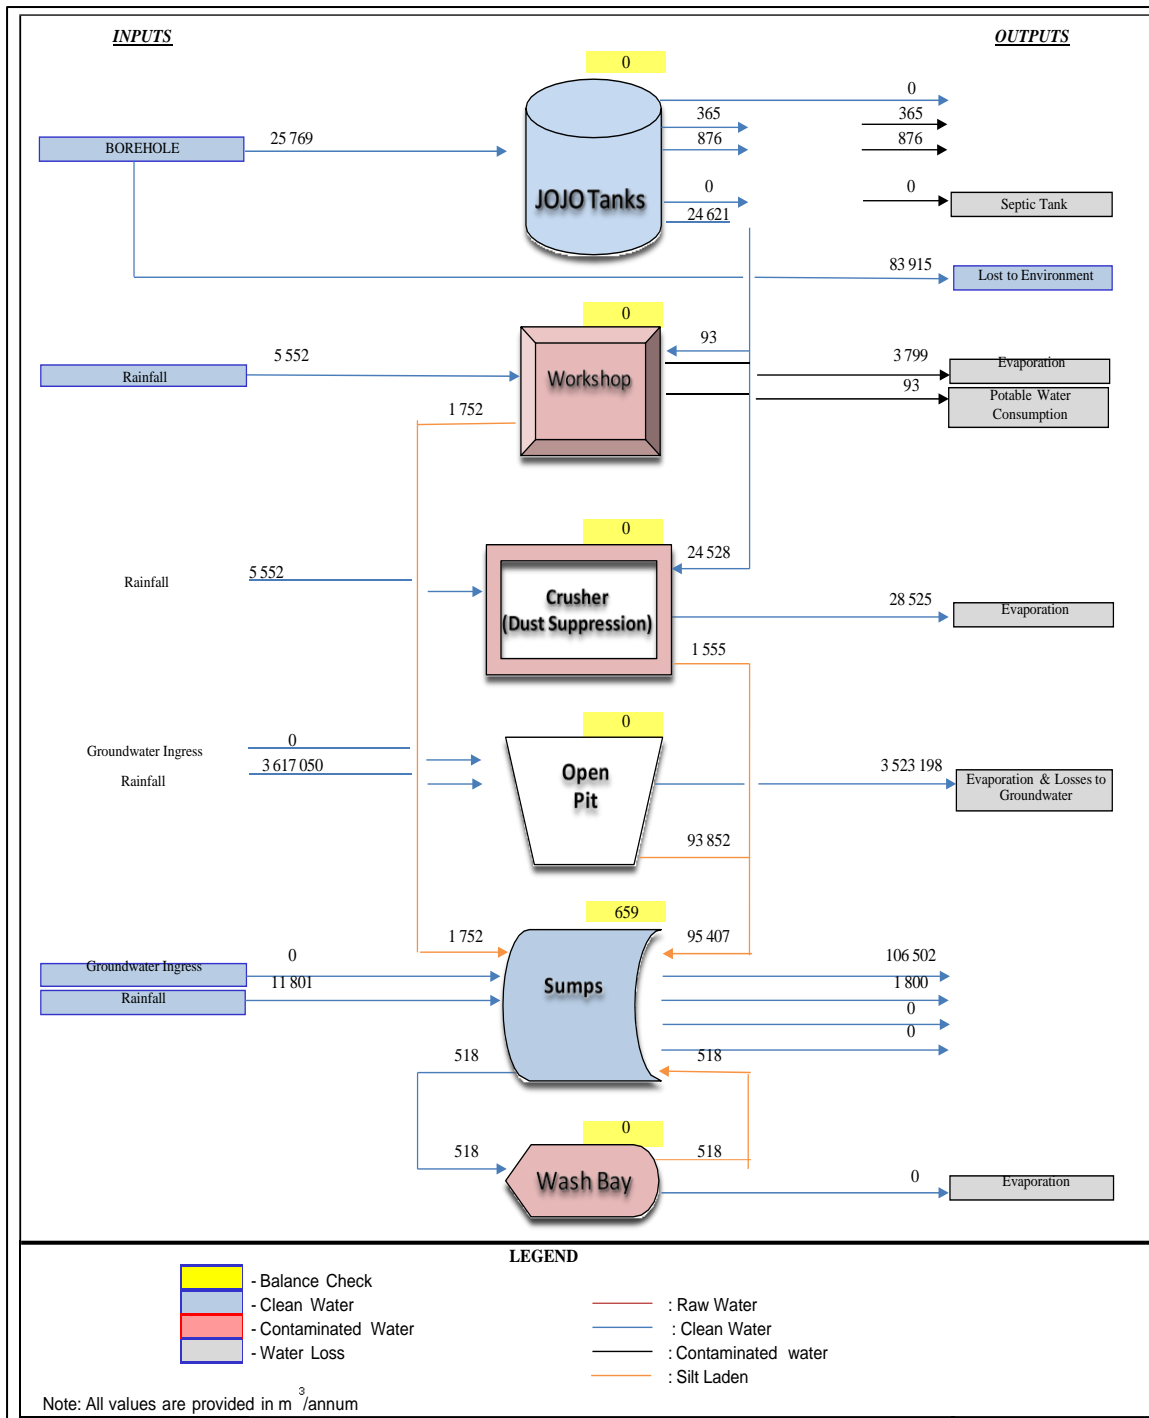
Figure 9: Tswana Lime Quarry Average Annual Water Balance

The water balance for the Tswana Lime Quarry was based on a number of assumptions (based on experience with similar projects), information supplied by management of the quarry and notes taken during a site visit in January 2022. The accuracy of the resulting water balance is therefore related to the accuracy of the assumptions/estimations made in the compilation of the water balance. The water balance compiled as part of this project provides average daily water movement in cubic meters for annual average, dry period average (based on the months of July) and wet period (based on the months of February (JG Afrika, Water Balance, 2022)).
