**ASSESSMENT OF TWO WETLANDS IN THE VICINITY OF THE
LAFARGE TSWANA LIMESTONE MINE NEAR BODIBE IN RELATION
TO A WATER USE LICENCE APPLICATION**

March 2022

Prepared by:
JG AFRIKA (PTY) LTD

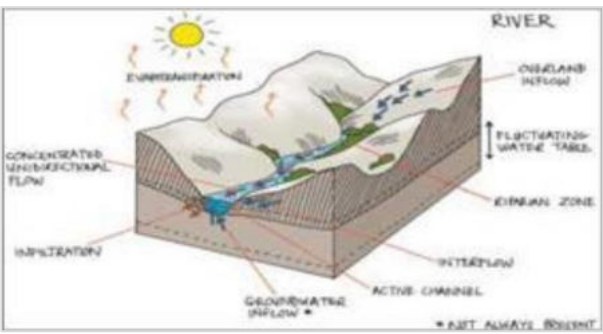
<p>Rivers are linear landforms with clearly discernible banks and a channel, which permanently or periodically, carries a contained and defined flow of water. A river is taken to include both the active channel and the riparian zone.</p>
Floodplain

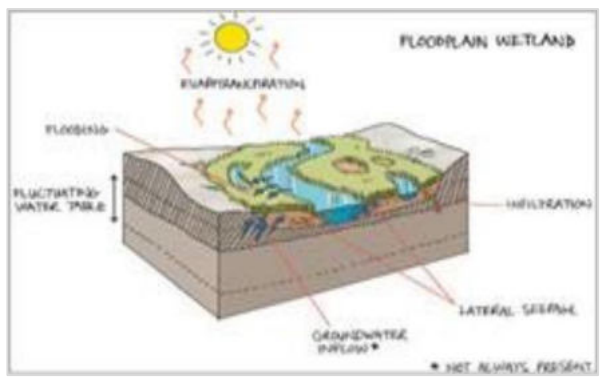
<p>Valley bottom areas with a well-defined stream channel, gently sloped and characterised by floodplain features such as oxbow depressions and natural levees and the alluvial (by water) transport and deposition of sediment, usually leading to a net accumulation of sediment. Water inputs from main channel (when channel banks overspill) and from adjacent slopes.</p>

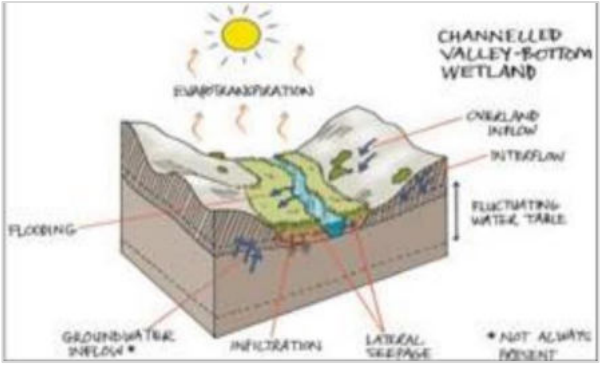
<p>Valley bottom areas with a well-defined stream channel but lacking characteristic floodplain features. May be gently sloped and characterised by the net accumulation of alluvial deposits or may have steeper slopes and be characterised by the net loss of sediment. Water inputs from main channel (when channel banks overspill) and from adjacent slopes.</p>
Valley bottom without a channel

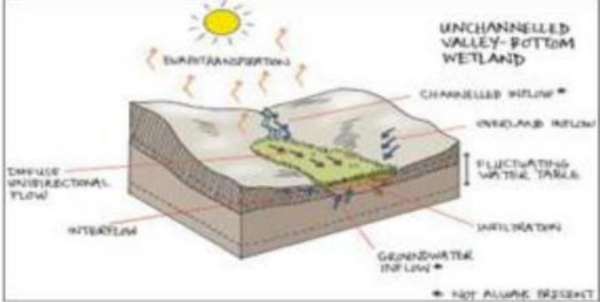
<p>Valley bottom areas with no clearly defined stream channel, usually gently sloped and characterised by alluvial sediment deposition generally leading to a net accumulation of sediment. Water inputs mainly from channel entering the wetland and also from adjacent slopes.</p>
Hillslope seepage linked to a stream channel

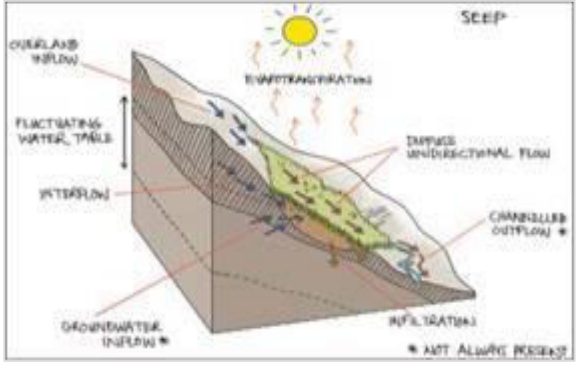
<p>Slopes on hillsides, which are characterised by the colluvial (transported by gravity) movement of materials. Water inputs are mainly sub-surface flow and outflow is usually via a well-defined stream channel connecting the area directly to a stream channel.</p>

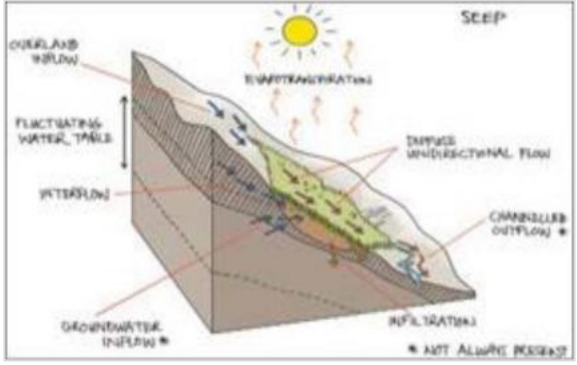
<p>Similar to other hillslope seeps but with no direct surface water connection to a stream channel. Slopes on hillsides, which are characterised by the colluvial (transported by gravity) movement of materials. Water inputs mainly from sub-surface flow and outflow primarily by diffuse sub-surface and/or limited surface flow.</p>

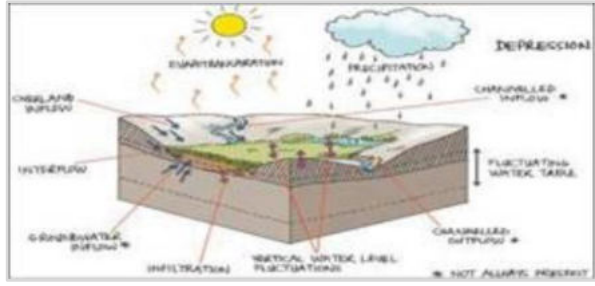
<p>A basin shaped area with a closed elevation contour that allows for the accumulation of surface water (i.e. it is inward draining). It may also receive sub-surface water. An outlet is usually absent, and therefore this type is usually isolated from the stream channel network.</p>
Wetland Flat

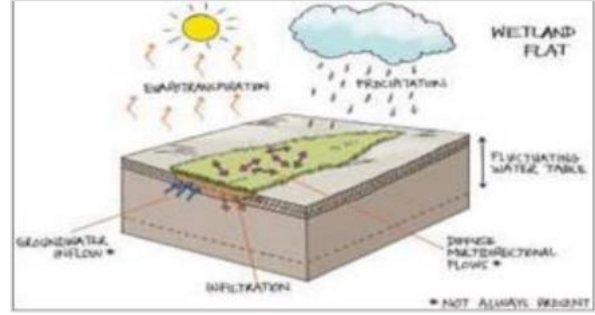
<p>A flat wetland with no apparent inlet or outlet points. Water is obtained from surface or near surface flows and is lost either by downward percolation or evapotranspiration. May be only seasonal in terms of its wetness and hydromorphic soils may be only weakly developed or else be absent. Vegetation may be the strongest indicator.</p>

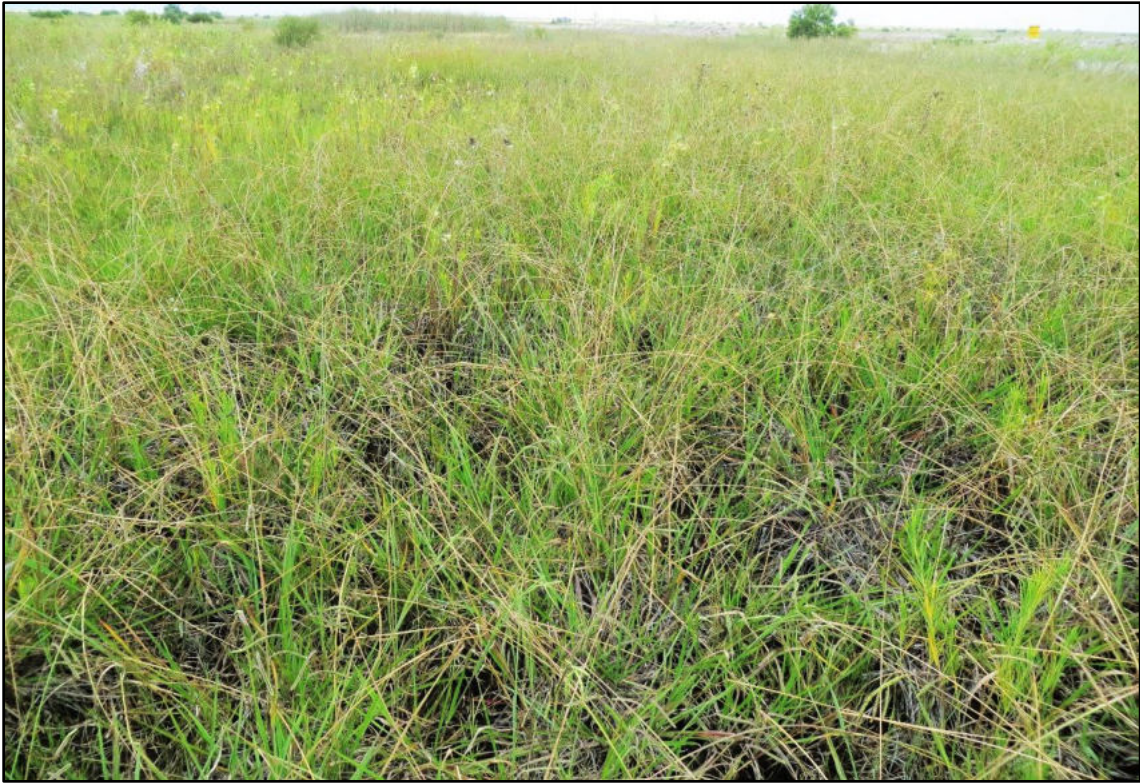
Plate 1: View of hygrophilous grassland (the ground was damp underfoot)

Table 5 and Plate 1. It was, however, noted that such conditions are not permanent since plants such as *Hyparrhenia tamba* (Thatch Grass), *Gomphocarpus fruticosus* (Cotton Milkweed), and *Searsia lancea* (Karee), which are not commonly found in waterlogged conditions, were also present. Plants found in more natural conditions in the 500 m radius around the mining right area are listed in Table 9.

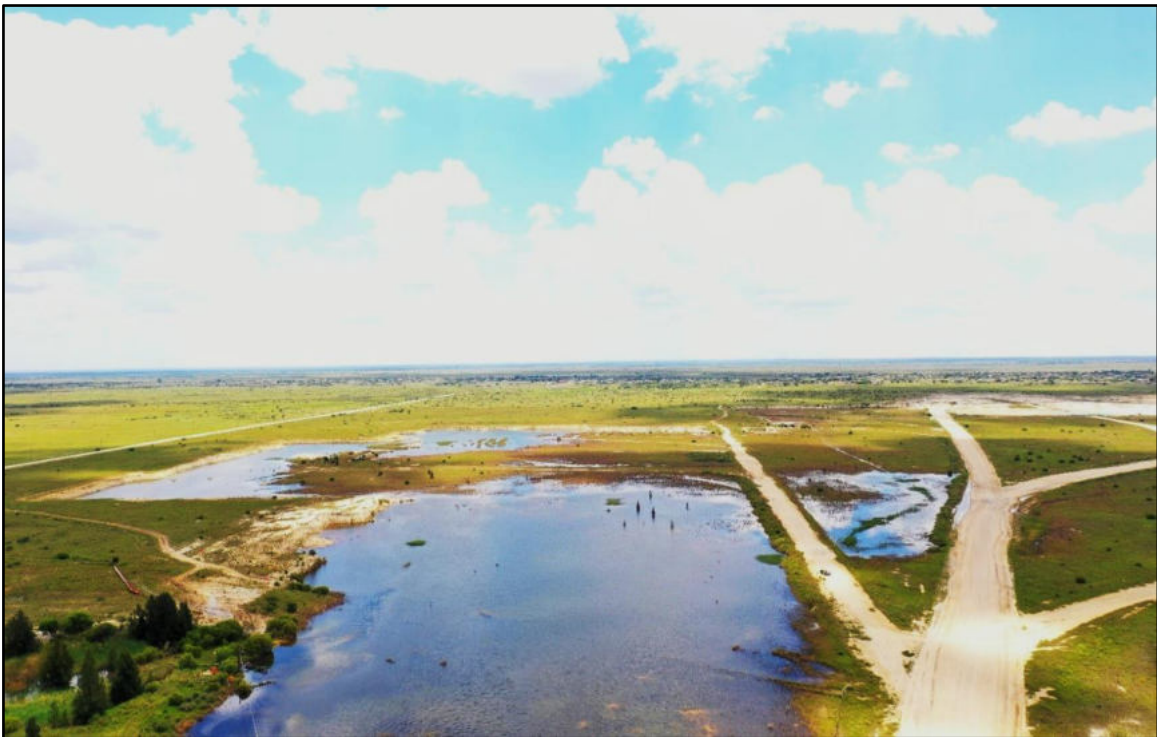
Plate 2: View of depression wetlands (these areas dry out completely during the drier winter months)

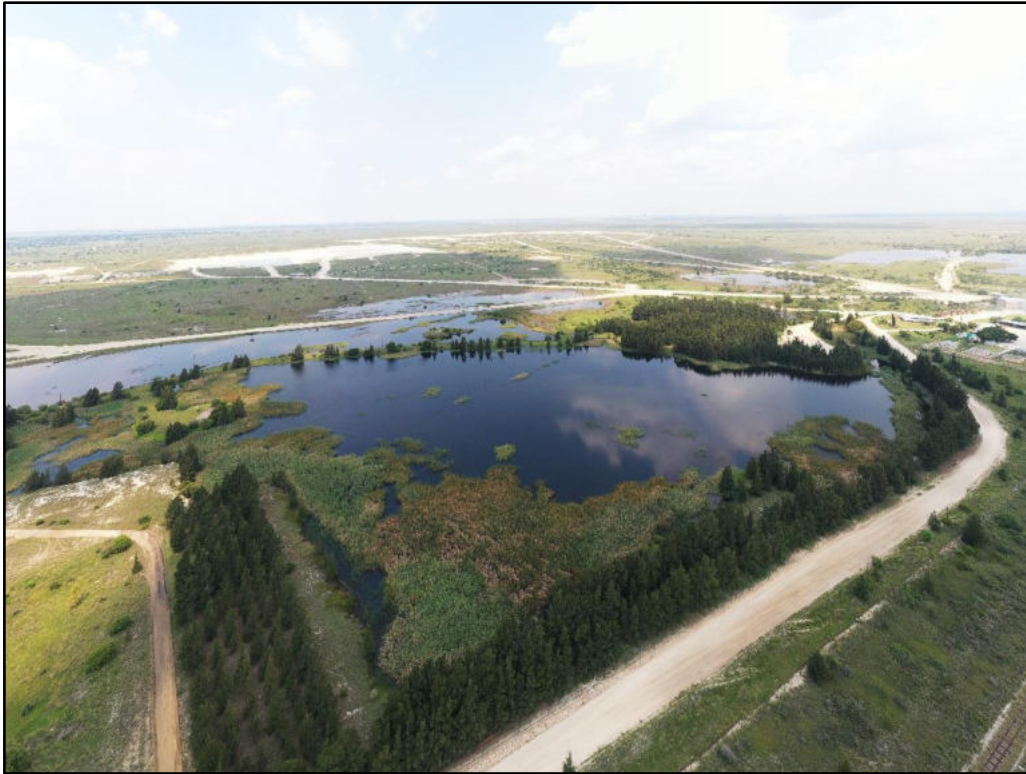
Plate 3: View of a mine pit wetland (note the marginal emergent vegetation)

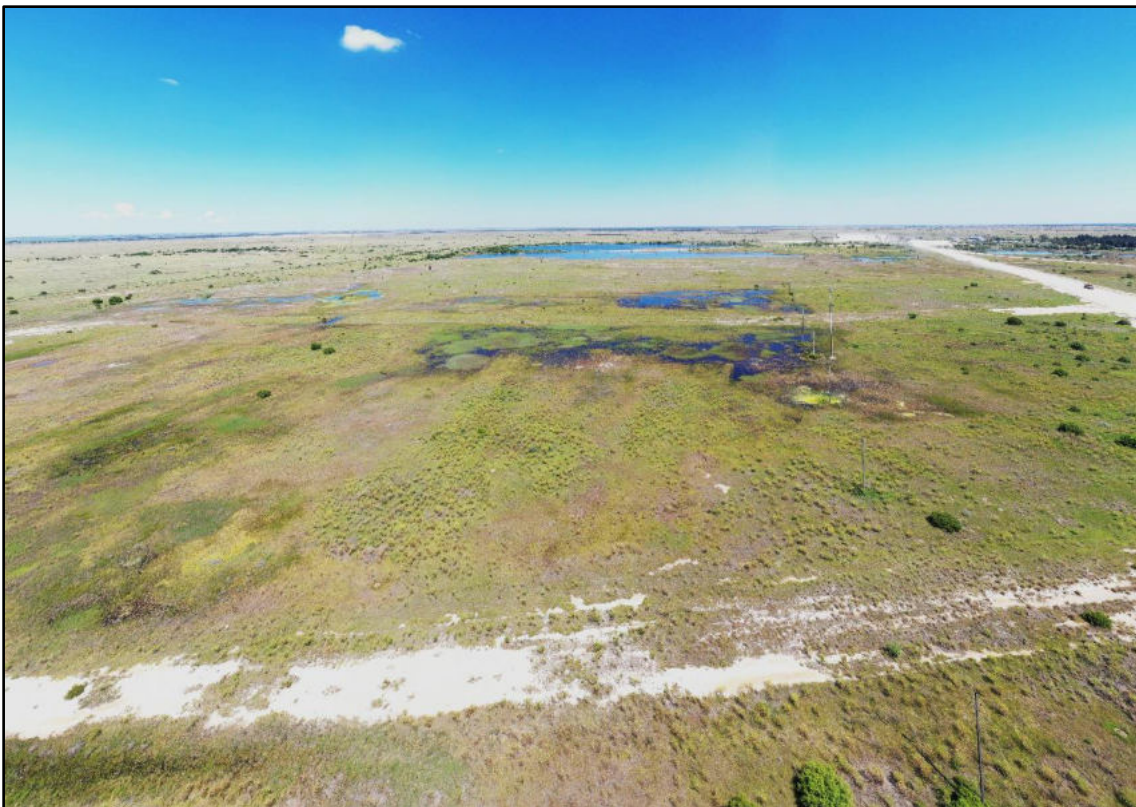
Plate 4: View of a depression wetland area (note the reworked ground surface)

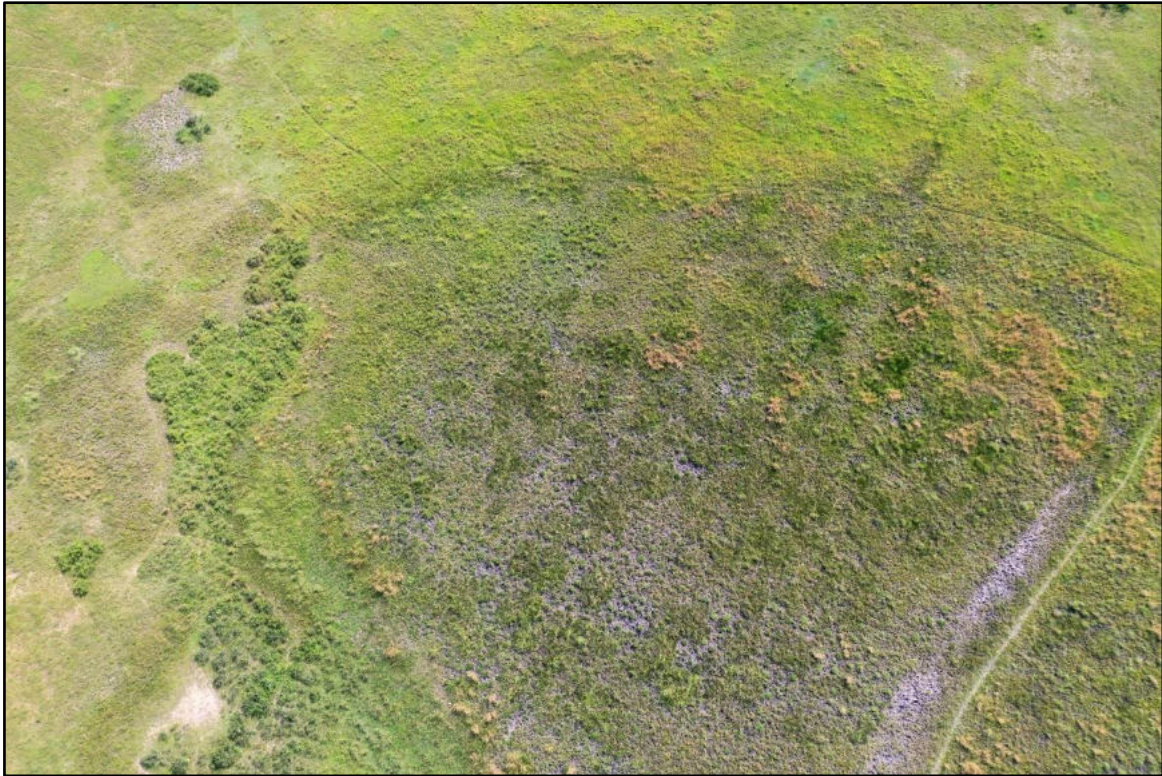
Plate 5: View of a depression wetland outside the mining area (note the intact vegetation)

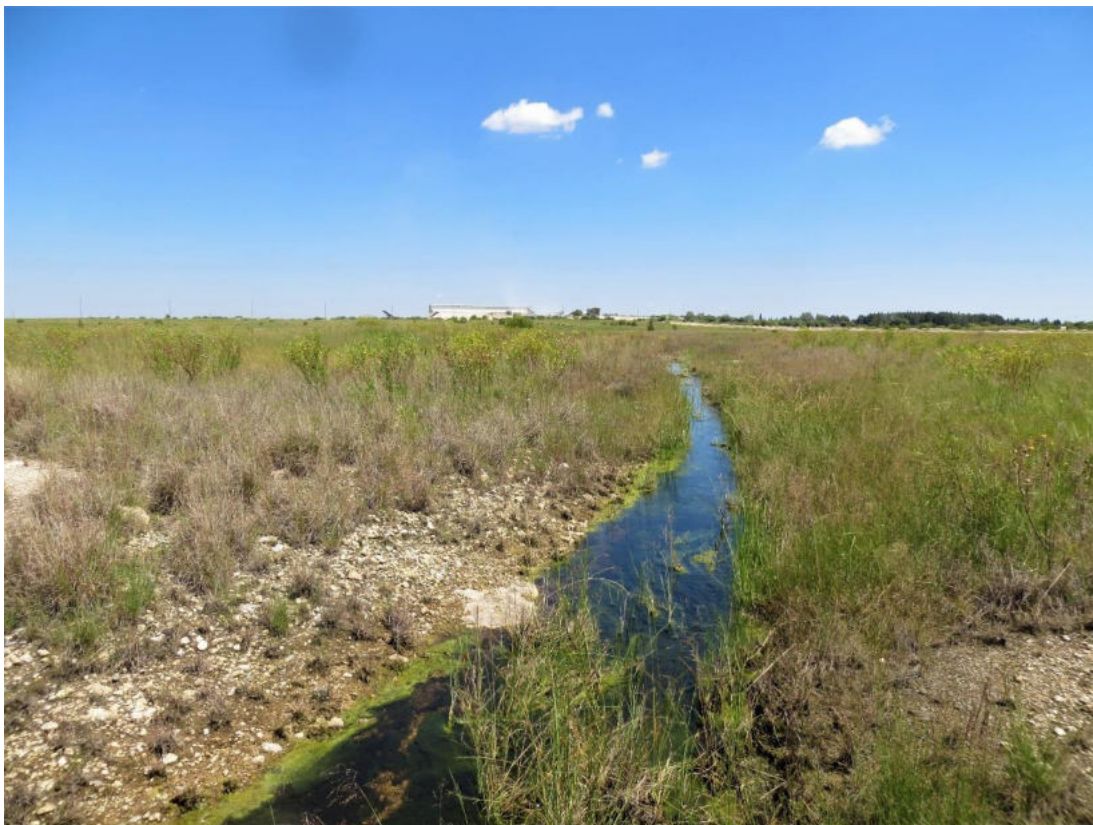
Plate 6: View of an excavated ditch leading from a depression wetland to a pit wetland

Saturated (Phreatic) Zone. See Figure 9. Rainfall is of considerable importance to these wetlands as the depth of water table will be driven by it. In general, the mine pit wetlands have no channeled outflow, and so are endorheic, while some of the depression wetlands do have excavated outflow channels which usually lead to a nearby mine pit wetland. See Plate 6.

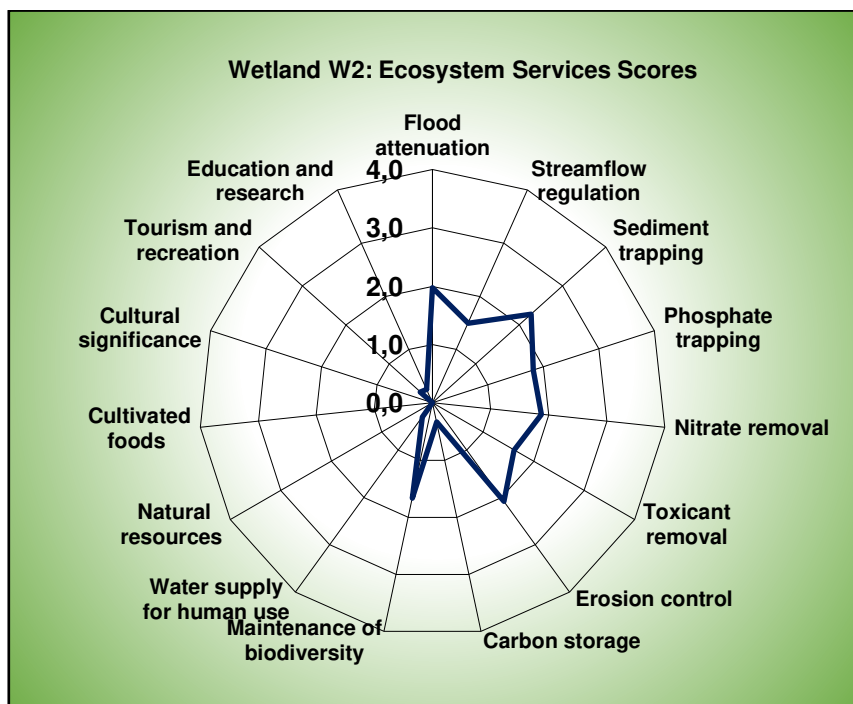
Figure 11: Ecosystem service delivery at Wetland W2

The WET-Ecoservices model indicates that the levels of ecosystem service delivery from the three wetlands are generally “Intermediate” to “Low”. Even the higher scores obtained for services such as “Flood Attenuation”, “Sediment Trapping” and “Erosion Control” are misleading since the figures are based on the vegetation cover in the sites but are meaningless as the sites generally have no inflows or outflows that leave the area. Wetland W3 does offer some benefit in the form of “Natural Resources” (provision of grazing for livestock) which the others do not offer.

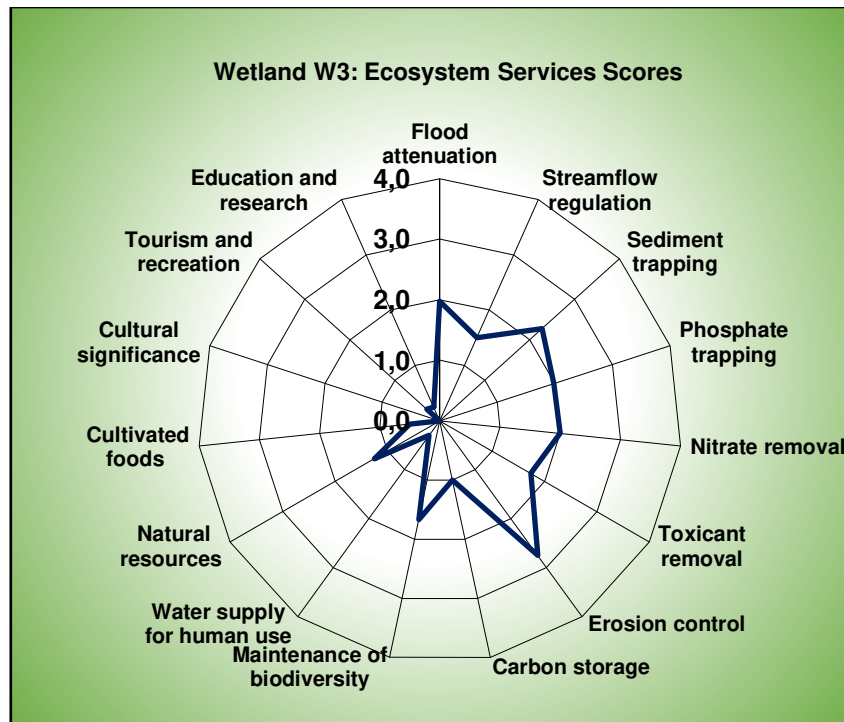
Figure 12: Ecosystem service delivery at Wetland W3

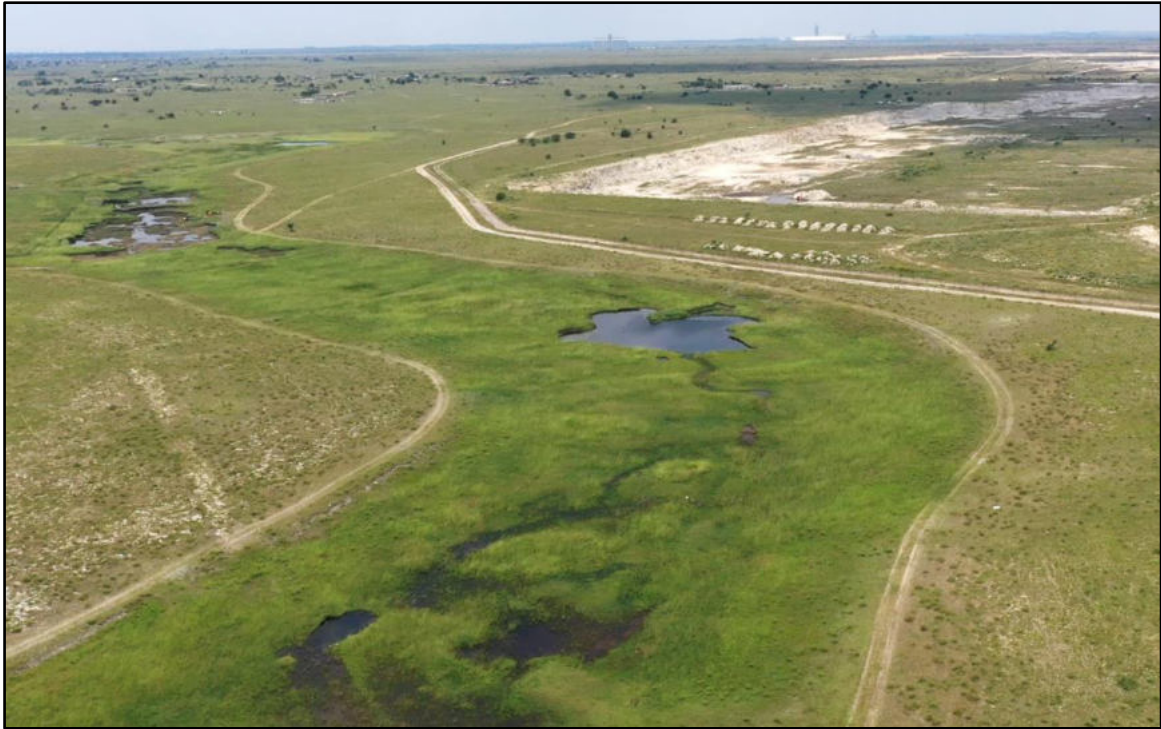
Plate 7: Aerial image of a section of the Polfontein Spruit

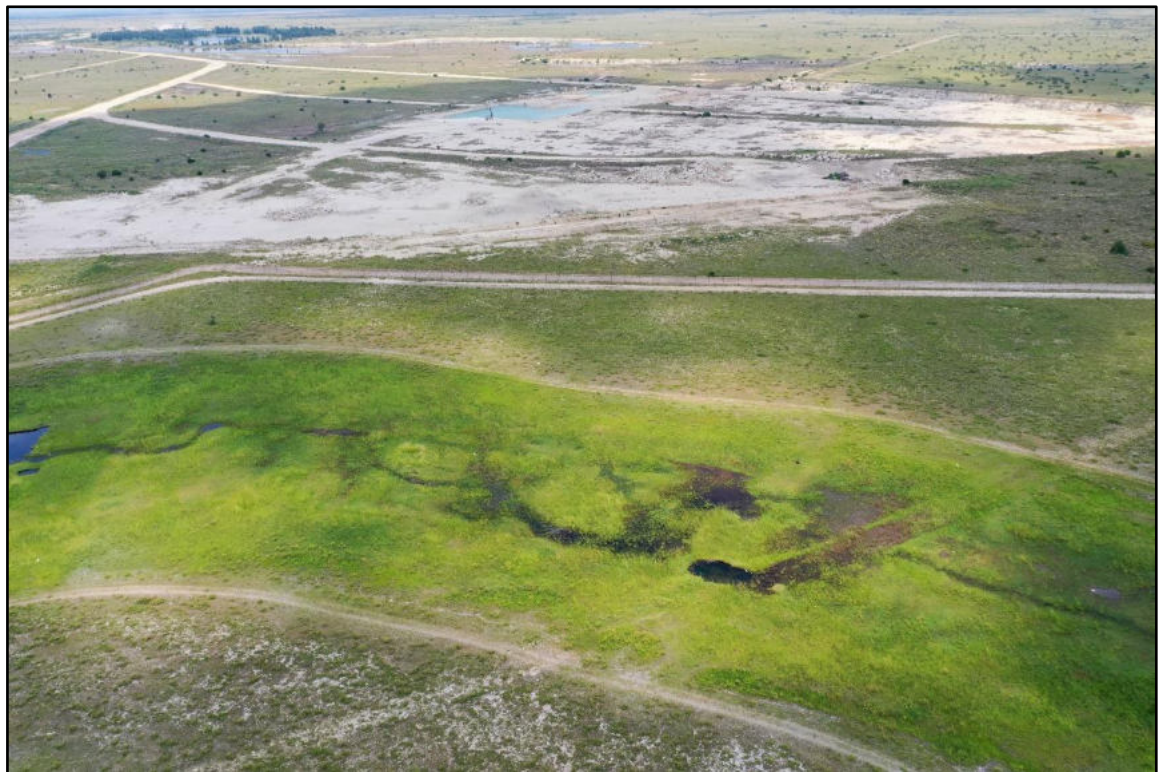
Plate 8: Aerial image of a section of the Polfontein Spruit

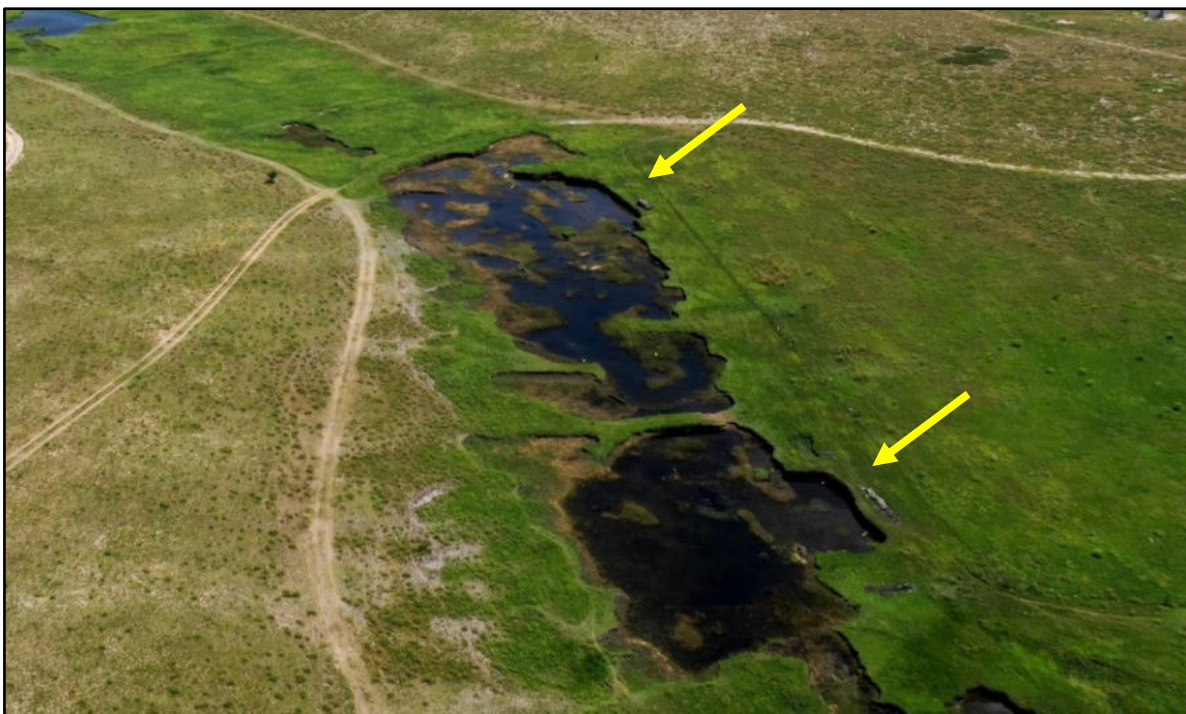
Plate 9: Excavated pit in the Polfontein Spruit with piles of blocks indicated

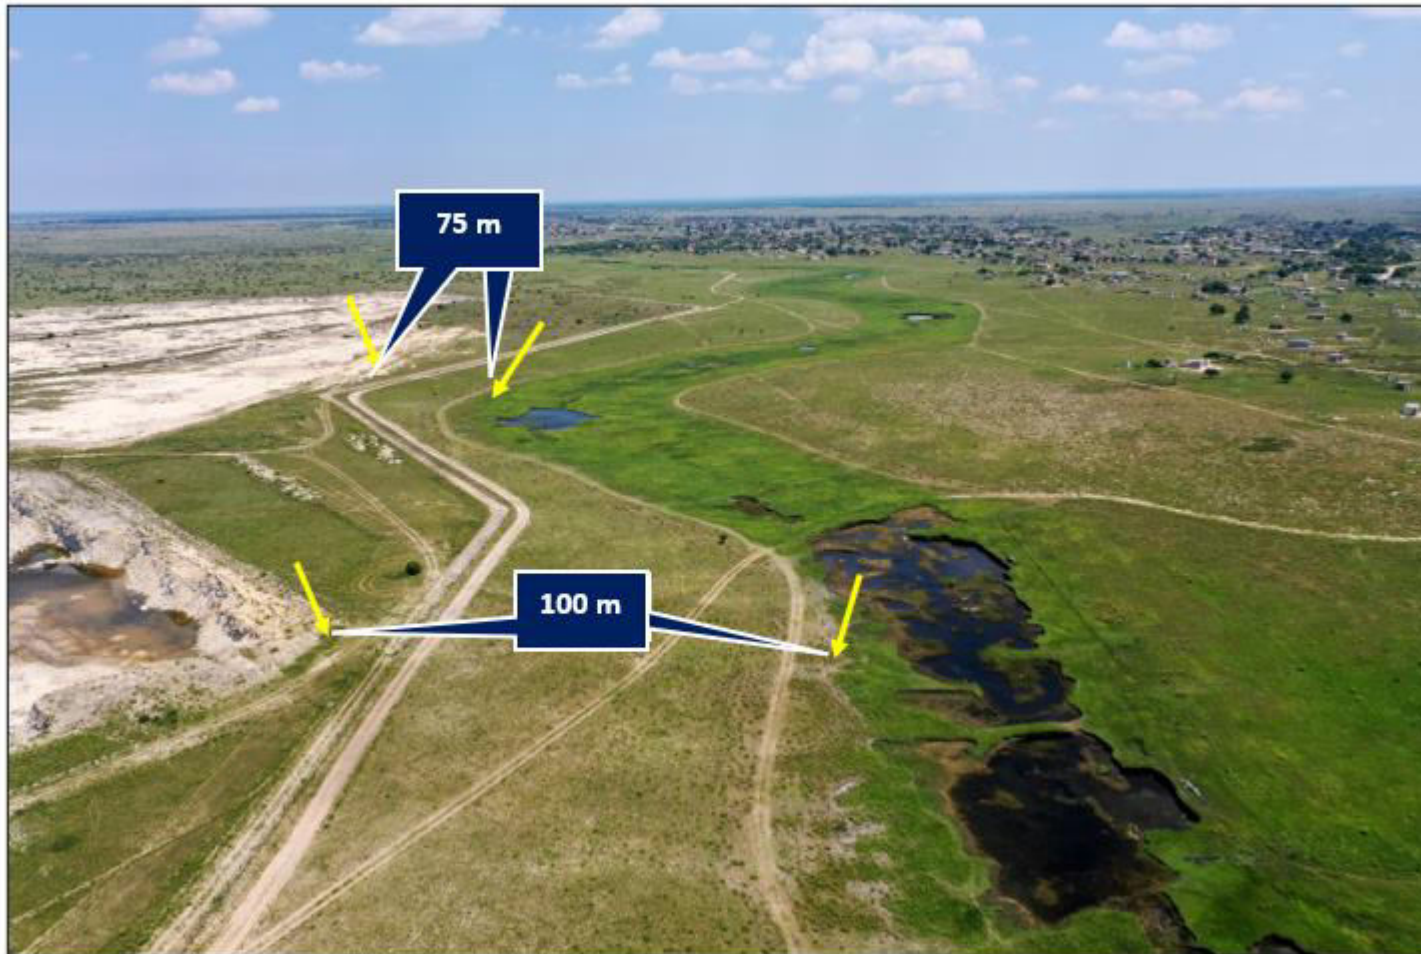
Figure 16: Northern edge of the present mine at the two points closest to the Polfontein Spruit
