DOORNEKRAAL MINE ON A PORTION OF PORTION 5 OF THE FARM DOORNEKRAAL NO 830, MALMESBURY, SWARTLAND DC, WESTERN CAPE PROVINCE

ENVIRONMENTAL AUDIT REPORT

DMR REFERENCE NUMBER:	WC30/5/1/3/2/10115MP
AUDIT PERIOD:	MARCH 2021

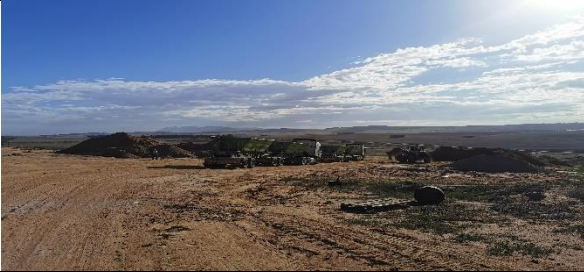
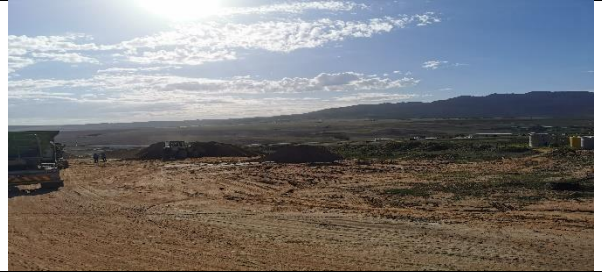
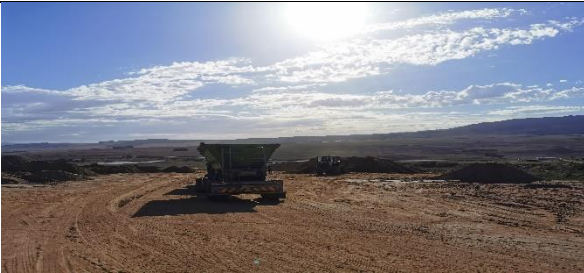
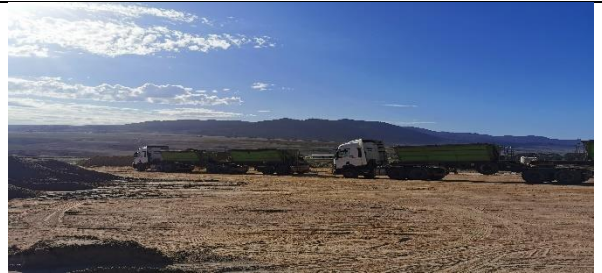
MINING PERMIT AREA

All mining activities and infrastructure are taking place within the permit boundary area.

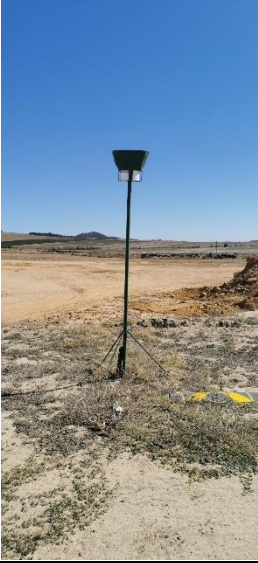
UNIT 1

The fallout dust monitoring was implemented on the 27th of June 2018, Monitoring results has thus far proved that dust emissions are within the guidelines. This site has a monthly dust monitoring cycle that is changed on the same date as ECO inspection. No change was done in January 2021. Buckets were installed in December and removed on 26 February, next units were changed on the 26th of March 2021.
