# DOORNEKRAAL MINE ON A PORTION OF PORTION 5 OF THE FARM DOORNEKRAAL NO 830, MALMESBURY, SWARTLAND DC, WESTERN CAPE PROVINCE

## ENVIRONMENTAL AUDIT REPORT

<b>DMR REFERENCE NUMBER:</b>	<b>WC30/5/1/3/2/10115MP</b>
<b>AUDIT PERIOD:</b>	<b>APRIL 2021</b>

# ENVIRONMENTAL PERFORMANCE ASSESSMENT DOORNEKRAAL

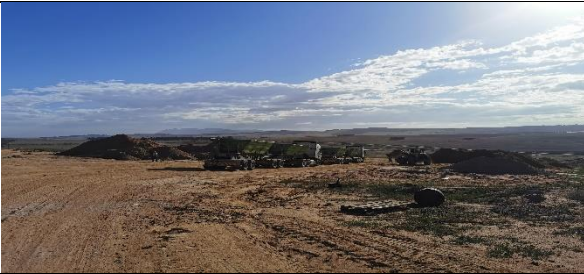
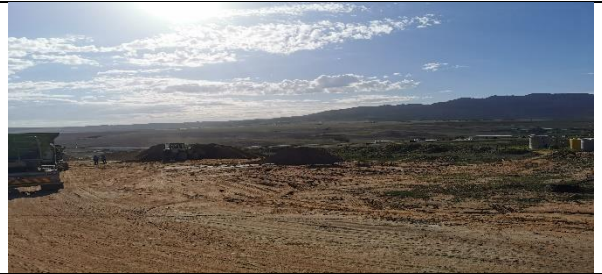
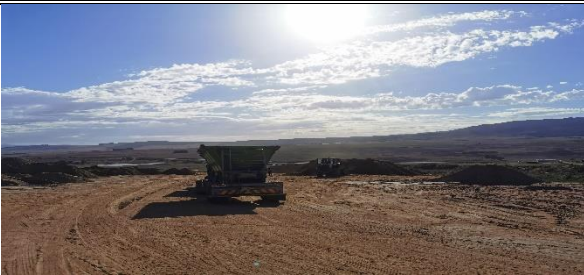
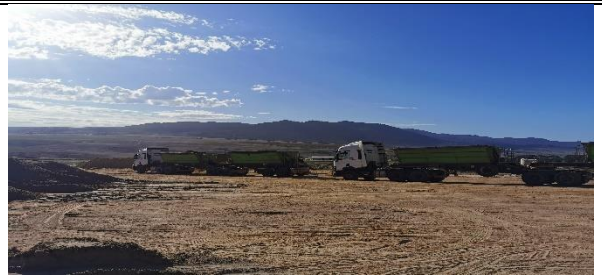
### MINING PERMIT AREA

All mining activities and infrastructure are taking place within the permit boundary area.

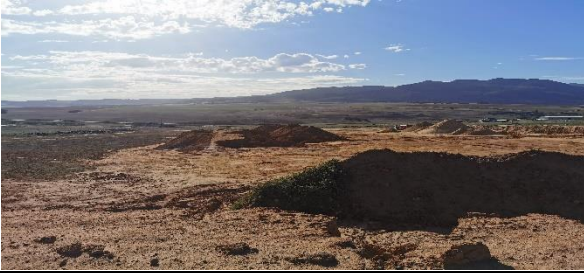
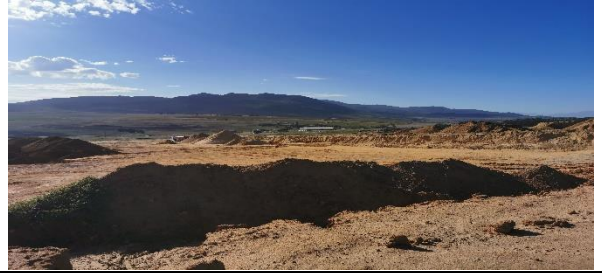
**CURRENT OPEN AREAS TO BE REHABILITATED ONCE ALL THE MATERIAL IS SOLD. NO EXCAVATION WILL BE DONE UNTILL THIS SECTION IS REHABILITATED.**

1. Remove the weeds that is currently visible on some of the stockpiles.
2. Rehabilitate open mining area.

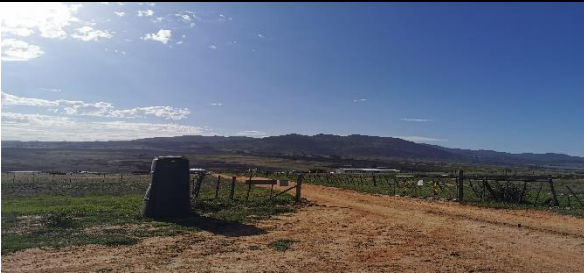
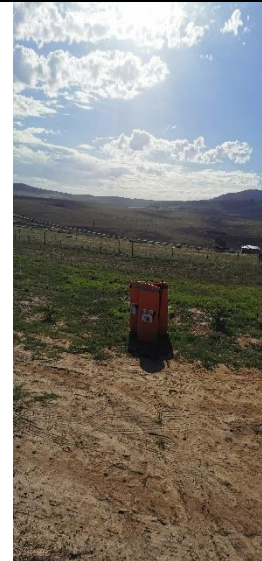
**WASTE CONTAINER BINS**

The client has placed three sealable refuge bins on site. For hazardous waste, general waste and Non-biodegradable waste. Up to date no hazardous waste was generated on site. A register must be kept on site with proof of waste removals. ***An oil spill kit must be kept on site.***

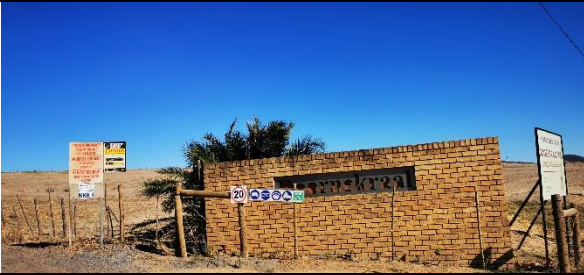
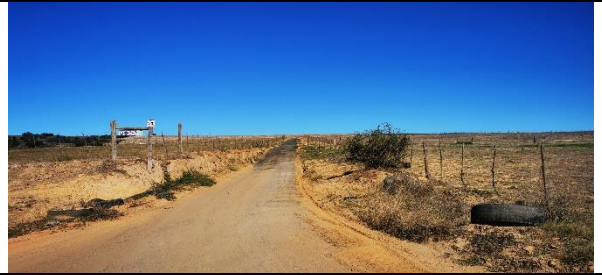
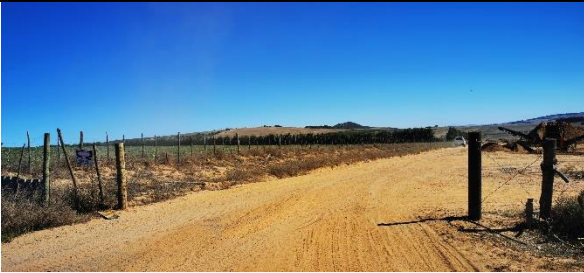
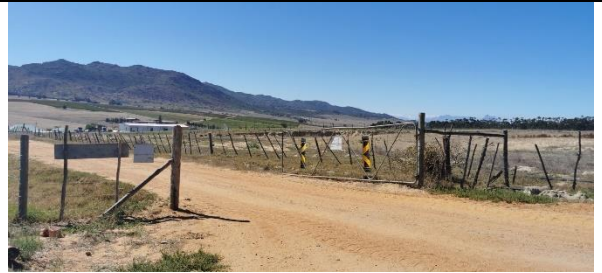
**MINING SIGNAGES**

Vehicles utilising the access road must restrict speed to 40km/h. The client implemented a 20km/h restriction.

These restrictions were erected and placed in all the areas which are highly visible.

Workers were inducted and informed of EMP conditions. All workers signed as confirmation of understanding the induction. Appropriate notification signage was erected at the mining site. This gives a clear warning to the public about the hazard around the mining site and presence of heavy vehicles and machinery.

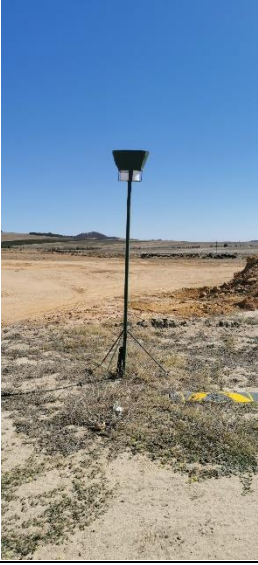
**UNIT 1**

The fallout dust monitoring was implemented on the 27th of June 2018, Monitoring results has thus far proved that dust emissions are within the guidelines. This site has a monthly dust monitoring cycle that is changed on the same date as ECO inspection. No change was done in January 2021. Buckets were installed in December and removed on 26 February, next units were changed on the 26<sup>th</sup> of March 2021.
