## ***WATER USE LICENCE APPLICATION*** ***Geohydrological Assessment***

**Wisteria Boerdery (Pty) Ltd  
PO Box 254  
Patensie  
6335**

Report: DHS-22-192

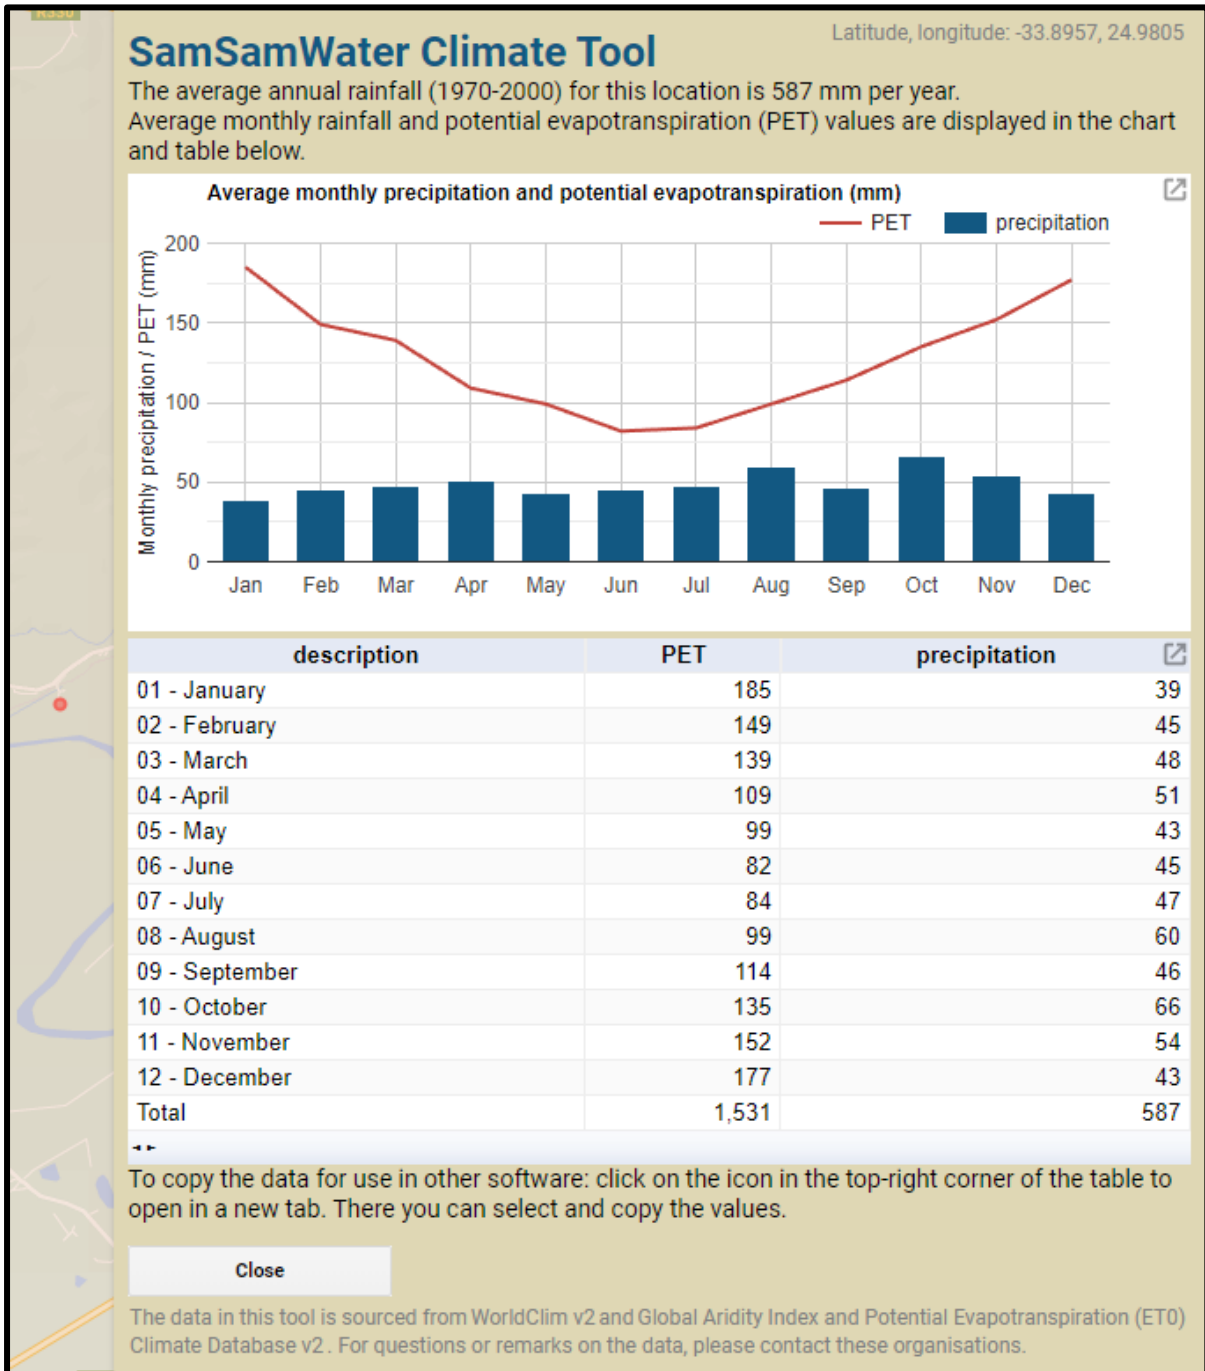
**Figure 1. Precipitation and Evapotranspiration within the project area**

Meteorological data obtained from SamSam Water Climate Tool<sup>1</sup> is presented in Figure 1. Figures of 587 mm for the mean annual precipitation (MAP) and 1531 mm for the mean annual evaporation (MAE) is reported. The MAE exceeds the MAP by an order of magnitude, resulting in a negative moisture index. Rainfall within the study area is bimodal where both summer and winter rainfall occurs, a feature typical of the south-east coastal region of the country.

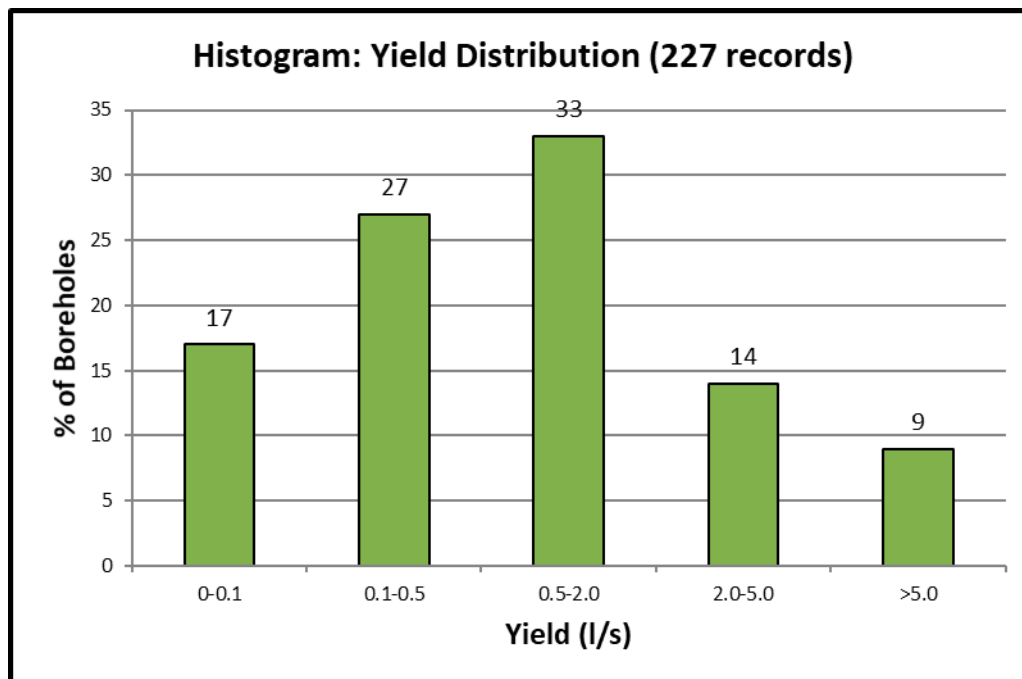
**Figure 2. Yield Frequencies of borehole in the Uitenhage Group**

The Uitenhage beds are described as a dense mass of rock with low permeability and limited groundwater potential. A borehole yield analysis indicates that close to 40% of successful boreholes yield less than 0.5 l/s. This does not account for unsuccessful boreholes which were destroyed or backfilled, which makes the success rate even worse.

Higher borehole yields are not uncommon, with yields of 2-5 l/s and >5 l/s (14% and 9% of borehole yields on record respectively) being reported, but this is not the norm.

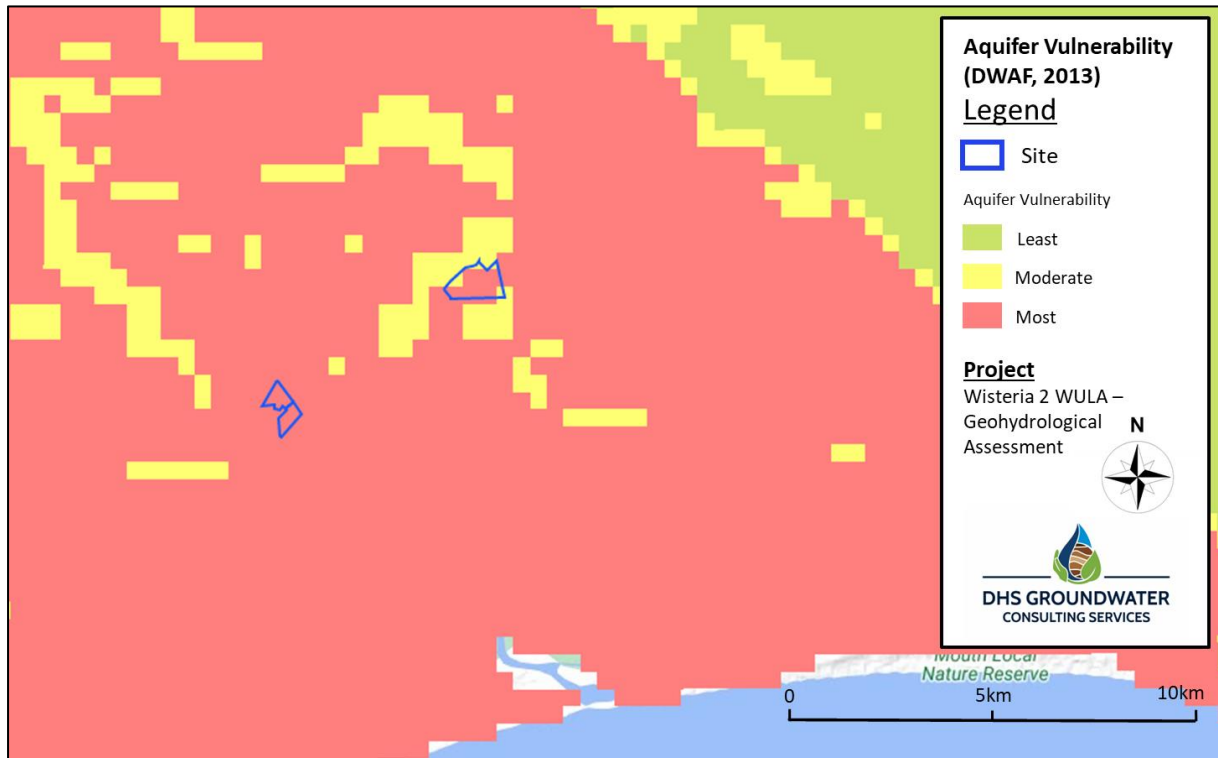
**Figure 3. Regional groundwater vulnerability for the study area (DWAF, 2013).**

Green represents the least vulnerable region that is only vulnerable to conservative pollutants in the long term when continuously discharged or leached
Yellow represents the moderately vulnerable region, which is vulnerable to some pollutants, but only when continuously discharged or leached.
Red represents the most vulnerable aquifer region, which is vulnerable to many pollutants except those strongly absorbed or readily transformed in many pollution scenarios.

The vulnerability of the aquifers within the project area is rated as “moderately to most vulnerable to pollutants”.

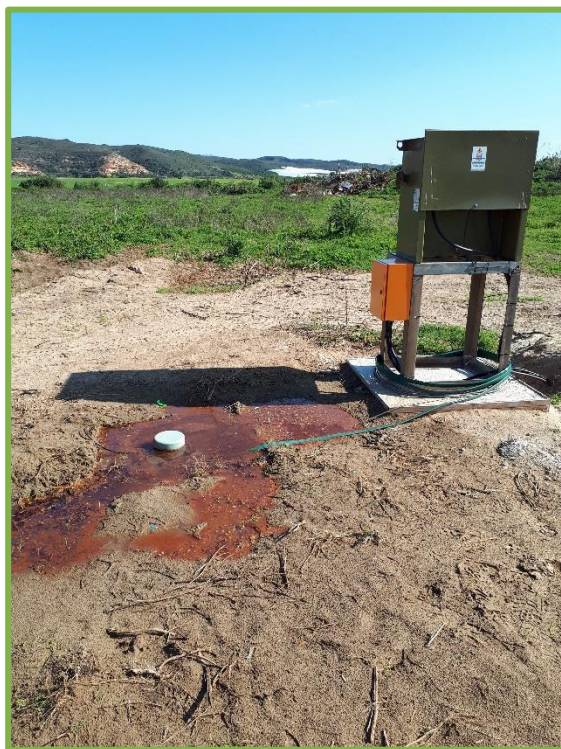
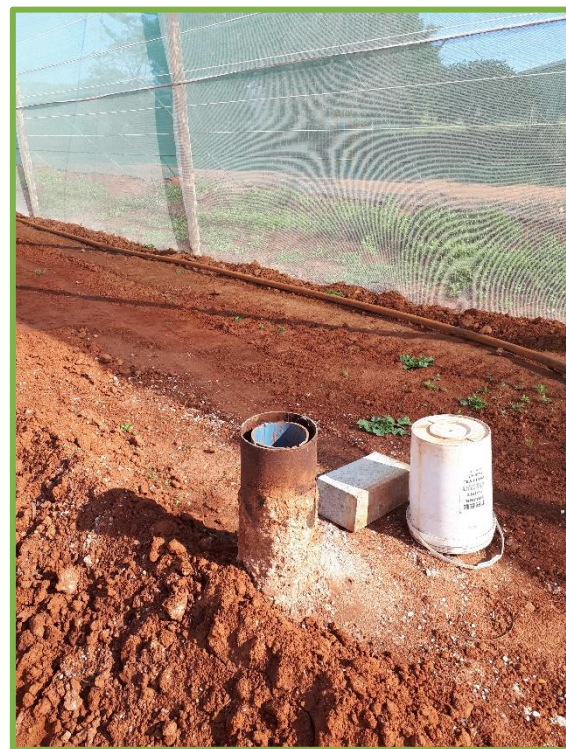
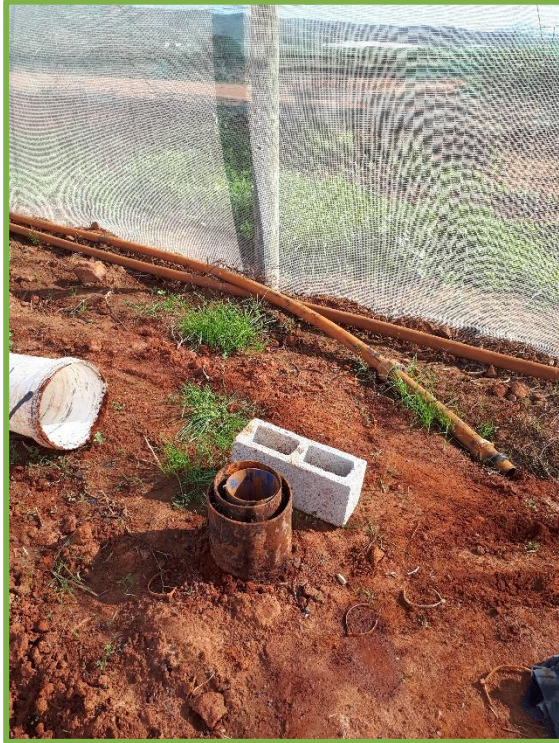
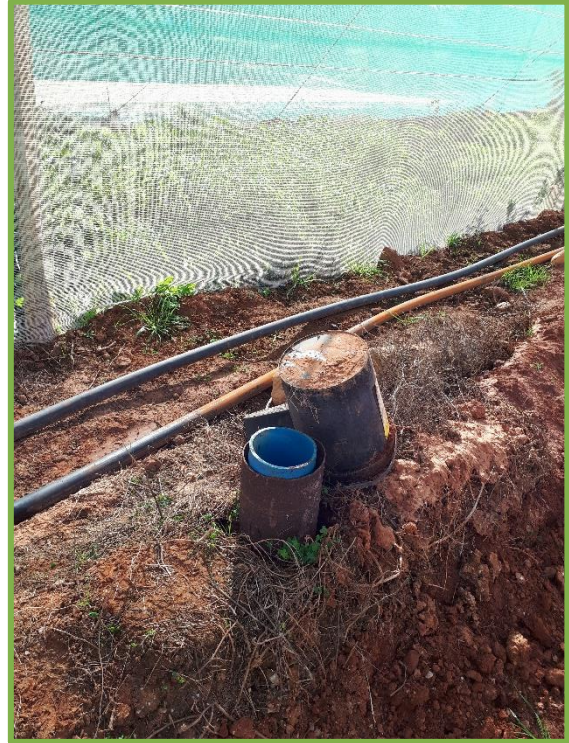
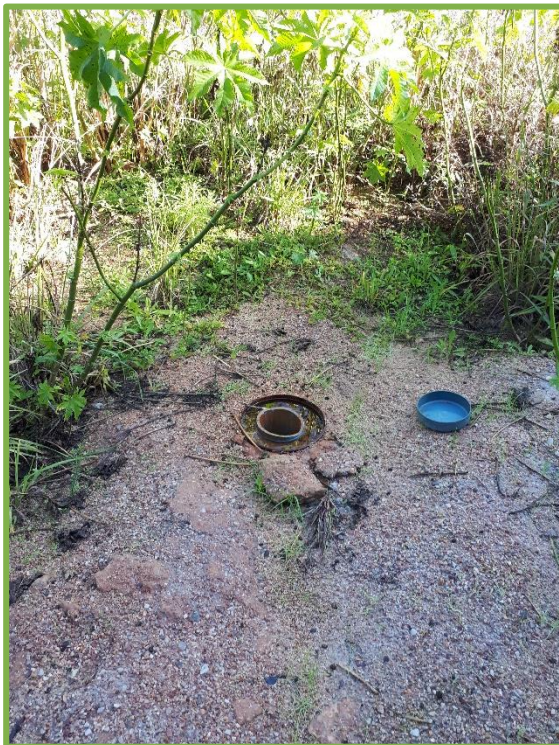
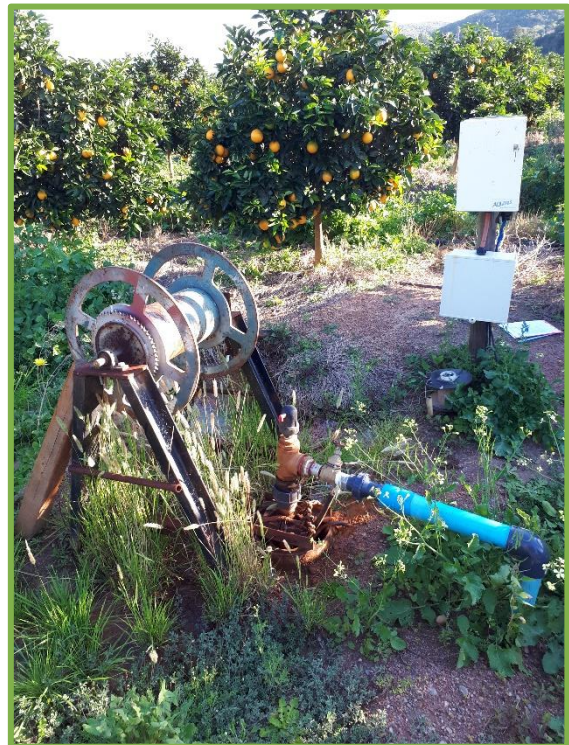
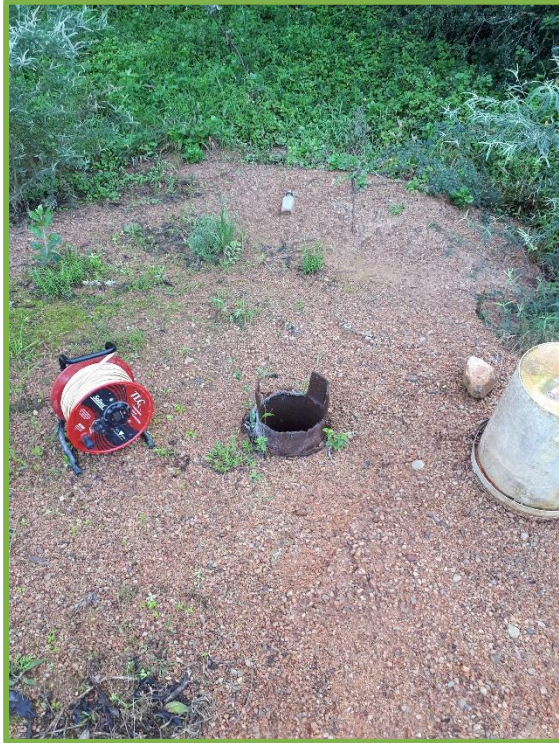
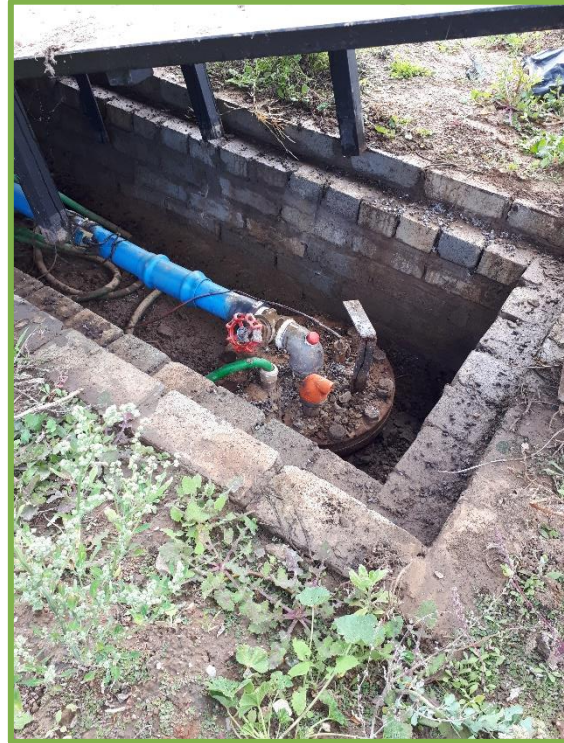
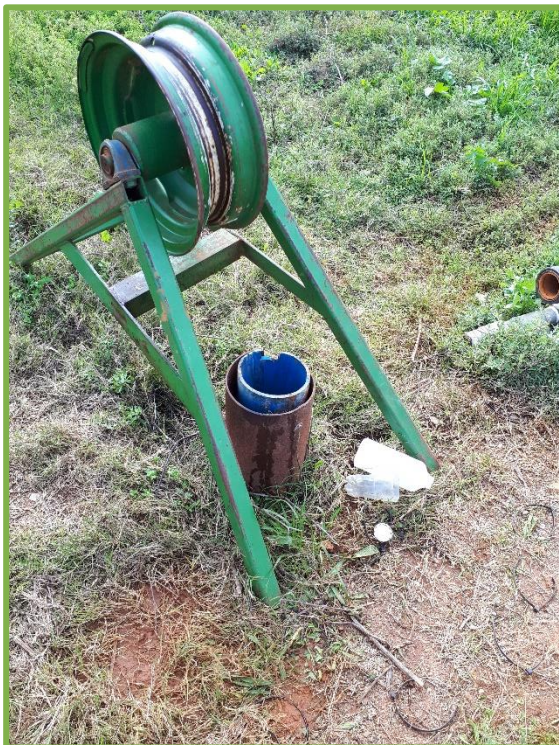
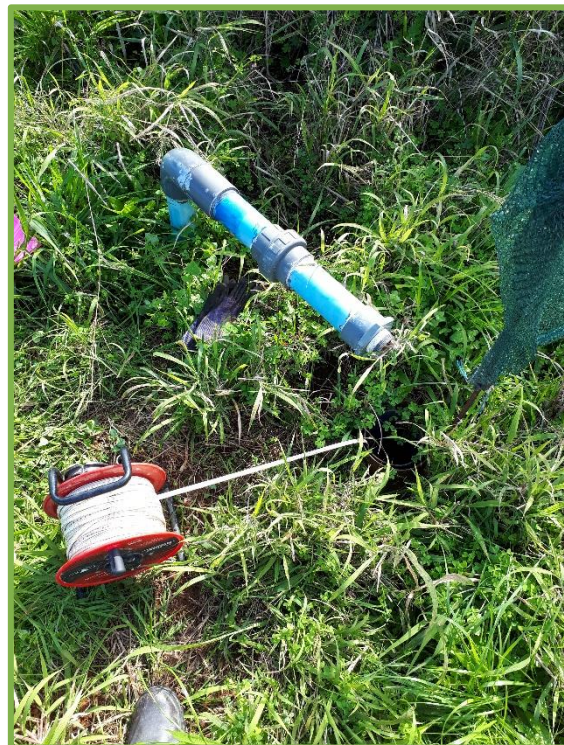
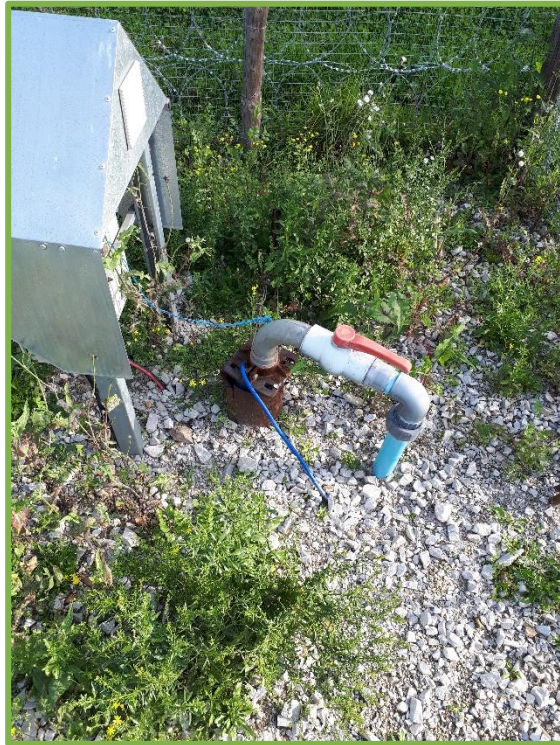
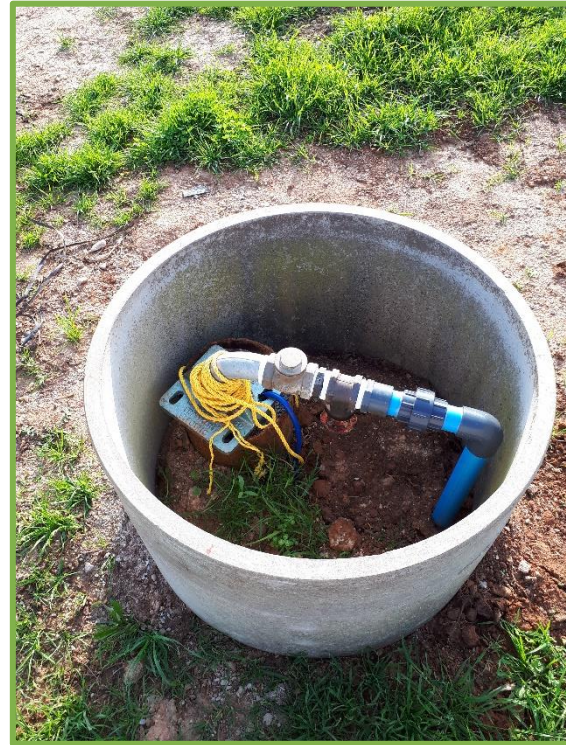
**Figure 5. Borehole Photos on neighbouring properties**

BH nr	Coordinates Decimal Degrees (WGS84)	Depth (m)	Estimated Yield (l/s)	EC (mS/m)	Static water level (mbgl)	Equipment	Water Use	Property Owner (Cell nr.)
JFBH1	S -33.910634 E 024.943598	250	12.64	99	0	Submersible	Irrigation	Julian Ferreira (082 498 0166)
Josef 6	S -33.902730 E 024.947390	147.9	5	272	27.55	Unequipped	~	Lomon Ferreira (071 175 3715)
Josef 5	S -33.903060 E 024.947140	149.1	1.94	146	26.35	Unequipped	~	Lomon Ferreira (071 175 3715)
Josef 4	S 33.745838 E 024.759844	148.9	~	203	25.59	Unequipped	~	Lomon Ferreira (071 175 3715)
PMBH1	S -33.869629 E 025.002186	303	2.08	105	0.93	Unequipped	~	Pierrie Moolman (072 047 5971)
ALBH1	S -33.876278 E 025.002399	300	11.11	75	1.94	Submersible	Irrigation	Ashley Ludwig (082 324 9316)
PMBH2	S -33.874544 E 024.995506	133.3	~	1830	4.03	Unequipped	~	Pierrie Moolman (072 047 5971)
JMBH1	S -33.887496 E 024.993290	303	1.94	73	~	Submersible	Irrigation	Jaco Muller (082 371 2735)

BH nr	Coordinates Decimal Degrees (WGS84)	Depth (m)	Estimated Yield (l/s)	EC (mS/m)	Static water level (mbgl)	Equipment	Water Use	Property Owner (Cell nr.)
DKBH1	S -33.897117 E 024.967512	180	3.61	330	10.08	Unequipped	Irrigation	Leon De Koning (082 822 3622)
DKBH2	S -33.896765 E 024.967242	180	~	1740	17.84	Unequipped	Irrigation	Leon De Koning (082 822 3622)
BJBH1	S -33.904292 E 024.957621	150	4.58	71.5	~	Solar	Irrigation/ Livestock	Bruce Johnson (082 653 4060)
BJBH2	S -33.903380 E 024.955706	150	1.39	239	14.5	Solar	Irrigation/ Livestock	Bruce Johnson (082 653 4060)
