**ZANDBERG SANDPUT (PTY) LTD**  
**PORTION 4 OF THE FARM ZANDBERG FONTEIN 97**  
**ROBERTSON MUNICIPAL DISTRICT**  
**WESTERN CAPE PROVINCE**

**STORM WATER MANAGEMENT PLAN**

**JANUARY 2022**

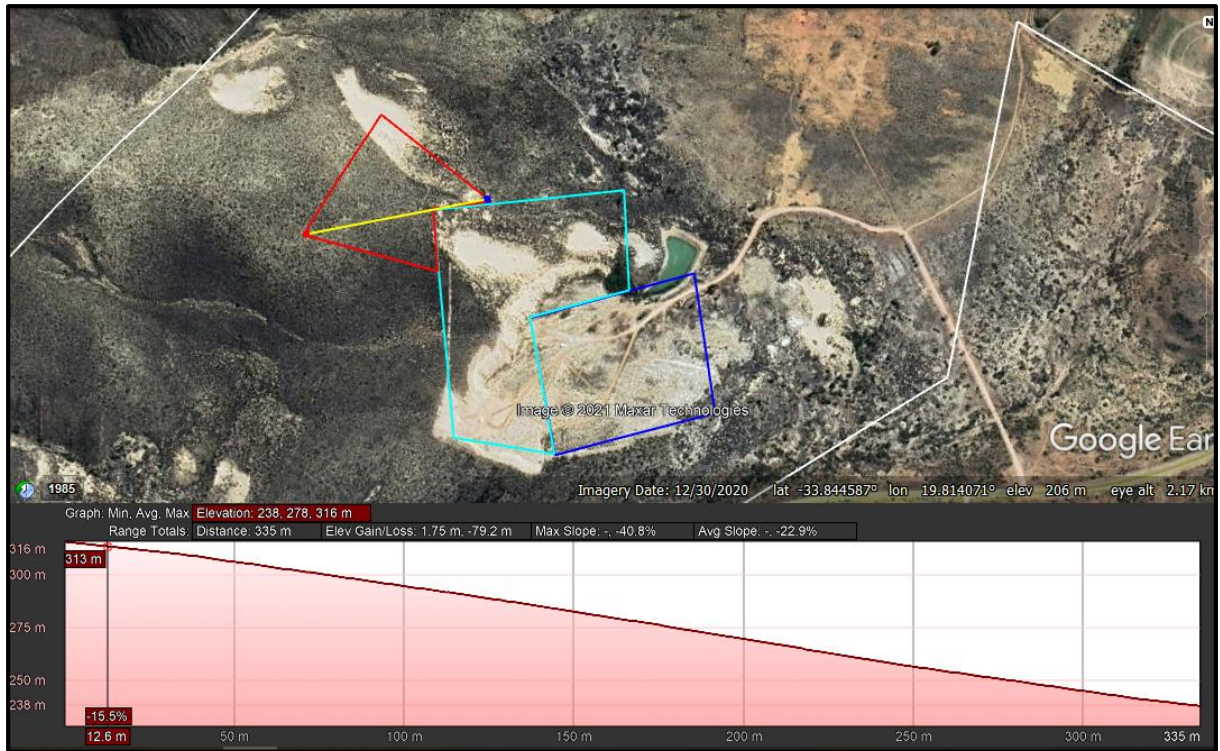
Figure 6: Elevation profile of the Site Alternative 2 (image obtained from Google Earth).

The topography of Site alternative 2 steeply slopes up the dune from the existing mining footprint, from 238 masl (eastern corner) rising to a maximum of 316 masl at the western corner over a distance of 335 m. The earmarked footprint has an elevation gain of 80.0 m, with a maximum slope of 40.4%, and an average slope of 22.8% between the lower eastern corner and the higher western corner as shown in the following figure.
