WETLAND DELINEATION  
FOR THE EXPANSION OF THE

# ZANDBERGFONTEIN

FARM 97/4 ROBERTSON  
SAND MINING OPERATION

A requirement of Section 40 of the National Water Act (36 of 1998)

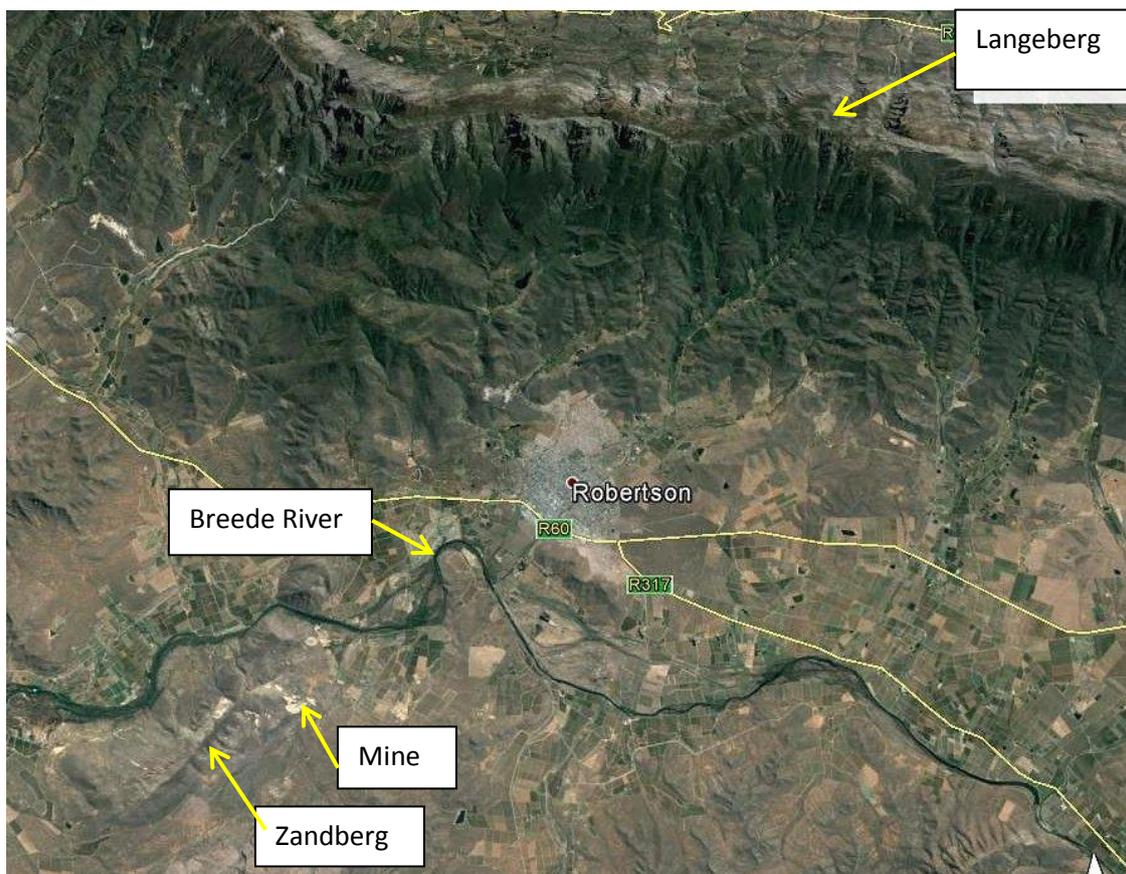
**Figure 1** Regional Setting

Zandbergfontein is located approximately 8km to the south west of the town of Robertson (Figure 1). The mine's product is an essential component of the region's building industry.

Robertson is at an elevation of approximately 200m above sea level. The mine against the slope of the Zandberg is on the same elevation. Rainfall increases with elevation. Robertson is semi-arid with a much lower rainfall than on the mountains (Figure 1).

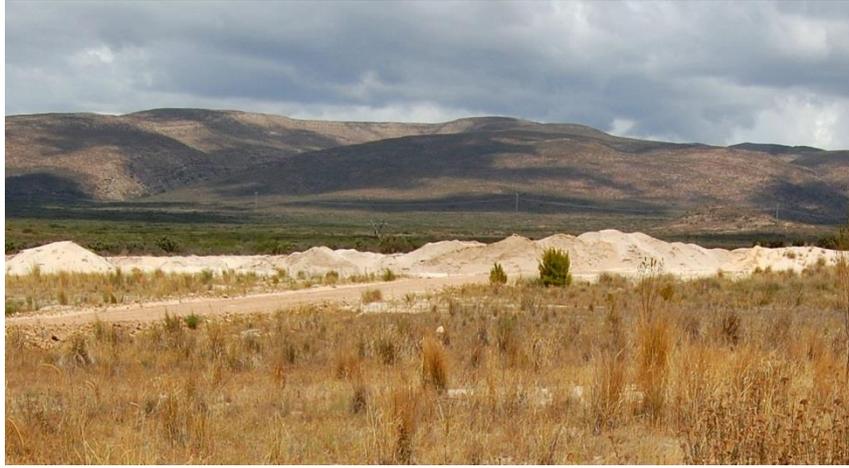
**Figure 2** Topsoil Stockpile

The topsoil is removed and stockpiled (Figure 2). The aim is to return the topsoil once the area has been mined out.

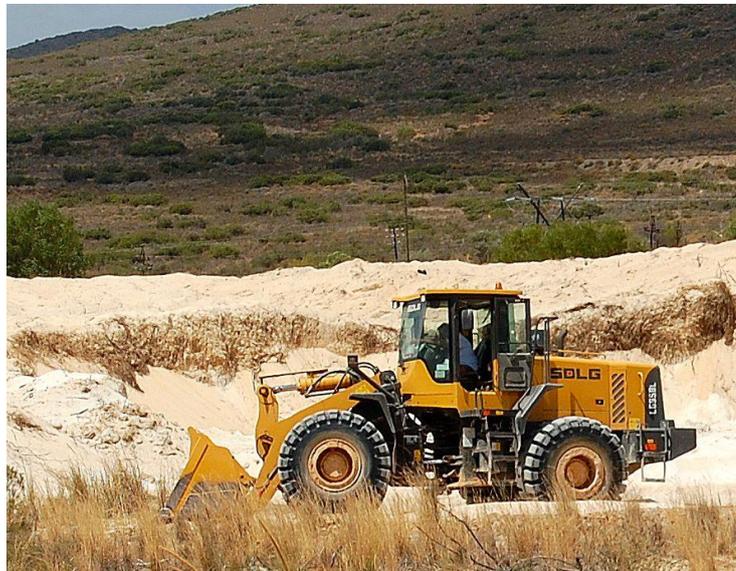
**Figure 3** Front end loader at Zandbergfontein

The sand is simply loaded with a large front end loader (Figure 3) onto a truck and the sand is then transported to wherever it is needed.

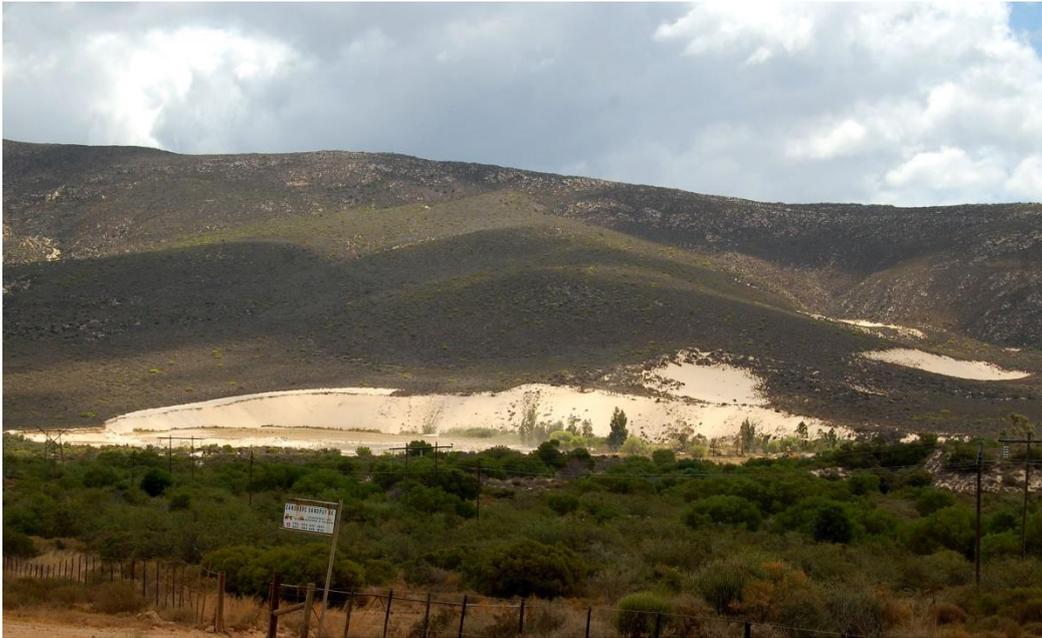
**Figure 5** Zandberg and Surrounds

**Figure 6** The dune at Zandbergfontein

Greeff (2010) eluded on a noticeable increase in groundwater yield from the temporary perched water table at the foot of the dune within 3 days of a downpour of rain. This is quite comprehensible, as the rather large sandy catchment area above the mine extends up right to the crest of the mountain (Figure 5 & 6).

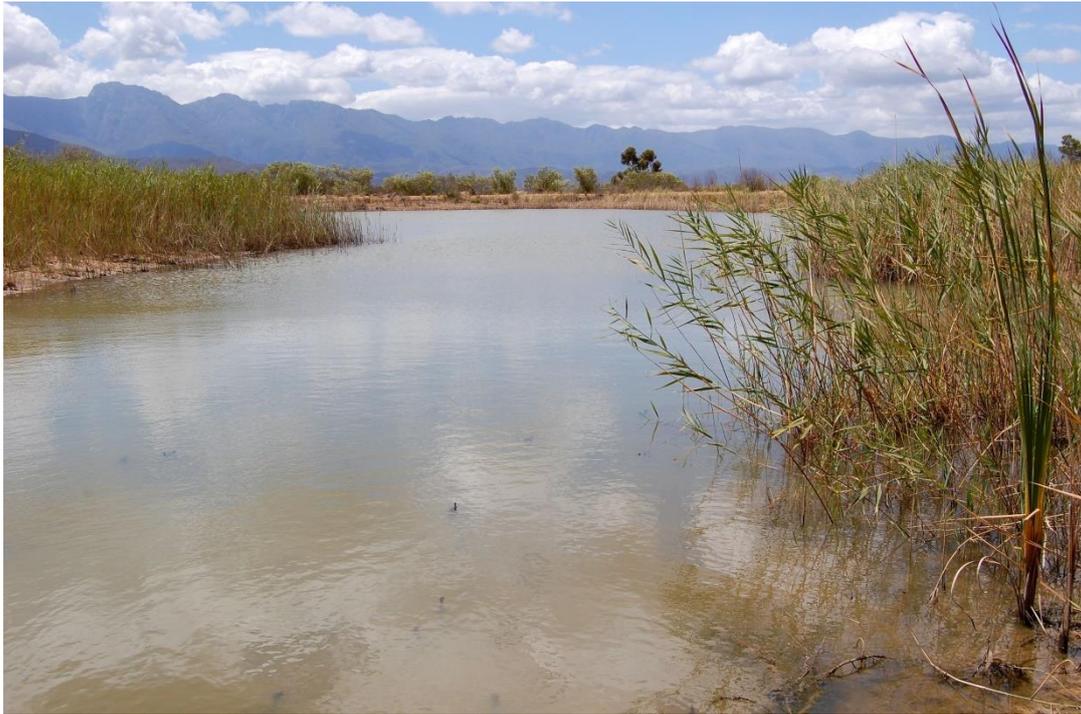
**Figure 8** The Dam

At this very interface, at the foot of the sand dune up the slope of the mountain, a trench of a metre deep was dug in order to intercept more of the ground water, not only the part that surfaced, but also more of it that found its way lower down into the sandstone. The trench stretches all the way to the dam (Figure 8) and the large volume of water in the dam bears testimony of a strong supply of ground water, even in the drought conditions during the field visit.

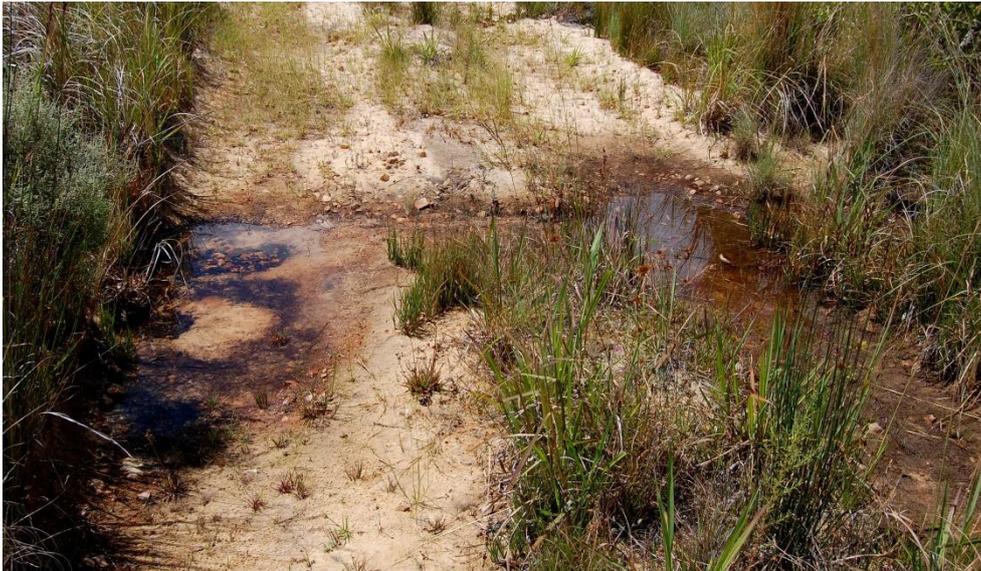
**Figure 9** Seepage

Ground water surfaced below the trench at various places (Figure 9) and indicates that only a portion of the ground water actually ends up in the dam. The removal of the sand layer in this part of the mined out area contributes to the decanting of ground water. The sand here is now much thinner and the remaining sand cannot hold the original volume of water. Hence it decants rather than entering the semi-saturated sandstone below. The end result is that more water evaporates and less ends up in the aquifer. This is not unique either, as a number of sand mines that WATSAN investigated in the Western Cape result in very much in the same ill effect. However, the affected area at Zandberg is small and it is surmised that the effect on the entire aquifer will hardly be noticed.

The soil adjacent and downhill from the trench was noticeably wet during the field visit. In some places water was emitted from the ground. If wetness was to be the sole indicator, this surely could be classified as a wetland. However, these wetland conditions may well be because of the recent mining, with the removal of sand and subsequent reduced water holding capacity and do not seem to be a natural or historic situation.

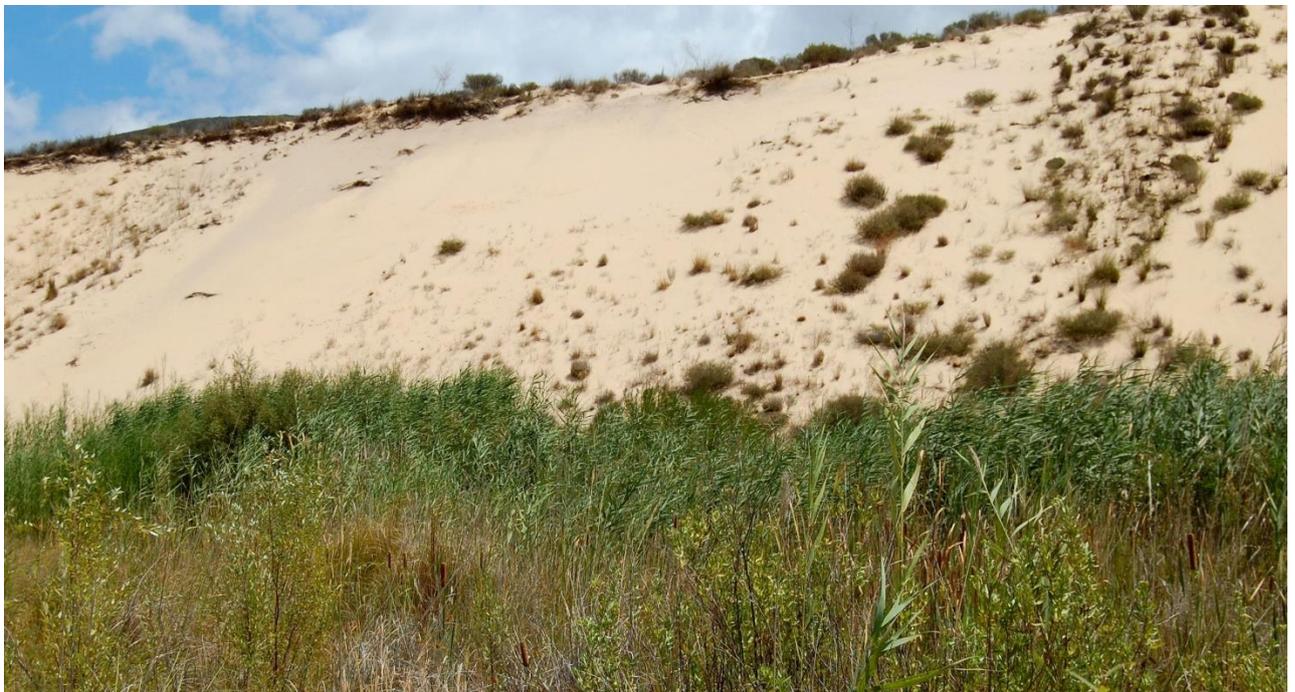
**Figure 10** Reeds

The digging of the trench at the base of the dune resulted in the accumulation of surface water. This was quickly colonised by reeds such as *Typha* and *Phragmites* (Figure 10). Today there is a thick stand of these reeds. It is doubtful if any reeds grew in this locality prior to the digging of the trench. There are no reeds where the trench stops.

The groundwater has a propensity to rather migrate downwards into the sandstone than to surface and the reason it appears above the ground is because the top layer has been removed. This clarifies the presence of sedges and restios (dekriet) in the area. Where the layer has not been removed, no sedges were detected during the field visit.

Evidently this is an anthropologically induced wetland. Perhaps it can be classified as “incidental” rather than “artificial”. It bears no special or other any conservation status.

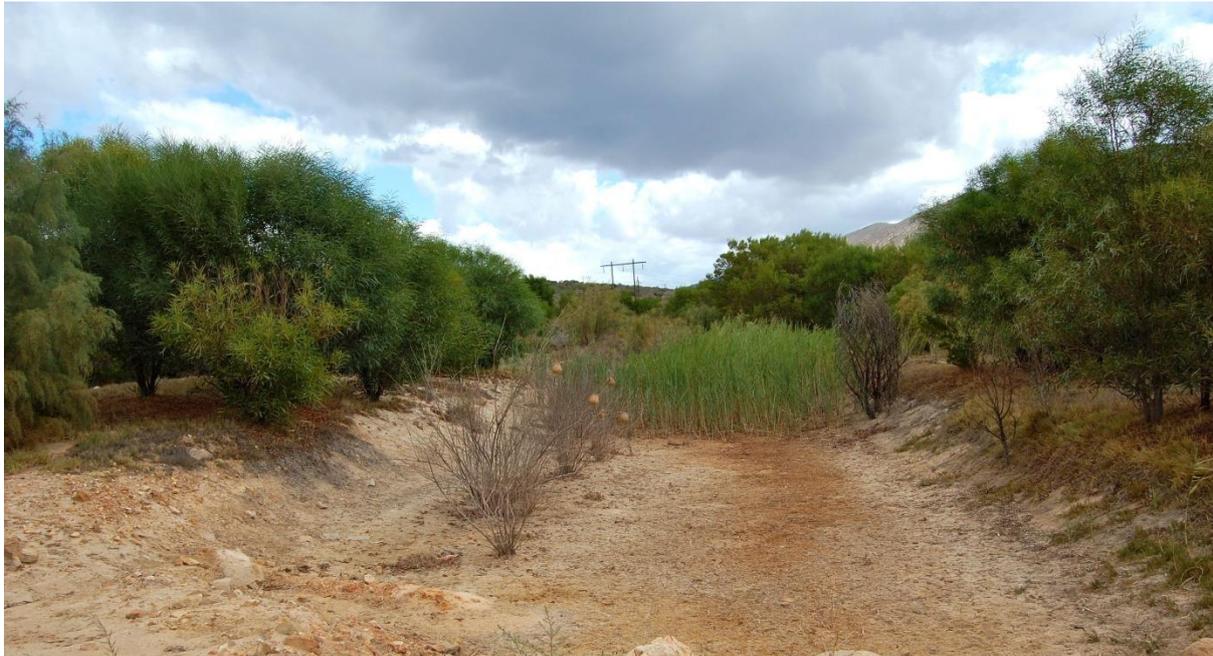
**Figure 11** Drainage Line

Because the landscape has been changed as a result of mining, it does not seem feasible to classify the Zandbergfontein Wetland. If it was nevertheless to be classified, it would be a foot slope seep against a lower mountain side without a discernible channel. The trench is artificial and is nothing that resembles a natural channel. The area of the mine does not have any connectivity with the drainage line in the valley below. The drainage line was dry during the field visit (Figure 11).
