**MINING OF SAND AND GRAVEL FROM A PORTION OF THE FARM  
DOORNKRAAL 832, MALMESBURY, WESTERN CAPE PROVINCE**

**ENVIRONMENTAL AUDIT REPORT**

<b>DMR REFERENCE NUMBER:</b>	<b>WC 30/5/1/2/2/10096 MR</b>
<b>AUDIT PERIOD:</b>	<b>30 April 2021</b>

**INSPECTION SHEET ENVIRONMENTAL CONTROL OFFICER**

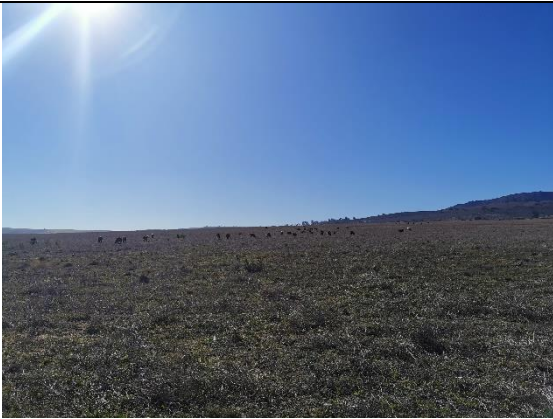
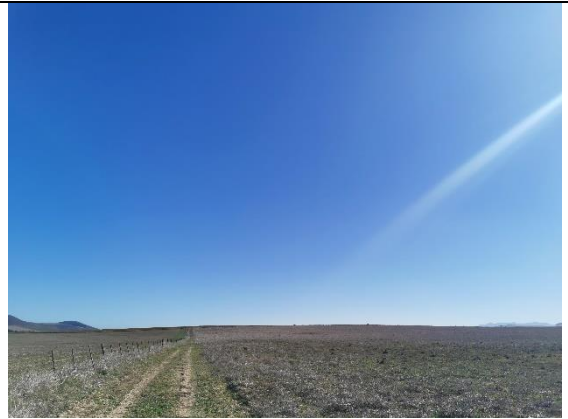
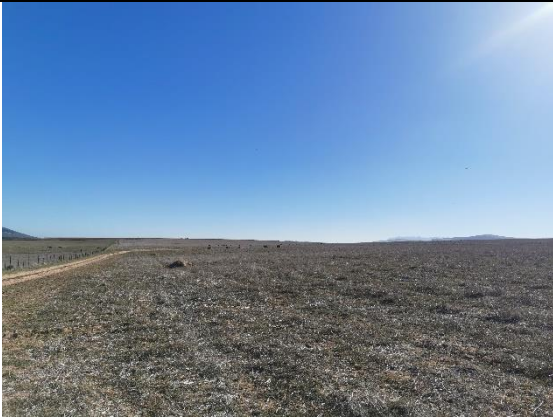
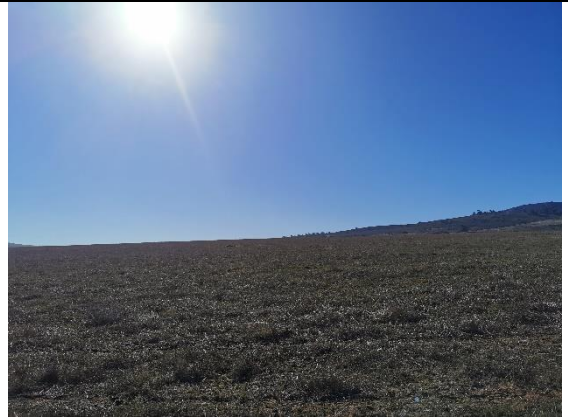
**ESKOM POWER LINES:** Buffers of 10m must be implemented and maintained in respect of the two eskom power lines to ensure that no construction work is executed close to any eskom structure or structures supporting mechanisms. No work or machinery is near to the conductors of the respective power lines and there is an obstruction free zone around all pylons.
