THABA STONE QUARRY

PORTION 2 AND THE REMAINING EXTENT OF THE FARM UITKOMST NO 558, THABA 'NCHU DISTRICT, FREE STATE PROVINCE

CLOSURE PLAN

DEPARTMENTAL REFERENCE NUMBER: FS 30/5/1/2/2/195 MR

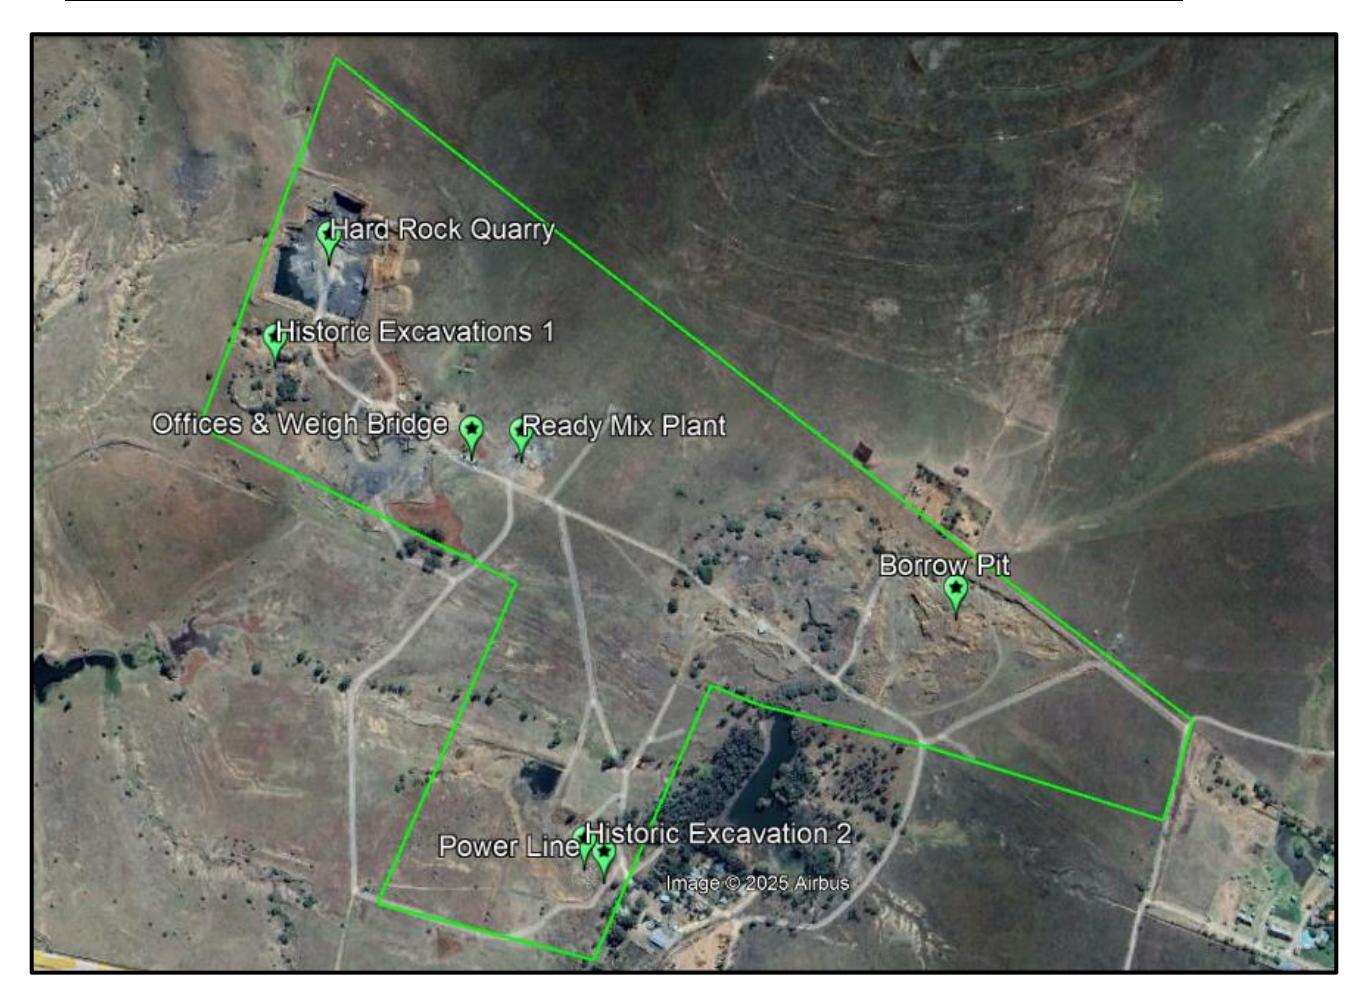
Site Coordinates	A1 29°12'54.36" S	26°52'21.28" E
	B1 29°13'18.75" S	26°52'57.21" E
	A 29°13'26.93" S	26°53'09.21" E
	F1 29°13'31.84" S	26°53'07.89" E
	C1 29°13'28.00" S	26°52'54.22" E
	D1 29°13'26.02" S	26°52'45.28" E
	G1 29°13'25.09" S	26°52'42.44" E
	H1 29°13'38.93" S	26°52'35.80" E
	l1 29°13'35.77" S	26°52'23.55" E
	J1 29°13'20.05" S	26°52'31.15" E
	E1 29°13'12.15" S	26°52'13.11" E

Figure 1: Satellite view of the layout of the Thaba Stone Quarry (image obtained from Google Earth).

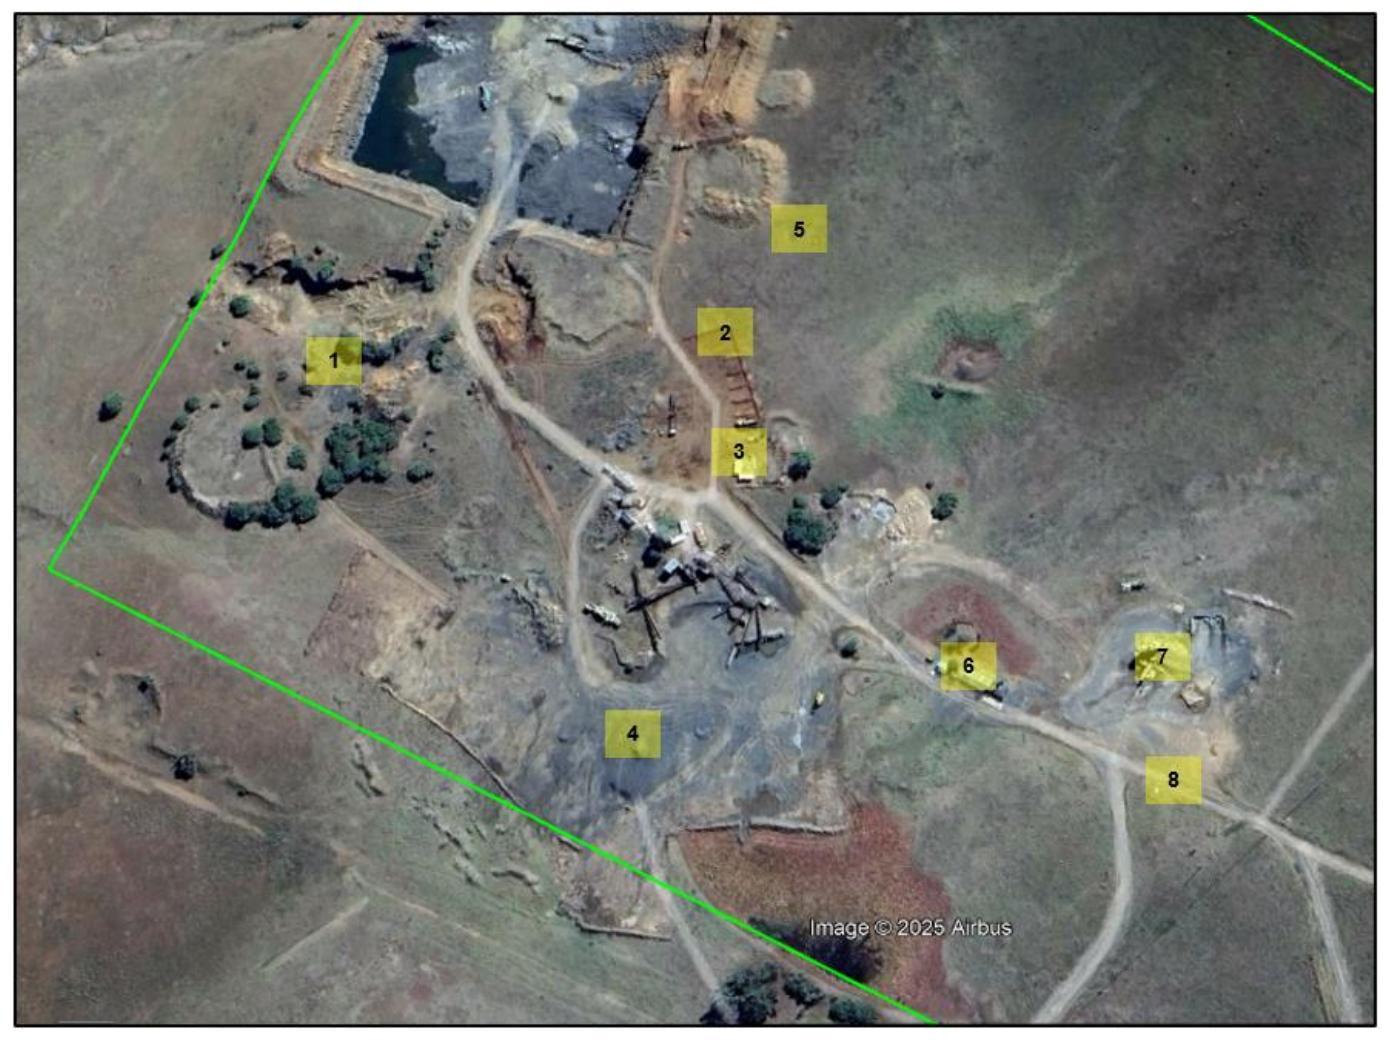
Figure 2: Satellite view of the various operational areas at Thaba Stone Quarry (image obtained from Google Earth).

The larger mining footprint is fenced while the hard rock excavation is defined by perimeter soil berms. Access to the mine is possible from the N8 National Road passing the mine to the south.

A workshop was established on site (Figure 2) where minor servicing and emergency repairs of project related equipment/machinery takes place. Fuel is stored in a 23 000 I tank with build in drip tray. As mentioned earlier a genset powers the infrastructure. Chemicals are stored in the designated storage containers in accordance with the product specific material safety data sheets.
