Rehabilitation Map

Mining permit application area: 4.8 ha
Client:

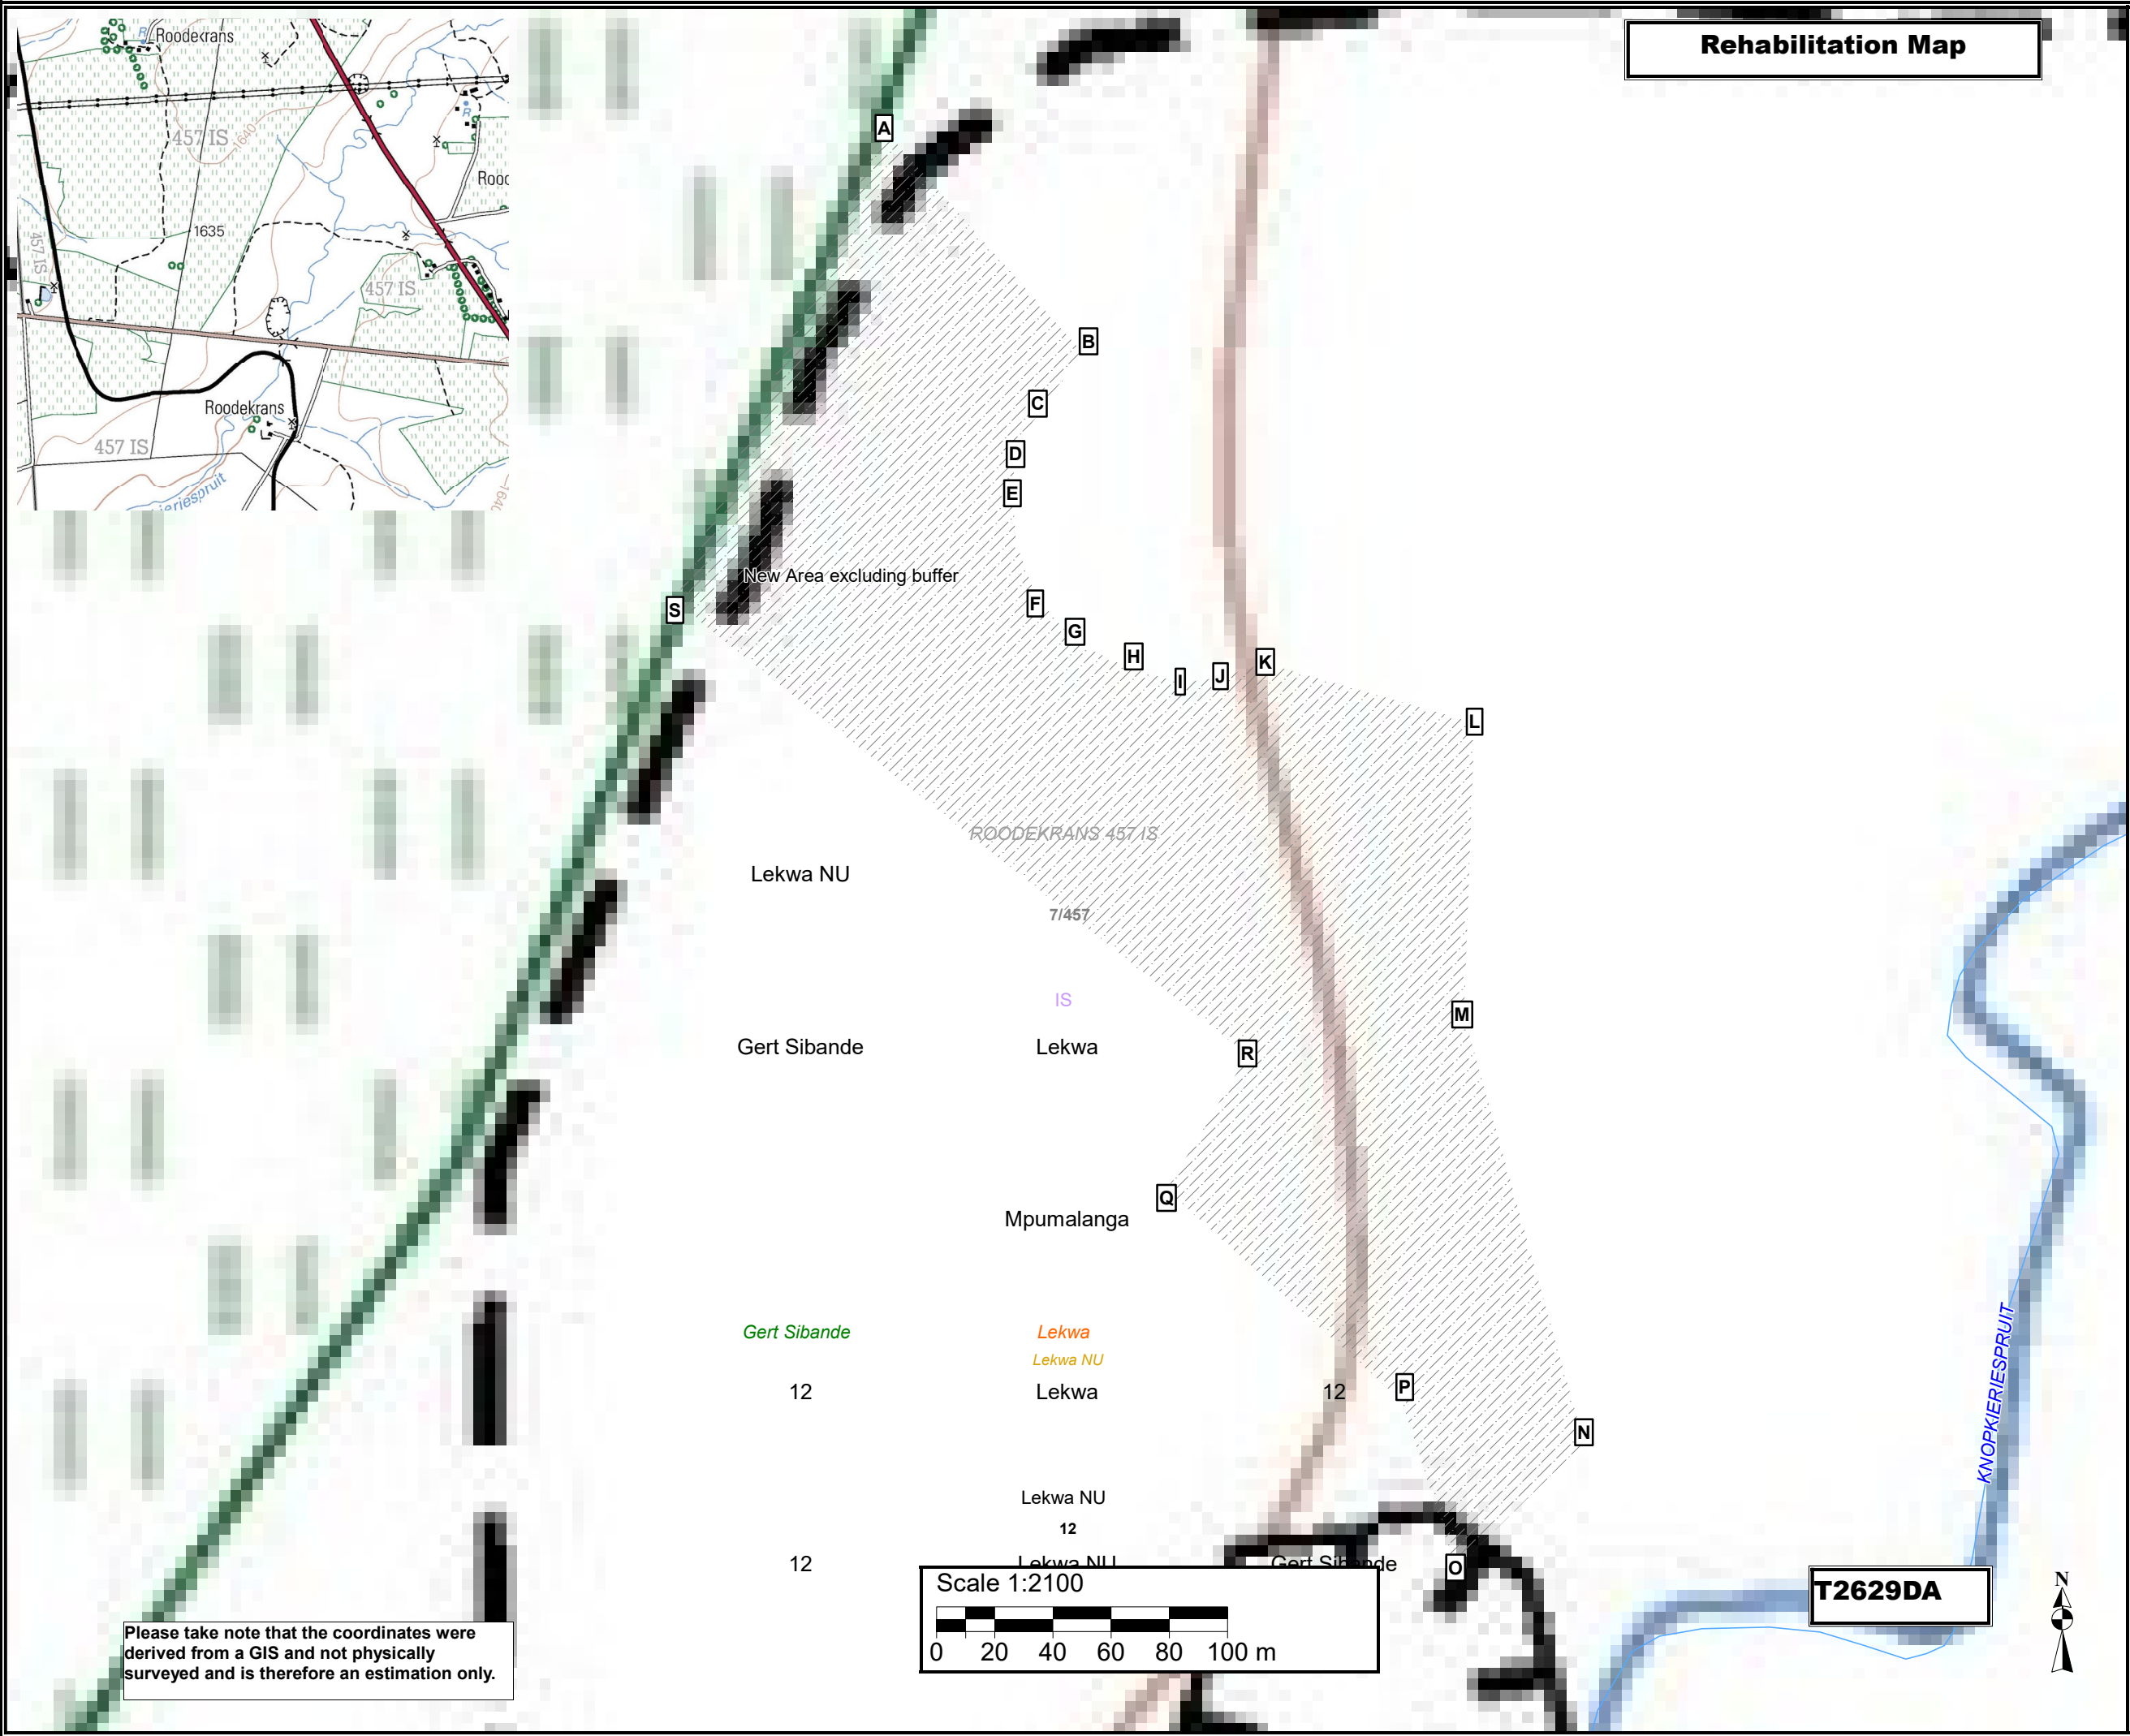
- Mining Permit Area Rehabilitated: Rehabilitation Overview
General Rehabilitation: Environment restored as close as possible to natural or agreed sustainable use.

- Access Roads
Unused Roads: Ripped/ploughed to allow regrowth of vegetation.
- Road Materials: Non-natural materials removed before rehab.
- Excavation Area
Quarry Rehab: Transformed into a natural-looking landscape with slopes and benches.

- Vegetation: Benches and slopes covered with soil for planting trees.
- Rock Fill: Rocks reused in quarry; no waste dumped.
- Quarry Floor: Capped with soil and re-vegetated.

- Processing Area
Ramp Material: Removed and placed in excavation.
- Compacted Areas: Scarified (loosened) to 300mm depth.
- Topsoil Return: Original soil layers replaced in correct order.

- New Coordinates 60m buffer

Proposed mining area coordinates:
A-26,682911°S; 29,580207°E
B-26,68433°S; 29,580982°E
C-26,684664°S; 29,582286°E
D-26,68557°S; 29,582235°E
E-26,686893°S; 29,582654°E
F-26,687277°S; 29,582214°E
G-26,68675°S; 29,582016°E
H-26,686107°S; 29,58122°E
I-26,685694°S; 29,581495°E
J-26,684296°S; 29,579529°E
A-26,682911°S; 29,580207°E
