BALMORAL QUARRY

**BALMORAL QUARRY (STONE GRAVEL / AGGREGATE) ON A PORTION  
OF PORTION 30 OF THE FARM DOORNRUG 302 JS, BALMORAL  
DISTRICT, MPUMALANGA PROVINCE**

**ENVIRONMENTAL PERFORMANCE ASSESSMENT**

<b>DMR REFERENCE NUMBER:</b>	MP 30/5/1/2/10104 MR
<b>DMR REFERENCE NUMBER:</b>	MP 30/5/1/3/3/2/1/ 00073 EM
<b>NEAS NO:</b>	MP/EIA/0000957/2015
<b>AUDIT PERIOD:</b>	<b>September 2025</b>

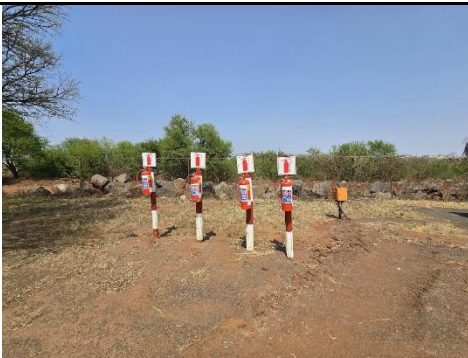
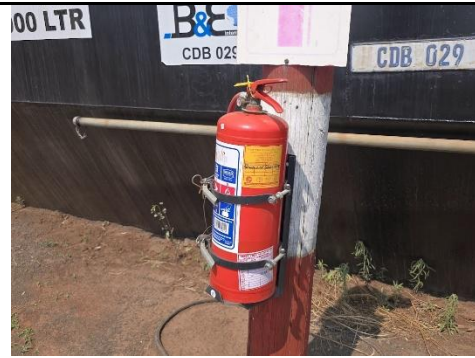
**FIRE EXTINGUISHERS VISIBLE AND SERVICED**

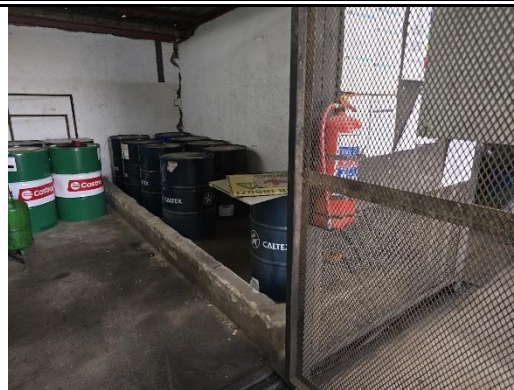
OIL STORE

OIL SPILL KIT

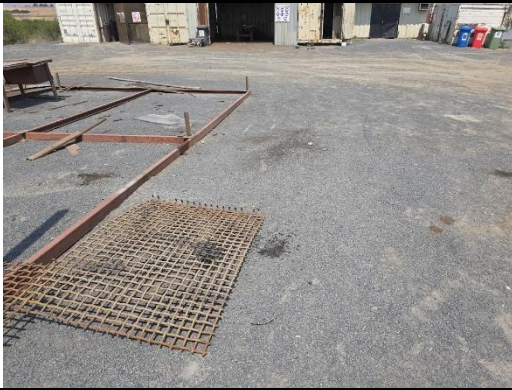
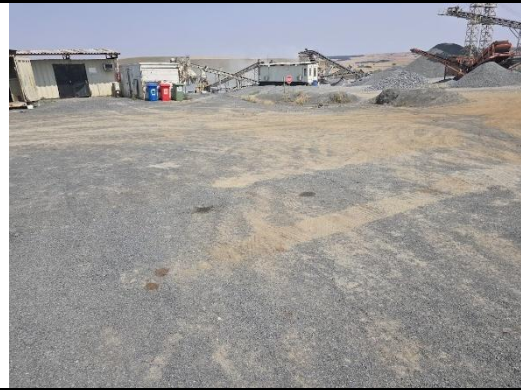
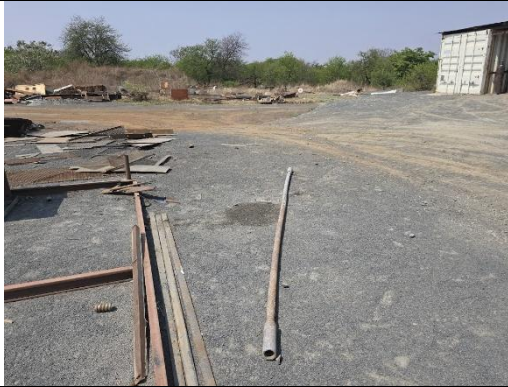
VEHICLE NOT BEING WASHED IN WASHBAY
